# Historic Structure Report

March 2004

## Oakland Plantation South Tenant Cabin Cane River Creole National Historical Park Natchitoches, Louisiana

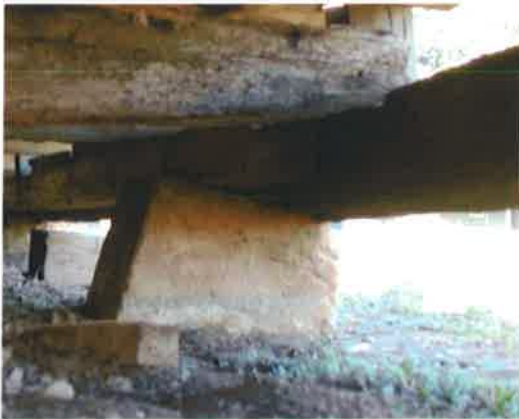
Beam at front gallery

The front gallery floor framing has a significant amount of recycled material, including some hewn members. Based on the characteristics of the materials used in the front gallery piers, the front gallery was constructed sometime during or after the 1920s. The joists are toe-nailed to the hewn beam of the main building with wire nails, a poor structural detail. Some of the joists are hewn. Prior to the National Park Service stabilization work in 1998, wood blocking was placed under some joists to provide additional support to the failed nail

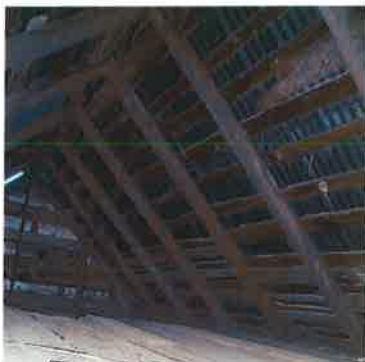
Roof framing over main building

The roof framing over the main building is 2" by 5" circular sawn rafters spaced at 36" on center with 1" shingle lath running horizontally at approximately 12" on center. There was no ridge member in the roof framing. Cut nails were observed, identifying the

roof framing as contemporary with the hewn-timber framed *bousillage* building below. Full access to the attic area to examine each member and its connection was not available. The spacing and size of the lath is consistent with support for wood shingle roofing.

- Structural calculations find that the roof framing is inadequate to meet current codes for wind load. Carefully consider the historic performance of the existing roof structure in relation to the extent of modification necessary to satisfy modern design calculations. Retain as much of the historic material and assembly as is possible. Any treatment should minimize the damage to the historic materials of the building while achieving adequate structural stability.
- Replace any roof framing members that are not structurally sound with materials that match the original in dimension, character, and species.

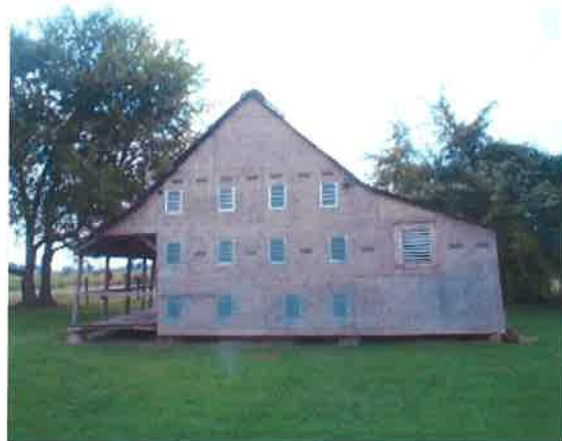
South Tenant Cabin, north elevation

The roof framing of the South Tenant Cabin is in fair condition but is inadequate to support the roof by modern standards. Moisture infiltration from poorly fastened roof covering has caused decay in the roof boards, rafters, and attic floor framing. The roof rafters were analyzed for compliance with current building codes. To comply with the International Building Code, the roof must support a live load of 12 psf. The roof was also analyzed for wind loading. Per the requirements of the International Building Code for wind conditions in the portion of the state of Louisiana in which the building is situated, the roof of the main portion of the cabin should resist a load of 15 psf (based on the pitch) and the overhang should resist a load of 22 psf. The existing rafters are

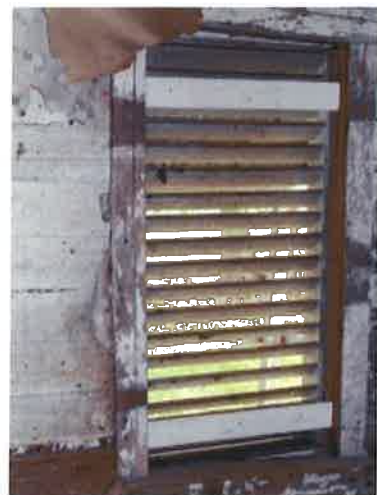
Exterior of Window E

*Window E:* Window opening E measures 2'-4" by 4'-7½". The jamb is a Type 2, and the sill is Type 1 (see illustration). The HABS drawings indicate that this window was double hung with four 2/2 divided lights in each sash.

- Treatment of the windows is important. Like those in the North Tenant Cabin, the windows are known to be a mid-twentieth century addition installed in a crude manner. It will be important for the windows to be repaired and sashes reinstalled in the same manner, based on existing conditions, while ensuring that they are watertight for continued use. This will require some careful attention to the existing construction details in order to replicate the historic configuration when restoring the windows.

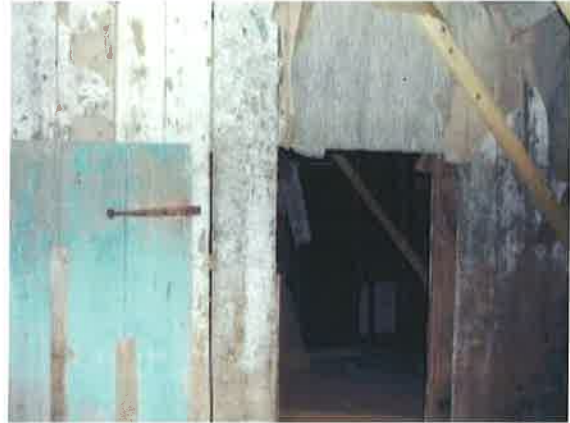
Detail of south wall of Room 102

The south wall is constructed of vertical boards in random widths of 8" to 11½", painted white. Portions of two layers of deteriorated wallpaper remain on the ceiling.

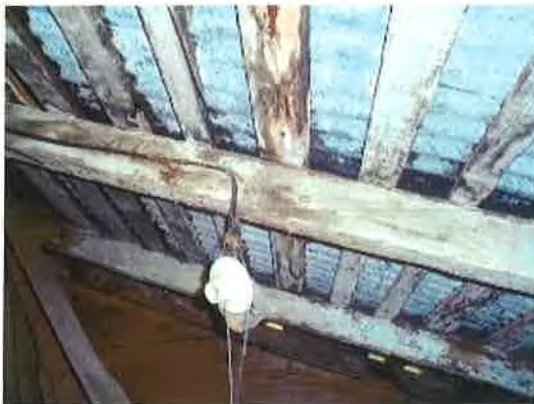
Detail of exposed roof and light fixture in Room 104

attic space and along the beams. All are in poor condition and cannot meet current National Electrical Code standards.

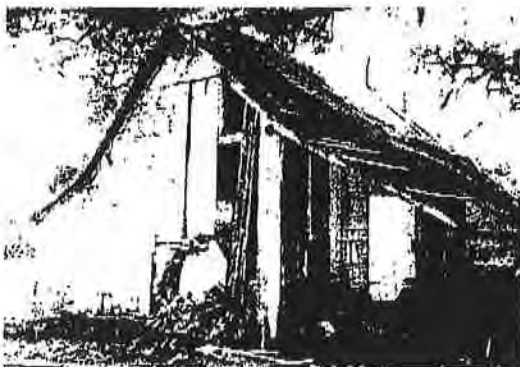
2-36. Northwest elevation of North Slave Quarter's prior to stabilization work.

- 2) *Roof Cover Repair.* The roof was inspected during several rainstorms and we found many leaks. The Northwest hip was leaking along much of its length due to missing and failing hip caps. We repaired this by thoroughly cleaning the area then applying TopCoat Flashing Grade in the cracks and openings followed by wrapping the hip with 12" wide by 24" long pieces of aluminum flashing applied directly over the existing caps. The flashing was installed with a 6" lap over its top end and screwed in place. Two applications of TopCoat Flashing Grade and one finish coat of regular TopCoat were applied over the flashing to insure the water would stay out and the flashing will stay down. The other leaks were all around the valley flashing at the three dormers on the East slope of the roof. Close inspection revealed the asphalt tar at the top of each valley had dried out. The tar was probably applied after the roof was installed to compensate for the minimal amount of length the flashing extends under the shingles. We cleaned the area, scraped the old loose tar away, and replaced it, in kind.

- 3) *Roof Drainage System.* The gutter was full of holes and leaking throughout its length. Many of the leaders were missing or disconnected. Aluminum Flashband, a product similar to Ice & Water Shield, was used to line the gutter where holes were present. Two applications of TopCoat Flexseal were applied over the Flashband product. The loose eave tubes were reset, one was replaced, and new 3x4" temporary aluminum leaders (downspouts) were installed to replace the missing ones. The existing units were re-secured. We extended the leaders at their bottom with an additional 10' length making sure the water shed away as far as possible.
- 4) *Windows.* We installed a louvered plywood blank over the window on the West side of the kitchen addition. The unit was failing. We left the window in place.

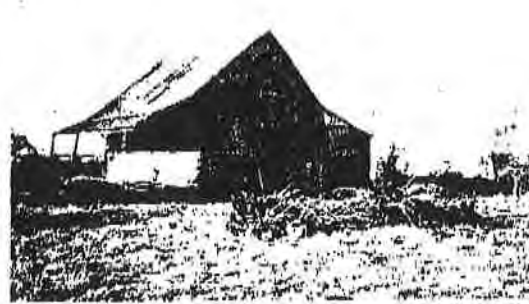
9-24. South Slave Quarter's, north elevation wall complete. Note poison ivy on ground.

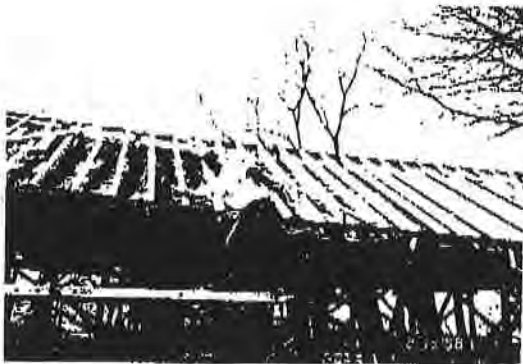
7-5. The Wagon Shed, south slope of roof during structural stabilization work.

- 1) *Structural System.* The open timber framed structure was near collapse. The rafter plates, rafters, collar ties, roof sheathing, and many of the posts are decayed. However the structure is still standing. We installed a diagonal cribbing system to support the structure from leaning on the East side. We then installed temporary walls along its length to support the rafter plates and eaves. The failing rafter system required augmentation and we fabricated and installed wood trusses throughout to assist with keeping the roof from further collapse.

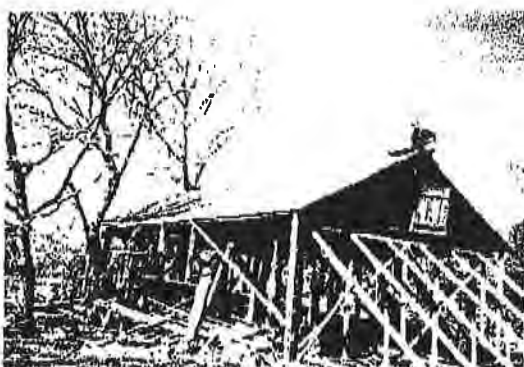
10-10. The Wagon Shed. Asphalt roof cover on south slope almost complete.

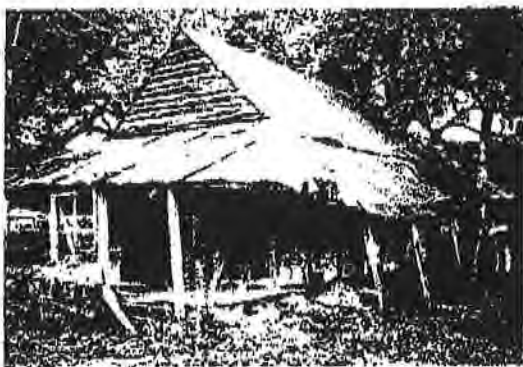
3-35. The Cook's House. Northeast elevation prior to stabilization work.

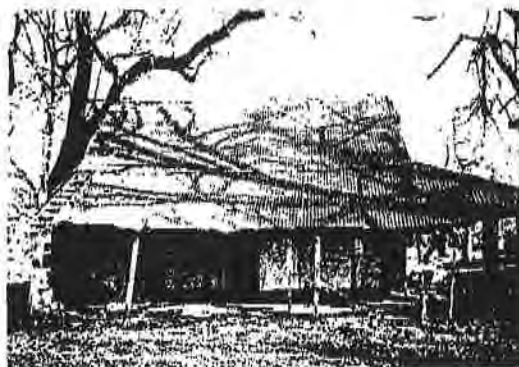
8-4. The Cook's House. South elevation prior to stabilization work.

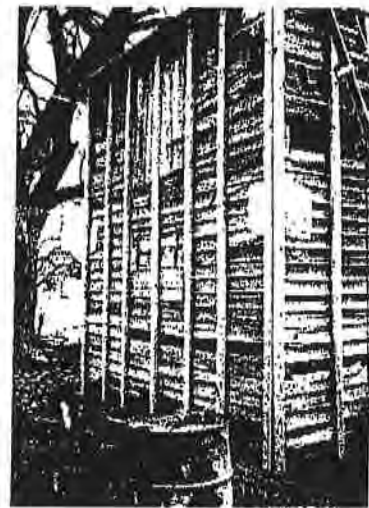
5-3. The East Pigeoneer during installation of the studs.

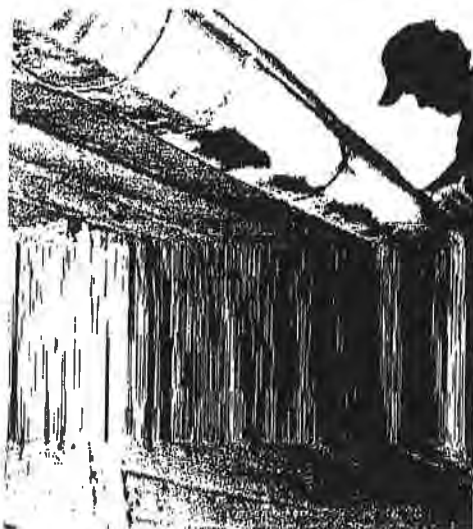
9-17. The wrap around gutter on the Main House during the patching process.

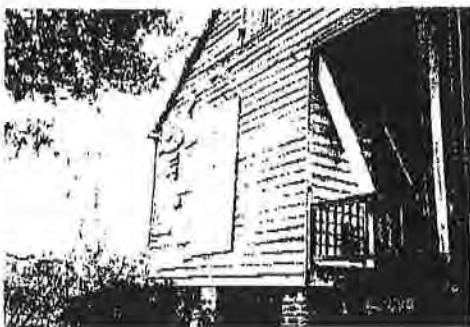
11-21. West elevation of the Main House showing the stabilized window complete.

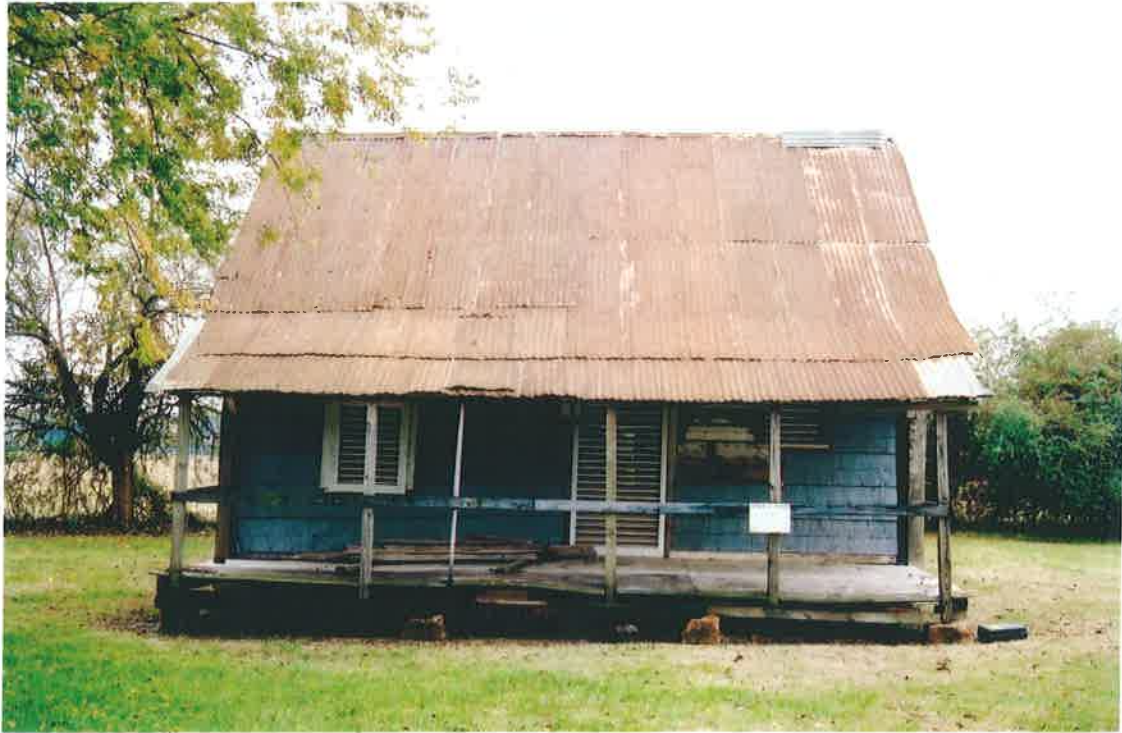
*Image 66: Oakland Plantation. South Tenant Cabin, east elevation, 2002.*

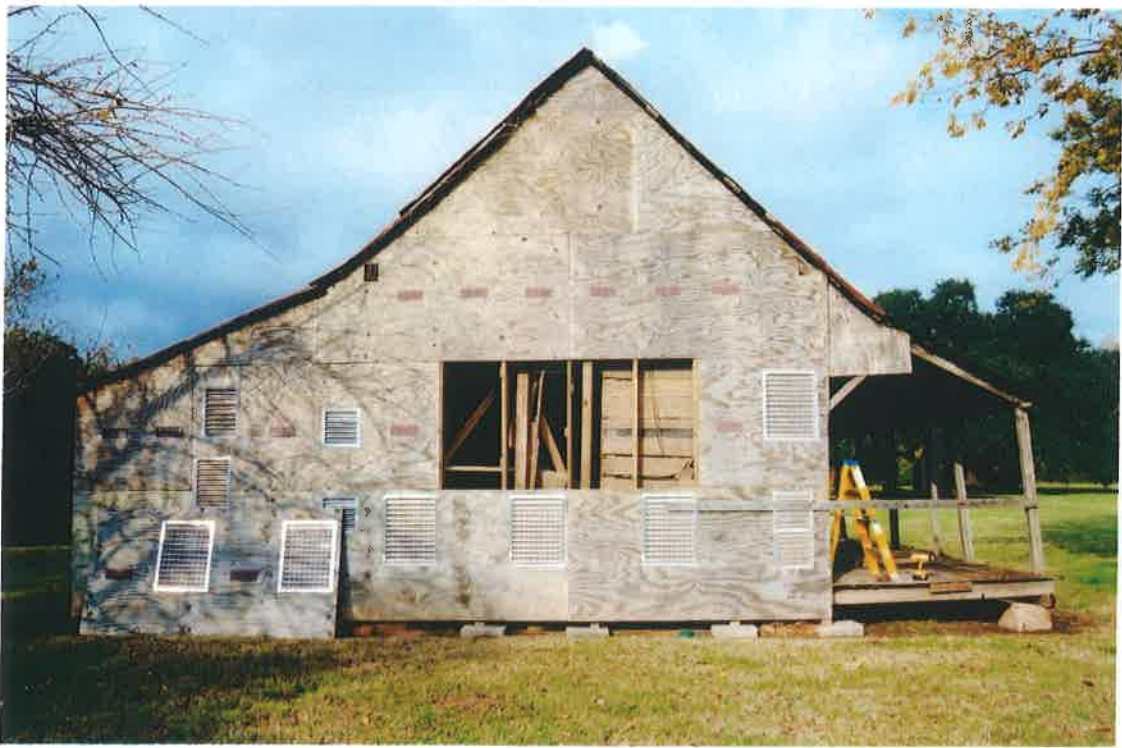
*Image 67: Oakland Plantation. South Tenant Cabin, south elevation, 2002.*

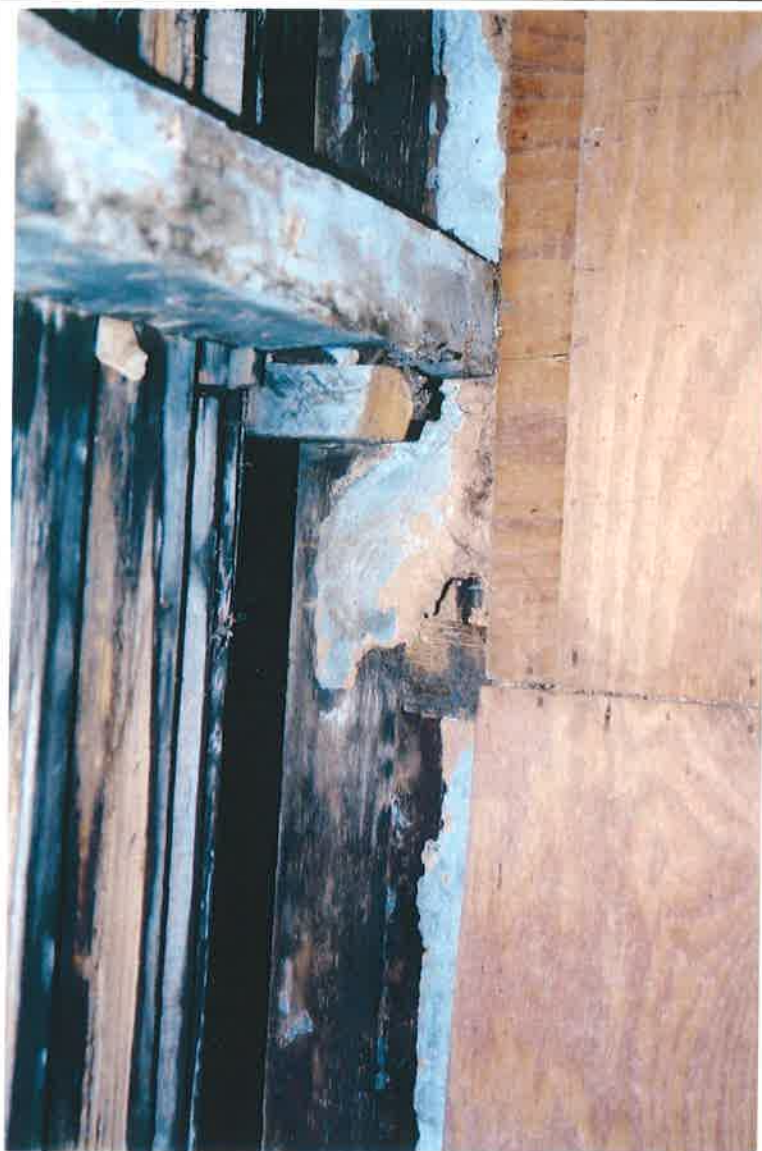
*Image 68:* Oakland Plantation. South Tenant Cabin, Room 104, east wall, 2002. The original *bousillage* walls can be seen behind the protective plywood sheathing.

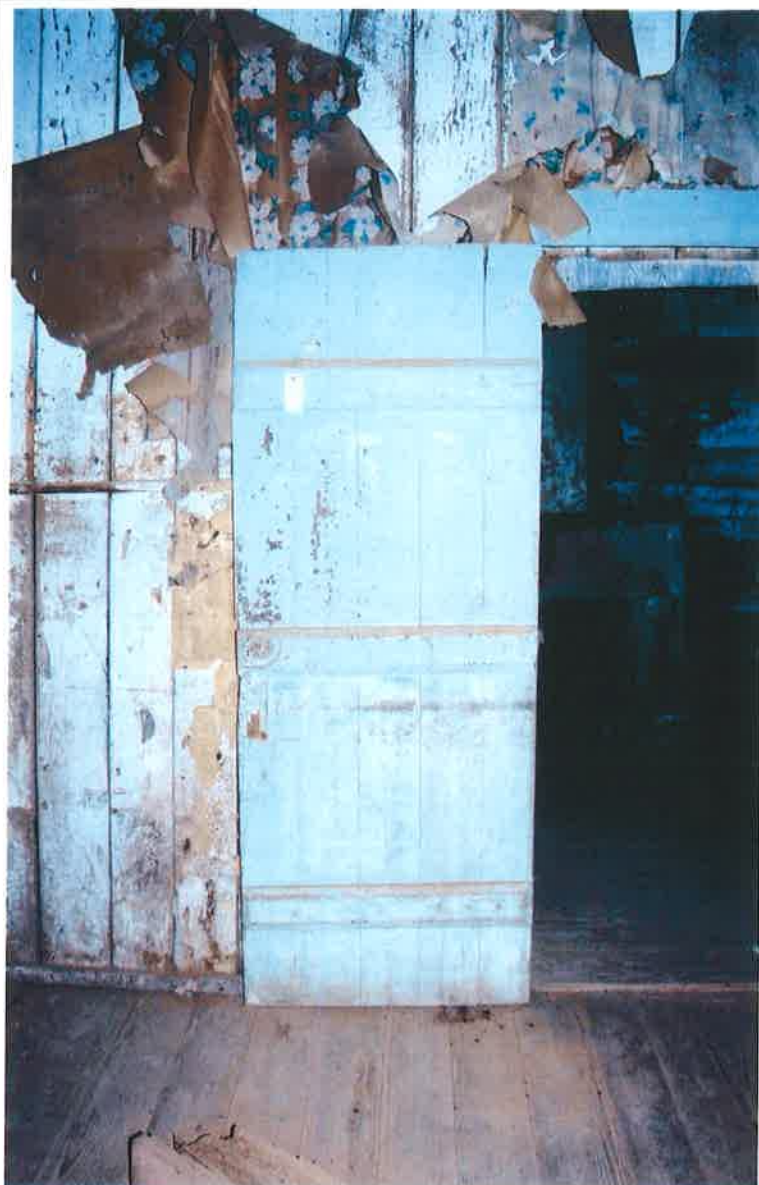
*Image 78:* Oakland Plantation. South Tenant Cabin, Room 102, south wall, 2002. Door D2.

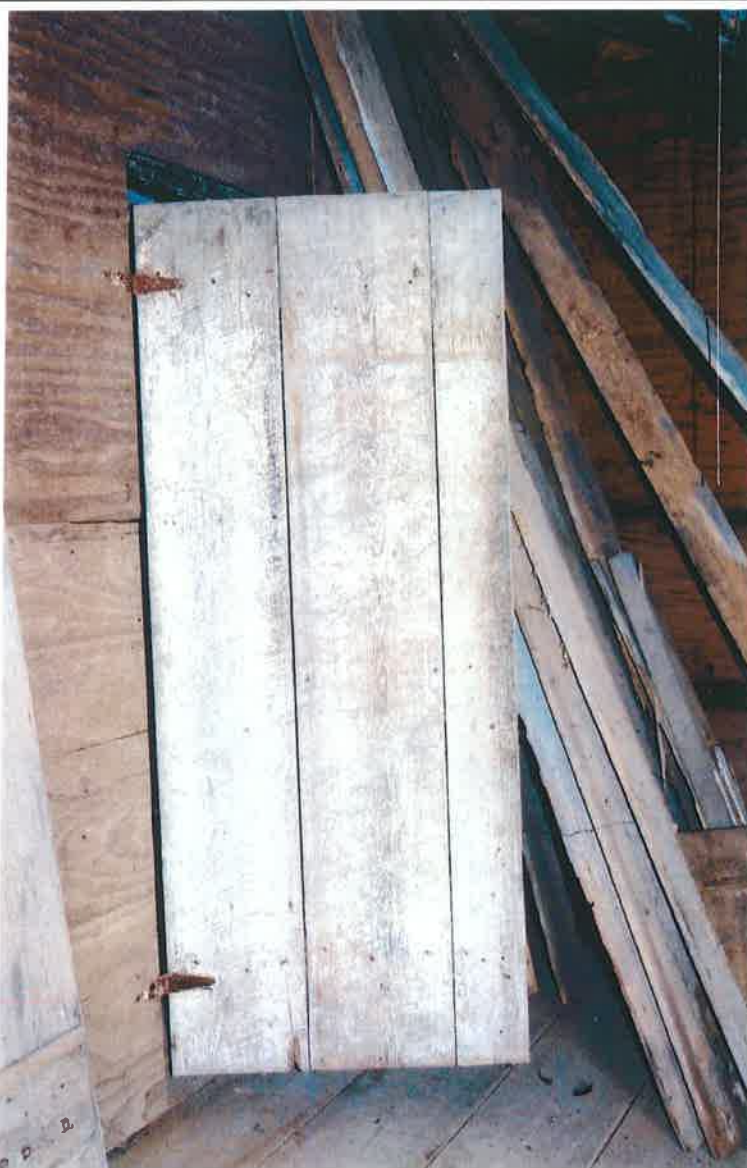
*Image 80:* Oakland Plantation. South Tenant Cabin, Room 104, 2002.  
Door D3.

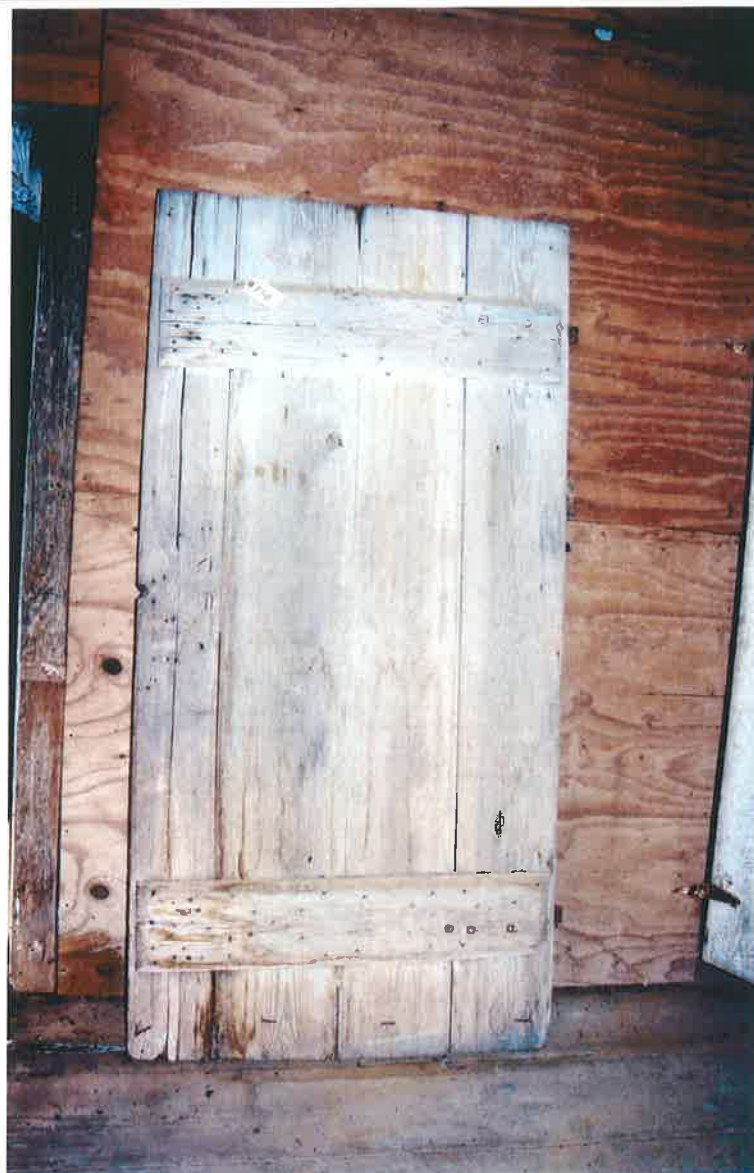
*Image 81:* Oakland Plantation. South Tenant Cabin, Room 104, 2002.  
Door D4.

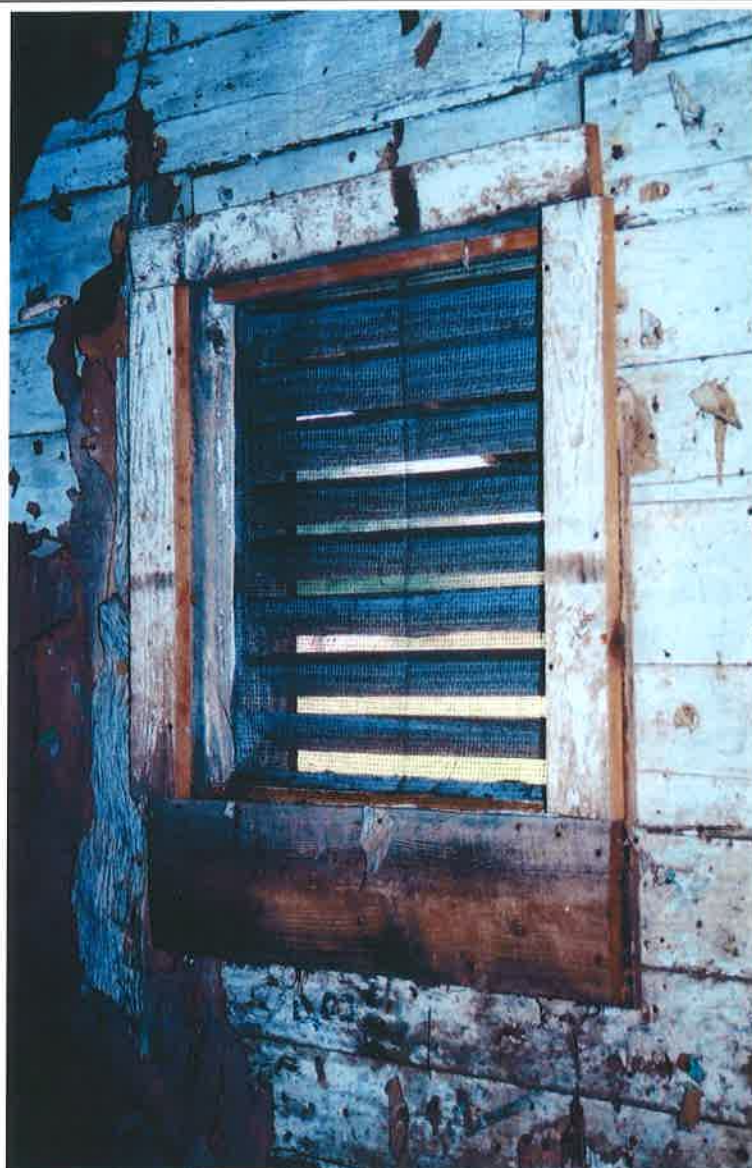
*Image 84:* Oakland Plantation. South Tenant Cabin, Room 103, 2002.  
Window surround on east wall.

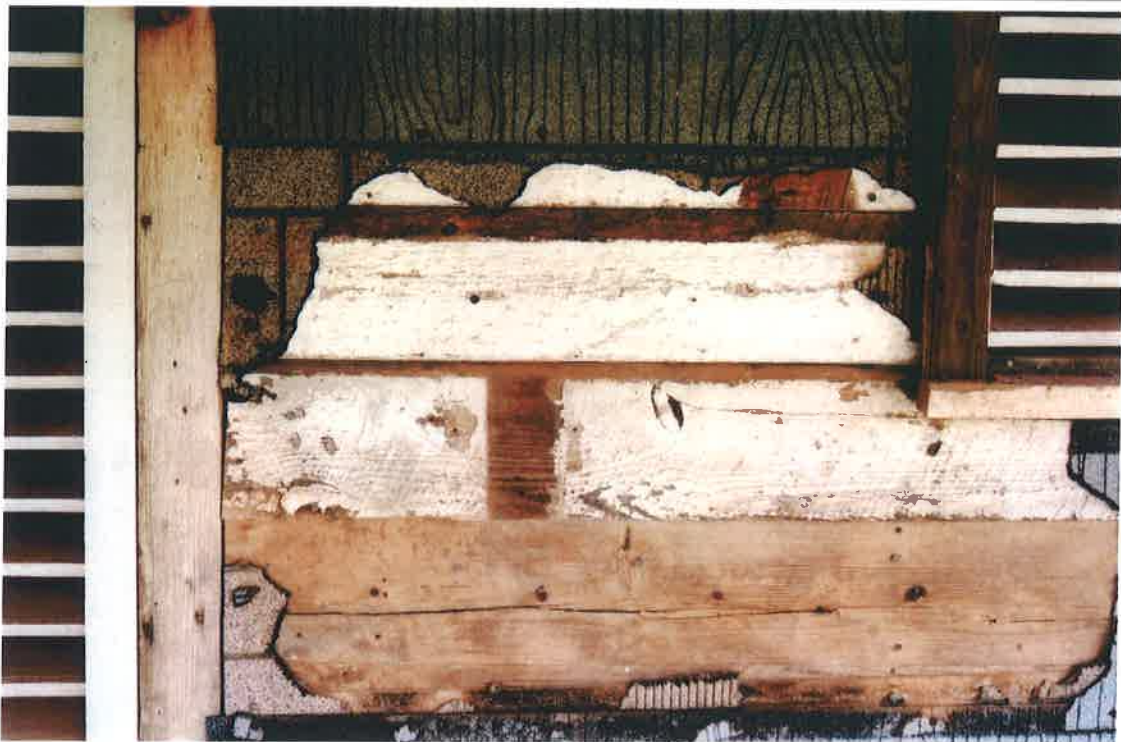
*Image 86:* Oakland Plantation. South Tenant Cabin, east elevation, 2002. Recycled board-and-batten sheathing under asphalt paper (and over *bousillage*).

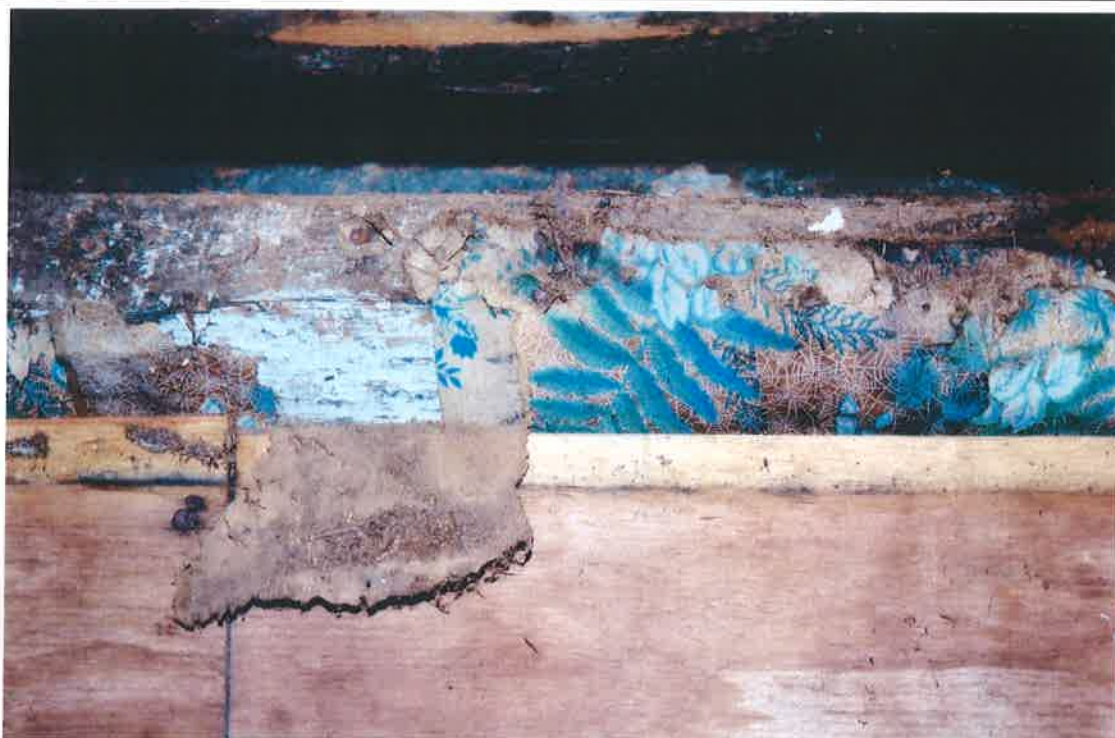
Image 88: Oakland Plantation. South Tenant Cabin, Room 104, 2002. Remnants of one of the wallpapers and earlier whitewashed framing under the plywood sheathing.
