## Doris Leeper House Cape Canaveral National Seashore

This report is based on a site visit to the Doris Leeper House on 25-26 March 2002. The purpose of the visit was to evaluate the integrity of the 1.63-acre site, which lies on the western shore of the barrier island at the northern end of Mosquito Lagoon. The site includes three buildings---a house and garage, both apparently built in 1927; a combination guesthouse and artist's studio, built in 1969; an asphalt tennis court, which may also date to the 1960s; and a wooden dock of indeterminate age.

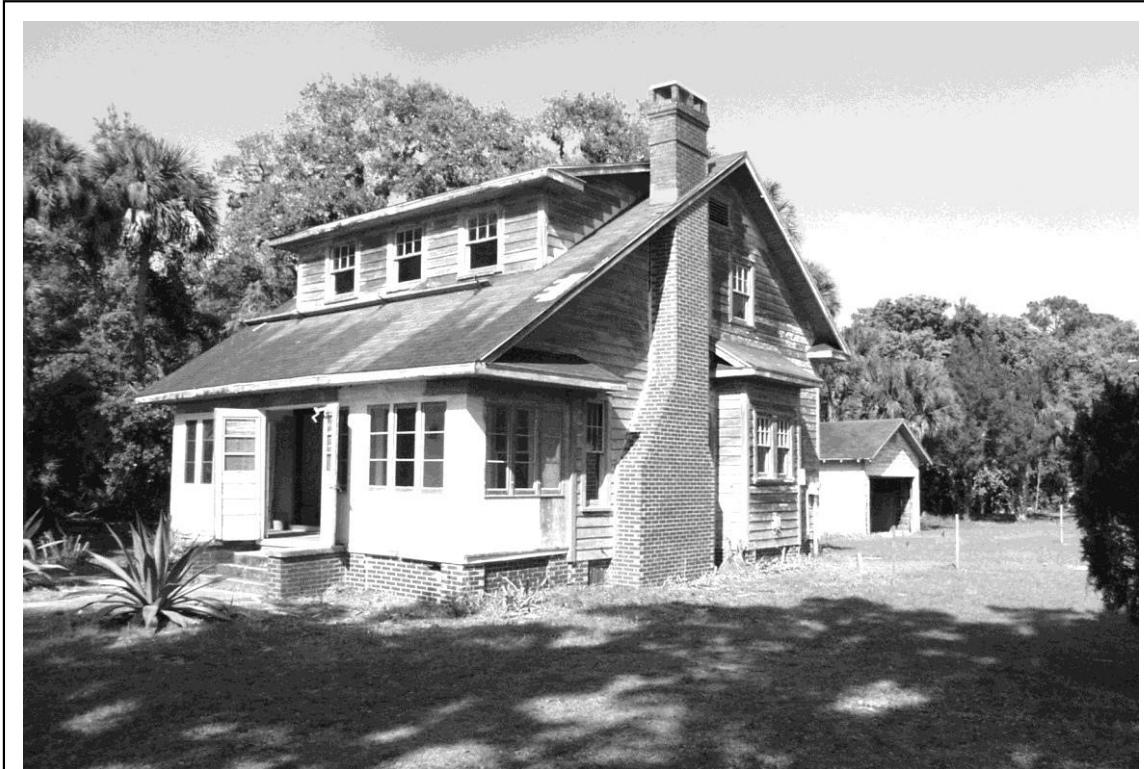
**Figure 4** View to northeast of Leeper House. (NPS-SERO-CRS, 2002)

**Main House:** Facing in a generally westerly direction, the house is a one-and-a-half story, Craftsman-style structure. Wood-framed with end gables and with shed-roofed dormers on the front and back, the house features a full-width front porch and a small back porch, both of which have been enclosed. The first floor encompasses about 865 square

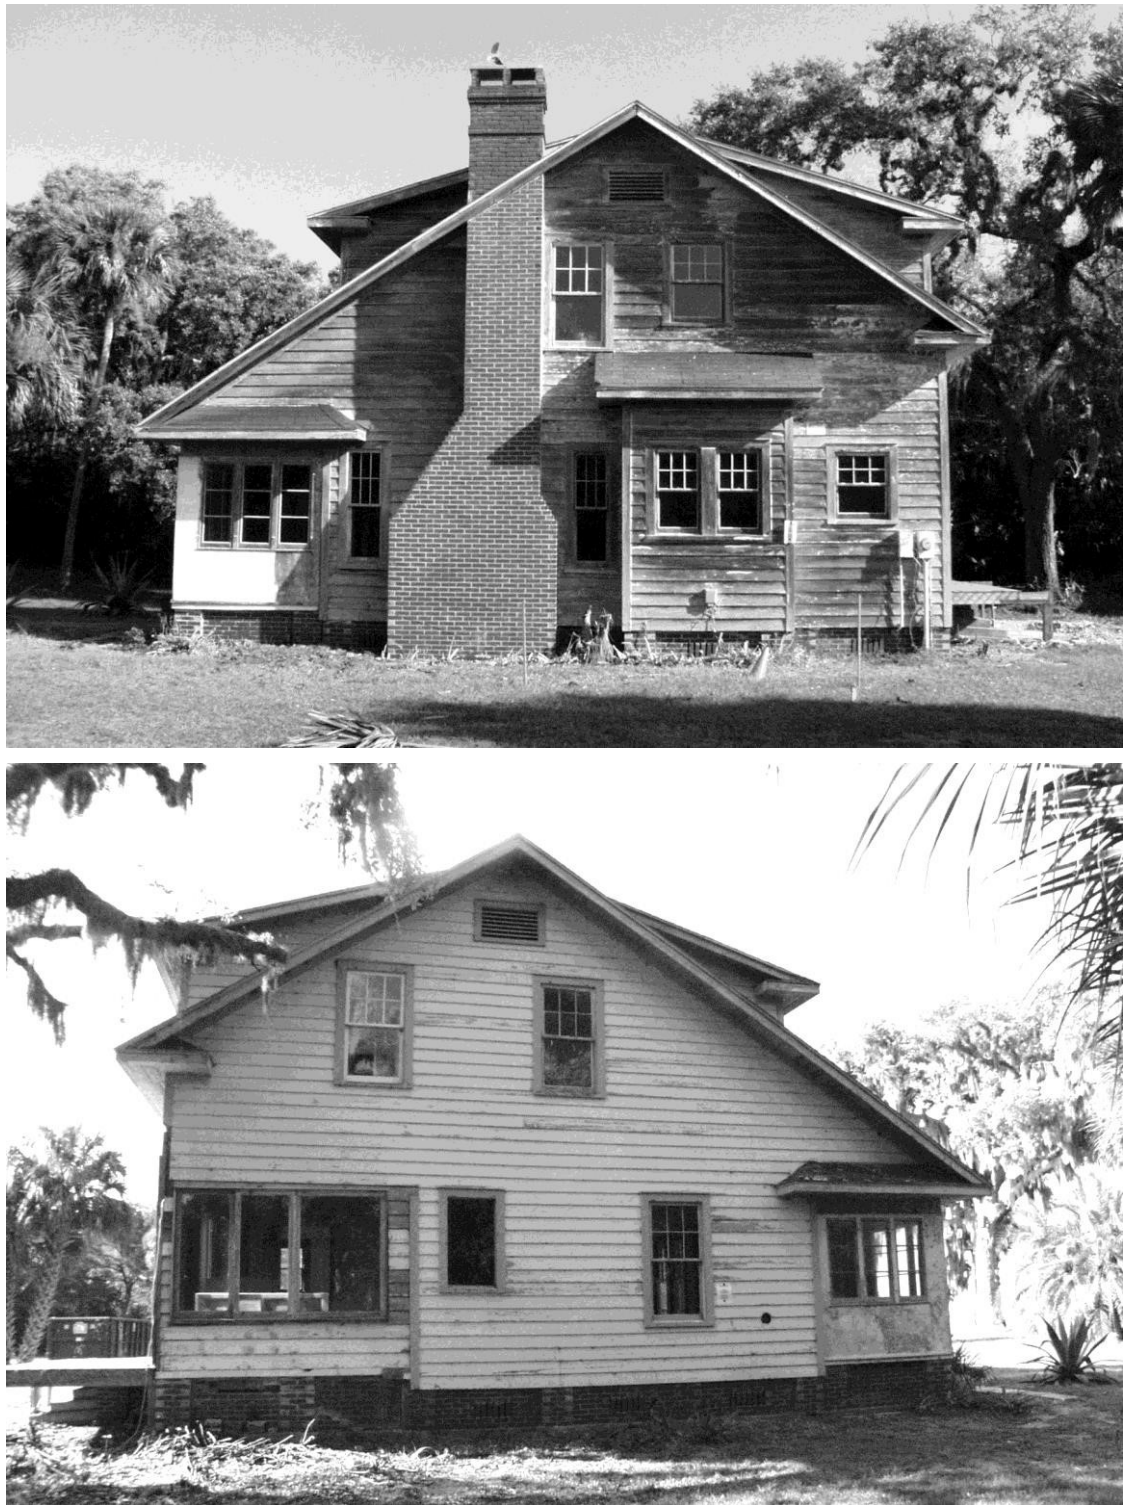
**Figure 5** Top, view of south side of house; bottom, view of north side of house. (NPS-SERO-CRS, 2002)

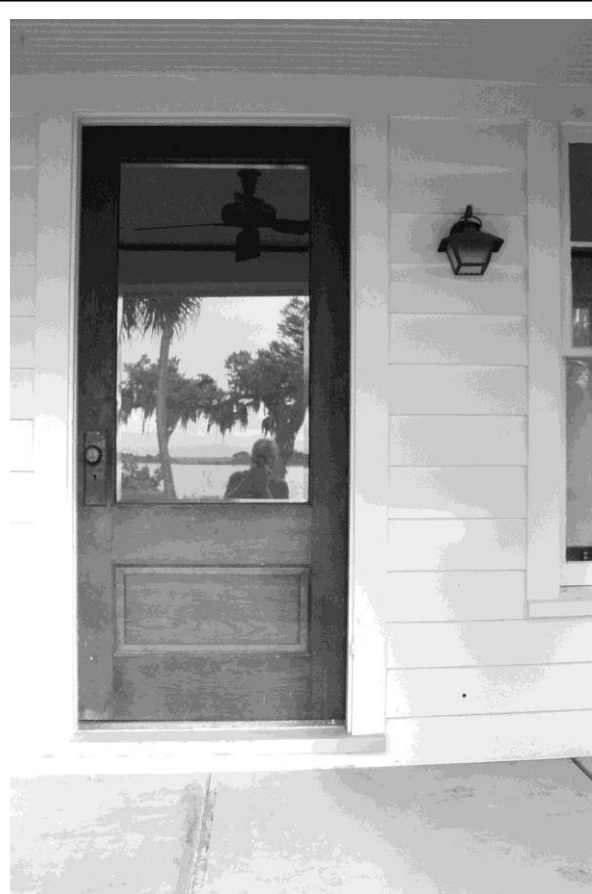
**Figure 10** View of original front door. (NPS-SERO-CRS, 2002)

have disappeared and all have been replaced with the present fixed panes of glass. The oak front door is a typical, early-twentieth-century door with a large panel of beveled glass above a smaller, raised wooden panel. The hinges feature an unusual surface-mounted leaf and are of the same type used elsewhere in the house. The double doors added when the south end of the front porch was enclosed (in the 1960s?) each have three horizontal panels beneath a three-light sliding sash. Neither door is in good condition. The doors that were used when the back porch was enclosed have been replaced with modern store-front doors, probably when the rear deck was installed in the 1980s or 1990s.

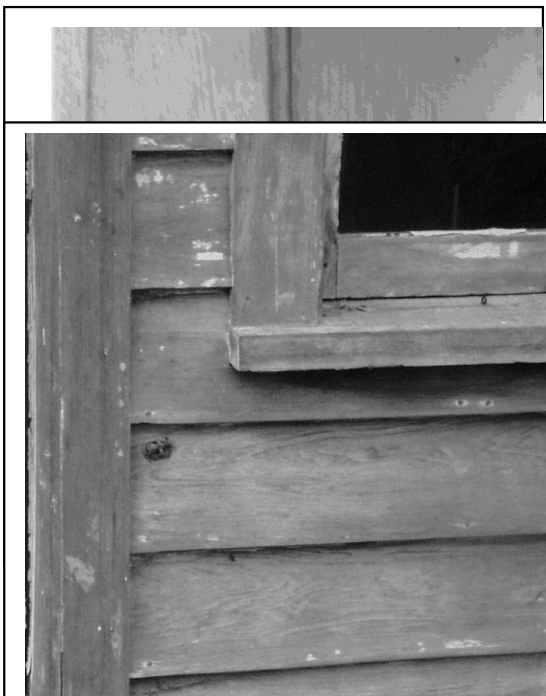
**Figure 12** View of typical siding and trim. (NPS-SERO-CRS, 2002)

*Exterior Finishes:* The exterior is finished with cypress siding and trim, almost all of which is in excellent condition. Paint has been stripped or has worn away from most of the south side of the house.

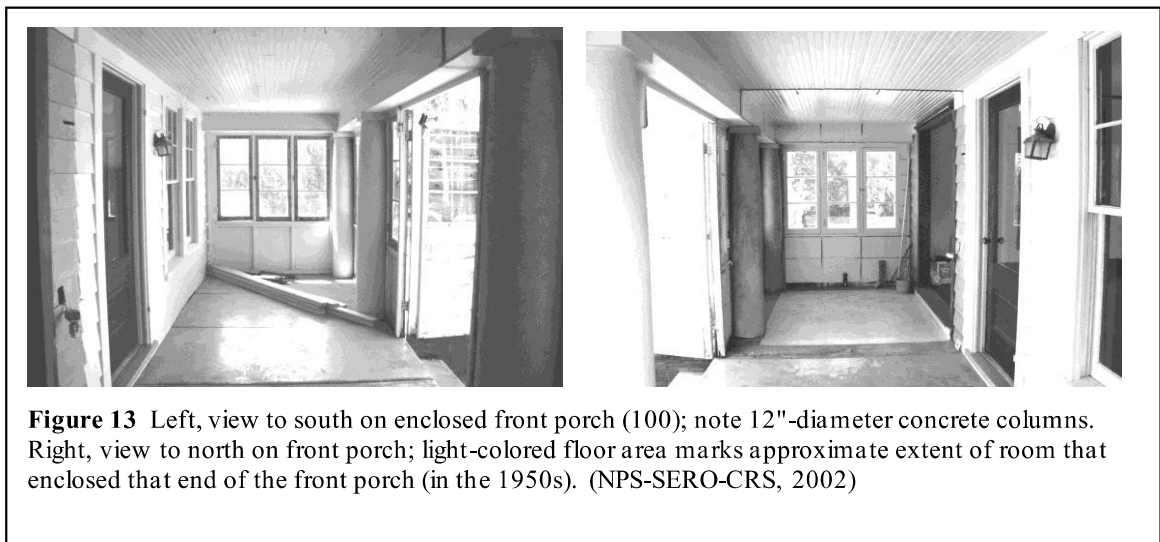
Most of the floors are finished with oak tongue-and-groove flooring, 2-1/4" wide, although the small upstairs bedroom (204) is carpeted and could not be inspected. The front porch (100) is concrete slab on fill. The back porch floor, which is now covered with pine tongue-and-groove flooring, is a similar concrete slab that covers a large concrete cistern, which remains intact beneath the present flooring (see Figure 5).

**Figure 13** Left, view to south on enclosed front porch (100); note 12"-diameter concrete columns. Right, view to north on front porch; light-colored floor area marks approximate extent of room that enclosed that end of the front porch (in the 1950s). (NPS-SERO-CRS, 2002)

**Main House:** The only evident structural problems with the house relate to the brick foundation and concrete floor slabs at the south end of the front porch and on the north side of the back porch. At the front porch, heaving of the floor slab and foundation cracks probably relate to large vegetation that was recently removed from that end of the porch. Three or four bricks are missing from the front of the foundation at that end of the porch, allowing loss of some of the fill material. These should be replaced, but the other cracks and slight displacement of the floor slab should be left alone and simply monitored to insure there is no further movement.

- Replace missing brick in foundation; reinstate lost fill at front; monitor both porch slabs for continued movement and/or cracking.
- Replace roofing---document earlier roof coverings.
- Complete repair of windows and doors, including repair and reinstallation of wood-framed screens.
- Install roof-hung, half-round gutters and round downspouts, insuring good drainage away from foundation.
- Remove wooden deck from rear; construct handicapped-accessible ramp.
- Inspect existing electrical system; replace/repair wiring as necessary.
- Replace water supply lines as necessary---refinish and reinstall existing fixtures in bathroom and kitchen.
- Refinish clear-coated woodwork.
- Install and maintain "Sentricon" or equivalent termite protection system around all three structures on the site.
- Install central HVAC system if necessary for new program of use.

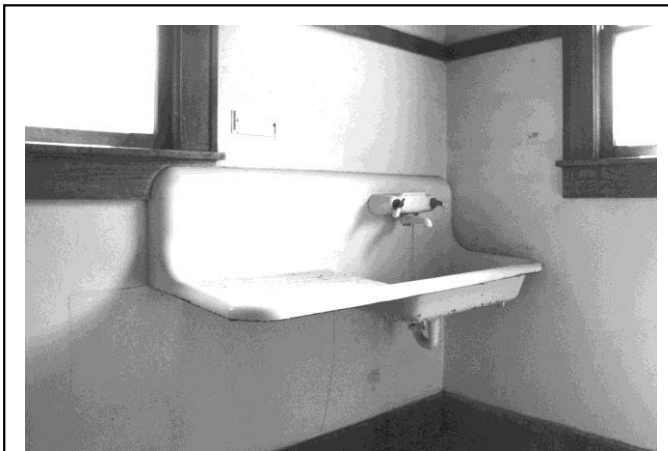
**Figure 19** Left, view of original kitchen sink. Right, view of north end of kitchen. (NPS-SERO-CRS, 2002)

The kitchen and the bathroom have not been remodeled since the house was built, with the original sinks, toilet, tub, and faucets still in place. Some if not all of the water supply lines have been replaced by plastic pipe, but the original cast-iron waste lines are still in use. Waste lines and probably supply lines as well are run through a chase built in the southwest corner of the kitchen.

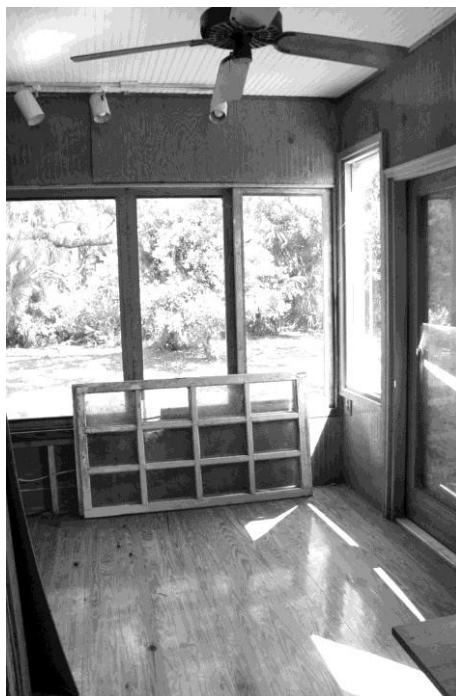
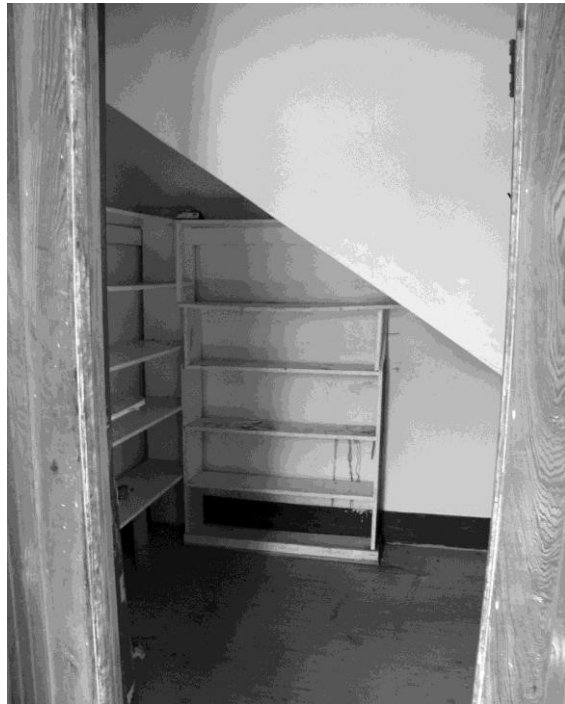
The casement windows that were used to enclose the front porch remain intact, but half of the sliding sash used to enclose the back porch

**Figure 21** Left, view north on porch, showing one of wooden sash first used to enclose porch; all existing windows and door are modern. Right, view of pantry (105) under stairs. (NPS-SERO-CRS, 2002)

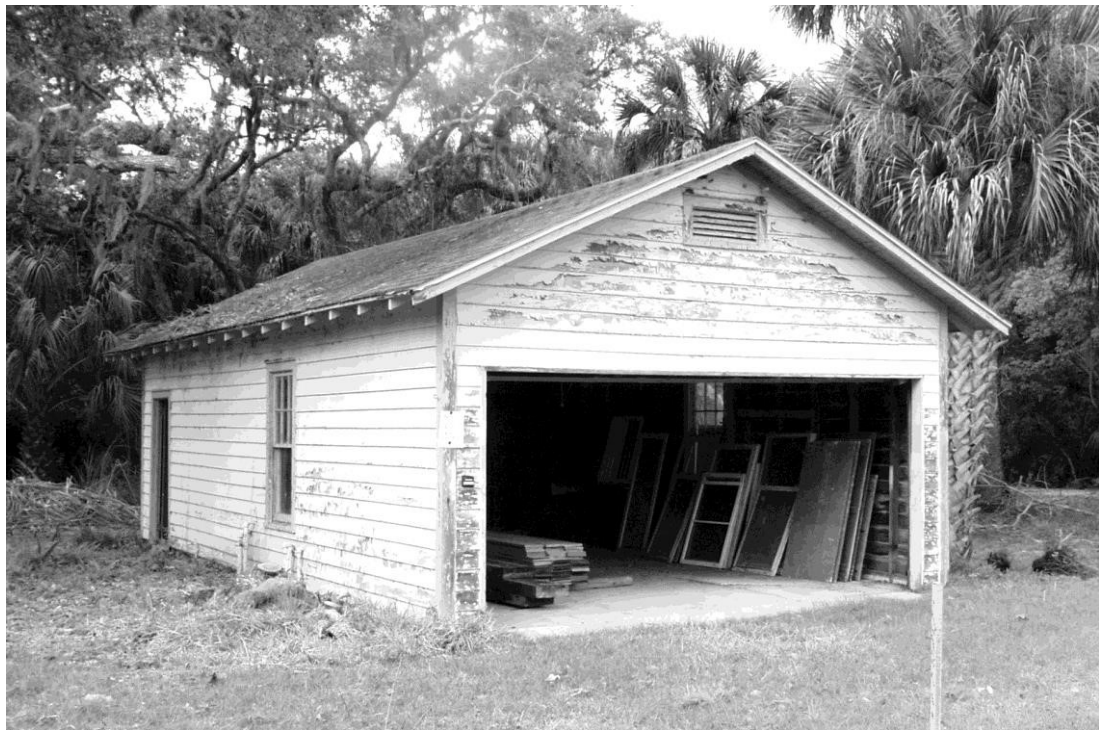
**Figure 29** View to northeast of garage. (NPS-SERO-CRS, 2002)

Measuring about 31'-6" north to south and about 17'-5" east to west, the garage is a wood-framed structure set on a poured concrete slab. The interior is partitioned using 1" by 6" tongue-and-groove boards, installed vertically, to create two small rooms at the rear (north end) of the structure. The room at the east end is entered from inside the garage; the room at the west end is entered from the outside of the building. Walls are finished on the exterior with lap siding laid with a reveal of about six inches. The overall condition of the building is good.

**Garage:** The garage is in reasonably good condition. The door to the room at the northwest corner of the building should be repaired to working order. Roofing and painting should be coordinated with repairs to the main house. Existing historic water tanks and associated equipment should be preserved *in situ*.

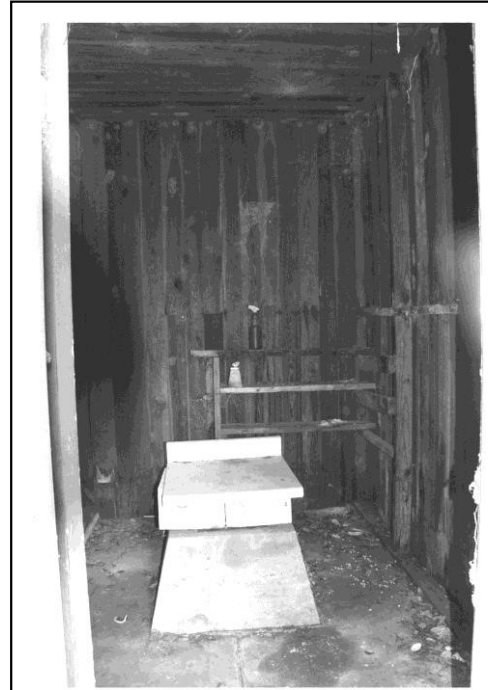
**Figure 28** View of pump room at northwest corner of garage. (NPS-SERO-CRS, 2002)

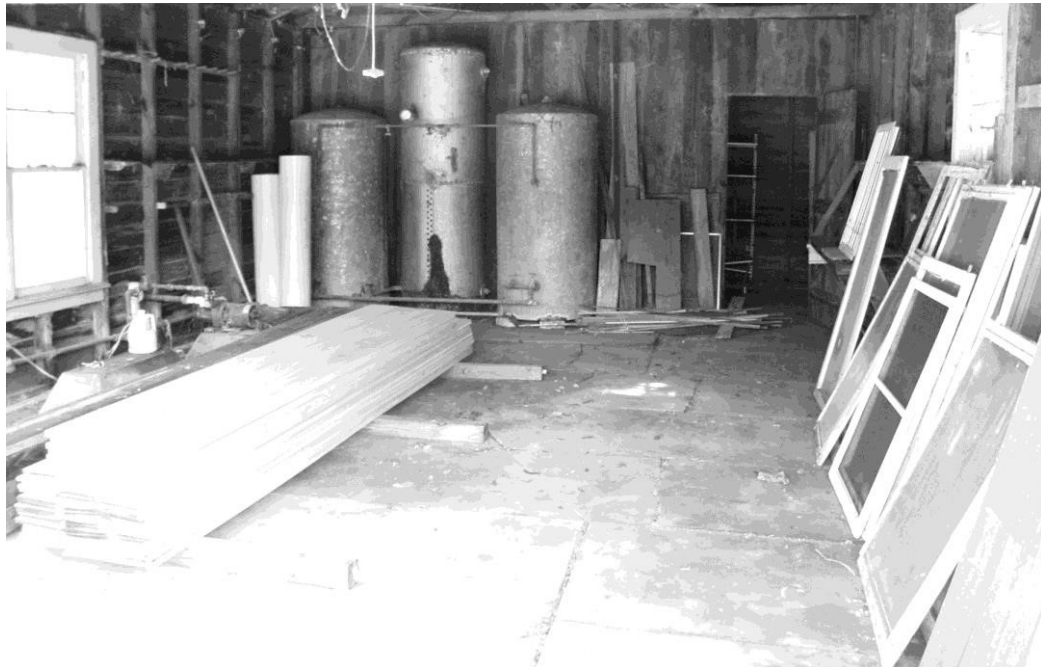
**Figure 30** View to north of parking bays in garage; note water storage tanks at rear and, at right, screens and storm shutters for the main house. (NPS-SERO-CRS, 2002)

Park staff is in the process of repairing window. This work should also include repair/replacement of wood-framed screens at all windows and doors. Solid storm shutters now stored in the garage should also be repaired, repainted, and stored for use.

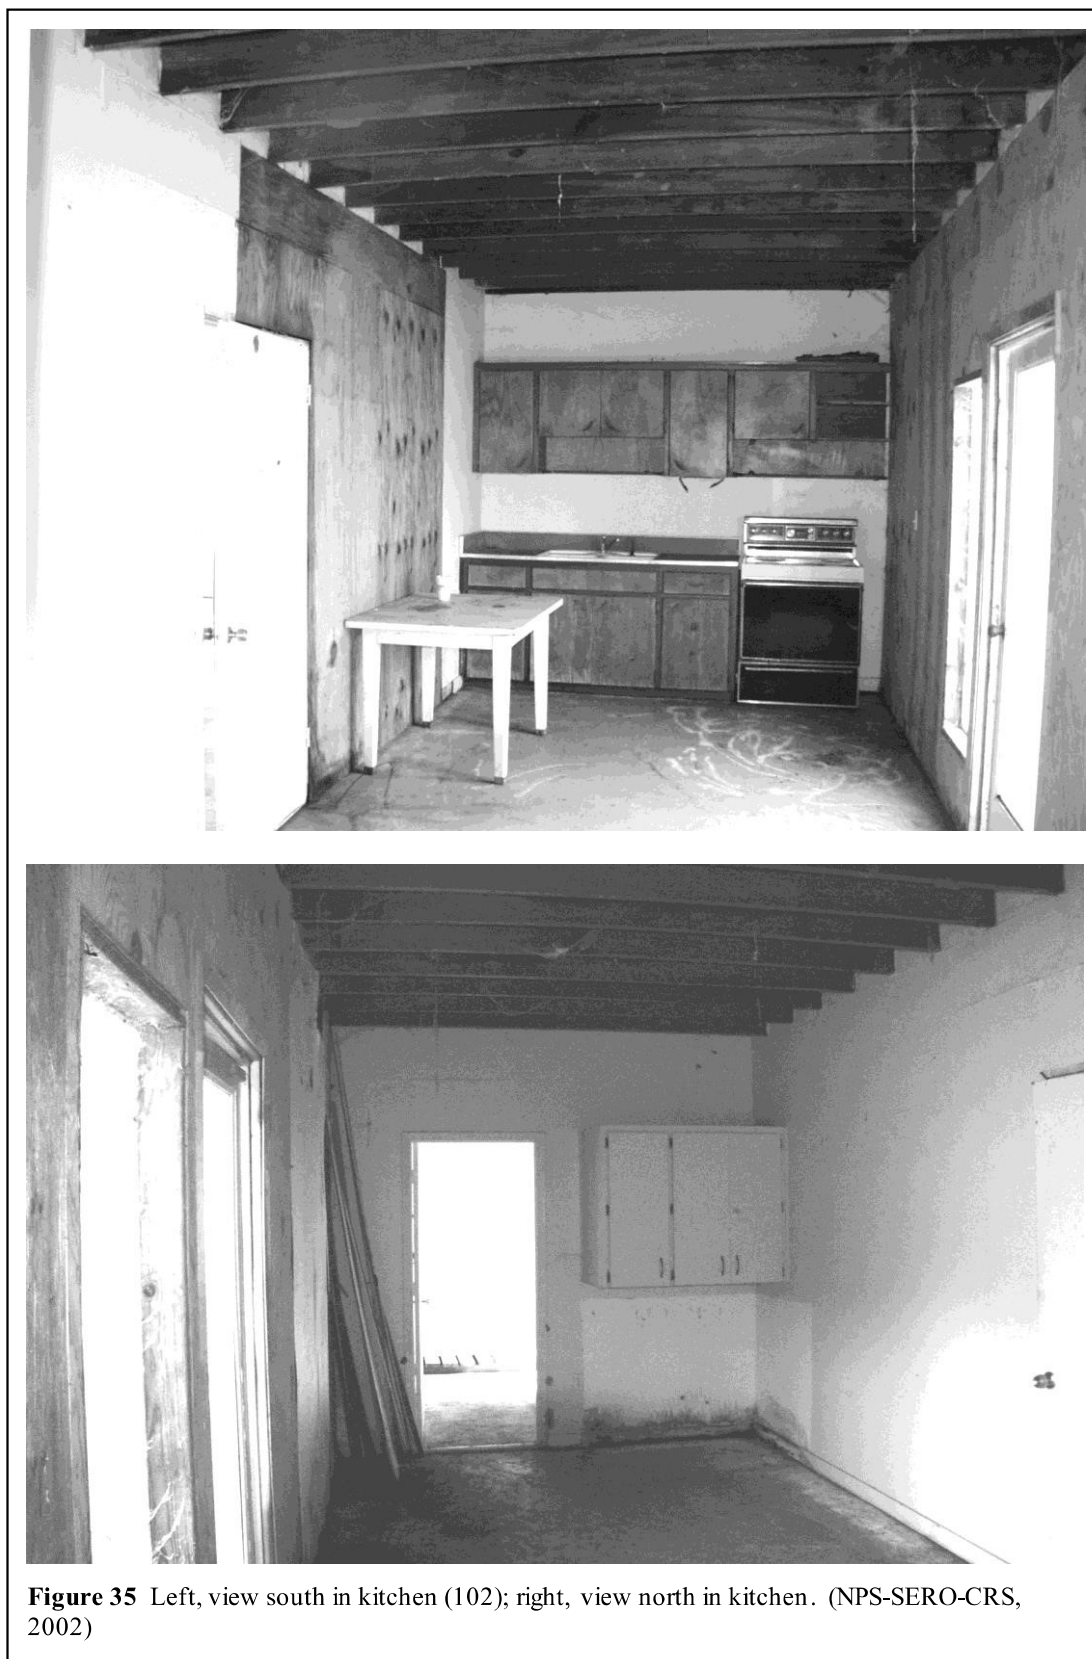
**Figure 35** Left, view south in kitchen (102); right, view north in kitchen. (NPS-SERO-CRS, 2002)

Other problems of repair with the building are cosmetic. The unpainted plywood on the kitchen walls should be removed and the wall framing inspected and repaired as necessary before reinstalling and painting the plywood wall covering. Some limited replacement of ceiling material may be necessary on the west side of the studio. Most of the exterior hardboard siding is in good condition, with only limited replacement needed, mostly on the lower parts of the west wall of the kitchen block. All painted surfaces, both inside and outside the building, should be thoroughly cleaned and treated for mildew prior to repainting.
