Robert Cravens House & Dairy  
Chickamauga and Chattanooga National  
Military Park  
**Historic Structure Report**

**Historic Structure Report**

**Joseph K. Oppermann–Architect, P.A.**

2012  
Historic Structure Report  
Robert Cravens House & Dairy  
Chickamauga and Chattanooga National Military Park

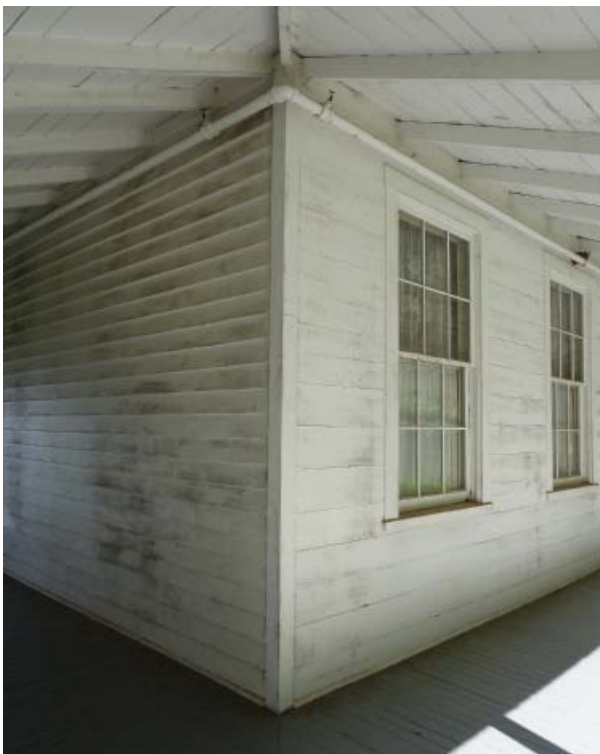
**Figure 67.** Northwest oblique with 1956-57 weatherboard on north wall and 1866 flush siding on west wall.

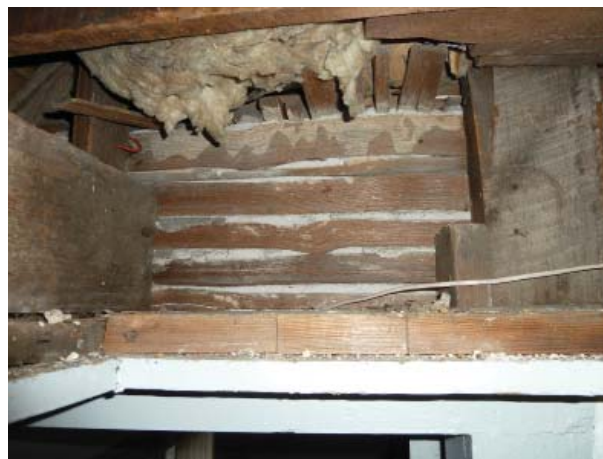
**Figure 68.** Riven lath and salvaged lumber for framing as seen at the ceiling hatch of the South Bedroom (Room 204).

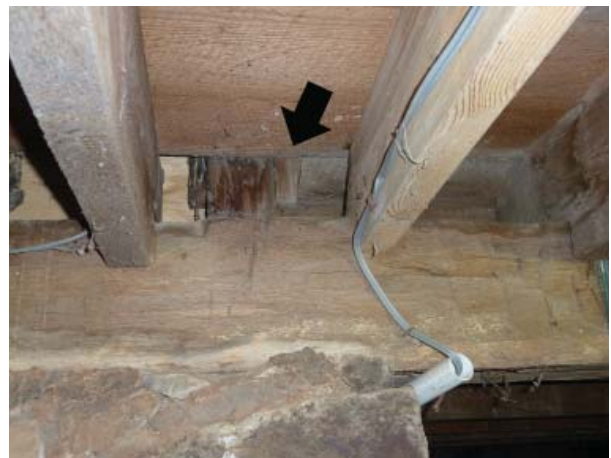
**Figure 71.** 1866 2" by 4" wall stud (arrow) and notched 1866 and 1956-57 floor joists at west wall sill, Room 003D.

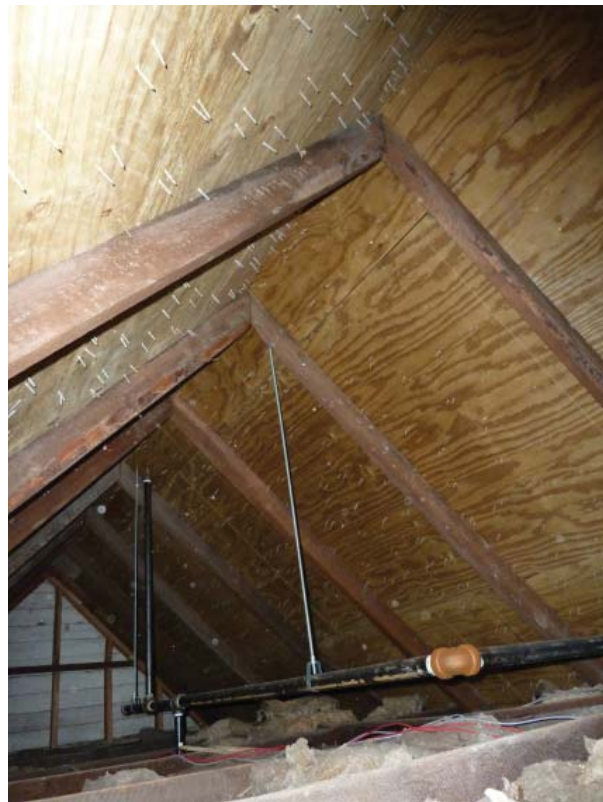
The second-floor ceiling joists exposed at attic level are circular-sawn, measuring 2" by 7". They run east-west spanning the exterior walls and are spaced 25" on center. The rafters, also circular-sawn, measure 2" by 4" and are spaced 25" on center, a pair of rafters resting atop each joist. The rafters are mitered at the gable. There are no collar ties. The roof deck is made of modern plywood sheets.

**Figure 73.** Roof rafters (1866) and modern plywood decking.

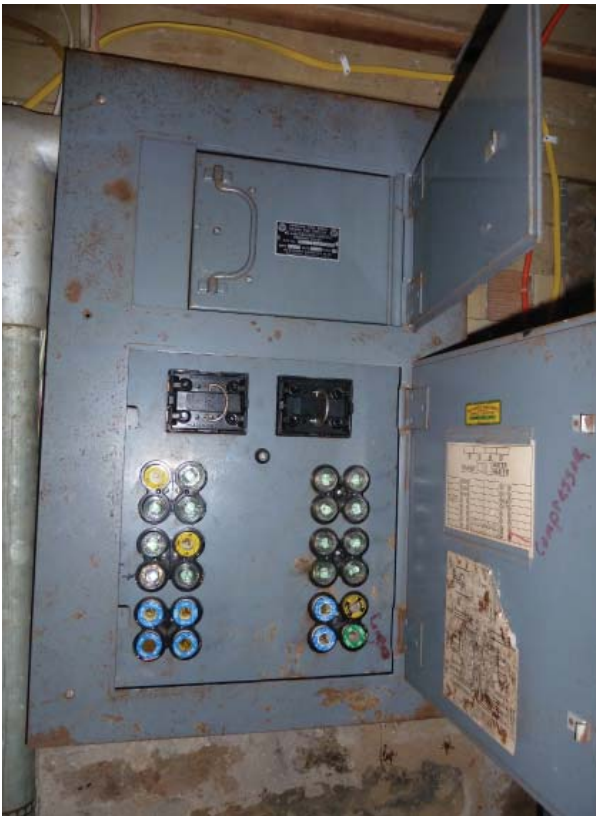
Electrical service is provided by Chattanooga Electric Power Board. A 200-amperage electrical fuse box is located on the east wall of Room 003B in the basement. An installation date is not indicated. Cloth-wrapped 1950s-era wiring is visible in various locations throughout the house.

**Figure 74.** Electrical panel in the Utility Room (Room 003B).

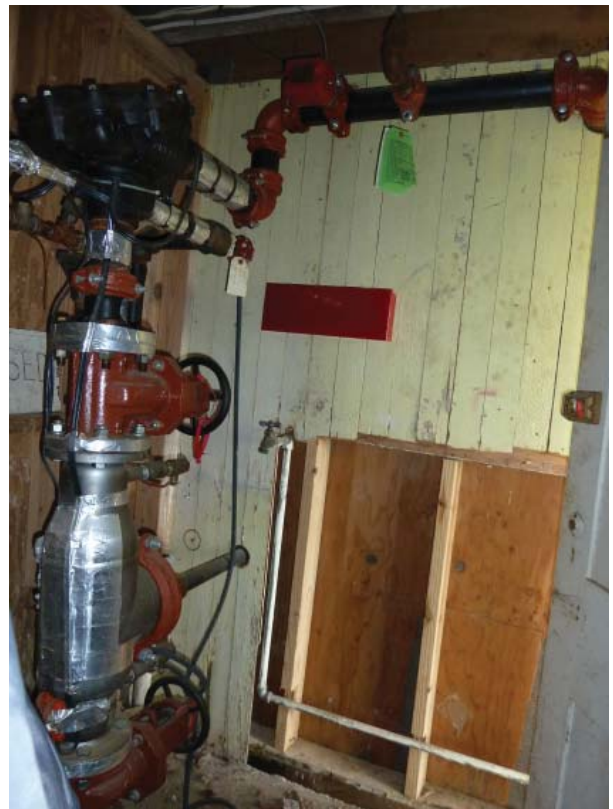
A dry-pipe fire suppression system was installed in the mid-1990s. The water pump for the system is located in the Utility Room (Room 003B). A heater was installed in 2001 after the water pump froze and burst. Smoke detectors and sprinkler heads are located in each room of the house.

**Figure 76.** Water pump for the fire suppression system in the Utility Room (Room 003B).

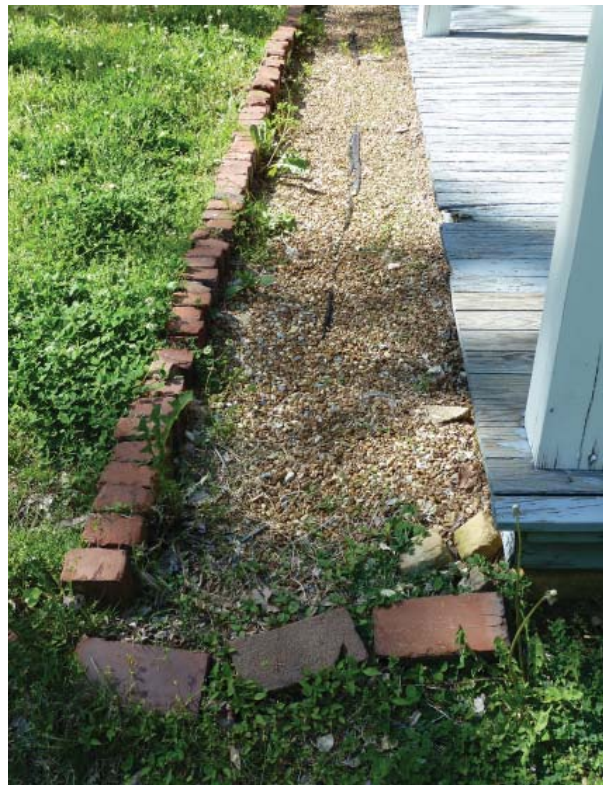
**Figure 79.** French drain along the West Porch.

serious failures in the collecting of rainwater from the building exterior and dispersing offsite.

One failure is at the second-floor windows of the long east and west elevations. The windows are set just above the porch roofs and are regularly saturated from the splash of runoff from the upper roof.

The second failure occurs along the masonry walls of the basement perimeter, especially at the north end of the west wall. Rain runoff falls around the base of the house and seeps into the basement through the stone foundation walls. Additional runoff comes from the parking area to the west, which is at a slightly higher elevation. A French drain was installed, probably during the 1950s restoration, along the eave line of the west porch to divert runoff away from the house; unfortunately, it had only moderate success. Attempts were made in the 1990s and 2000s to expand the drain, and in addition a dry well was dug approximately fifteen feet north-northwest of the house. A pipe was run from the French drain to the dry well. Although some improvement was reported, water infiltration through the basement walls remains a major problem.

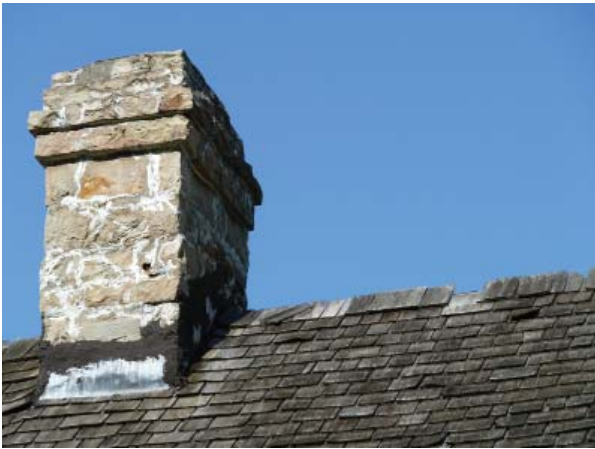
The house has two stone chimneys, both centered on the roof ridge. Both are internal to the building. One is just inside the north exterior end; the other is slightly south of the center of the house. They were repointed, capped, and re-flashed with aluminum flashing by NPS staff in 2000. Nonetheless, each chimney has remained a point of persistent water infiltration as evidenced by the continuing deterioration of second-floor interior plaster of ceilings and walls in those locations. The subsequent application of a bituminous coating along the chimneys at the roofline likewise has been unsuccessful in stopping the rainwater infiltration.

Figure 80. Central stone chimney.

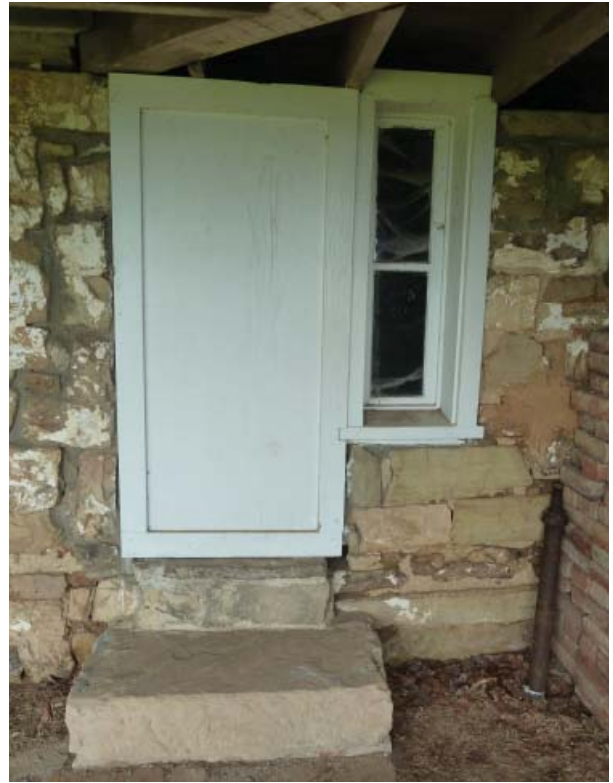
Figure 83. Two-light sash window at Room 001.

There are two window types in the basement level. All are on the east exterior wall. The northernmost window opening holds a 12"-wide twentieth-century two-light sash. Another window to the north of the middle door has a two-light sash of same design, but measuring 1'-2½" in width. On the south side of the middle door are two four-light sash windows that are paired. They each measure 2'-8" wide (*Figure 86*).

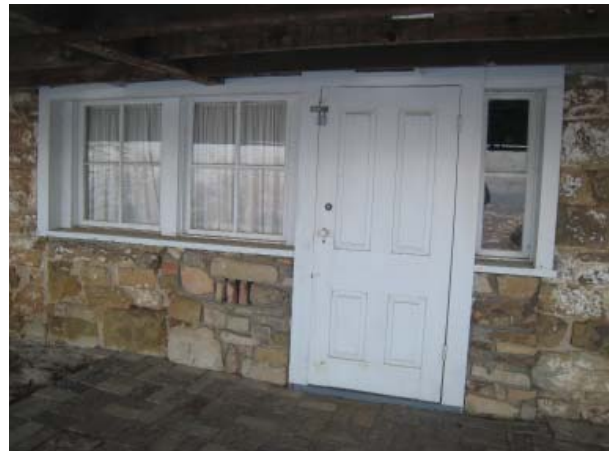
**Figure 86.** Windows and door at Room 002.

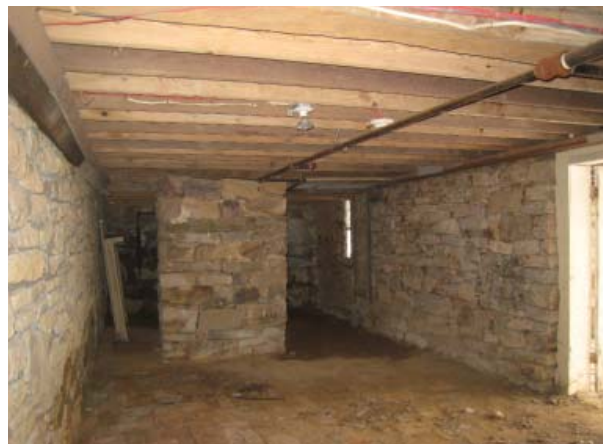
**Figure 95.** Northeast oblique view of the North Room (Room 001).

for this, the Second Cravens House, is not known. Today, this space is an unfinished basement room and is not used except for occasional storage. The lack of use is due in part to the apparently frequent flooding from moisture infiltration through the stonework of the west wall, primarily, and some through the north wall. The only access to this room is through the exterior doorway on the east wall.

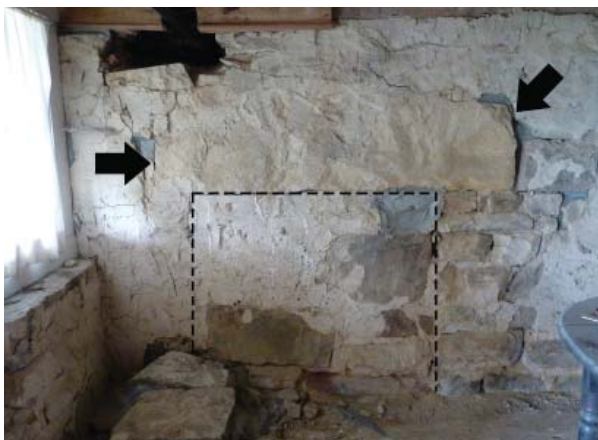
On the south wall approximately 1'-6" from the east wall, a fireplace, apparently dating to the original 1856 Cravens House and mirroring the one on the north wall of Room 001, has been filled with rubble stone and plastered over. The large stone firebox lintel, approximately 4' wide, is visible in the wall stonework. The outline of the firebox can be further discerned from cracks in the plaster along the edges between wall masonry and infill material.

**Figure 102.** Filled-in fireplace on south wall of the Middle Room (Room 002), originally the south exterior wall of the 1856 House. Note the large stone lintel.

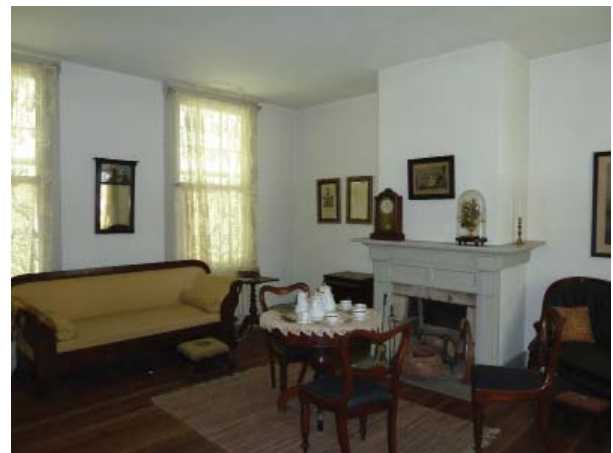
**Figure 109.** Northwest oblique of the North Parlor (Room 101).

The walls throughout the first and second floors of the house are wood studs finished in textured plaster; the plaster finish coat, at least, probably dates to the 1956-57 restoration. Water damage is visible on the east wall over the exterior doorway.

The ceilings throughout the first and second floors of the house are the same textured plaster as the walls; the plaster finish coat, at least, probably dates to the 1950s restoration. A great deal of water damage is visible on the ceiling over each exterior opening on the east and west walls.

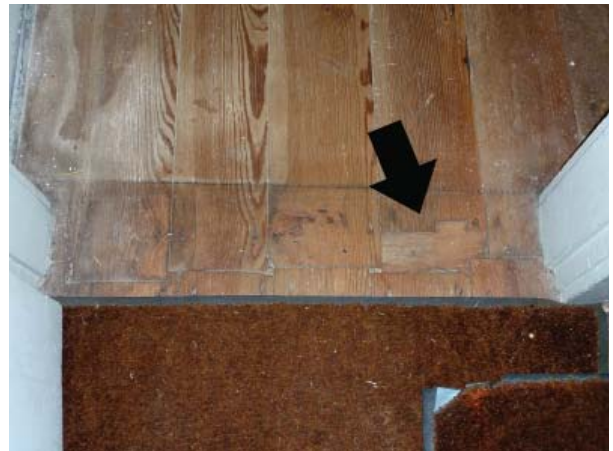
**Figure 113.** Seam in flooring at the south doorway. Note the patch possibly for a wall stud.

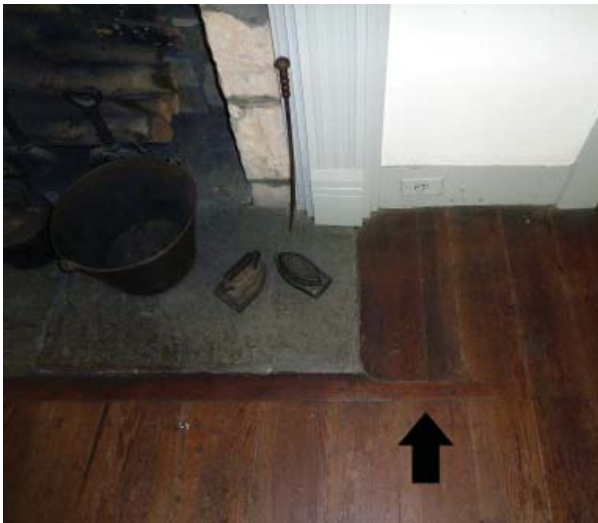
**Figure 117.** Modified hearth trim board, perhaps reused from the 1856 house, indicates a wider hearth.

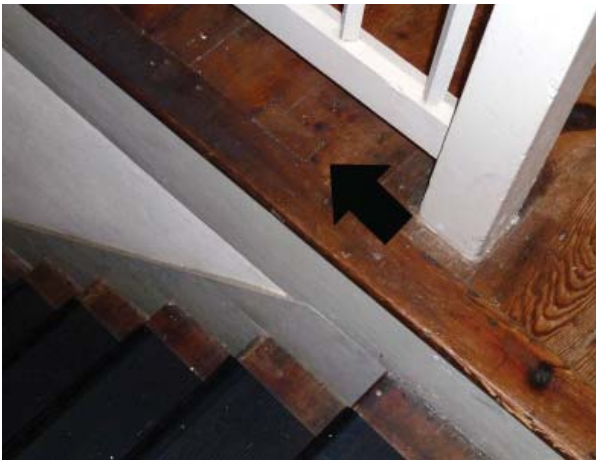
**Figure 123.** Floor patch for door frame of early board wall.

There is a single Dutchman patch in the flooring at the south end of the room, approximately 4'-7" off of the east wall, adjacent to the stair landing of Room 202. The patch, measuring 1½" by 3½", aligns with a door frame stud for the board wall that is indicated in the 1956 APTA pre-restoration drawing. A row of nail holes and wear marks in the flooring further confirm the presence of the board wall, probably dating to 1866, shown in the drawing.

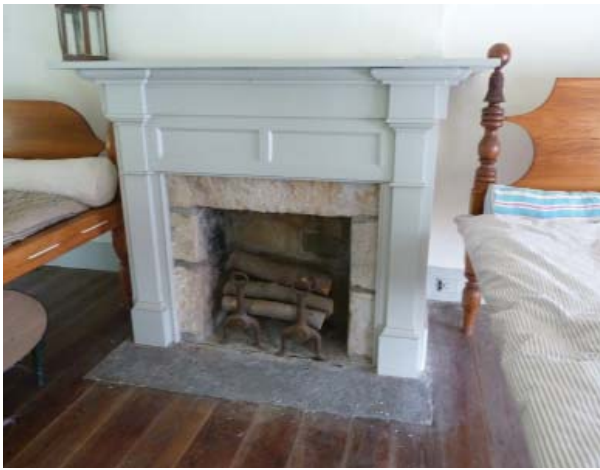
At the north wall, extending into the room 2'-3" is a stone fireplace and chimney breast. There is severe water damage to the chimney breast plaster above the fireplace. The hearth is made of a single stone measuring 1'-2" deep by 4'-4" wide. There is no hearth trim board. The stone firebox has been repointed with modern Portland cement-rich mortar and it appears that the stones of the back of the firebox may have been replaced. The wood mantel probably dates to 1866; it is visible in a 1956 pre-restoration photograph. The shelf is 5'-1" wide and 3'-10½" above the floor.

**Figure 125.** Fireplace and early mantel on the north wall of the North Bedroom (Room 201).

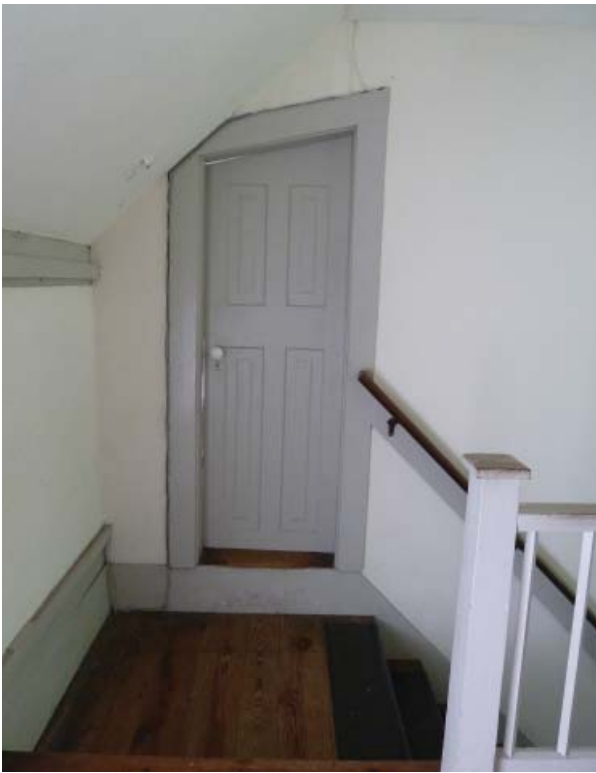
**Figure 127.** The doorway off of the Upper Stair Hall (Room 202) connecting to the Central Bedroom (Room 203). Note the door is hung upside down.

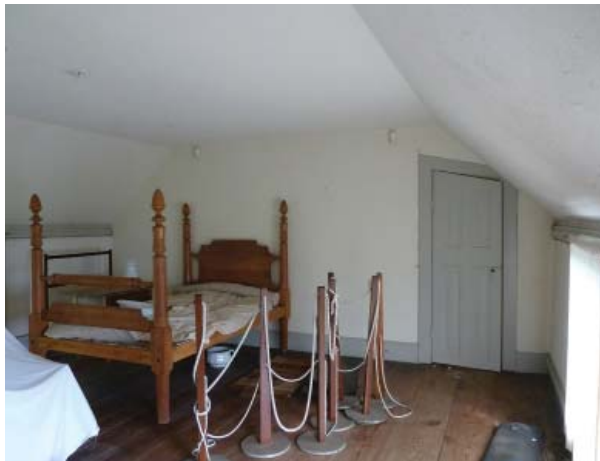
**Figure 130.** Looking north in the Central Bedroom (Room 203). Note sloped doorway lintel.

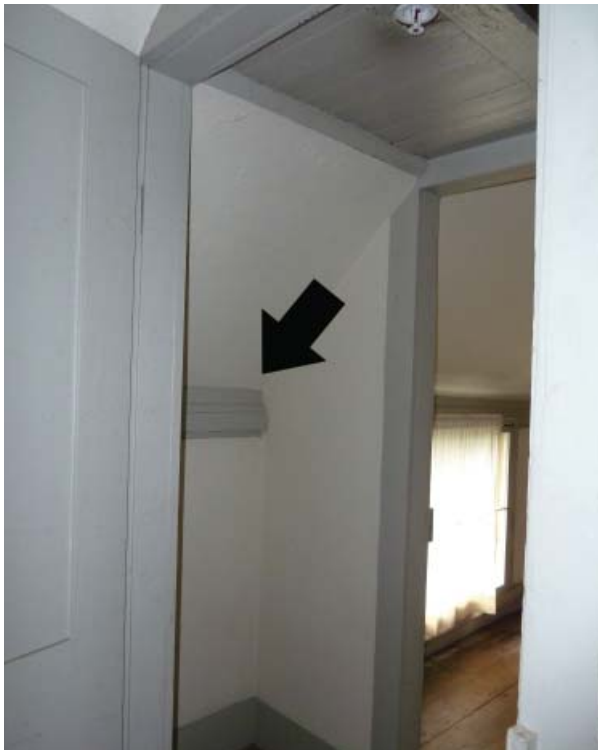
**Figure 135.** Window track continues from the Central Bedroom (Room 203) behind plaster walls through the passageway into the South Bedroom (Room 204).

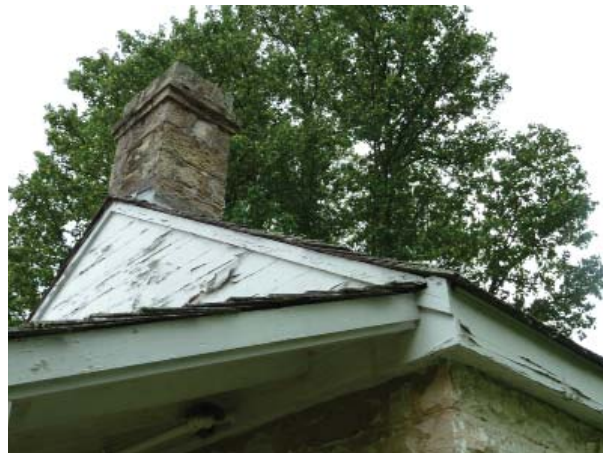
The rusticated stonework of the exterior has remnants of a limewash, which has mostly washed away. The earliest identifiable mortar is tan in color and has a variety of sands. Records show that in the mid-1990s NPS staff repointed portions of the building. Other portland cement repointing work has been done in various locations, especially evident on the south and east sides. The gable ends have random-width flush siding, which was installed during the 1956-57 restoration. Today it is severely rotting at the south gable.

**Figure 141.** Dairy gable, cornice, and porch roof.

1. Shedding Water – Failure of the Roofing Material: Like the House, the wood shingles installed in 1993 are in poor condition and rapidly deteriorating. The shingles are fragile; many are broken or out of position. Damage to the underlayment roofing material is undoubtedly occurring. Replacement of roofing material is overdue.
2. Shedding Water – Failure of Flush Siding at South Gable: There is an extensive amount of rot throughout the siding. The entire area of south-gable siding will need replacement.

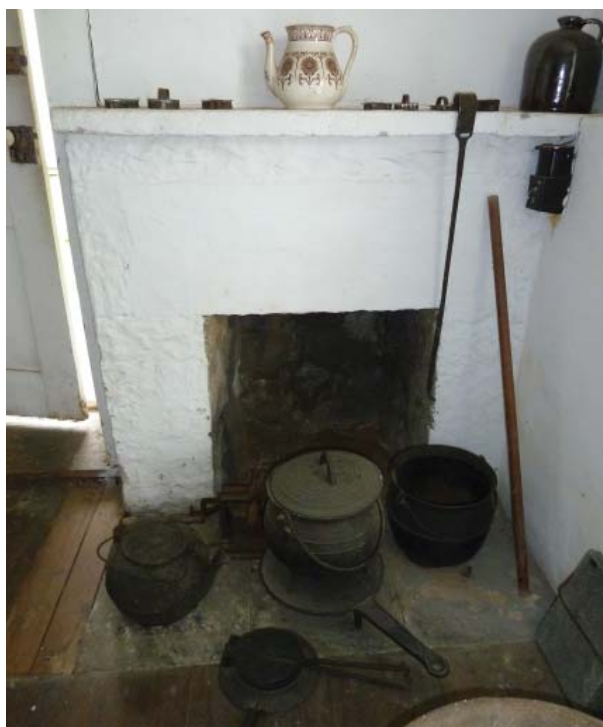
A small fireplace with a stone hearth is located in the north wall, east of the front door. The fireplace sits flush with the wall; the front of the firebox is 2'-0" wide by 2'-0" tall and 1'-3" deep. The jambs of the firebox taper to a back wall 1'-6" wide. The stone hearth measures 3'-8" wide by 1'-8" deep. The stone of the fireplace and hearth were found intact during the 1950s restoration. A metal flue cover is on the north wall.

**Figure 145.** Fireplace on the north wall of the Dairy, upper level.

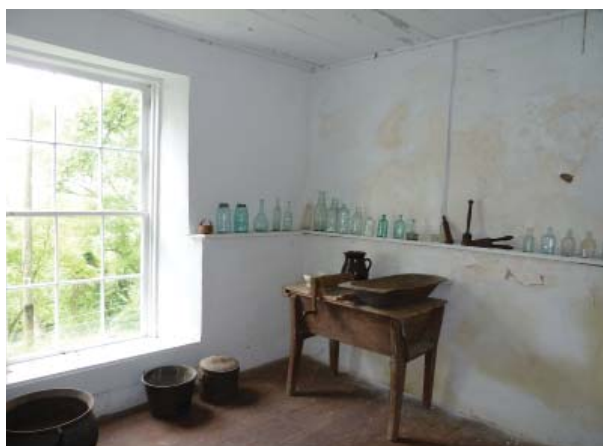
**Figure 146.** Southeast oblique of Dairy, upper level.

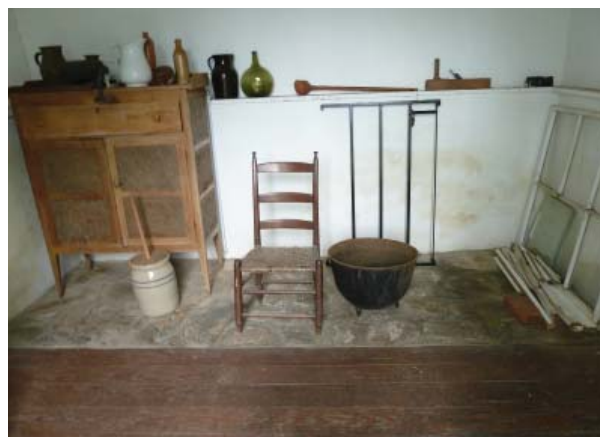
**Figure 147.** West wall of Dairy, upper level.

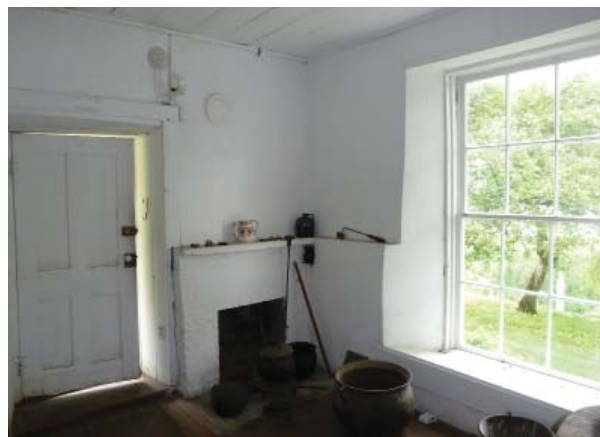
**Figure 148.** Northeast oblique of Dairy, upper level.

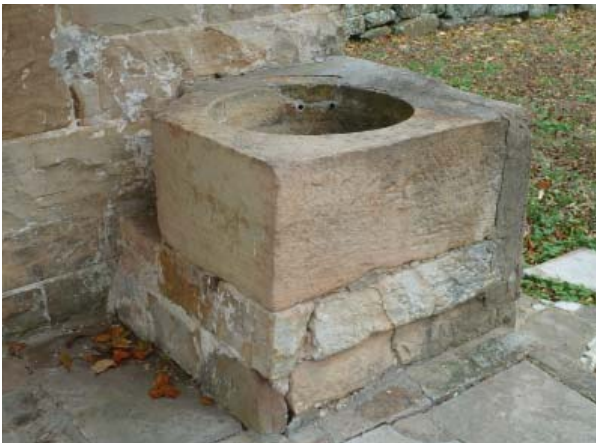
A water basin, chiseled from a single block of Crabapple Orchard sandstone, sits outside on the porch against the northwest corner of the Dairy. The stone block is roughly square, 2'-6" by 2'-6". The center of the top surface has been hollowed out to create a 1'-10" diameter basin (*Appendix A Drawing 4*). The block sits upon a short stone pedestal to reach a height of 2'-4" above porch floor level. According to earlier accounts, the basin used to collect water from a spring uphill from the Dairy. From the basin, water was piped to the level below.

**Figure 149.** Water basin on front porch of the Dairy.

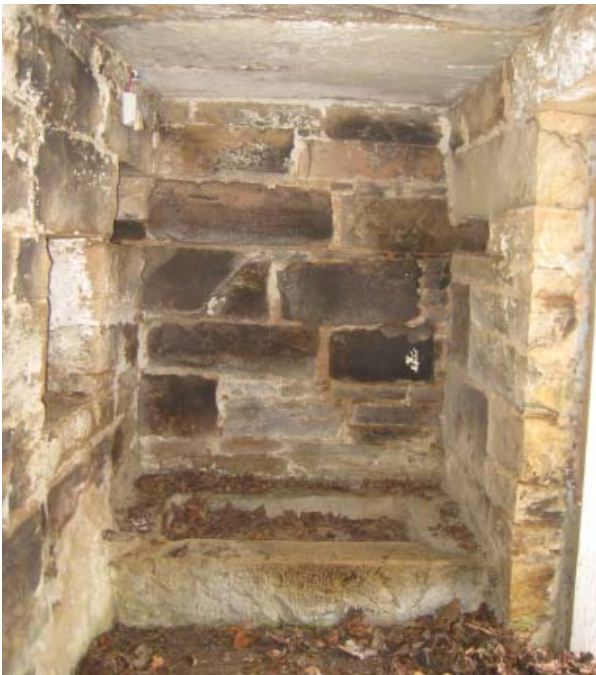
**Figure 150.** Stone basin along the north wall of the Dairy at basement level.
