**PRE-RENOVATION  
LEAD-BASED PAINT INSPECTION REPORT**

**NIKE MISSILE SITE  
ADMINISTRATION AND CONTROL AREA  
AND  
LAUNCH AREA  
EVERGLADES NATIONAL PARK  
HOMESTEAD, FLORIDA**

March 4, 2010  
Revised August 27, 2010  
EE&G Project No. 2009-2333

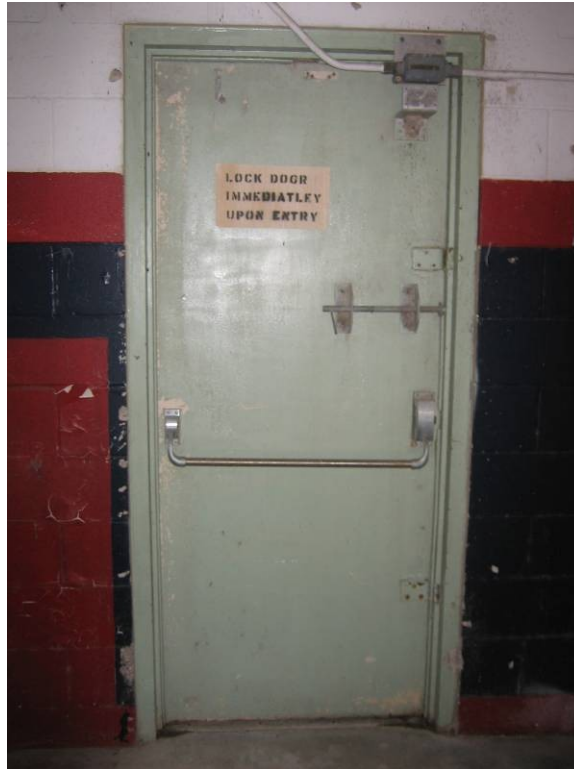
Missile Barn B: Peeling green paint on interior metal exit door.

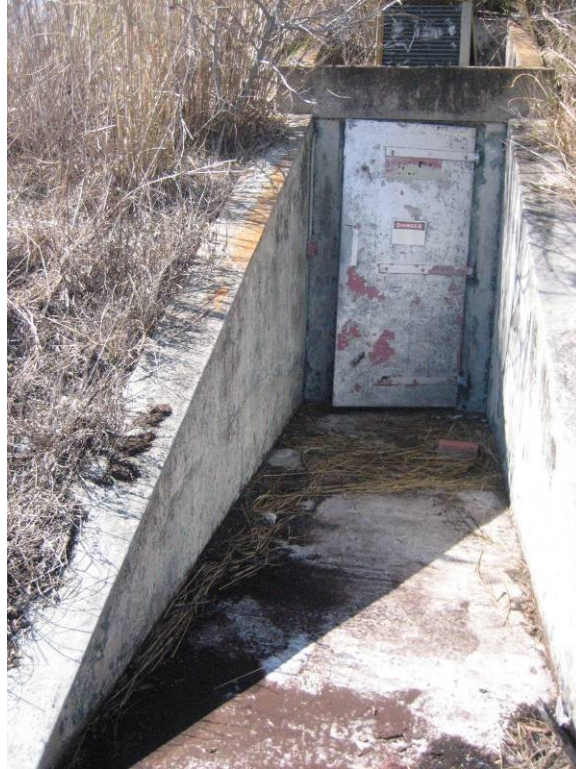
Fire-control Bunker B: Peeling red paint on exterior metal door.

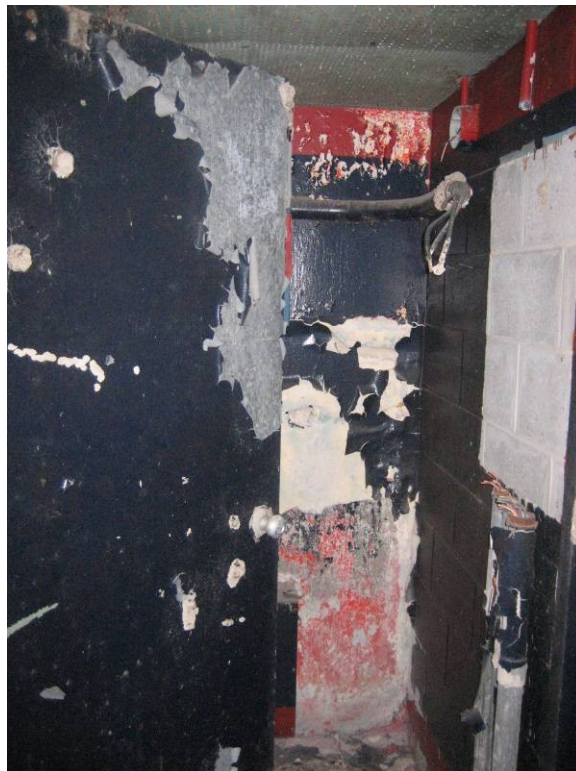
Fire-control Bunker B: Peeling gray paint on interior metal door.

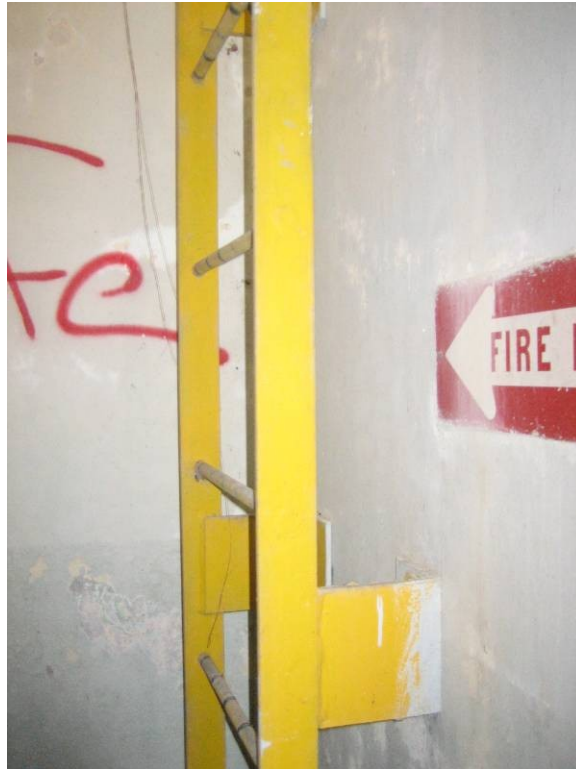
Fire-control Bunker C: Intact yellow paint on ladder in escape hatch.

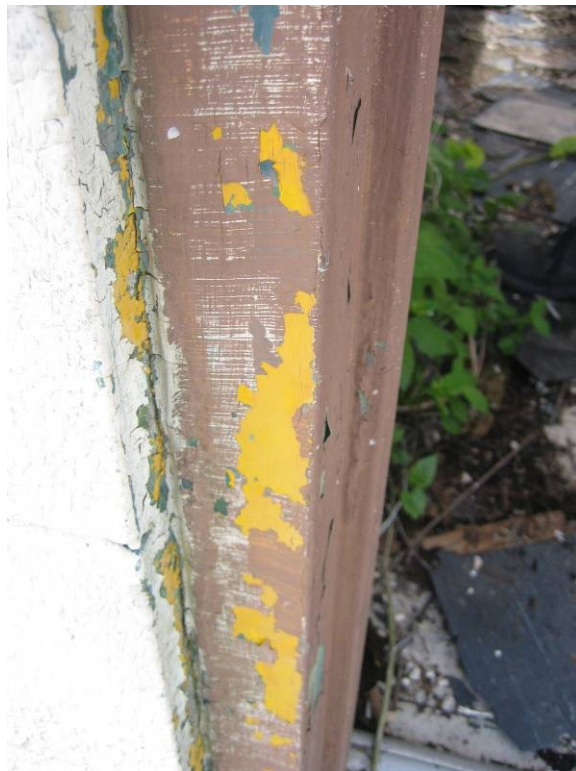
Kennel Building: Chalking brown paint on metal door casing.
