# National Park Service Cultural Landscapes Inventory 2022

**HM-69 Nike Missile Site Landscape**  
**Everglades National Park**  
**[2022 Condition Reassessment]**

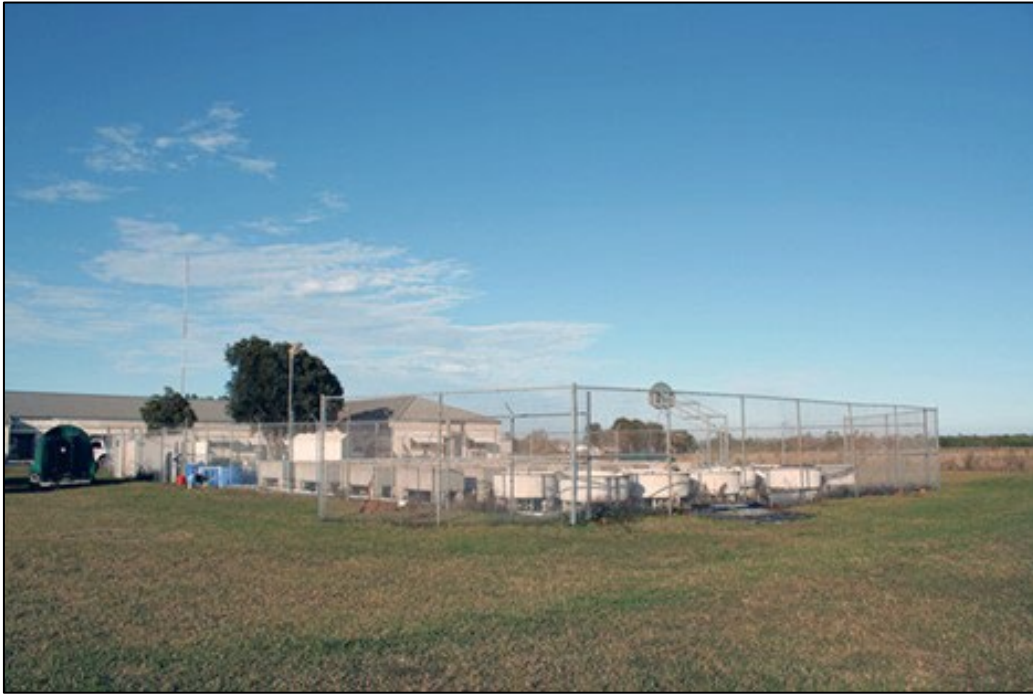
*Fig 9. The athletic court is now utilized to house captured pythons. Source: JMA, 2010.*

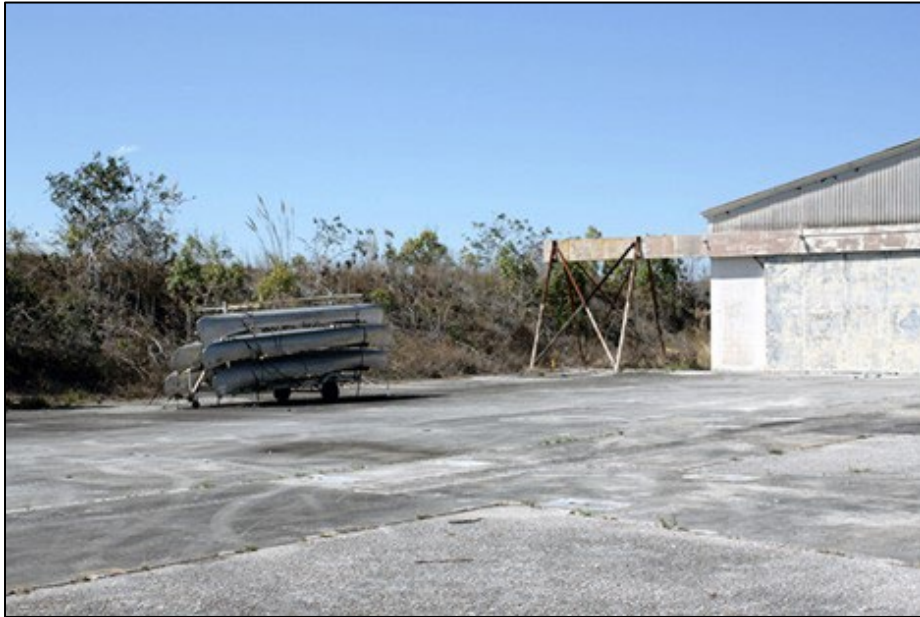
*Fig 11. The former launch pads are periodically used for storage during storms. Source: JMA, 2010.*

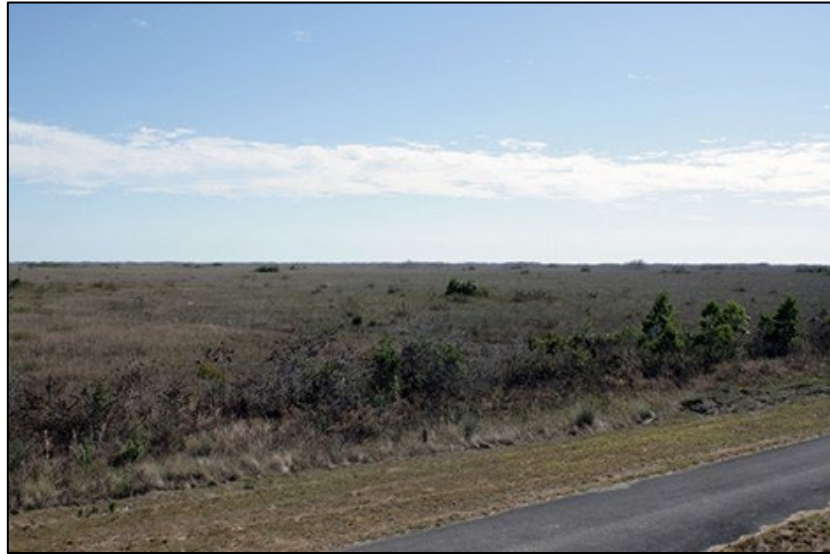
*Fig 13. The natural topography of the site is very flat. Source: JMA, 2010.*

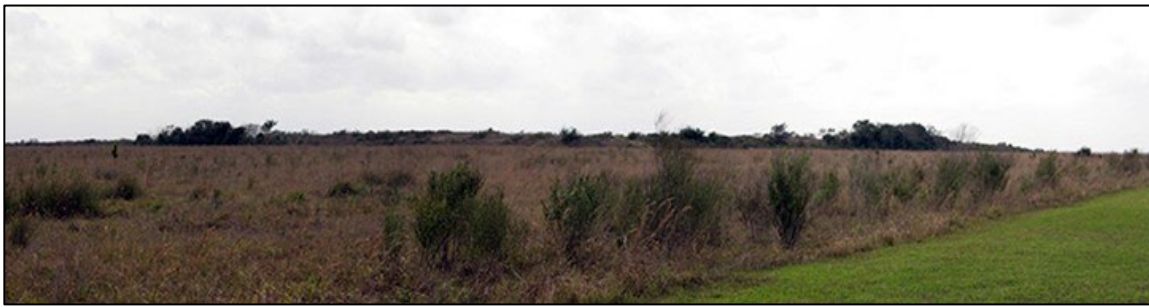
Recent topographic modifications have resulted from efforts to restore native vegetation within the Hole-in-the-Donut. Soil scraped from areas infected with Brazilian pepper has left enormous soil disposal mounds that are currently stored on-site. One of these soil disposal mounds is within the boundaries of the Nike Missile Site southwest of the Control Area (Fig. 23). The 20-acre mound intrudes into the line-of-sight from the Control Area to the Launch Area, interfering with the historic viewshed.

*Fig 23. The Hole-in-the-Donut soil disposal mound intrudes on the historic viewshed. Source: JMA, 2010.*

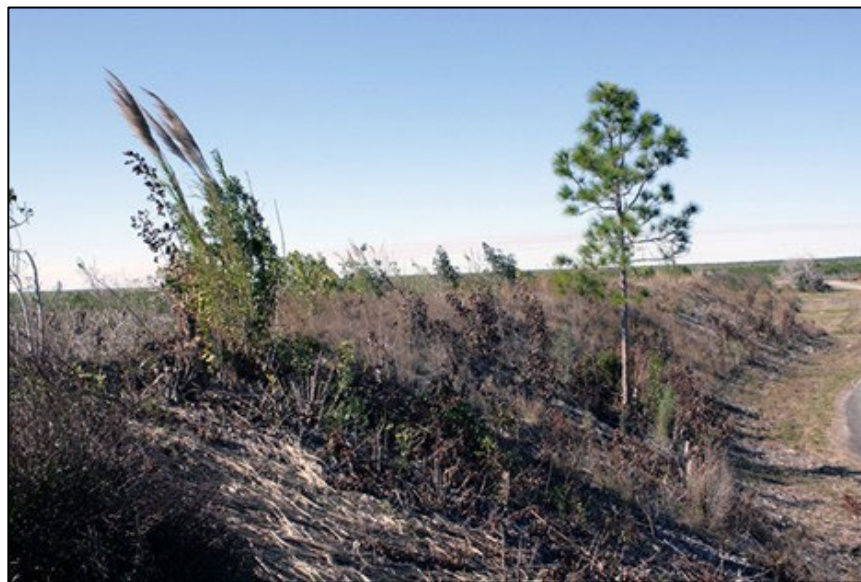
*Fig 34. A variety of native and non-native species, including some trees, grows on the Launch Area berms. Source: JMA, 2010*

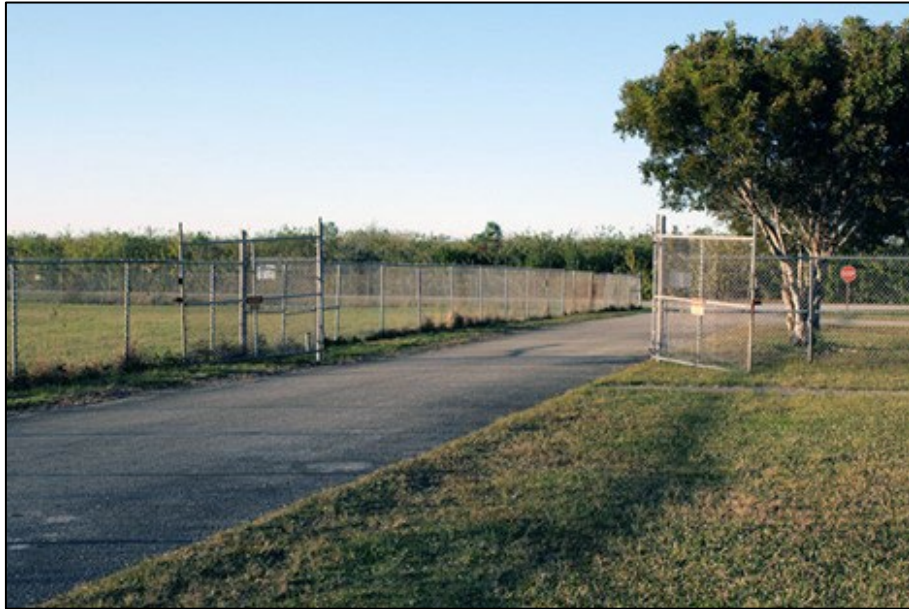
*Fig 38. Access to the rear portion of the Control Area is restricted. Source: JMA, 2010*

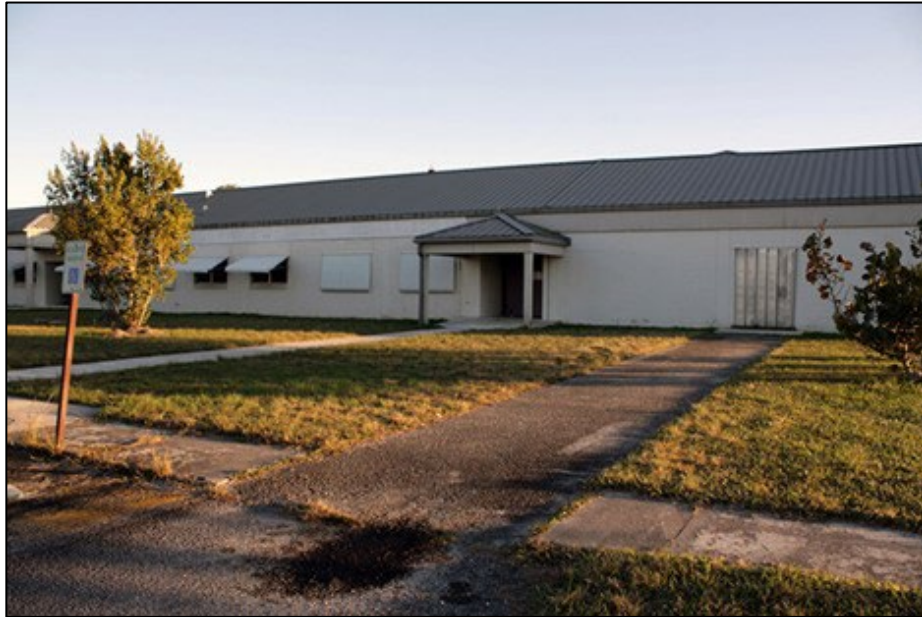
*Fig 41. Asphalt and concrete sidewalks in front of the administration and barracks building. Source: JMA, 2010.*

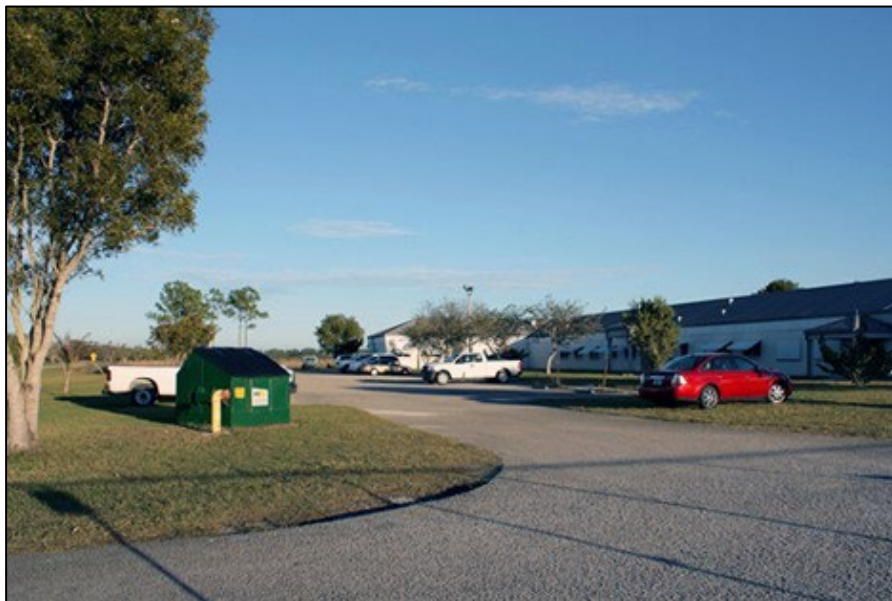
Parking in the Control Area is concentrated mostly in the asphalt-paved lot north of the administration and barracks building (Fig. 42). Several other small parking areas are located along the access road between the administration and barracks building and the pumphouse, between the generator building and the interconnecting corridor building, and along the part of

*Fig 42. Asphalt parking lot in front of the administration and barracks building. Source: JMA, 2010.*

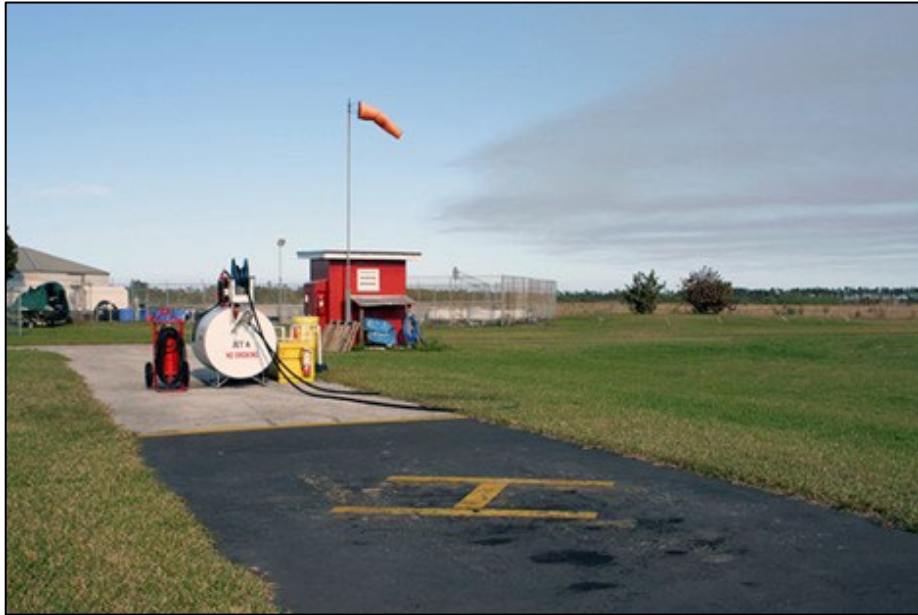
*Fig 45. Part of the sewage plant access drive used as a helicopter landing pad. Source: JMA, 2010.*

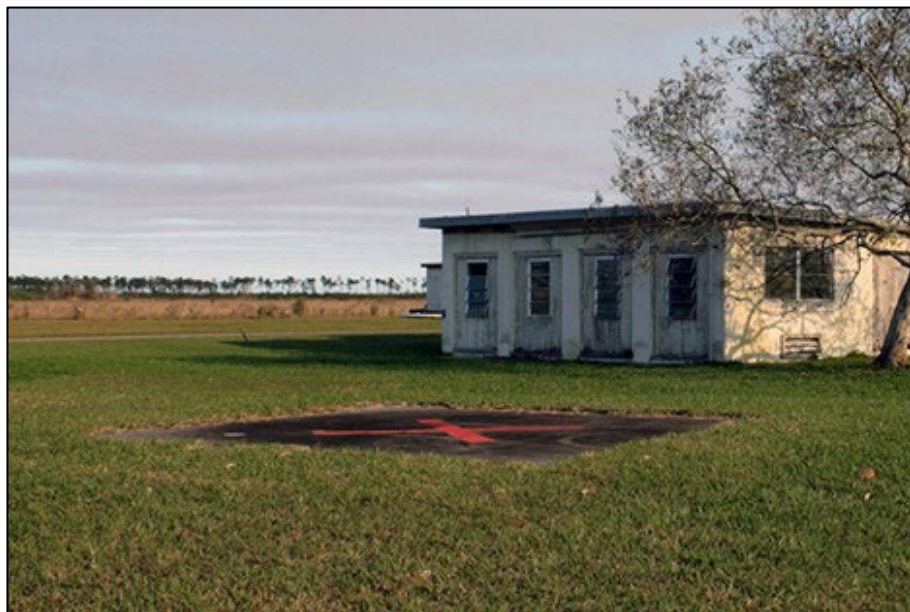
*Fig 46. One non-historic helipad is located north of the generator building. Source: JMA, 2010.*

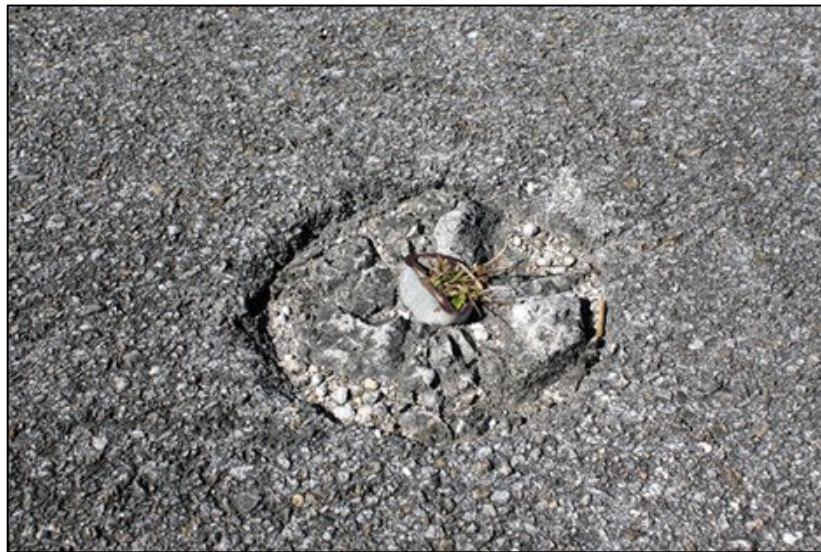
*Fig 50. Remnants of the Launch Area security gates are still embedded in the loop road. Source: JMA, 2010.*

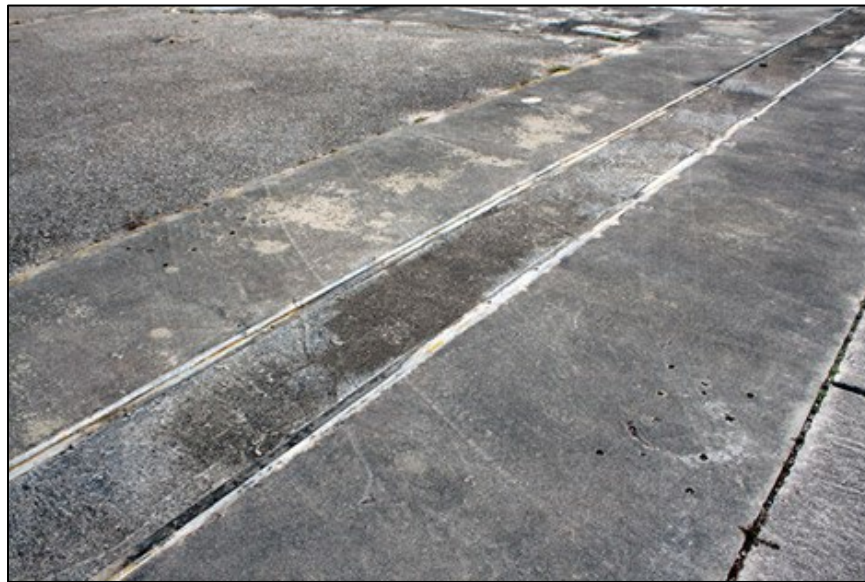
*Fig 54. Remains of the missile-moving track, embedded in the concrete launch pad. Source: JMA, 2010*

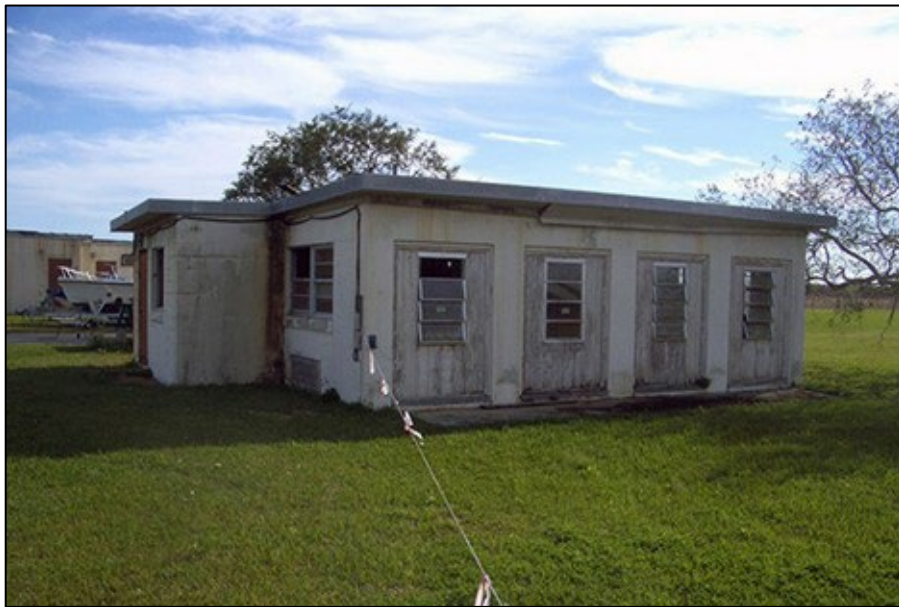
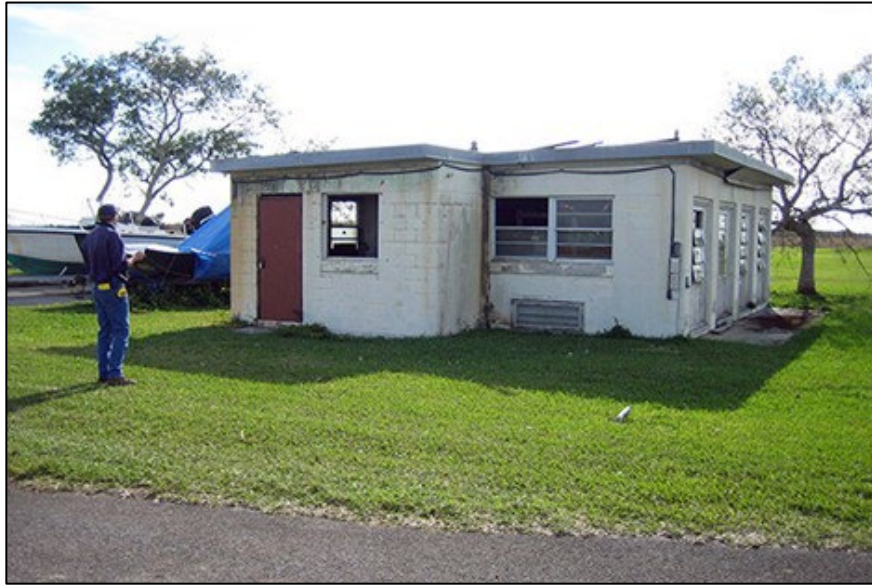
The generator building is a one-story structure consisting of two components: a generator room and a restroom addition (Figs. 62 and 63). The generator room is constructed of concrete columns and beams infilled with CMU. The low-slope shed roof structure is supported on metal bar joists. The restroom addition is attached to the generator room and is constructed of CMU. The main entrance to the building is located on the west elevation and has been boarded up with plywood. A second entrance on the east elevation consists of a painted steel flat panel door with painted steel frame and concrete sill. Typical window openings on the south, east, and west elevations have a concrete sill and contain aluminum-framed double-hung windows. Four large openings, which at one time each contained a set of louvered double-doors, have been infilled with vertical board siding and a non-original stacked four awning window group. The generator building is in disrepair and is abandoned.

*Fig 62. North elevation of the generator building. Source: WJE, 2010*

*Fig 63. East elevation of the generator building. Source: WJE, 2010*

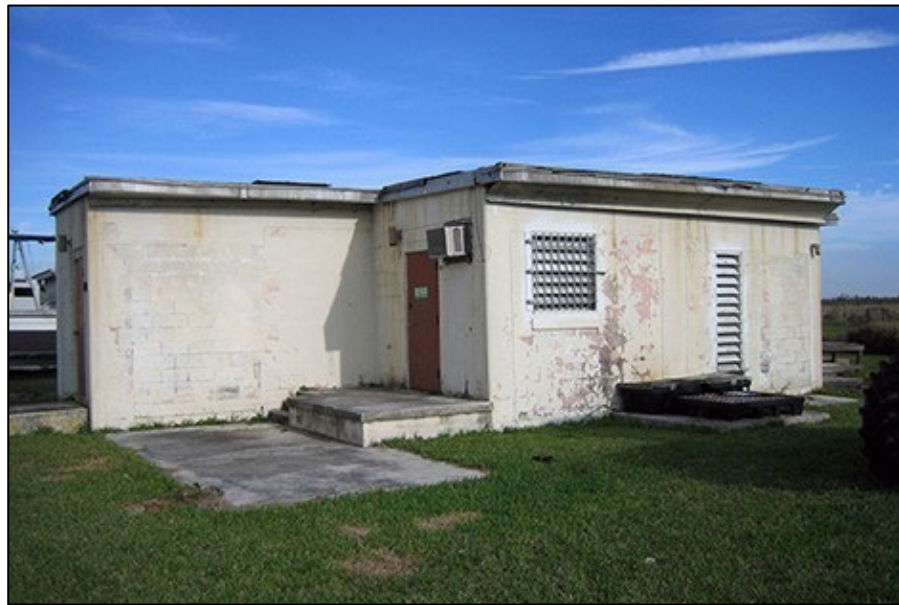
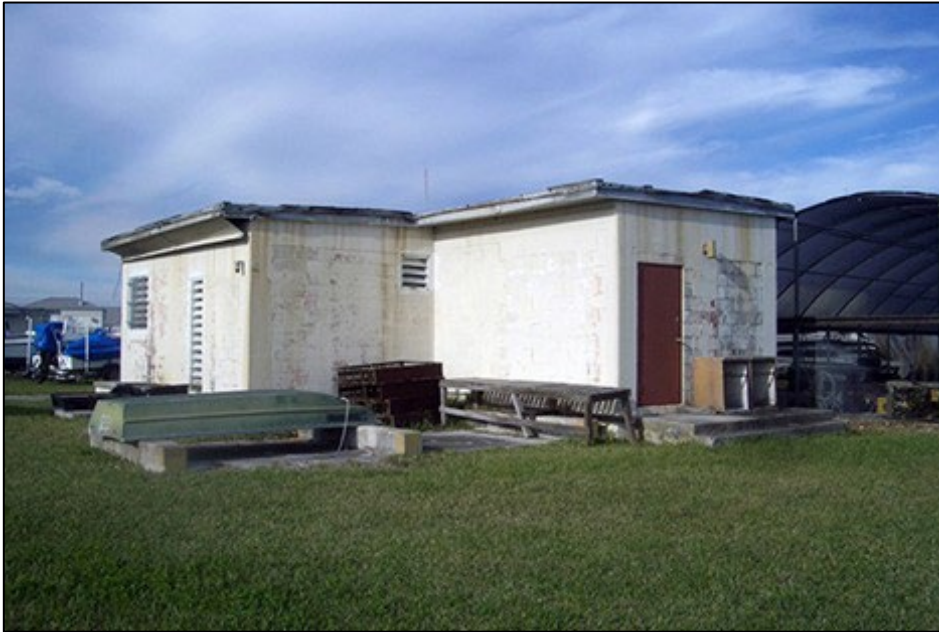
The interconnecting corridor building is a one-story building constructed of concrete columns and beams with CMU infill and a shed roof supported on metal bar joist framing (Figs. 64 and 65). There are four door openings located on the north and south elevations, one of which has been completely infilled with CMU. The remaining door openings have been partially infilled with CMU and contain a painted steel flat panel with painted steel frames and concrete sills. Concrete stairs and platforms are located in front of each entry point and provide a transition between grade level and the interior floor height. Window openings are located on the east and west elevations. Two aluminum-framed double-hung windows separated by an aluminum mullion are located in the window opening on the east elevation. Wood-framed louvered windows are located in west facade window openings. Upon completion, the building provided mechanical support, storage, and a common space for the radar control, battery control, and alternate battery acquisition radar (ABAR) tower control telecommunication trailers. The three trailers were connected to the building through large openings in the east and west facades. When the trailers were removed in 1985, openings in the interconnected corridor building were infilled with CMU. The building is in disrepair and is abandoned.

*Fig 64. West elevation of the interconnecting corridor building. Source: WJE, 2010*

*Fig 65. South elevation of the interconnecting corridor building. Source: WJE, 2010*

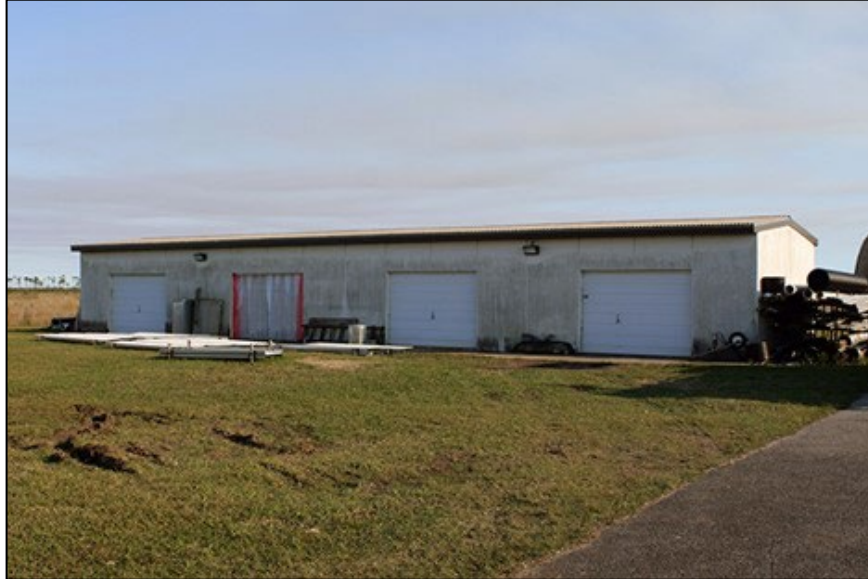
The general purpose warehouse is a one-story building with a corrugated sheet metal gabled roof, painted stucco wall cladding, and four steel overhead garage doors (Fig. 66). The rear of the garage has four windows with corrugated metal covers. This building was significantly altered in the mid-1980s, when all of its exterior wall and roof cladding was replaced and the garage doors were installed. Due to a loss of integrity, this building is considered non-contributing in the National Register nomination.

*Fig 66. North elevation of the general purpose warehouse. Source: JMA, 2010*

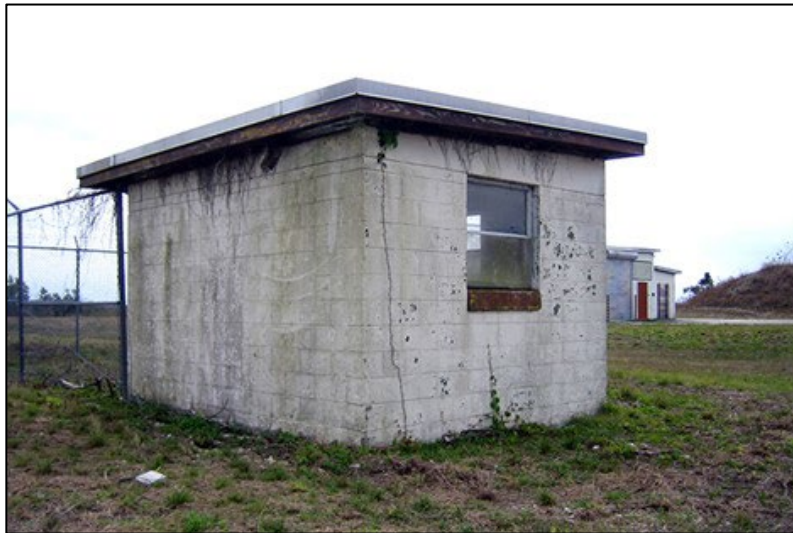
The canine support building is located at the south end of the Nike Missile Launch Area in close proximity to the missile assembly and test building. The building is oriented on an east-west axis and has a wood-framed shed roof. The CMU structure is capped by a reinforced concrete tie beam with the high point of the roof on the south and sloping to the north (Fig. 82). An 8-foot-tall chain link security fence with barbed wire extends from the corners of the east elevation of the canine support building and encloses a pen. The door opening to the building is centered on the east elevation and contains a six panel hollow core door. Window opening are centered on the south and west elevations and consists of two stacked aluminum-framed awning windows. The one room interior of the canine support building contains a wood-framed counter, shelving, and a utility sink. The wood-framed roof is deteriorated and the building interior is exposed to the elements.

*Fig 82. View from northwest of canine support building. Source: WJE, 2010*

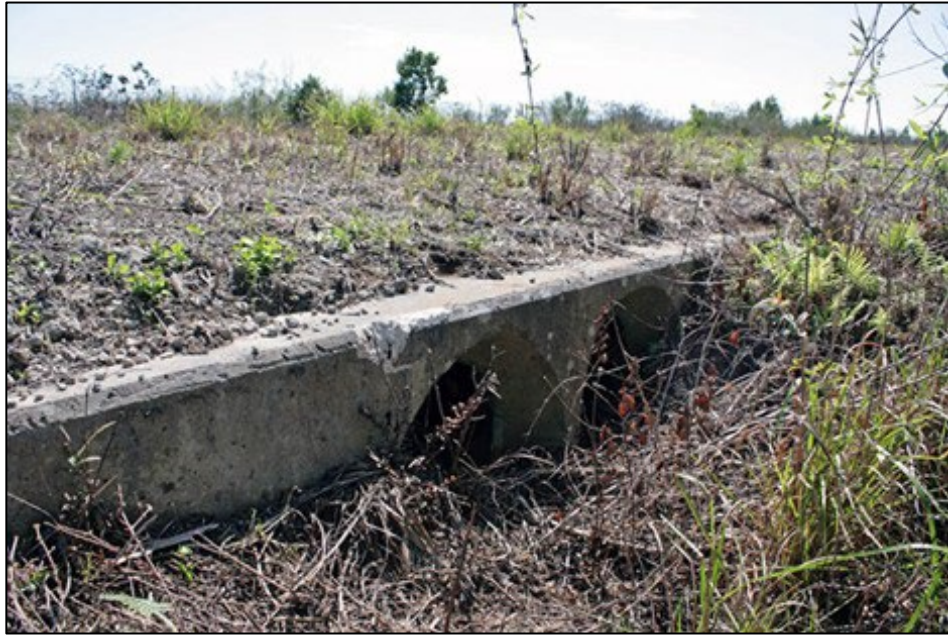
The as-built construction plans of the base show a total of eleven drainage structures corresponding with drainage swales, with eight drainage structures in the Launch Area and three along the Launch Area Road. Each drainage structure is composed of two concrete headwalls connected by one 15-inch or two 18-inch corrugated metal pipes. Only two structures in the Launch Area have a double pipe elevation; the double-pipe structures collected a greater volume of runoff, which drained into the borrow pit (Fig. 83). Not all of the drainage structures were located and observed in the field, but it is likely that most of the structures, if not all, are extant. Those that were observed have some damage, include chipping caused by vehicles, spalling, and biological growth.

*Fig 83. A drainage structure with a double pipe elevation. Source: JMA, 2010*

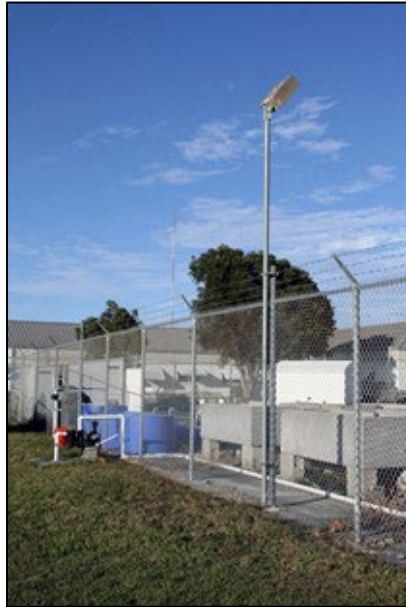
*Fig 89. Chain link fence surrounding the former athletic court. A pump and tanks associated with aquatic invertebrate and fish research are also visible. The light pole may be remaining from the period of significance. Source: JMA, 2010*

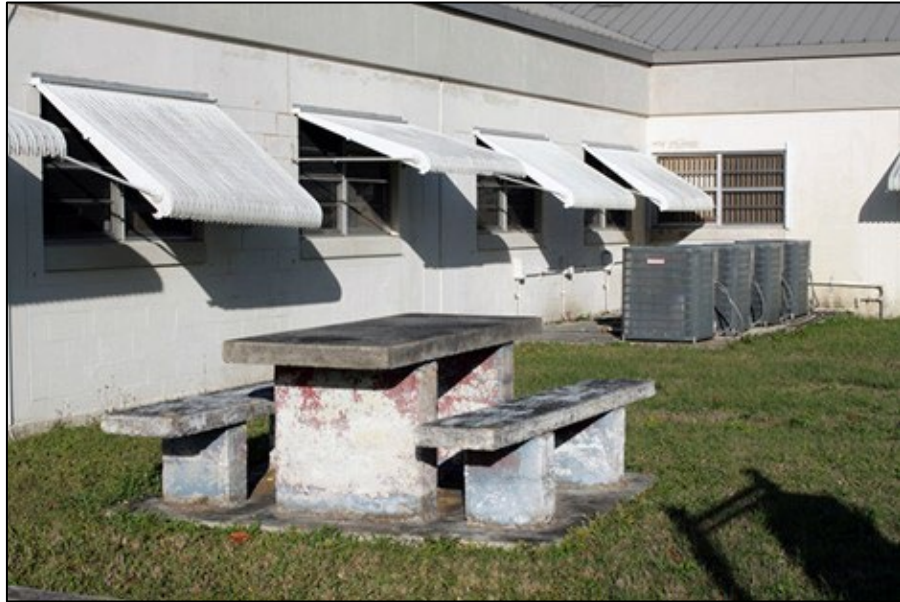
A concrete picnic table and benches made from concrete blocks and poured concrete slabs is located in the grassy area between the research center and the athletic court (Fig. 95). Peeling paint on the concrete block supports indicated that they have been painted a variety of colors. An 8-foot-square concrete slab located in the same area has rectangular markings suggesting that an identical table and bench set once existed (Fig. 96).

*Fig 95. Concrete picnic table and benches located between the research center and athletic court. Source: JMA, 2010*

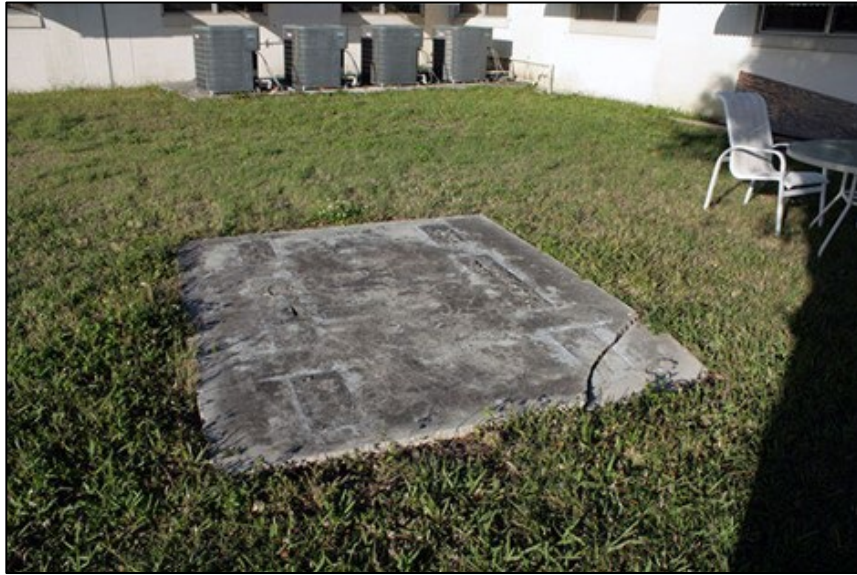
*Fig 96. A concrete slab with rectangular markings indicates that a second table and benches similar to those still extant once stood nearby. Source: JMA, 2010.*

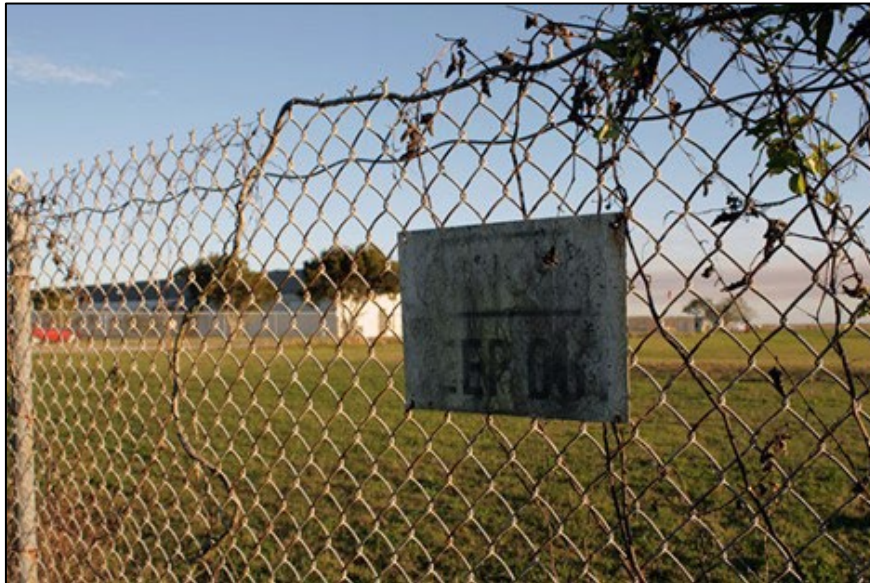
A section of fencing running along Long Pine Key Road west of the Control Area road is remaining from the period of significance. The chain link fencing has a “Keep Out” sign tied with wire to its westernmost section (Fig. 97).

*Fig 97. Historic "Keep Out" sign on remnant fencing. Source: JMA, 2010.*

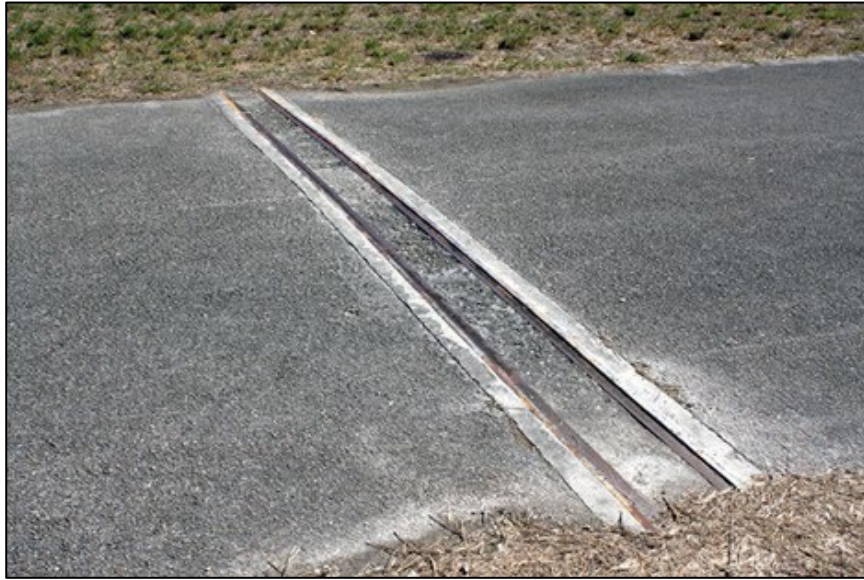
*Fig 112. Cable trenches carried electrical cables beneath the roadway. The trenches were filled with concrete following the removal of the cable trays. Source: JMA, 2010*
