Assessment for Geraldine Coffman  
Historic Crawford/Shoaf Barn  
<https://khri.kansasgis.org/index.cjm?in=045-6833>  
Inspection on September 24, 2020  
November 6, 2020

Assessment for Eric Jackson  
Historic McQuillan Barn <https://khri.kansasgis.org/index.cfm?in=045-6057>  
Inspection Performed 9/24/2020  
November 6, 2020

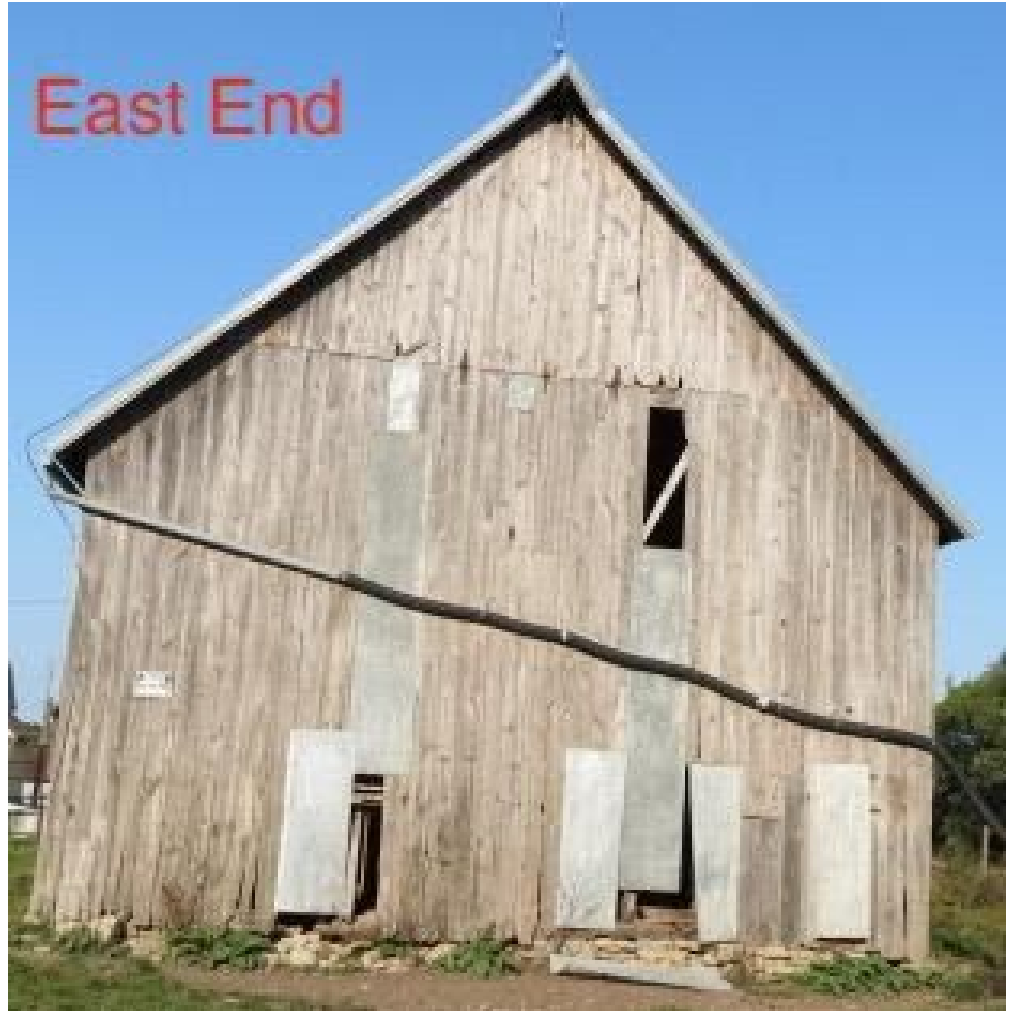
A half round gutter hangs from the south roof edge and a steel downspout runs to corrugated plastic tubing diagonally across the east end to the muddy ground on the north side.

| Priority | Recommendation | Rough Cost |
|---|---|---|
| 2 | Install a roof drainage system for the north side to keep water away from the foundation at least ten feet downhill | Approximately \$300 - \$800 |

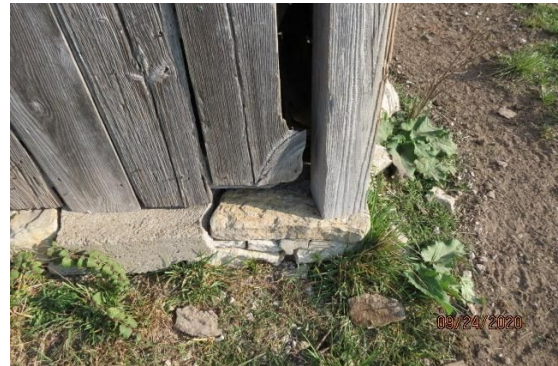
Some post bottoms are deteriorated from being in the soil and muck and on a rotted wall plate. The southeast post bottom has been replaced and now sits on a stone instead of the timber sill plate, which has rotted away.

| Priority | Recommendation | Rough Cost |
|---|---|---|
| 5 | Replace the deteriorated post bottoms. Once the posts are whole again, they may be used to lift the building to install the plates and work on the foundation.<br>Note: When replacing the bottoms of posts decisions need to be made as to how the post will be connected to the wall plate below and how timbers are connected end to end, like for corner and scarf joints. It is easiest to follow the lead of joints already in use rather than find another way. The distance from the roof plate to the bottom of each post is the same for each post. These may be crafted one at a time. Props may be inserted under the girts/nailers or tie beams and the plate may be removed from below to give clearance. 16 con. to sill plate. 2 -6 scarfs. | Approximately \$3,000 - \$7,000 |

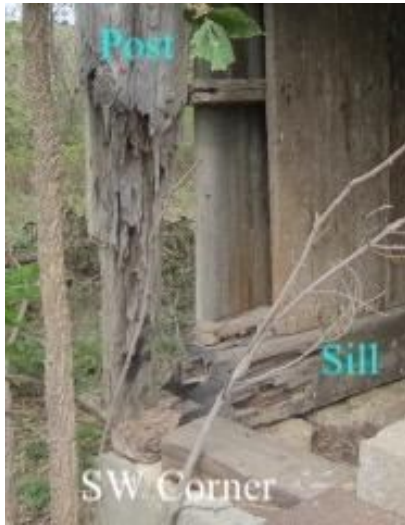
Many stones are out of place from the foundation. The north wall has had concrete formed up to support the wall plate.

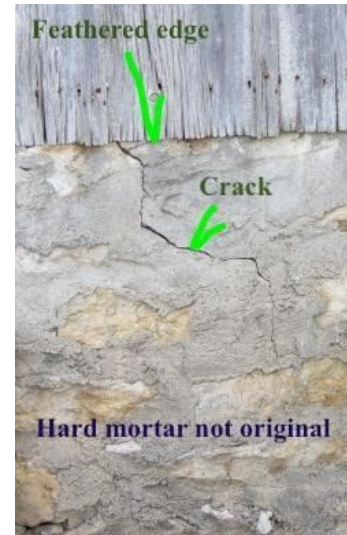
On the west side the taller wall has been repaired by repointing but cracking indicates uneven loading and lack of adhesion between the stones in the wall core.

The absence of a post bottom at the SW shifts weight northward on the west wall concentrating load where it was not intended. Stone is removed from the south foundation wall and some has been mortared together. Much of the wall looks as though it has been replaced with concrete.

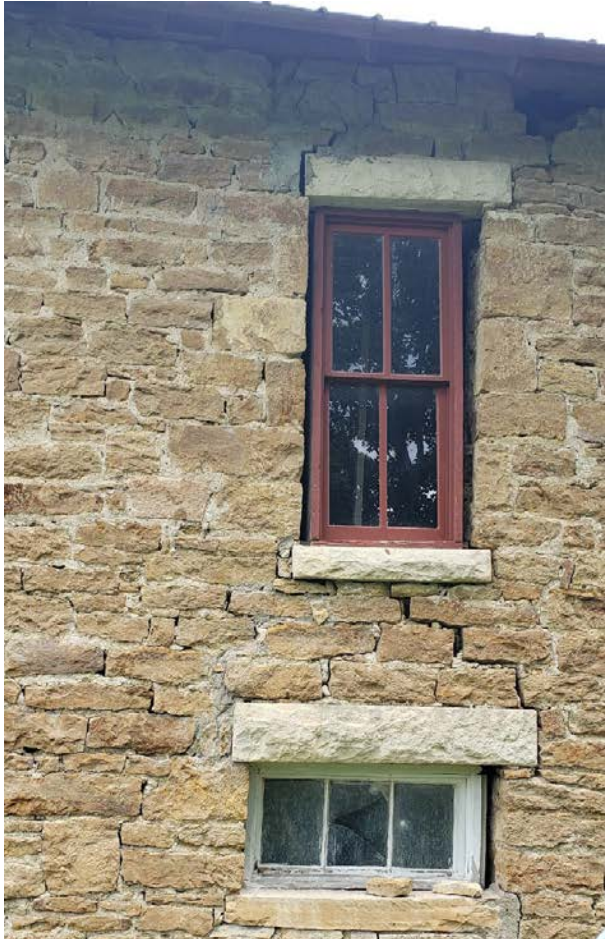
Vertical cracks (wider at their tops) run the full height of the building at the western window on the north face and the eastern window on the south face, indicating that the foundation has settled mostly on a diagonal to the northeast. Other cracks and breaks like in the sill of the west basement window on the south side show a generally unstable base.

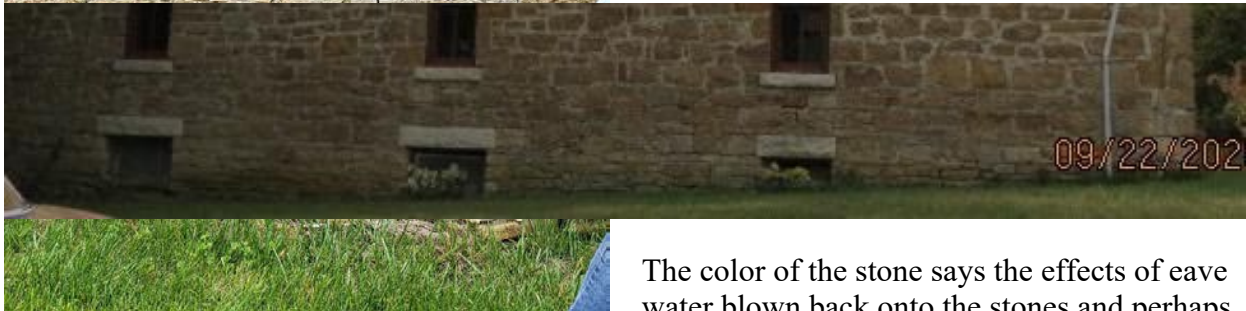
The color of the stone says the effects of eave water blown back onto the stones and perhaps from splash. There is no patina below the first layer of stone under the south basement sills. A similar line is seen on the north side, but higher, as is the ground level. Also, the washed out mortar joints point to erosion of the mortar and soil that was against it.

The north side also indicates change. From the north yard the center and west basement window sills seem below the turf saying, "I've settled or someone dumped a bunch of dirt here and spread it out".

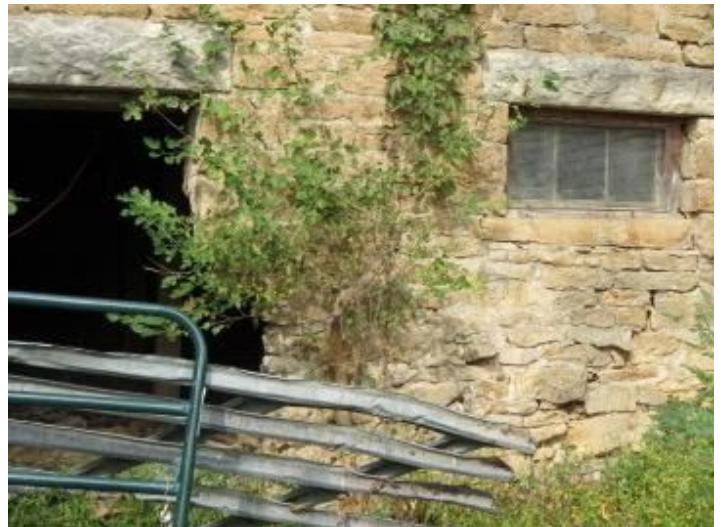
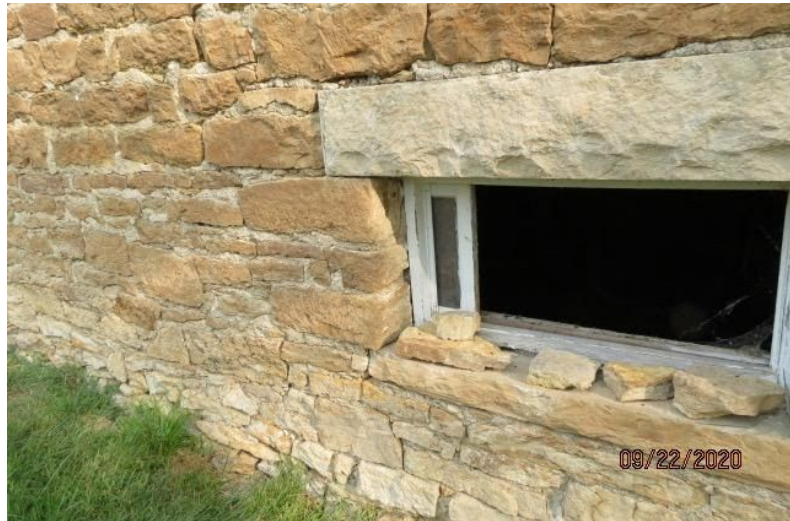
The doorway to the basement is damaged on the north side where the door frame is absent. There is no door there.

| 7 | Re-point all the limestone walls inside and out to tie it together with mortar approved for historic structures. Repair the basement wall and doorway simultaneously. Inside 3,321sq. ft. and outside 2,133 sq. ft.= 5454 sq. ft. roughly. | Approximately @ \$8 to \$12 a sq. ft. = \$43,632 to \$65,448. |

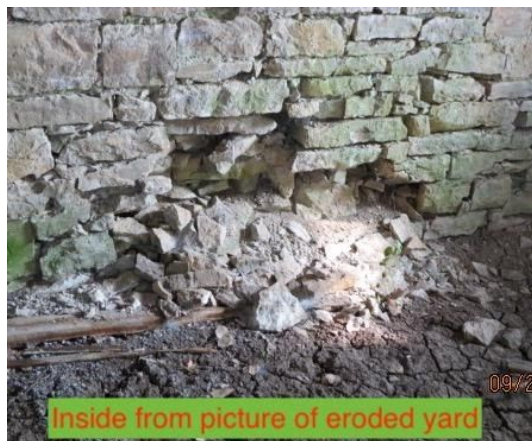
Mortar is missing from many joints, stones have fallen from the lower east end of the north wall, and vertical cracks correspond to those in the first floor walls. As water enters the stone wall, then freezes, it ruins the mortar and breaks the stones so gravity pulls them out.

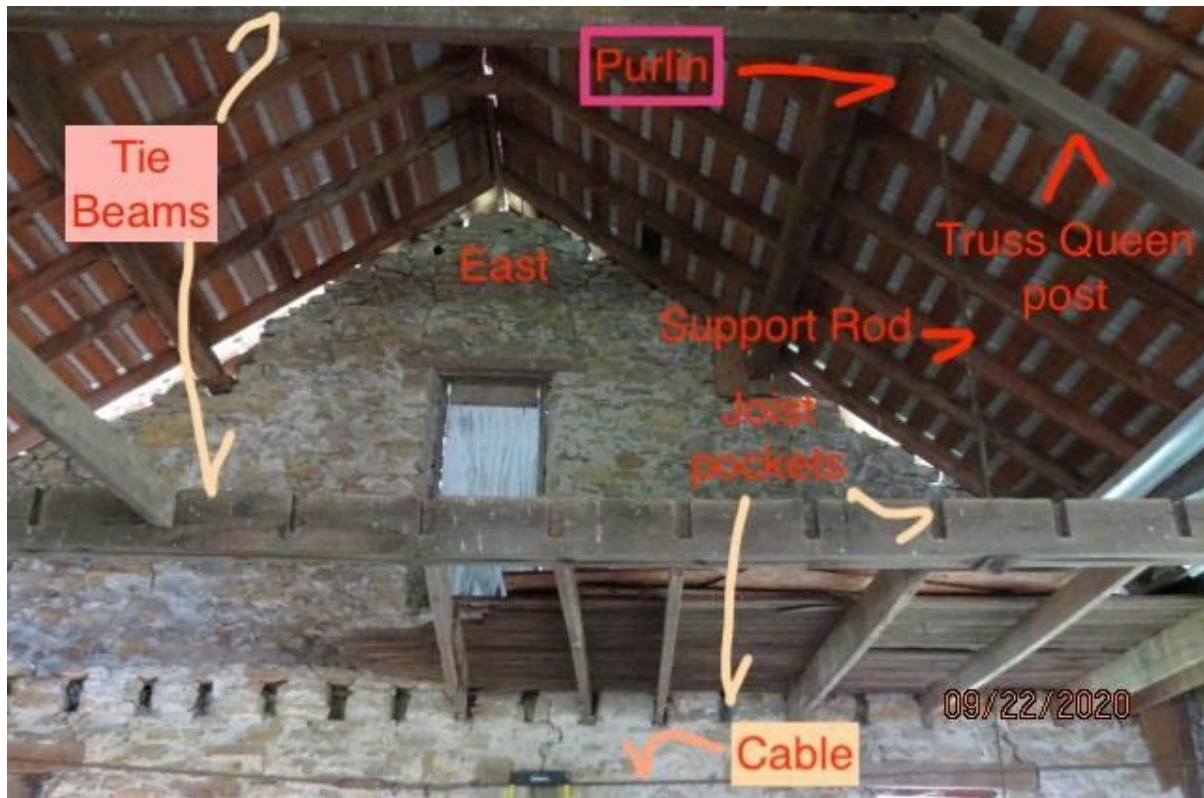
There are four “bents” (more of a truss assembly) north to south across the space whose beams lay on top of the walls without appearing secured. The joist notches in the beams above the first floor are now empty except in the SE corner. These failures to connect results in lack of horizontal support between the stone walls, both east to west and north to south.

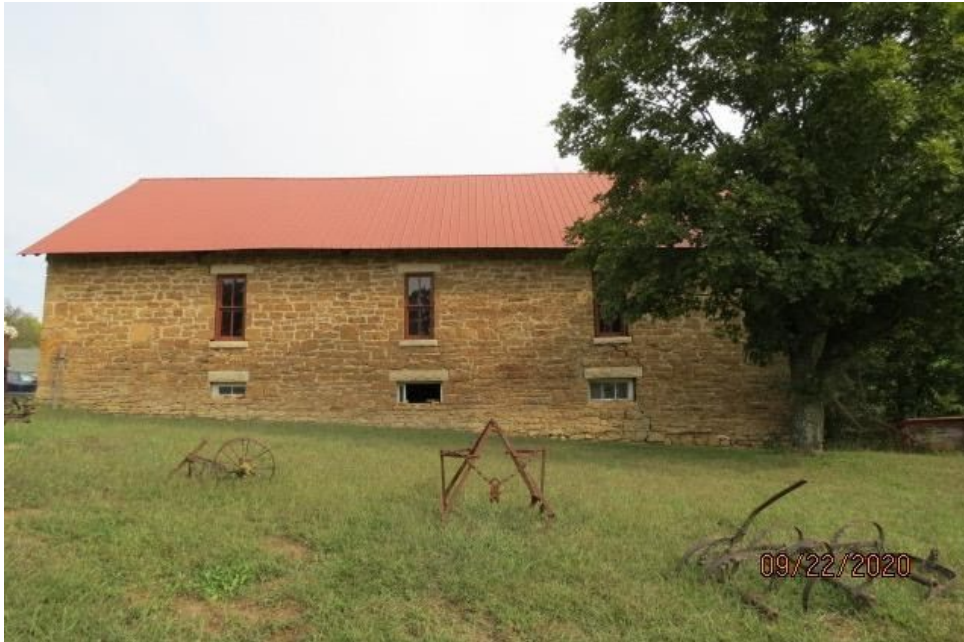
The basement, inside the door, has an area at least 3' in diameter where water puddles.

| Priority | Recommendation | Rough Cost |
|---|---|---|
| 1 | Eliminate a primary cause of the damage to this fruit barn. Install gutters, downspouts, and regrade so groundwater runs away from the barn so water can not remain any closer than 10 feet of the building nor in the basement. If soil is put against the building, repoint it first. | Approximately<br>124' of Gutters<br>\$480-\$1,440<br>Grading of 80<br>Cu.Yds. \$600-<br>\$1,200 |

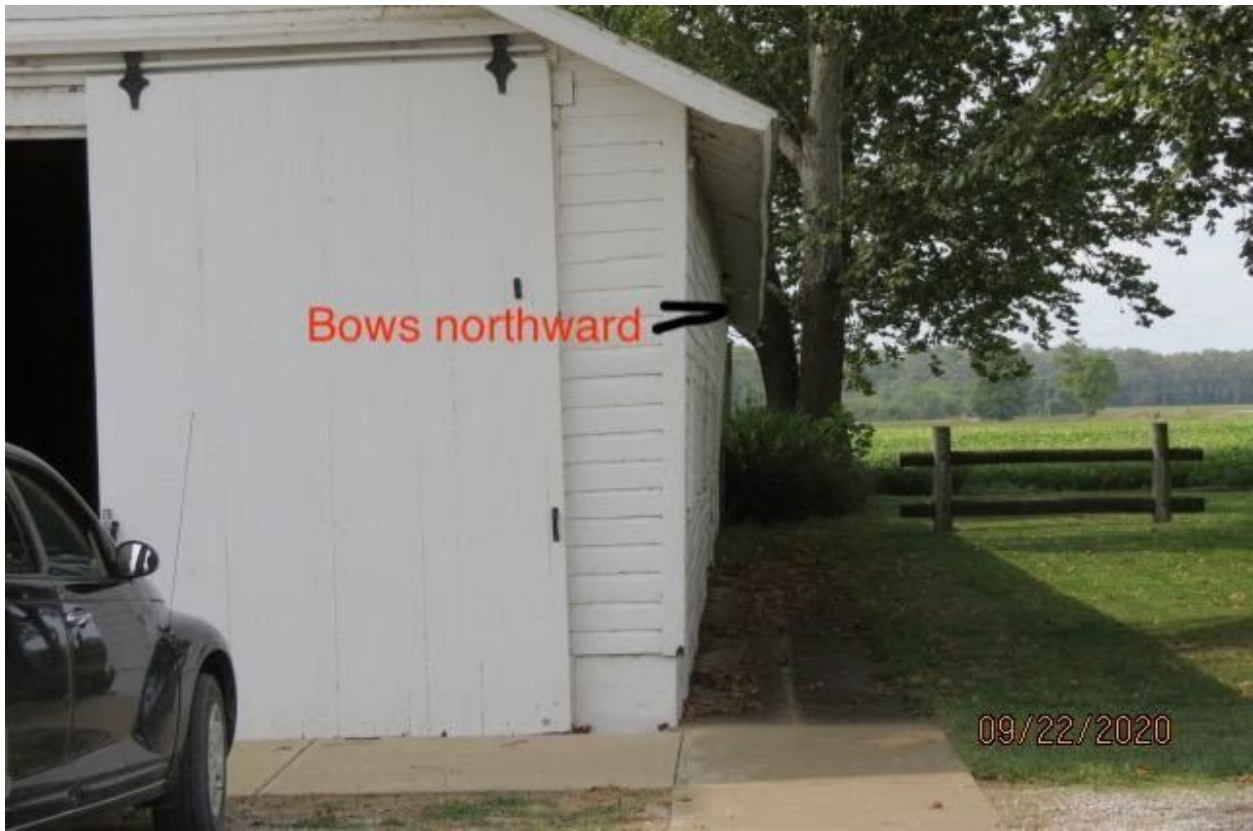
Siding is pressed down against the walkway and outward showing it is under pressure.

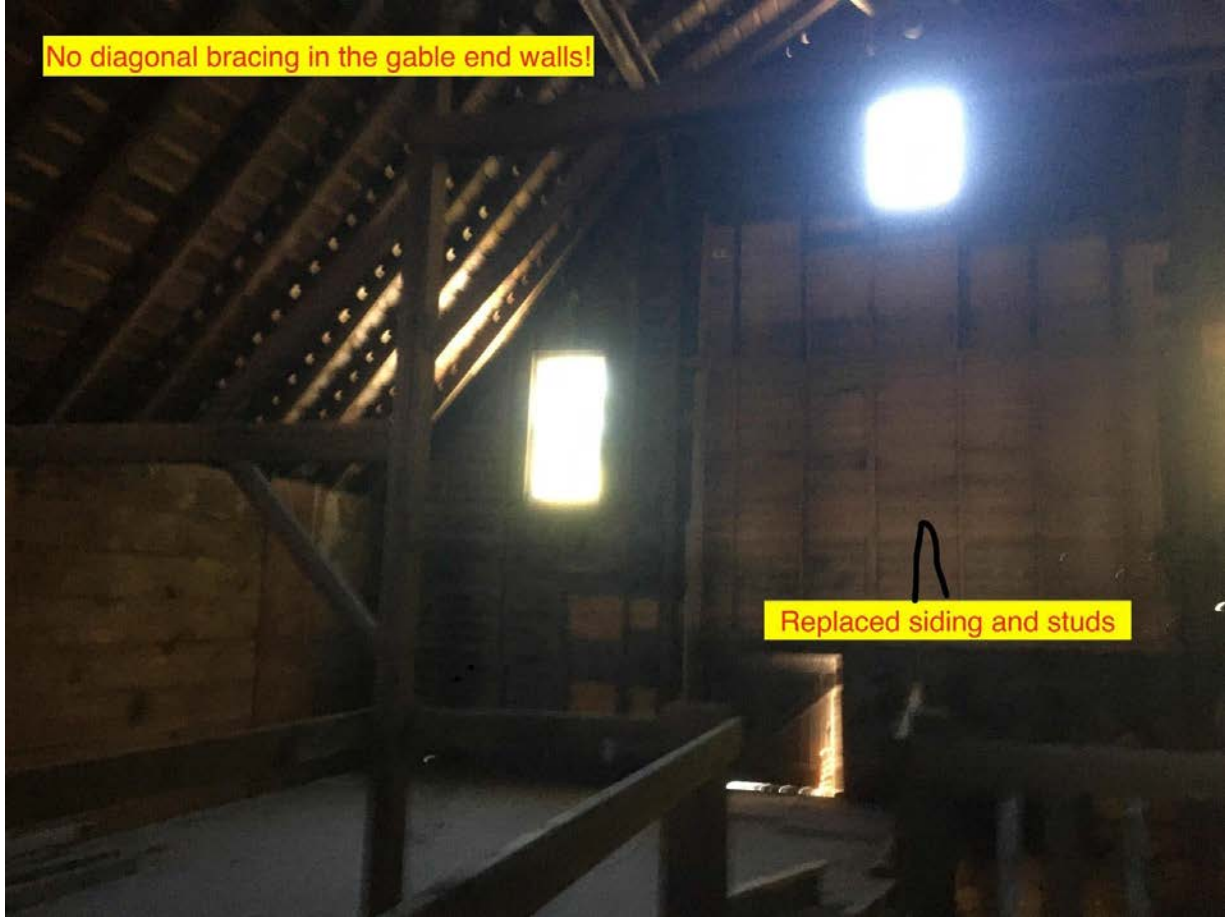
Above the main loft there is NO diagonal bracing in the gable ends of the barn to resist wind pressure and little below the loft.

No diagonal bracing in the gable end walls!

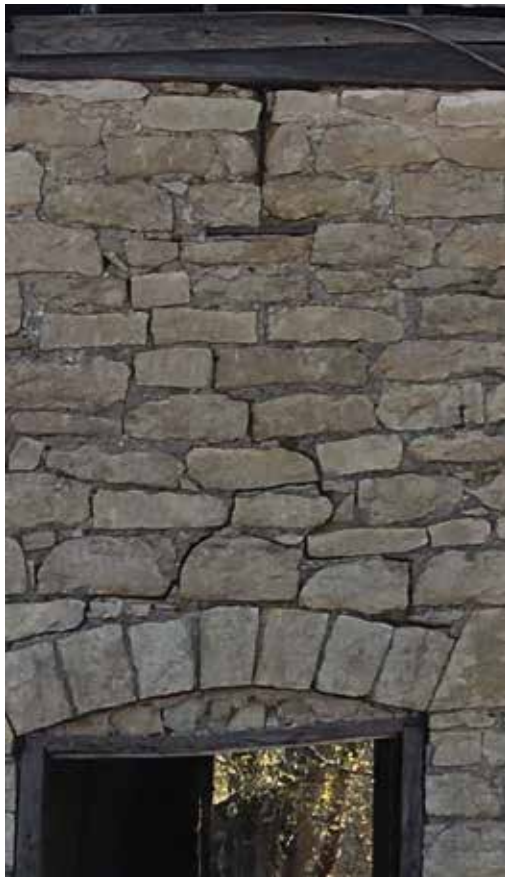
**Foundation-** The most soil erosion is at the northeast corner so the top of the foundation there is 12 inches above grade, that being the step out at the bottom of the main building wall where the wider stone wall is laid up from a lower point under ground. Foundation stone was found at 20 inches below grade but not at 24 inches. Much of the foundation step out around the building is at grade except on the north and east sides where the lay of the land falls away from the building toward the stream. The foundation was designed to rest on soil at least 32 inches below grade. The north and east side need more protection from frost.

Replace the washed away soil up to the top of the foundation wall on the north and east sides (Slope away from the building for at least 10 feet should not exceed 1 in 20 pitch).

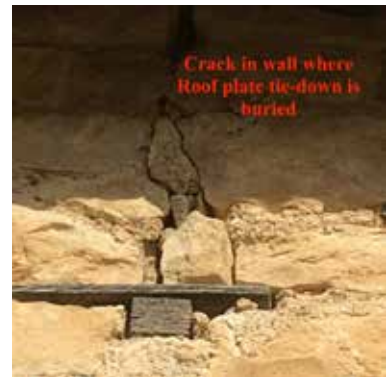
**Envelope/Siding-** The bulk of the building is laid up yellowish limestone to the level of the roof plate, which also serves as a wall plate in the gable ends. Some stones are absent, like at the bottom of the opening above the south doorway. Some cracking has developed like above the north door in the west wall.

Repair all cracks in the stonework, inside and out, with mortar of similar strength and color.

Replace absent stones, using mortar of similar strength and color.

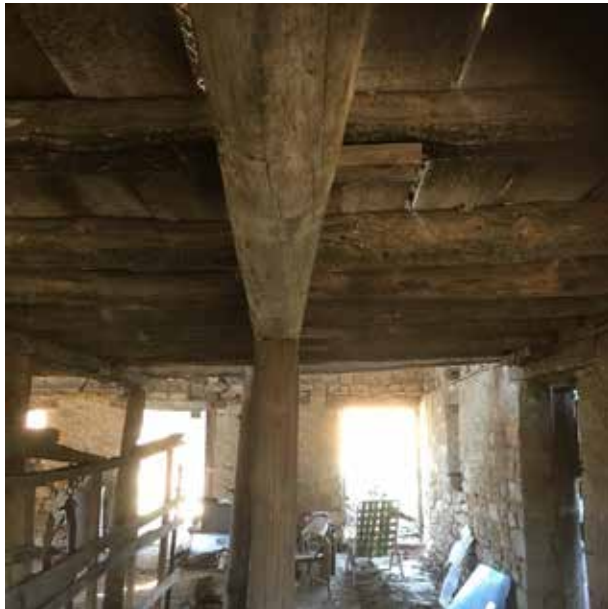
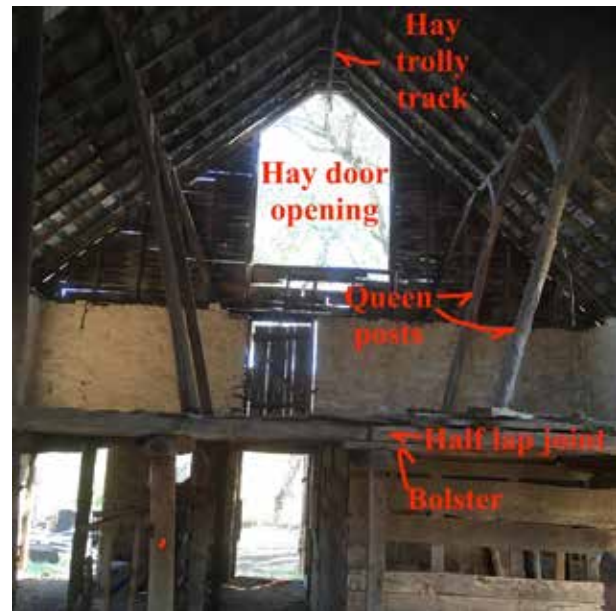
The loft settling can be caused by several

things. The bottoms of posts set on or in the ground tend to rot and crush the rotted material. That allows them to lower whatever is sitting on them. The beams seem to have bent. Is this due to the heavy loads or were they that shape when they were put in place? Timber frame barns were often built with green beams and posts so they may bend to adjust to stresses until they cure.

Install piers, at least to the depth of the base of the foundation, under each queen-post and loft post that rests in/on dirt.

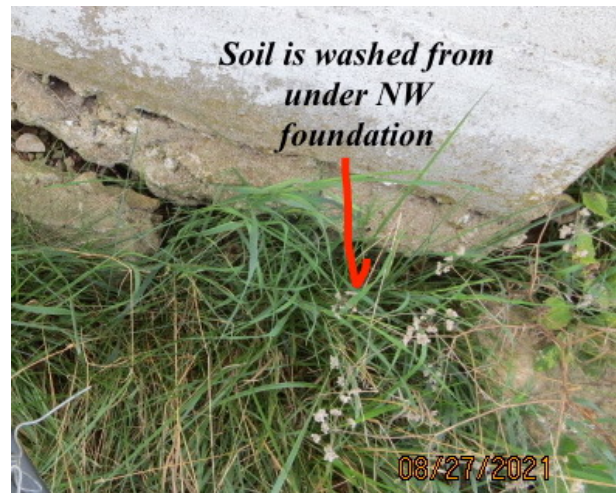
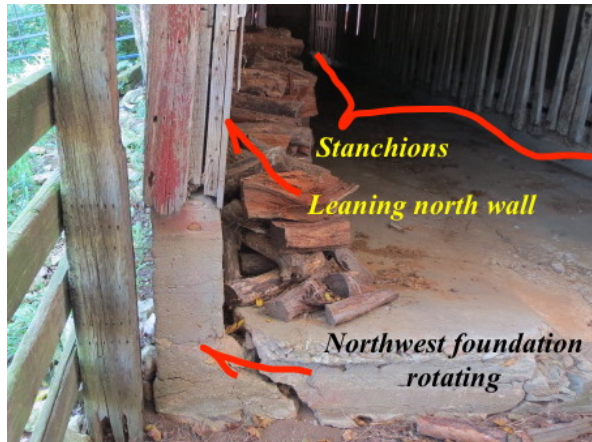
Much erosion from roof drainage is found west of the milk-house and along the north wall of the north lean-to. As well, trees have grown against the building in these areas. A clump of trees have been

cut off a few feet above ground about 25 feet from the northwest corner and it is there that the foundation wall is broken in two places. The wall at the northwest corner has rotated.

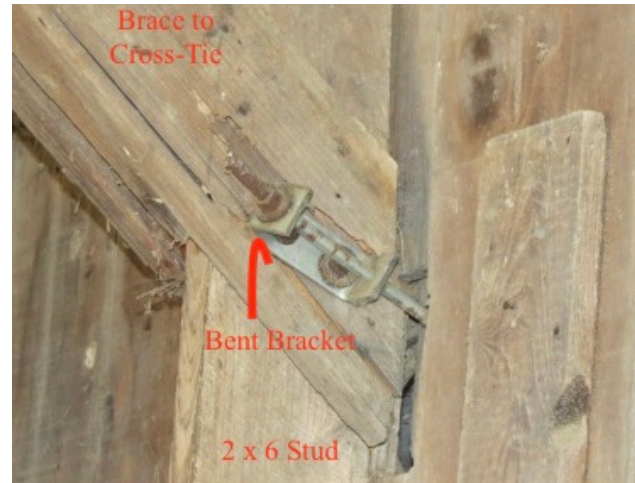
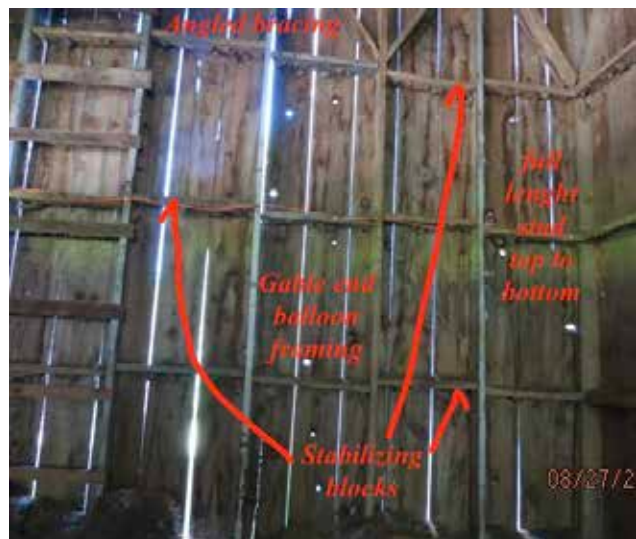
Diagonal braces toward the top of the north wall have helped to avoid east to west distortion of the building.

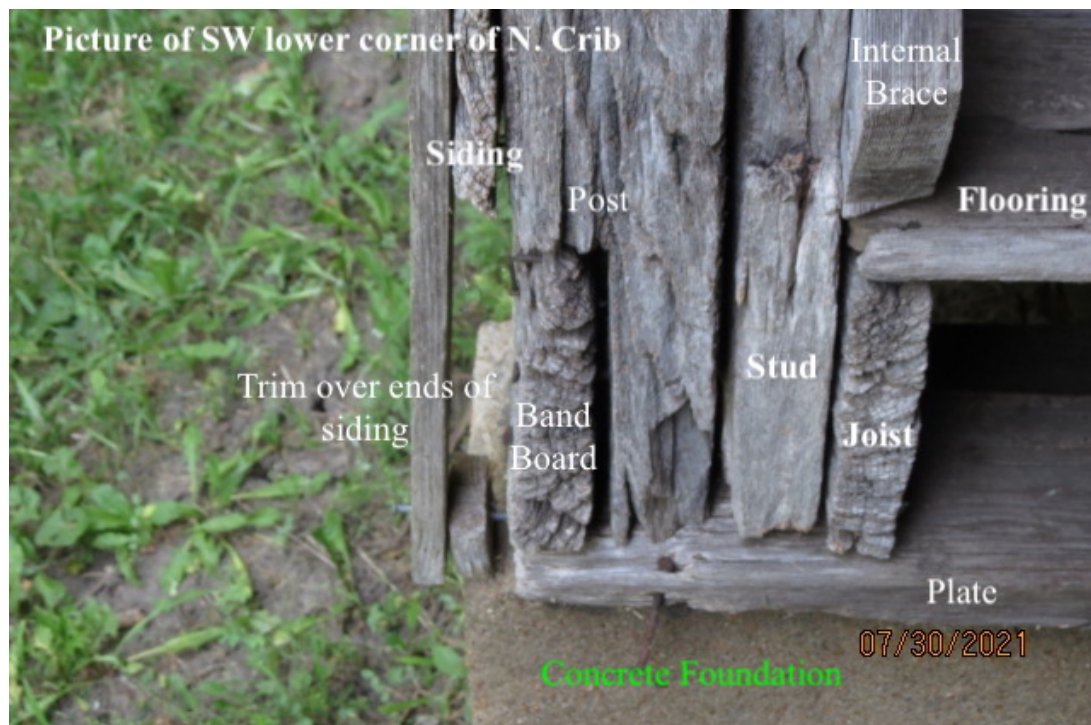
The barn frame is made of individual pieces of 2" thick lumber with a few larger timbers, maybe reused from an earlier building. Like at this southwest corner of the north crib, some structure is exposed to the weather.

Secondly, while siding is off repair the building where it has been damaged, such as the corner posts which show termite damage and rot.

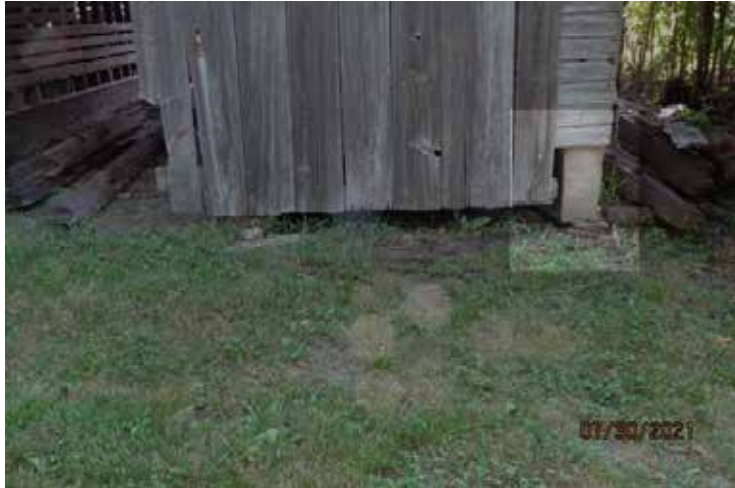
Erosion is evident at the southwest corner of the south foundation wall.

Apparently, a form was placed on the ground at the top of the footing, a little off center.

Eighth, further protect the foundation from frost damage. At least restore the original grade against the concrete, inside and out. The distance from the ground to the bottom of the west door is a clue to the original grade. It is almost the height of a step, which one needs to enter the cribs without difficulty.

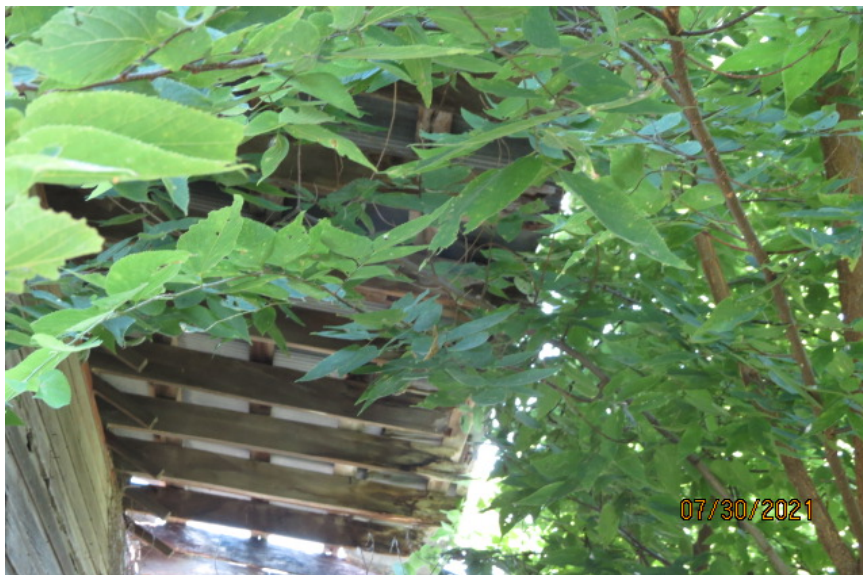
The close vegetation to the south provides protection from the constantly moving air. Unfortunately, the limbs and leaves closer than a several feet of the structure do not allow surfaces to dry to stave off the rotting process. Small trees closer than 10 feet, or so, send roots under and against the foundations of the building, pushing upward and sideways.

| Item | Unit price | Area to repair | Cost | Comment |
|---|---|---|---|---|
| Vegetation trimming | \$50 to \$75 per hour.<br>\$80 per large trailer load. | South of the barn- several trees plus weeds including poison ivy to the west.<br>Trim vegetation which is within 3 feet of the drip edge of the building, removing trees within 10 feet of same. | 8 man hours for \$400 to \$600.<br>Disposal \$80 to \$160.<br>Total \$480 to \$760. | Kill poison ivy to reduce hazard for workers.<br>To protect the foundations and other structure and surfaces. |

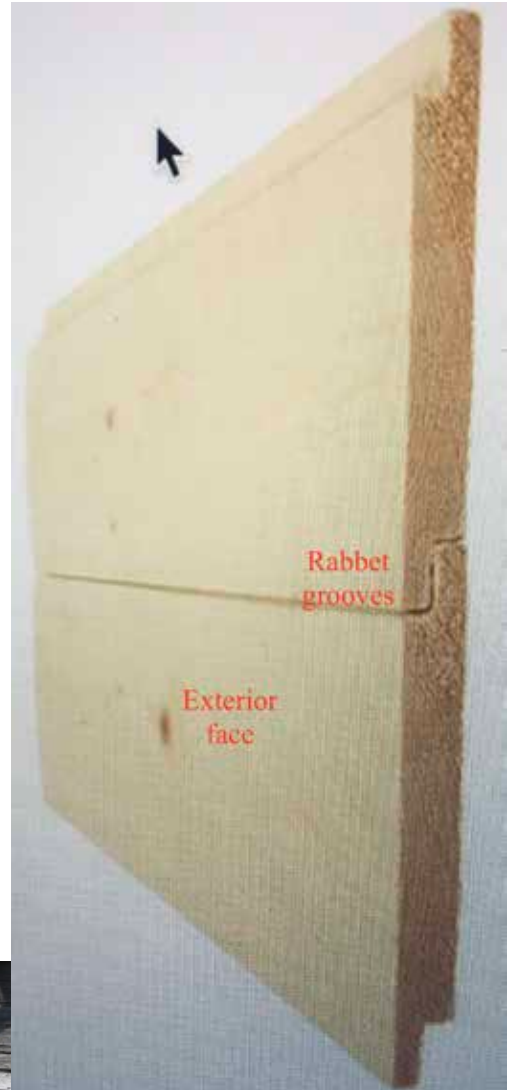
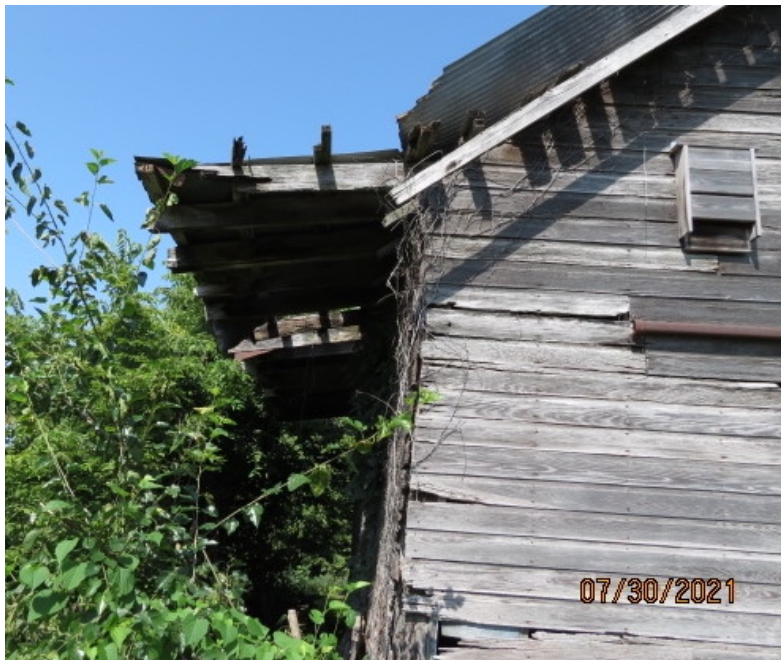
The ship-lap siding is gray in color which is typical of wood for many years without paint, but with hints of red in protected areas like under the eaves . There are numerous places where the siding is pulled away from the studs, worn through, or otherwise absent. The siding is applied directly to the studs as was typical in the day. In its present condition the siding cannot ward off the weather.

The first priority is to protect the building further from its number one enemy, water. Repair as needed or replace the siding and replace missing sheet metal, loose nails with roofing screws, and seal any leaks. This includes dealing with roof drainage.

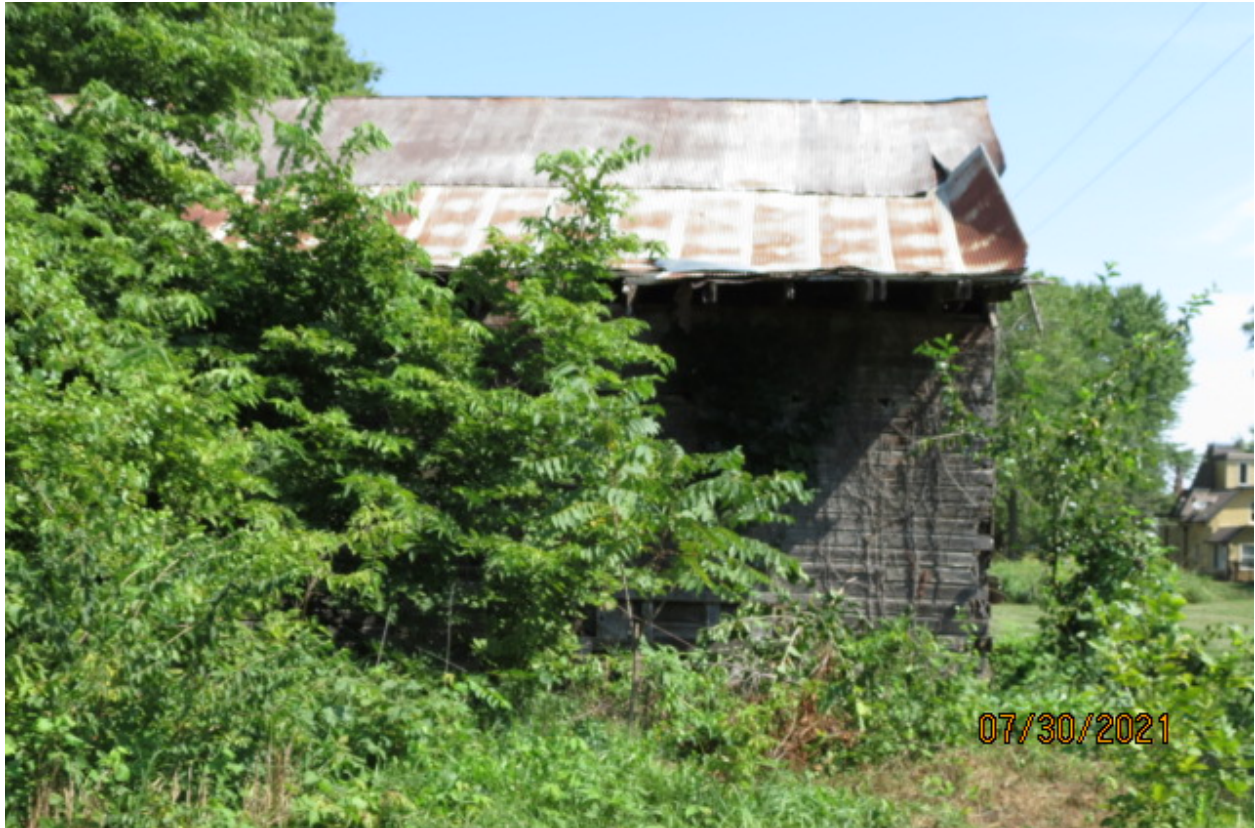
The finished layer of the roofing is corrugated steel with much zinc coating worn though resulting in a substantially rusted surface on the north side. The steel is badly bent and not

attached at the southeast edge. This allows rainwater and snow to fall inside.

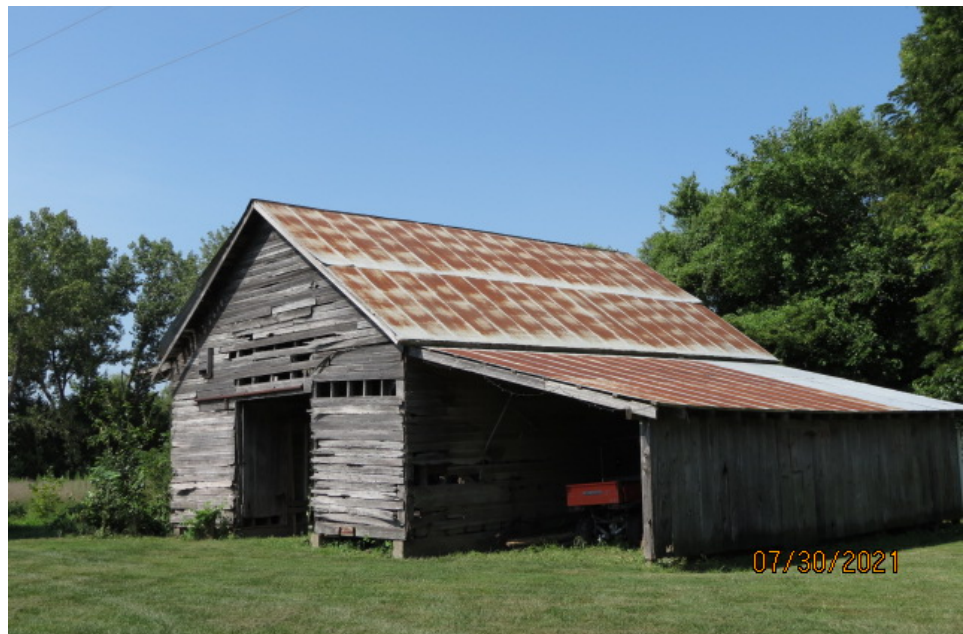
The corrugated roof of the lean-to was previously used, judging from the number of holes in the tops of the ripples, letting in light (which is not a bad thing), and is installed at a more shallow pitch than the main roof. Most

has little coating remaining to protect it.

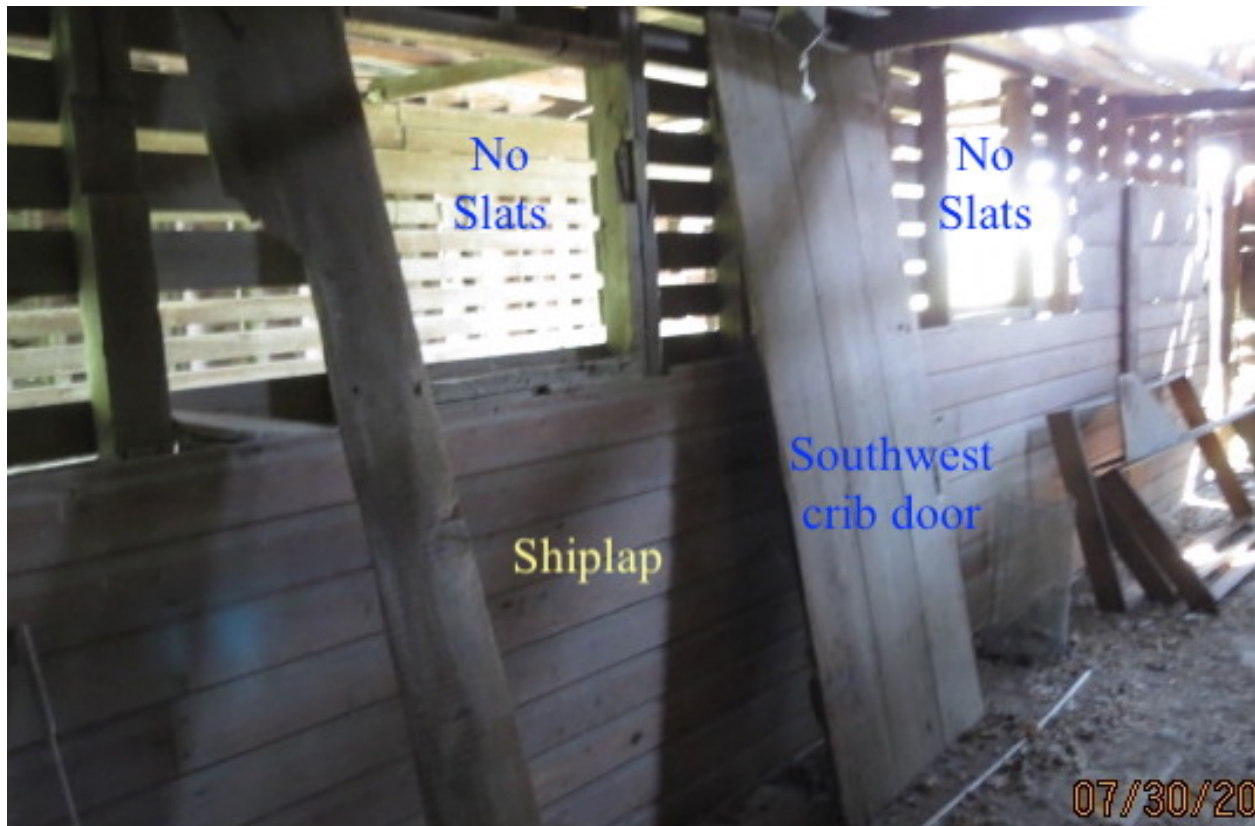
Doorways are the only openings to the outside. The south crib has two areas in its north wall

above the siding where it has no slats.

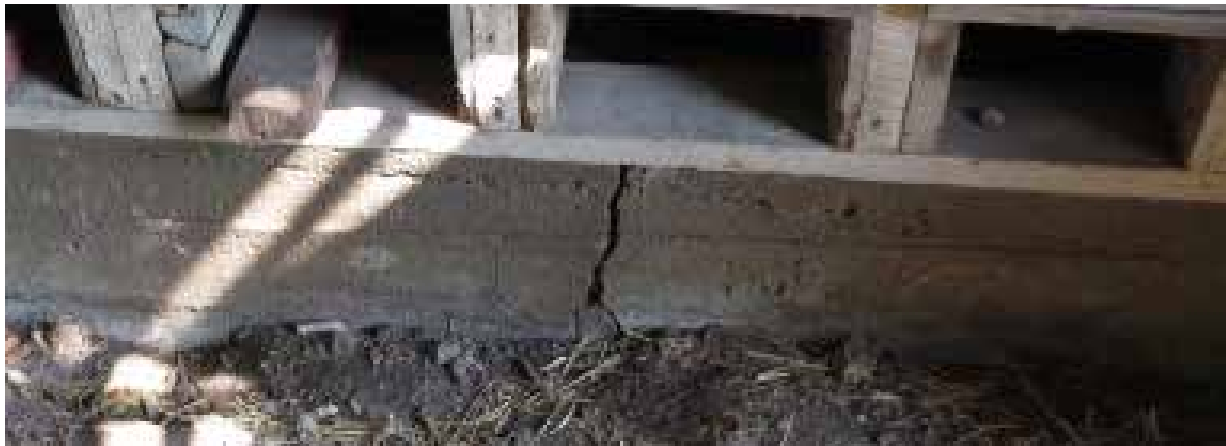
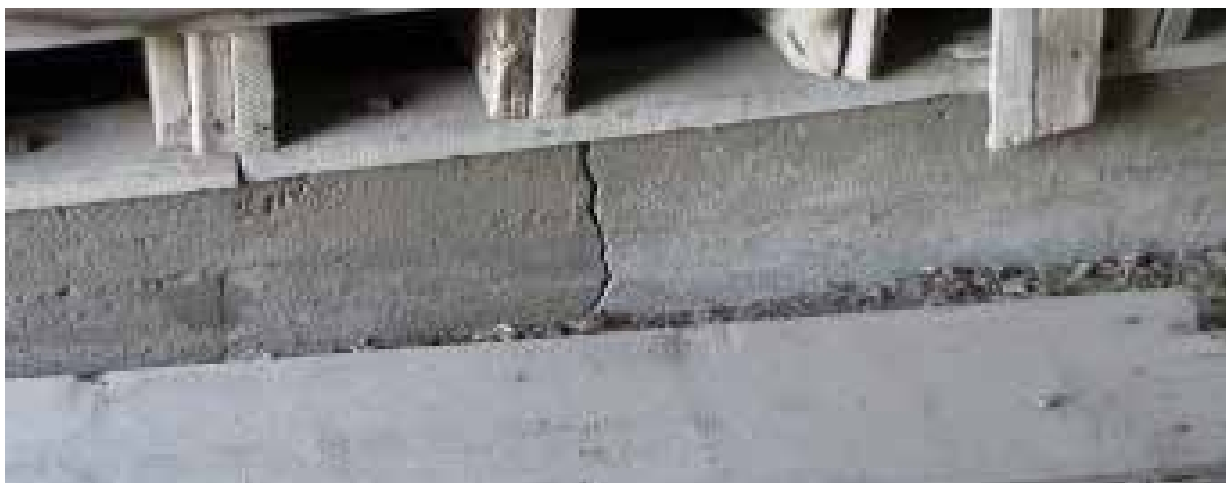
The concrete foundation walls are exposed. A vertical crack has developed in each of the two

concrete walls each side of the drive-through, consistent with how concrete behaves, it is almost

guaranteed to crack somehow. The other two walls were not explored.

The tops of the west ends of the foundations are 20 1/2 inches above grade. At the east ends, the wall plate is held 8 1/2 inches above grade by the concrete, making 12" of slope in 30 feet. This makes the exposure of the bottom of the foundation to the effects of temperature change different at each end. More of the footing is protected by soil cover on the east, assuming the bottom of the walls are relatively level like the tops. Soil swells when it gets wet and more when it freezes. The bottoms of the west foundation ends are closer to grade and so moisture and cold reach them much sooner than the east bottom ends. The soil at the east ends is 12 inches deeper and below frost line (30 inches). The west ends will more frequently be pushed up. Even if the rise is tiny it is stress on the rigid concrete. Stress causes cracks.

These foundation cracks are not alarming. The connecting and adjacent parts are still in line and are not causing damage to the structure above. If one desired to reduce the temperature differential stresses, this could easily be done by increasing the elevation of the soil surrounding the foundations, at least to original levels.

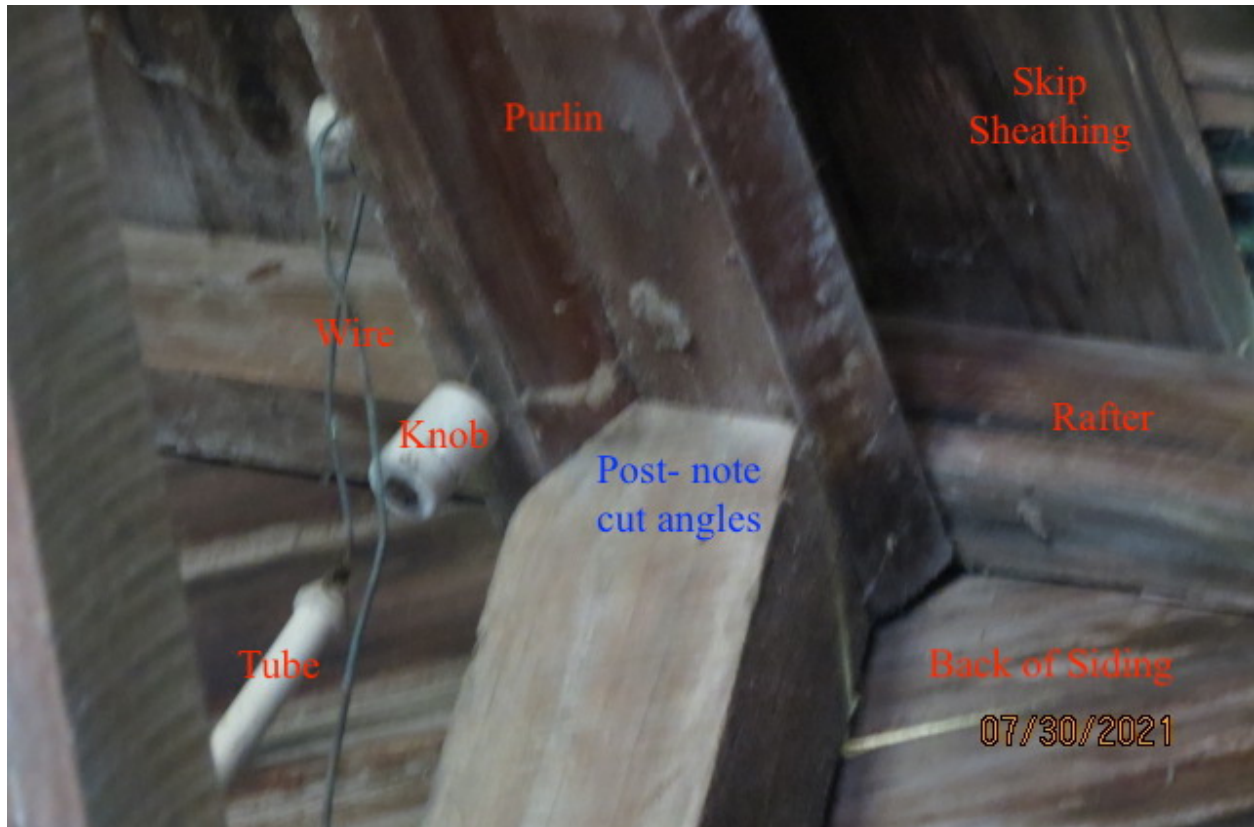
There are remnants of a rudimentary early 20th century electrical system called Knob and Tube as seen at the east end of the north purlin/post (picture below). Those materials overhead are some wire attached to a porcelain knob which used a nail, with a leather washer, and a porcelain cap to hold electrified wire away from the wooden structure in the event of overheating. A porcelain tube surrounded the wire as it passed through wooden structure. These components may remain as long as they are not electrified. They are what is left of a damaged system, but do

no harm. This otherwise excellent wiring method is not used today because it is labor-intensive

to install and hazardous because it is easily inappropriately modified.

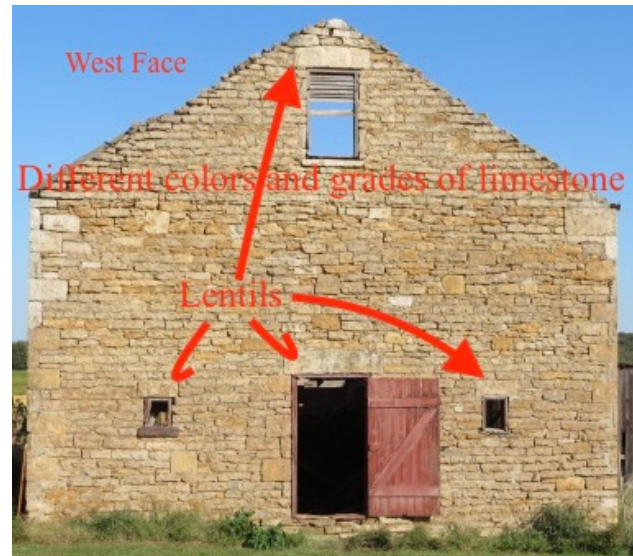
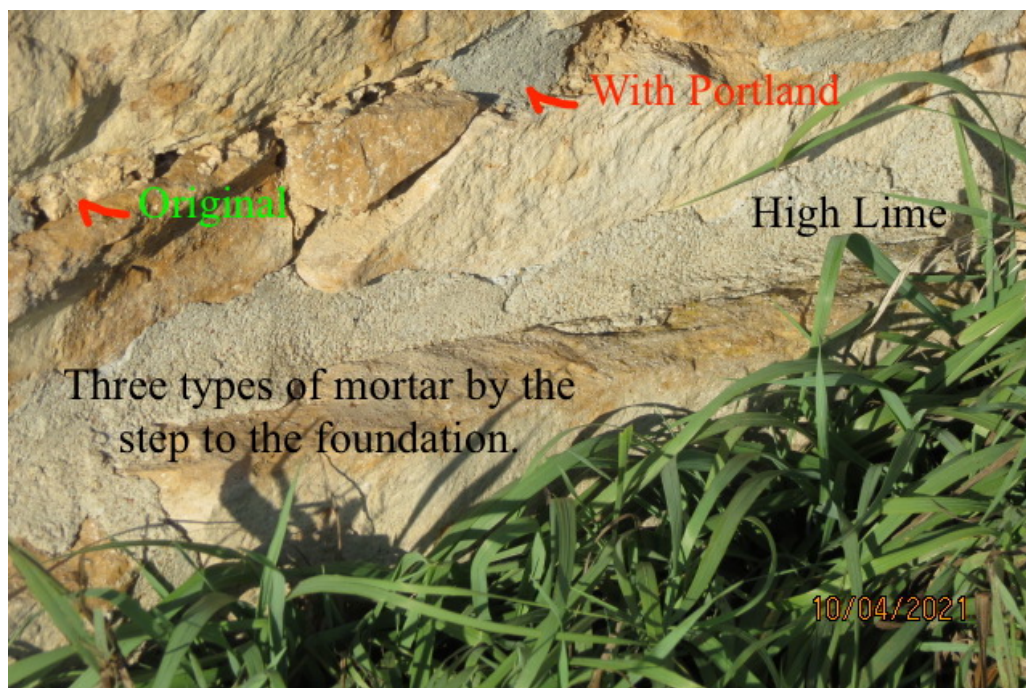
Envelope/Siding- The walls of the building are laid up with a variety of limestone shapes with cut stones defining features. At the corners and as lentils for doors and windows larger cut stones are used, frequently of a lighter color. The lentic of the two wider doorways is a large timber. The mortar between the stones has very fine sand, pieces of different kinds of stone like flint, chert, river pebbles, and sandstone. Mr. Ray Wilber, a retired mason who was visiting

while I was on site, said he saw no lime in it. Numerous places around the building where someone has refilled mortar joints with gray mortar (with Portland cement).

Replace the missing stones using a mortar of similar strength and color to the rest of the building. A local masonry institute or historic preservation organization can assist in finding someone to

Replace inappropriate and absent mortar.

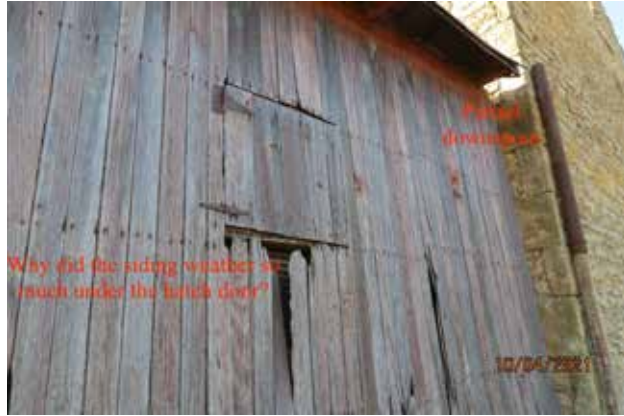
The granary has vertical tongue and grooved siding, some of which is deteriorated so it does not protect the structural members behind it. Perhaps the tops of the siding boards were not cut at an angle to shed water.
