Assessment for Geraldine Coffman  
Historic Crawford/Shoaf Barn  
<https://khri.kansasgis.org/index.cjm?in=045-6833>  
Inspection on September 24, 2020  
November 6, 2020

Assessment for Eric Jackson  
Historic McQuillan Barn <https://khri.kansasgis.org/index.cfm?in=045-6057>  
Inspection Performed 9/24/2020  
November 6, 2020

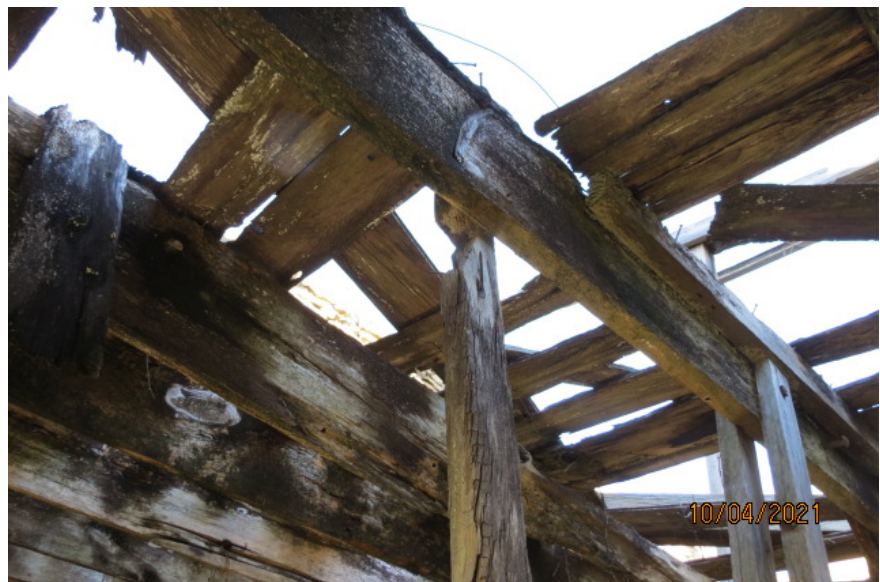
Vertical- Some posts remain so it can be discerned what the original frame design was. Posts sit on stones but frost protection could not be confirmed. At least one post has pulled away from the beam above it, indicating an inadequate footing, to which it had been toenailed only and with round nails (available after 1880).

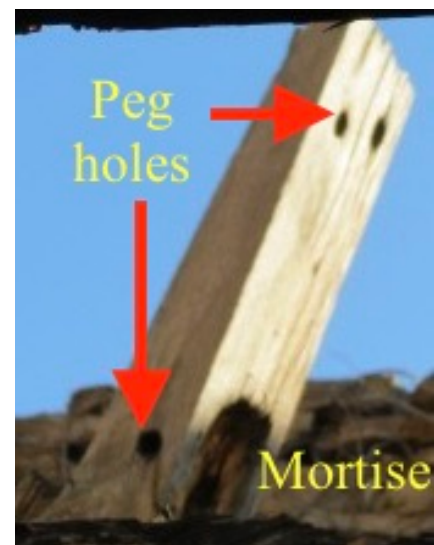
Joinery- Visible are scarf joints, mortises, tenons, and peg holes so it is clear

that the old interior framing was mortise and tenon post and beam style. Also visible are butt joints that are toenailed in place. These further indicate that modification of the original design and timbers has been done.

Replace the timber framing using mortise and tenon post and beam techniques. Reconnect to the steel brackets through the north and south stone walls.

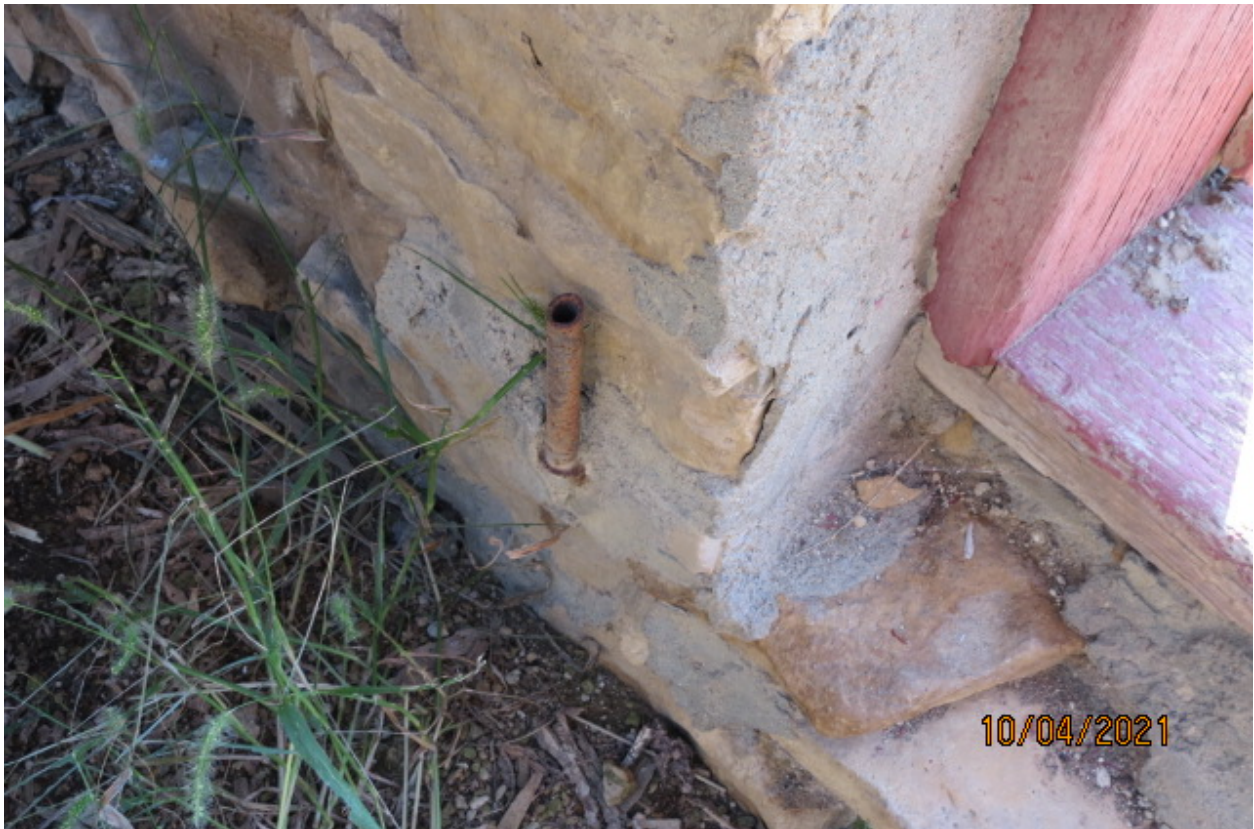
Plumbing- The only plumbing that remains is the pipe that comes through the foundation at the west doorway to supply Acetylene gas for lighting. The owner spoke of the

carbide gas generating building behind the house.

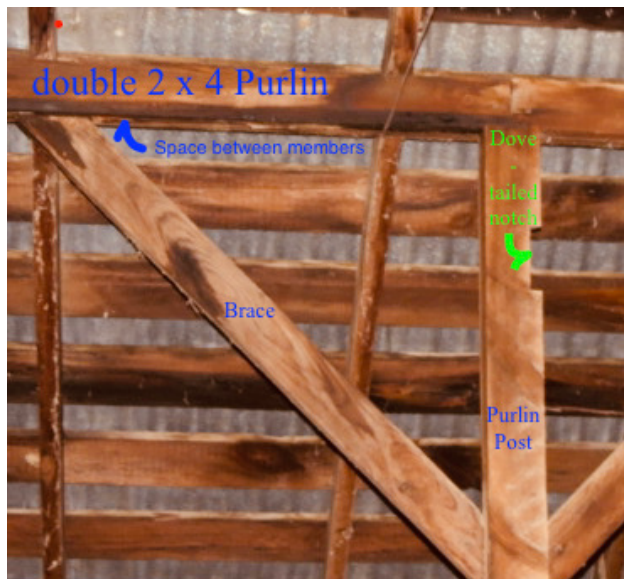
Materials and techniques used in the northern portion are from a later period. Rafters and posts are all of planed lumber. The technique of sandwiching angular braces between purlin members is probably a better technique for securing braces than cutting the ends off the braces at 45° angles and nailing them to the post and beam. As seen below, the joint can pull apart if nailed. The braces in the above picture are nailed to the 4 x 4 post. In

Reconnect all loose and missing bracing.

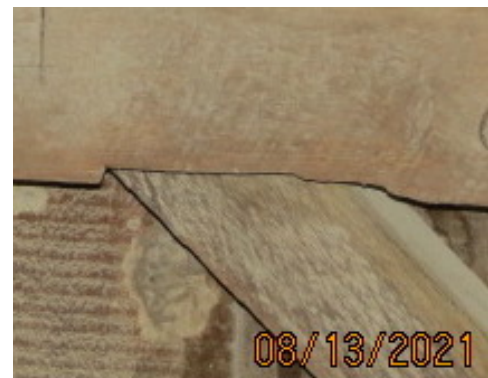
another instance, the brace is nailed but in a notch on the underside of the roof plate and is less likely to slide away from or toward the post. This was probably done in the southern portion of the barn because the rough circular sawn plate was not of uniform thickness, another indication the south portion was built first. There are no nails seen. A mortise and tenon joint could look the same and be more sound.

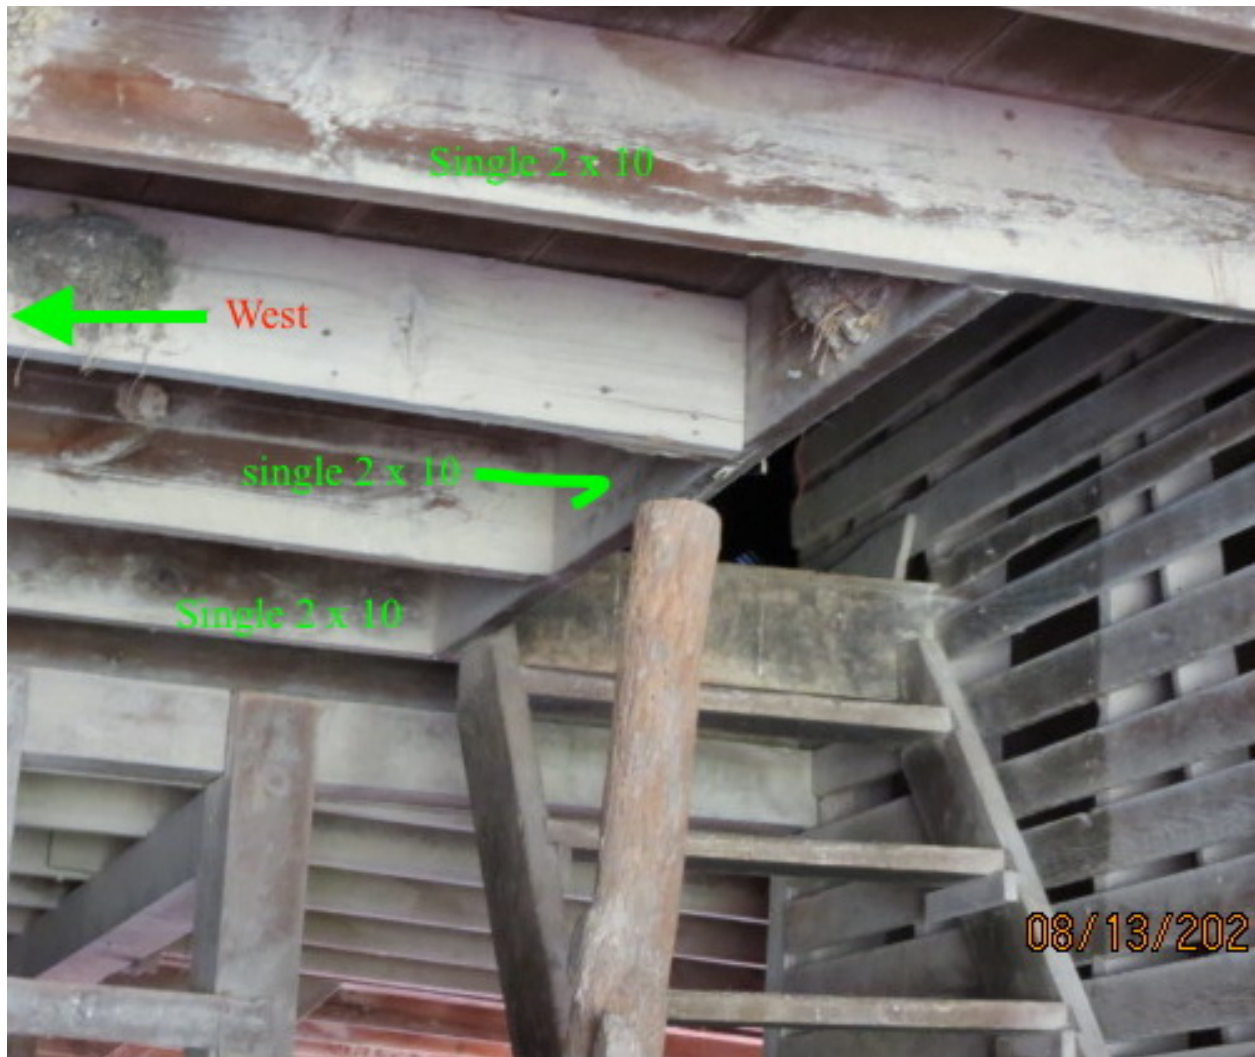
sides of the 2x stringers and the stringer on the west side is lower. The support for the loft joists along the stairway is a single 2 x 10. A crooked pole runs up from the ground past the west stringer and is set under this single "header". The east to west joists supporting the ends of the

opening are single 2 x 10s.

Repair the structure around the stair and make the stairs level and plumb.

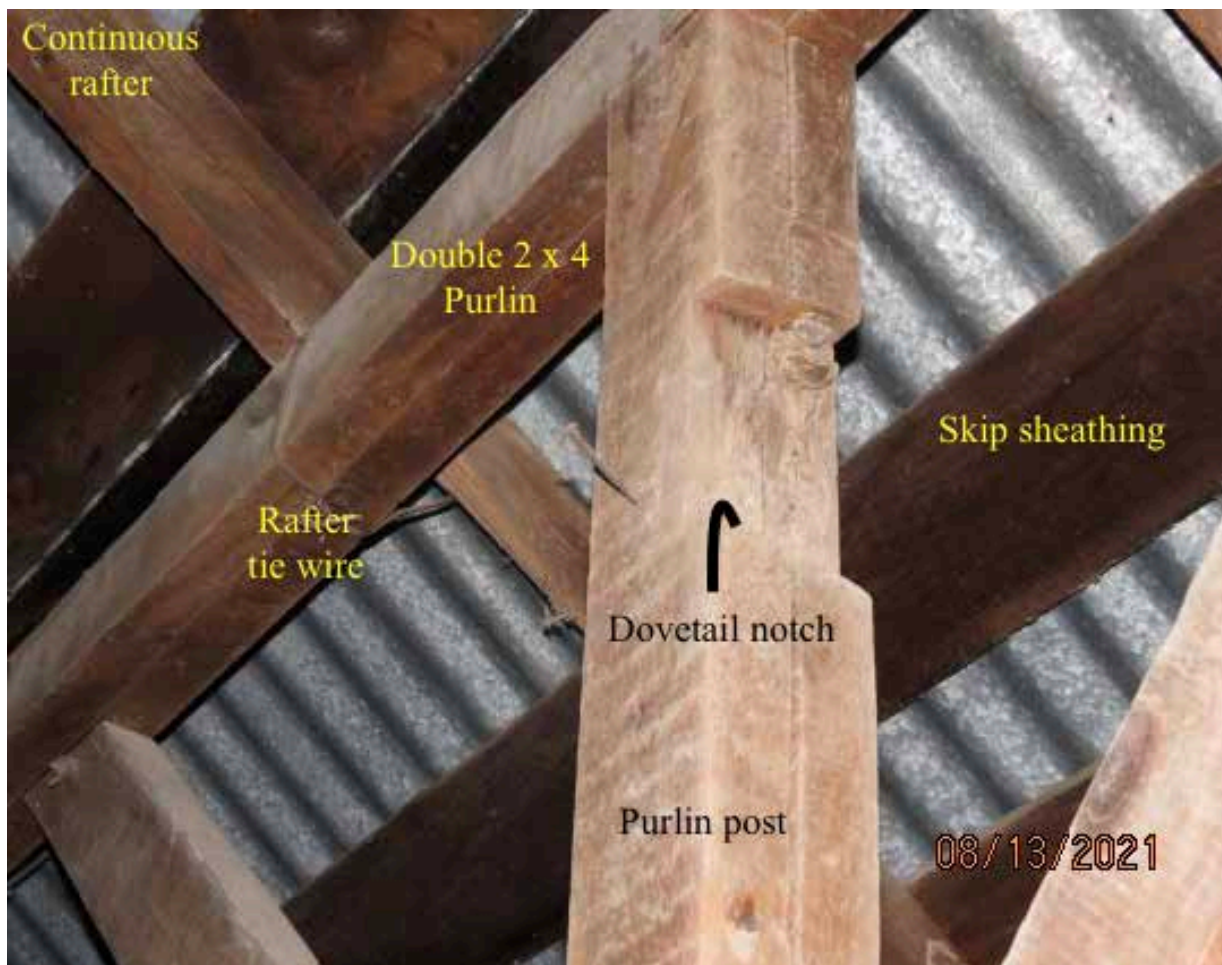
Looking northward from the south loft, several items are seen. The openings in the north gable end are covered by the exterior sheet metal siding. Also, the purlin posts on each side are out of plumb. Posts on the west side lean west at their tops. The posts on the east side lean east. The 4 x

4s used as posts in the north loft were apparently connected by tie beams with dovetail joints. Those tie beams are no longer present but the dovetail notches in a side of the posts remain.

These posts sit on the 6 x 6 north/south header under the loft joists.

Reinstall tie beams between purlin posts, loosely until the building is let back down on a sound foundation. Tighten the connections.

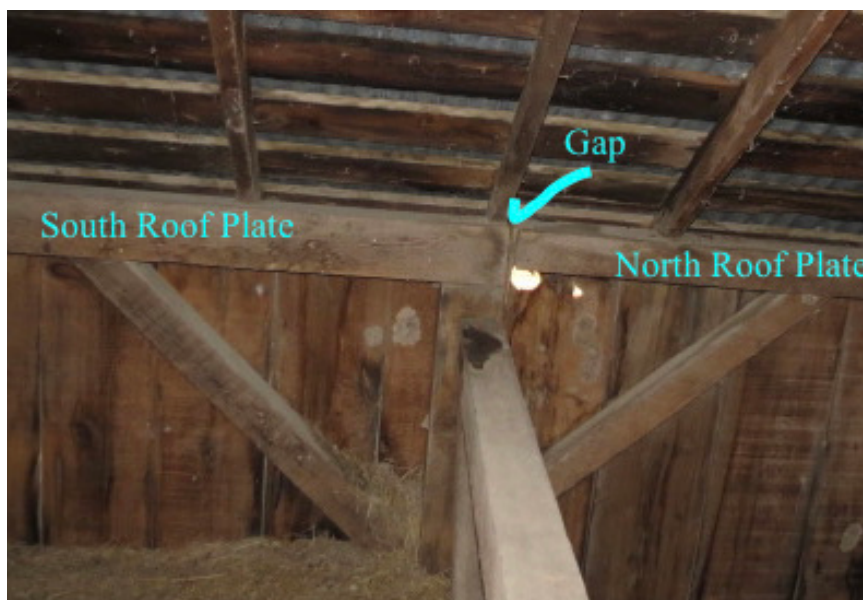
Along the top of the east and west exterior walls, the north roof plate has separated from the south roof plate where the north and south portions of the barn meet. The east side has about an inch gap and the west side about 3/4 of an inch separation of the toenailed butt joint (toenailing is used when it is impossible to nail straight through one piece of lumber into another so the nail is driven at an angle).

Repair the connection between the north and south portions.

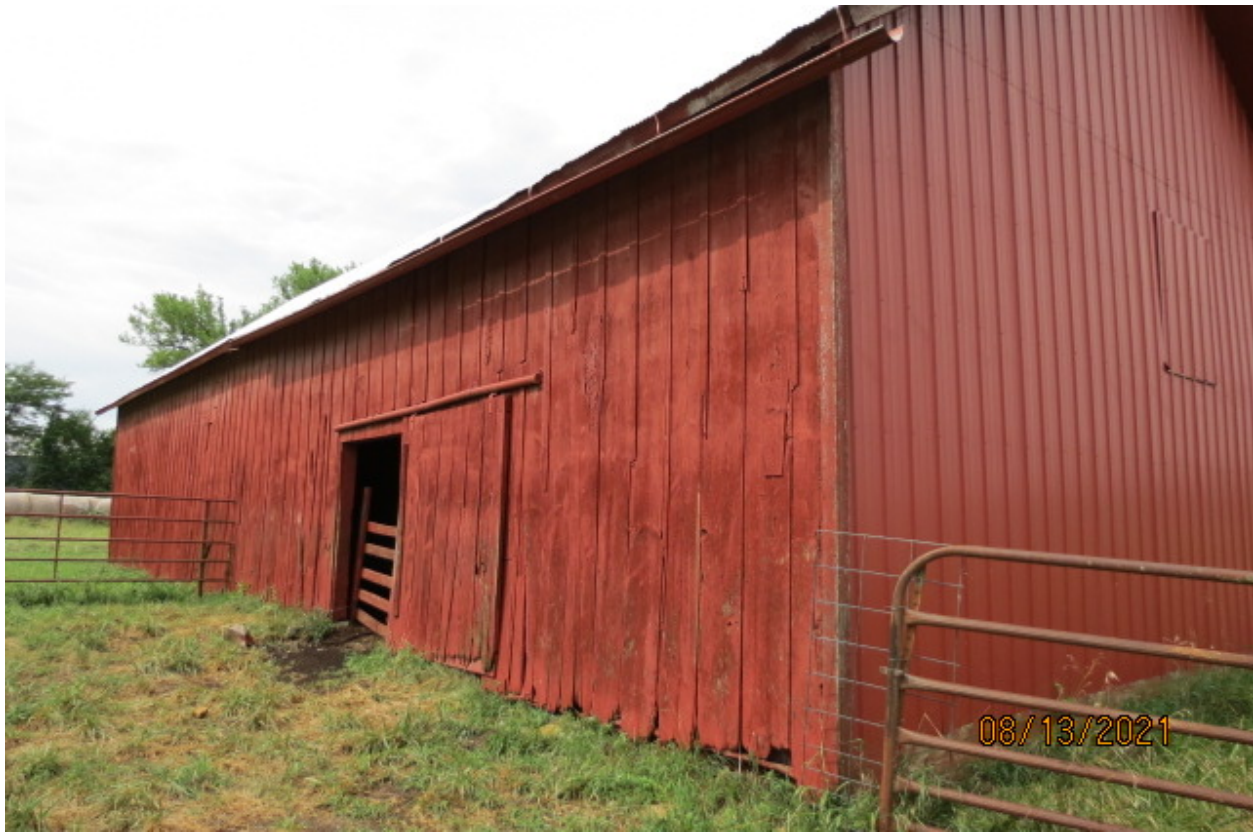
Storm drainage system- The half round gutter system is in bad condition and most is absent. Water therefore falls to grade beside the foundation stones. Difficulties develop from water falling on the ground. The first result is splash. Water builds up on top of the soil creating puddles and exposing stones. Both cause water to bounce upward and sideways. To one side is

the siding on the building. Even where there is gutter, excess water damages paint and impregnates the wood stimulating decomposition as is seen at the bottom of the siding. It is not likely that a jig saw was used to make this lacy feature.

Repair/replace siding that does not keep the weather out.

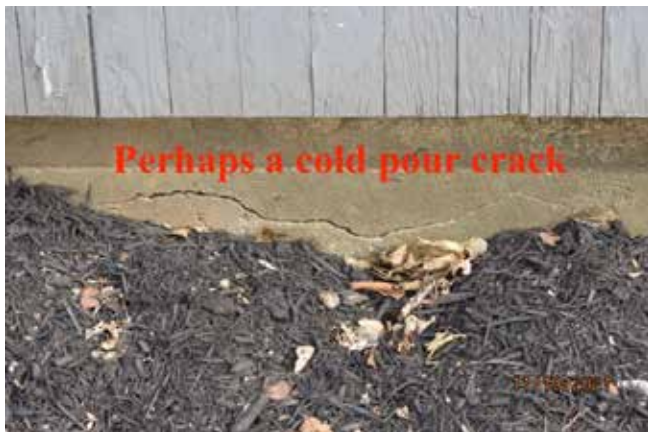
Foundation- The foundation rises in the soil from the depth of about 30 inches to a step back to the short concrete wall that surrounds the building under the 2 x 6 stud walls.

Roof drainage has washed away soil from the southeast corner leaving only about 10 inches of the foundation covered.

Protect the southeast foundation up to the step-back to the wall resting on it at least by backfilling it.

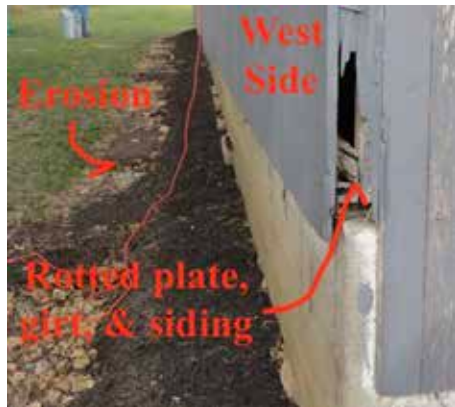
Envelope/Siding- The barn presents itself well but there are miscellaneous places in the siding and trim, including rafter tails, that are rotted to the point of no longer holding paint.

Replace rotted exterior wood siding and trim.

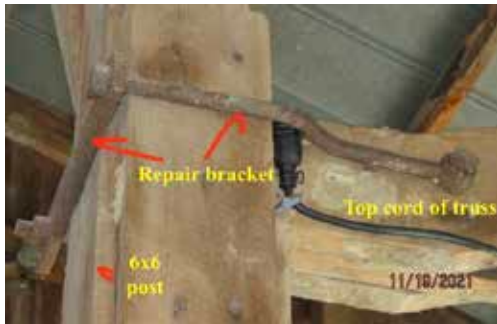
An interesting and effective bracket reconnects a truss to a post.

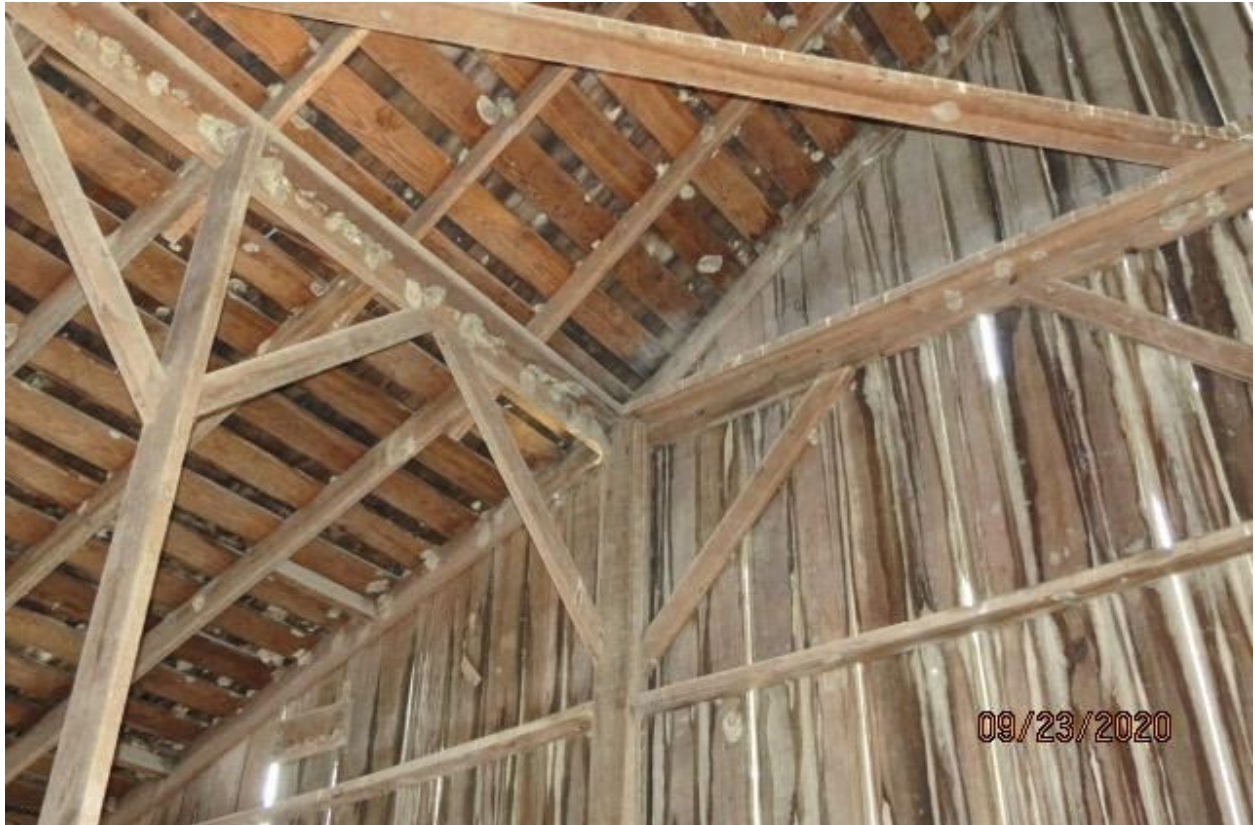
The north to south tie beam is the only member, except the east and west walls, working directly against the natural spread of a weighty gable roof and the downward pull a loaded hay hook moving along the track. Both ends of the tie beam have separated from the purlin/roof plate (See Joinery below).

| PRIORITIES | RECOMMENDATIONS, | ROUGH COSTS |
|---|---|---|
| 1 | Repair the north and south connections of the central tie beam across the peak of the barn to the purlins/roof plates. | Approximately \$500 to \$1,000 |

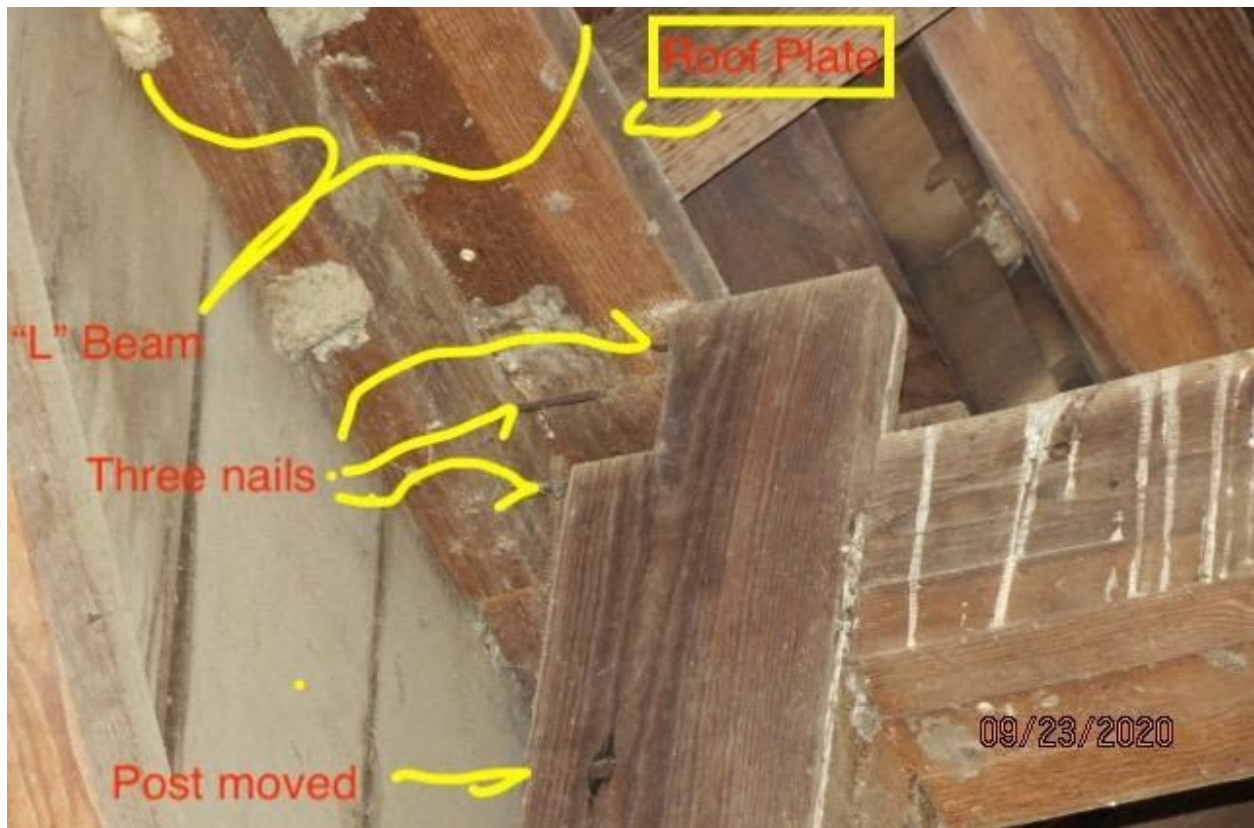
Round nails fasten the sides and ends of lumber together as in the picture where three nails were used to hold the center tie and post to the roof plate. That joint and its twin have pulled apart allowing the barn to spread north to south.

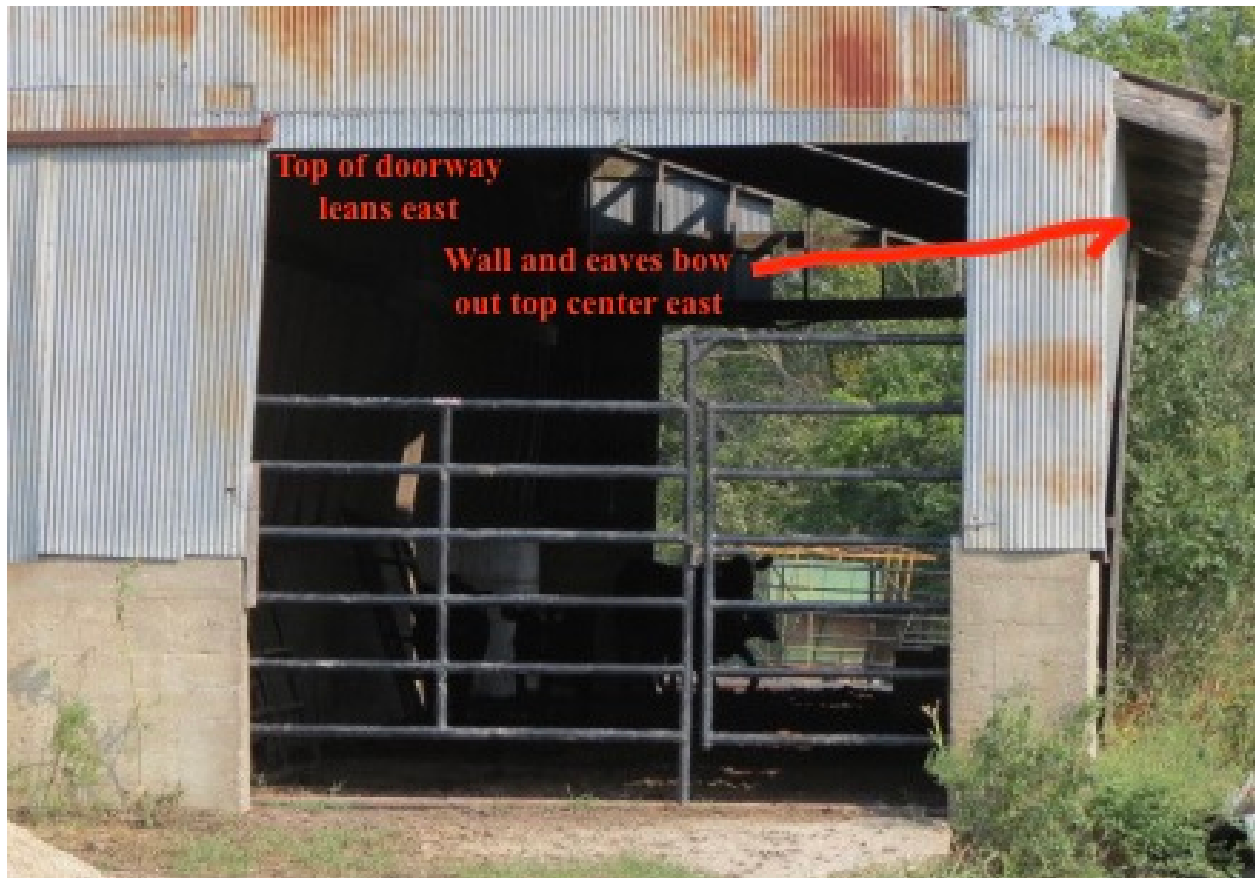
The building is distorted east to west. A slight clue is seen at the bottoms of the east and west wall studs where they meet the plate. The west studs in the picture are lifting off the plate on the inside while resting on the outer corner. A level says they lean west at the top to the tune of 4" in 4'. This is true on both sides. This is at least 8 inches of spread over the

When looking down the length of the barn alongside the bases of the bows, one notices a couple of things. The first is that the bows spread further above where they are bolted to steel plates set into the top of the wall, so the distance between them just below where the addition rafters join is greater than at their bottoms on the wall. Some is not surprising, but how much is appropriate?

Secondly, they do not curve equally, indicating that some have bent more than others. This is probably because the stress on them is beyond the uniform expected loading and those with less strength have bent more.

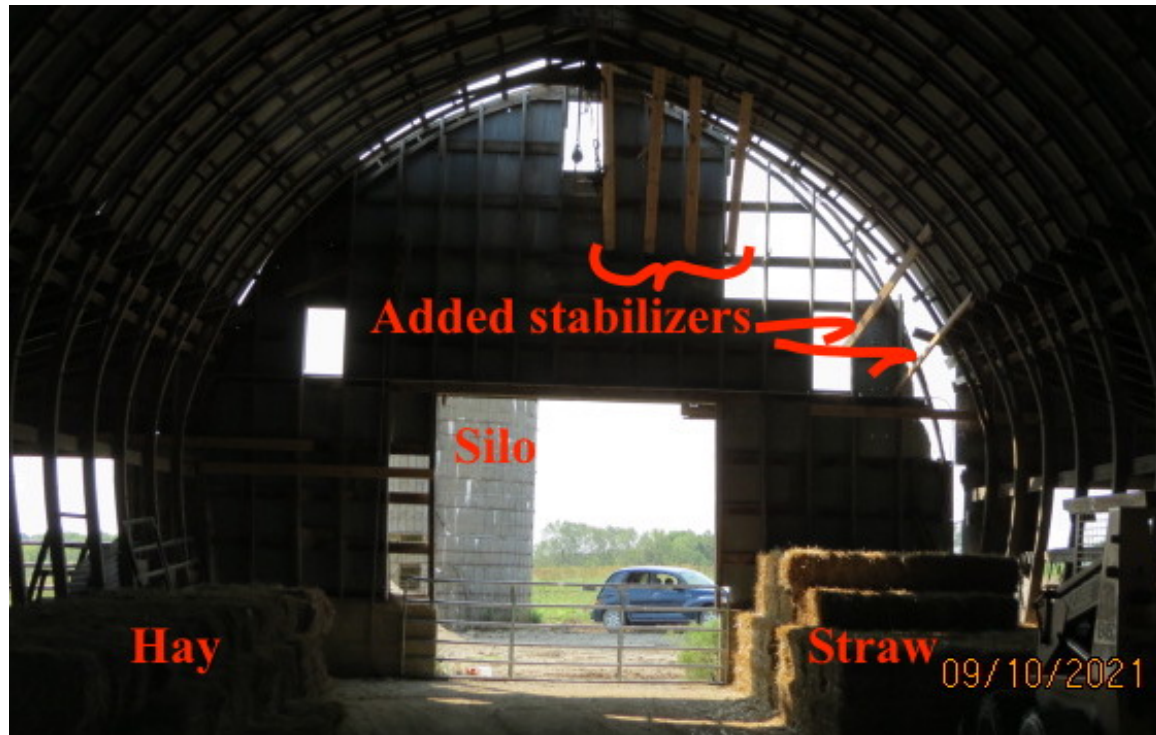
Some stabilization efforts are seen in the southwest corner of the arena with boards nailed on

place and come-a-longs in place to pull the corner together. The south bow has pieces missing on its west side. The north bow is likewise damaged though not quite as badly. At least six bows require rotted and broken portions replaced while dealing with the excess spread.

According to the engineer's recommendations, stabilize the bows to prevent them from further spread while being worked on.

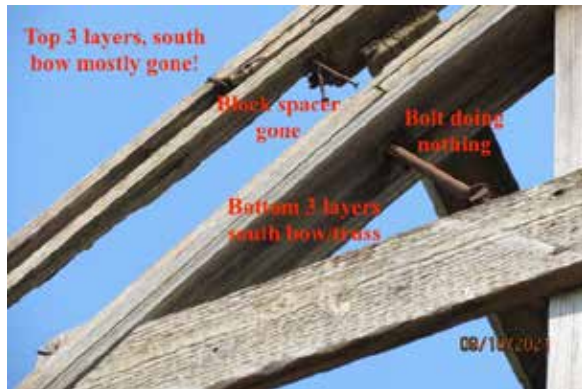
The southwest corner of the arena is badly deteriorated.

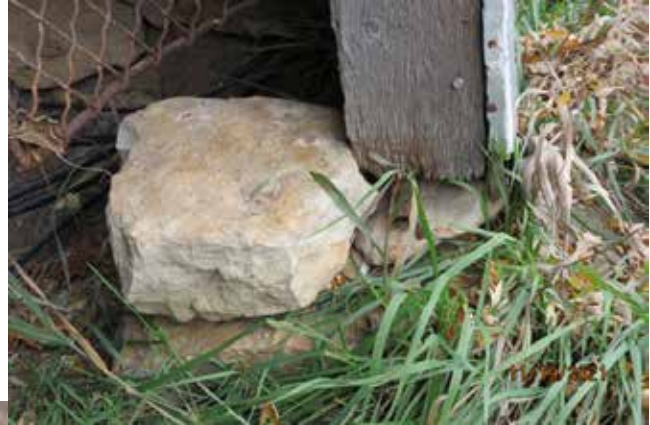
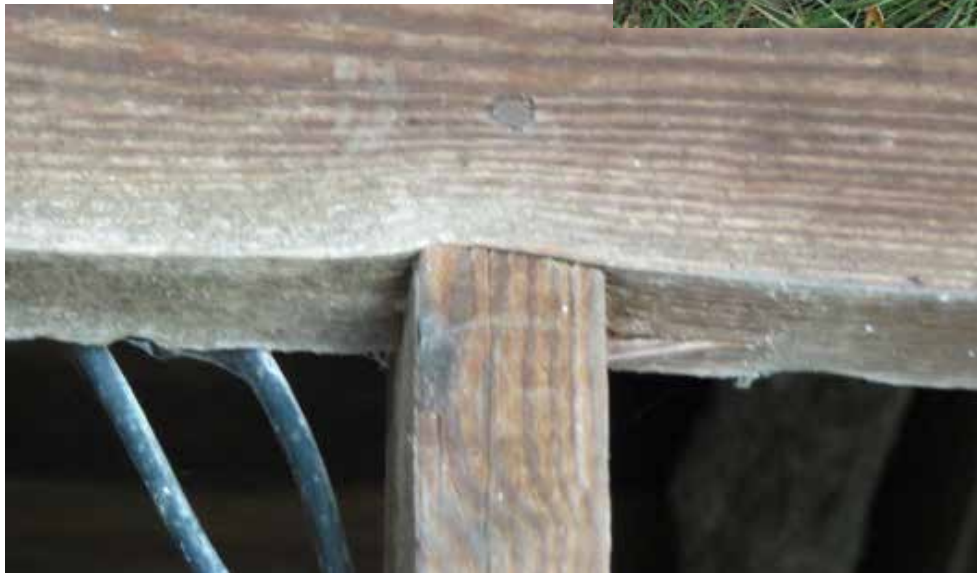
Along the south side, the laid-up stone foundation wall has crumbled. For example, at the east side of the southeast livestock door, the posts are dislodged from the stone on which they sat.

The result of the south wall damage has the

south barn weight falling on the next post to the north, causing the beam above to crush.

Repair the foundation problems including below frostline support (or to solid rock) of the summer beam, lifting the settled areas of the barn.

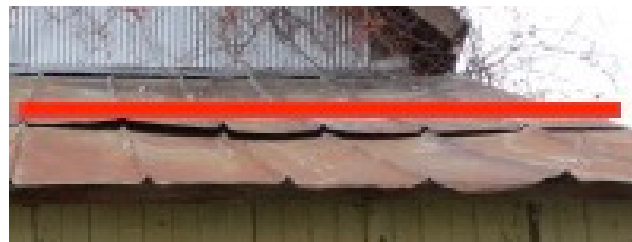
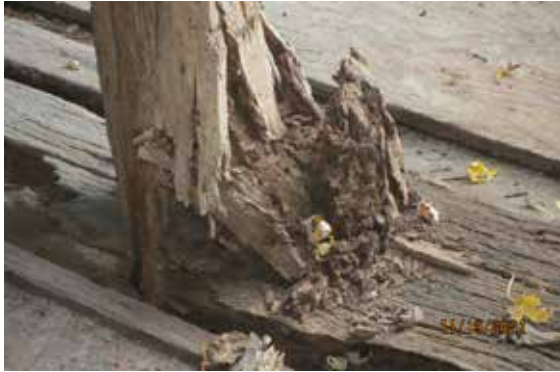
centers spanning 7 1/2 feet between each bearing point from the roof plate to the purlin to the ridge at a sharper pitch of 6" in 12". The lean-tos each have spans of 2 x 4s and 2 x 6s exceeding 15 feet at about 3.5" in 12" pitch on 4' centers. Note that the 2 x 4 rafter, 1st in from the west, of the north shed sags in the middle of the span (more obvious in the picture of the outside).

Repair/replace all damaged, inadequate, poorly supported structural members.

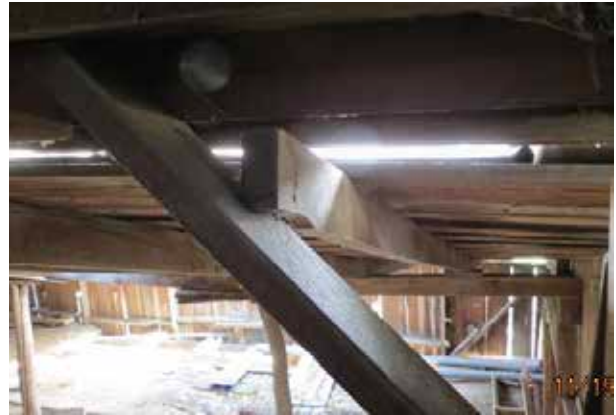
The span of the east shed rafters is about 14 feet from the single 2 x 4 roof plate to the purlin and then to the original barn, some with one piece of wood! A couple of things come to mind. The purlin does not run across under the roof evenly (see the bottom of a purlin post base).

Also, the connections to the older barn are tenuous, and that the upper end does not sit on a header or ledger strip, does not pass through the siding and nail onto the side of a stud but they often sit on one of the diagonal braces, which were not designed for that purpose, and nailed in place. Like the other shed roofs, these are on a 3" - 4" in 12" pitch centered every 4 feet.

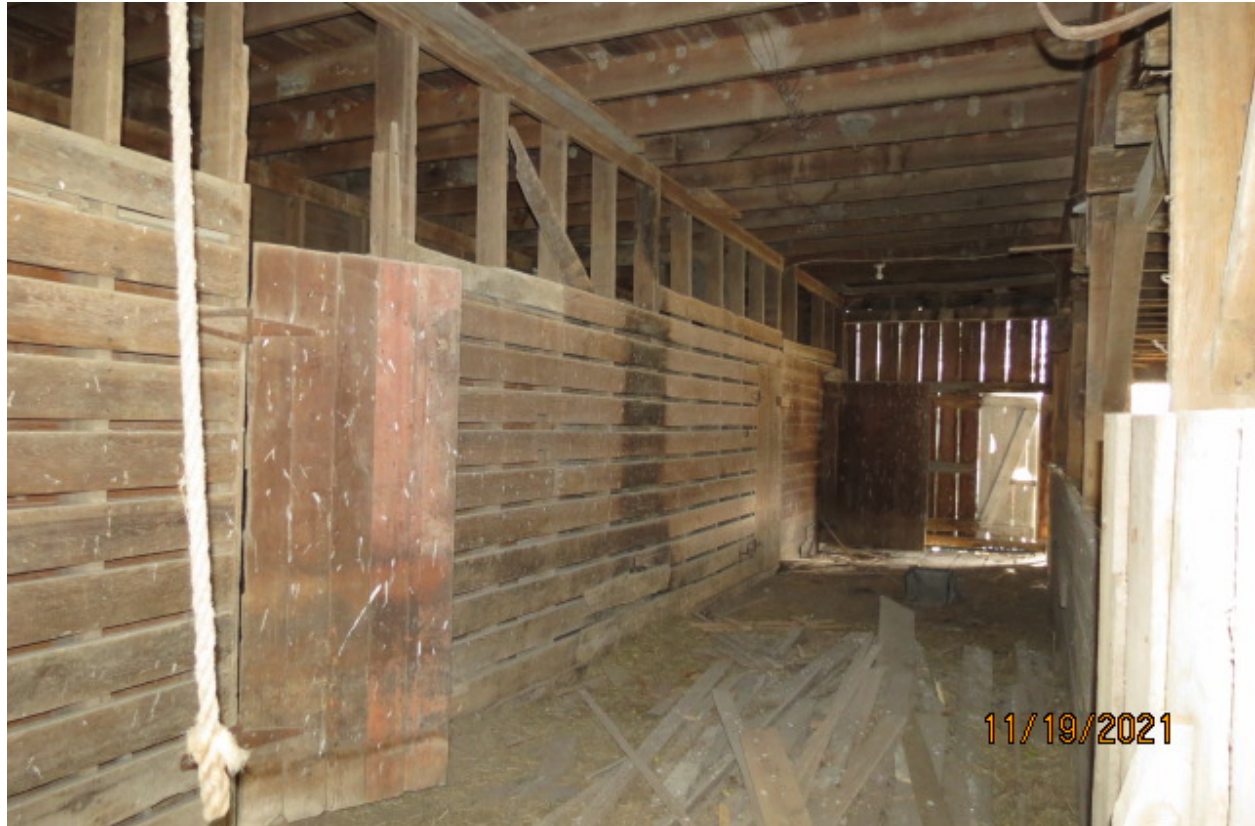
Partitions- Two walls partition off a granary head high in the northeast corner of the north lean-to. The north and east walls are covered with flat sheet metal. The partitions have

tongue and groove siding on the outside of the 2 x 4 studs. Why not on the inside?  
The stalls of the main barn are partitioned with 2 x 6 studs with slats up about 6 feet on the outside and tongue and groove siding on the inside. The south end has corrugated metal siding applied horizontally for about 12 feet on the east and west sides. These cover the south doorway to the space which has a slat nailed on the outside so it cannot be opened.  
A small storage room is divided off further south.

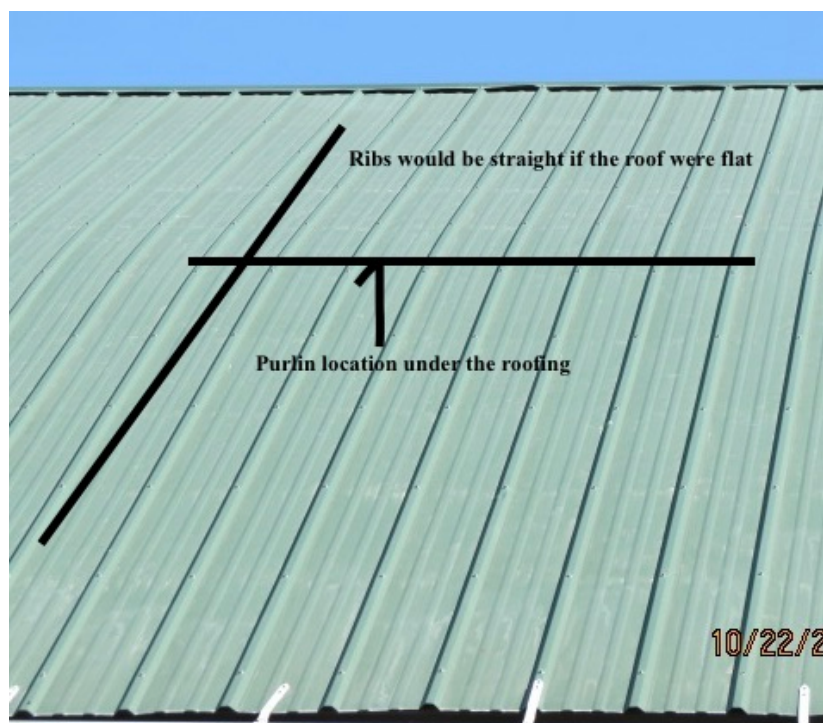
**Roof-** The rafters span 23.5' and the purlin, in the middle of the span, cuts the roof load by about 50%. The pitch is 7.5" rise in 12" of horizontal run. Over the 2 x 4 rafters the roof has 1 x 6 gap sheathing with wooden shingles on it. A fairly new raised ridge green colored metal roof shows a flaw. For a gable roof, the west side is not as flat as it ought to be. At about the location of the purlin, beneath a ridge is seen. This indicates either that the purlin has raised or that the west wall of the barn is lower than originally designed. This

bends the roof downward. Other indications reflect the lowering of the west wall.

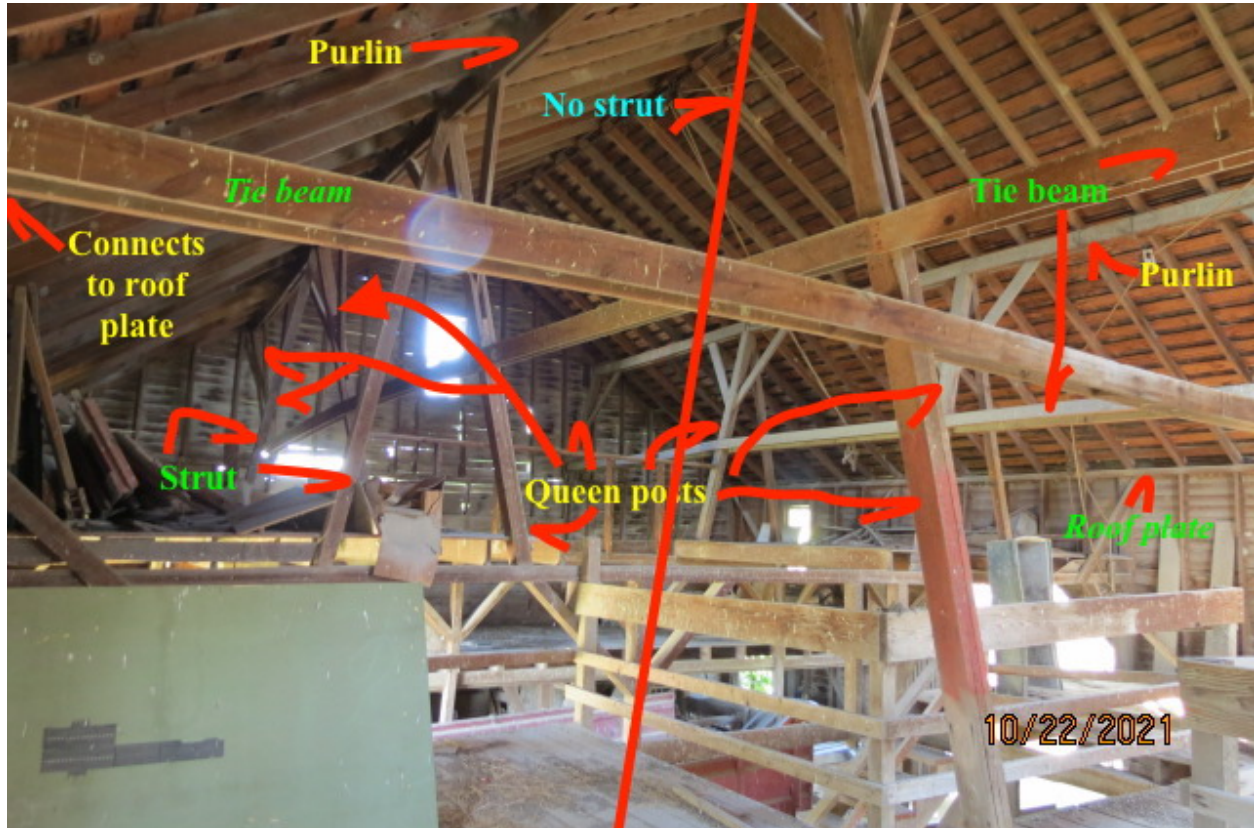
Vertical- For the most part the posts and other vertical lumber are doing their job. Some damage is evident in the south wall of the drive-through at the west end where some pieces are offset. Other than making sure they are on a good footing nothing else is really

necessary to repair these.

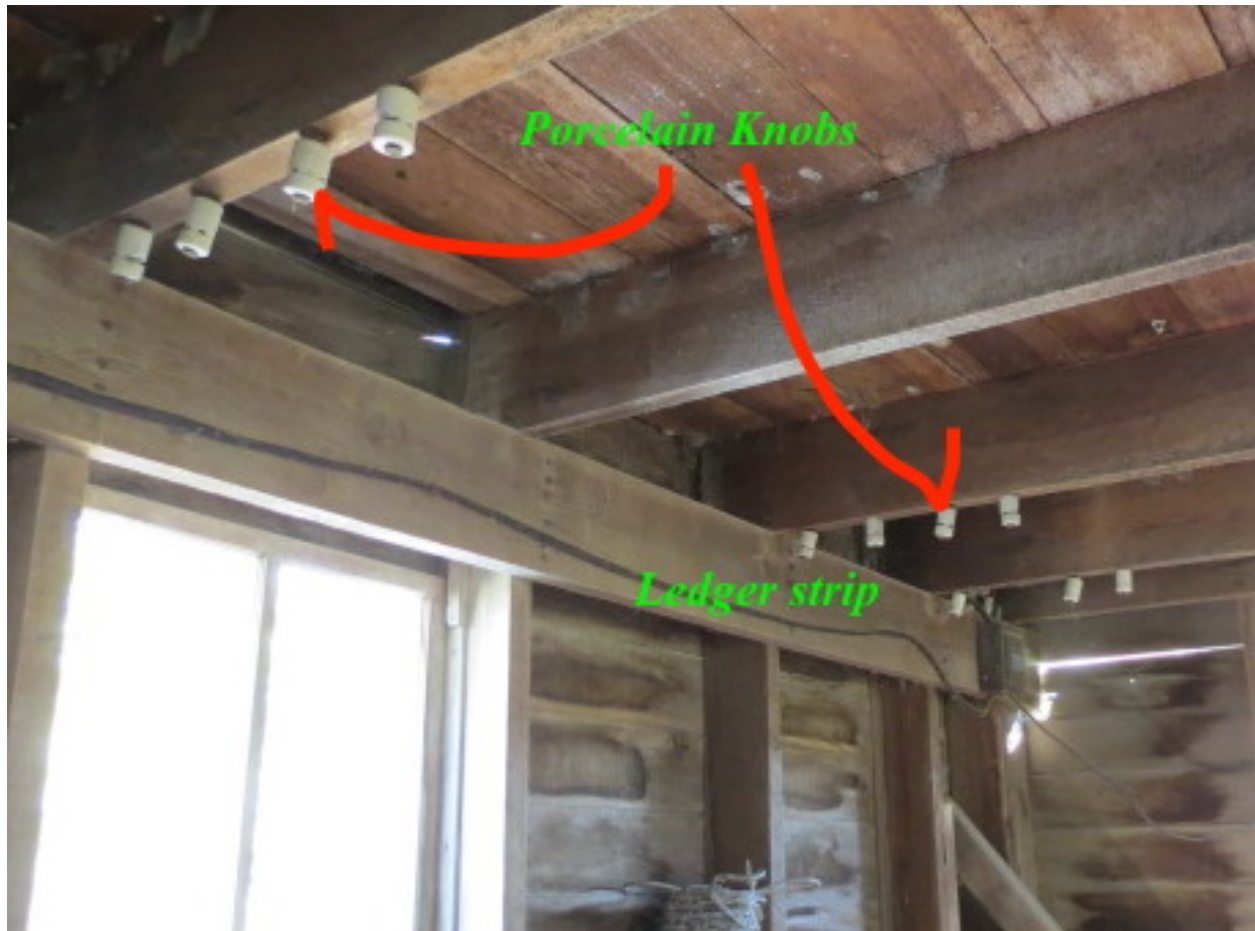
At some point, electricity was brought into the building as seen by the large insulators on the

south end of the east side. Porcelain knobs on the underside of joists are sign posts of knob and tube wiring which has been replaced by a more up-to-date electrical service.

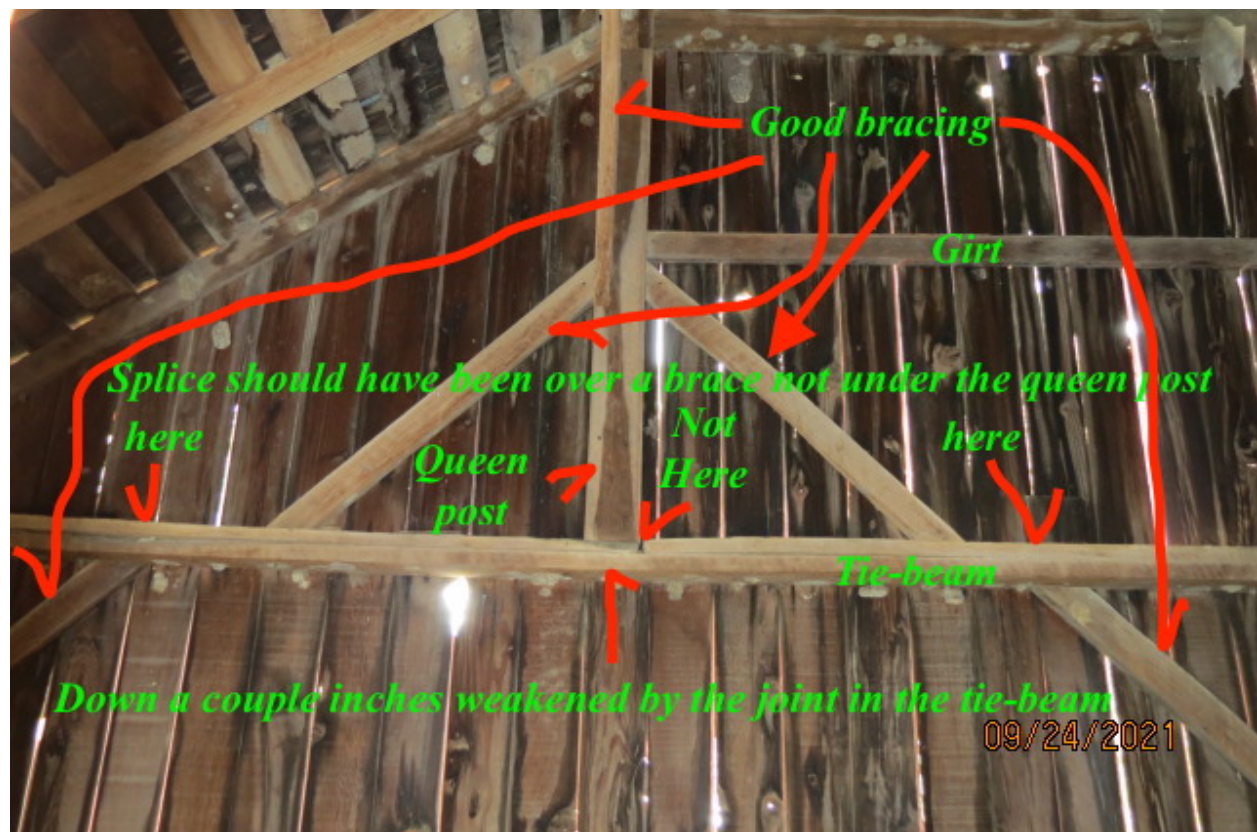
One configuration of timbers demonstrates some stress. The west gable bows out some. Its tie beam, at the height of the roof plate and upon which the queen post sits, is bowed downward as well. The location of the splice is crucial. A third plank in the tie beam would have give more

strength horizontally and vertically.

Repair the sagging west tie beam in the west wall.

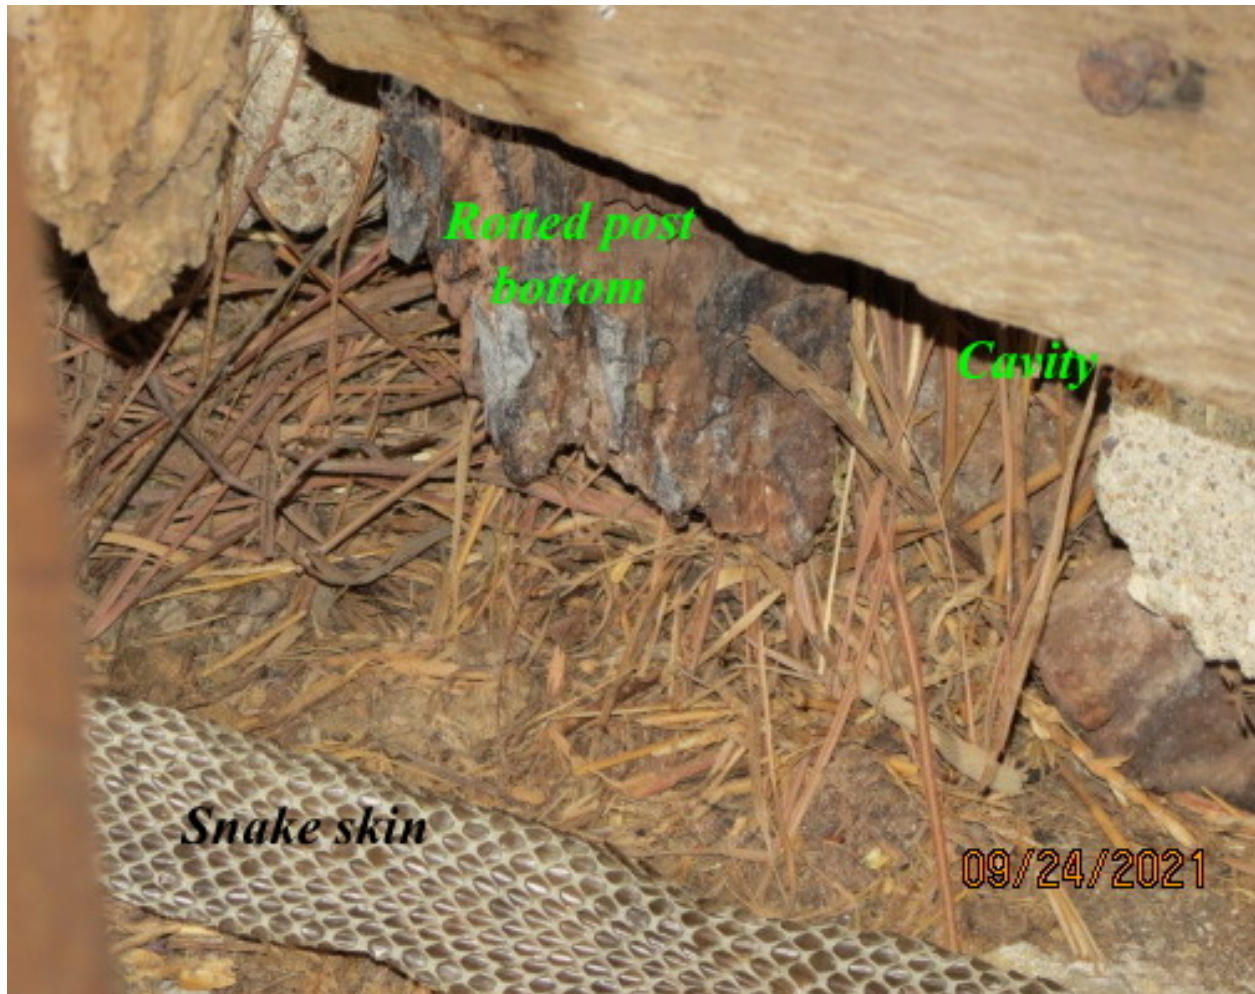
**Vertical-** The post in the line of stanchions is rotted off at the bottom. It was set in the dirt. See the "Floor" section picture below.

Floor- Some concrete floor, including a trough for the cows in their stanchions, has made this barn more cleanable than some. The concrete flooring in front of the stanchions

has a cavity under it. A snake has made it his home. The loft floor boards are of various widths and ages. Some are quite worn from having been outside in the weather for a long time, but most seem sound. some boards are loose and there are gaps here and there.

Repair or replace all post bottoms.
