**FACADE INVESTIGATION  
VISITOR CENTER  
FLOYD BENNETT FIELD**

**TONETTI ASSOCIATES**

January 30, 1984

The following is our report on the conditions of the exterior shell of the William Ryan Visitor's Building at Floyd Bennett Field, Gateway National Recreation Area. We trust that this report will serve as a documentation of the conditions at present and as a tool for evaluating future repairs and restoration.

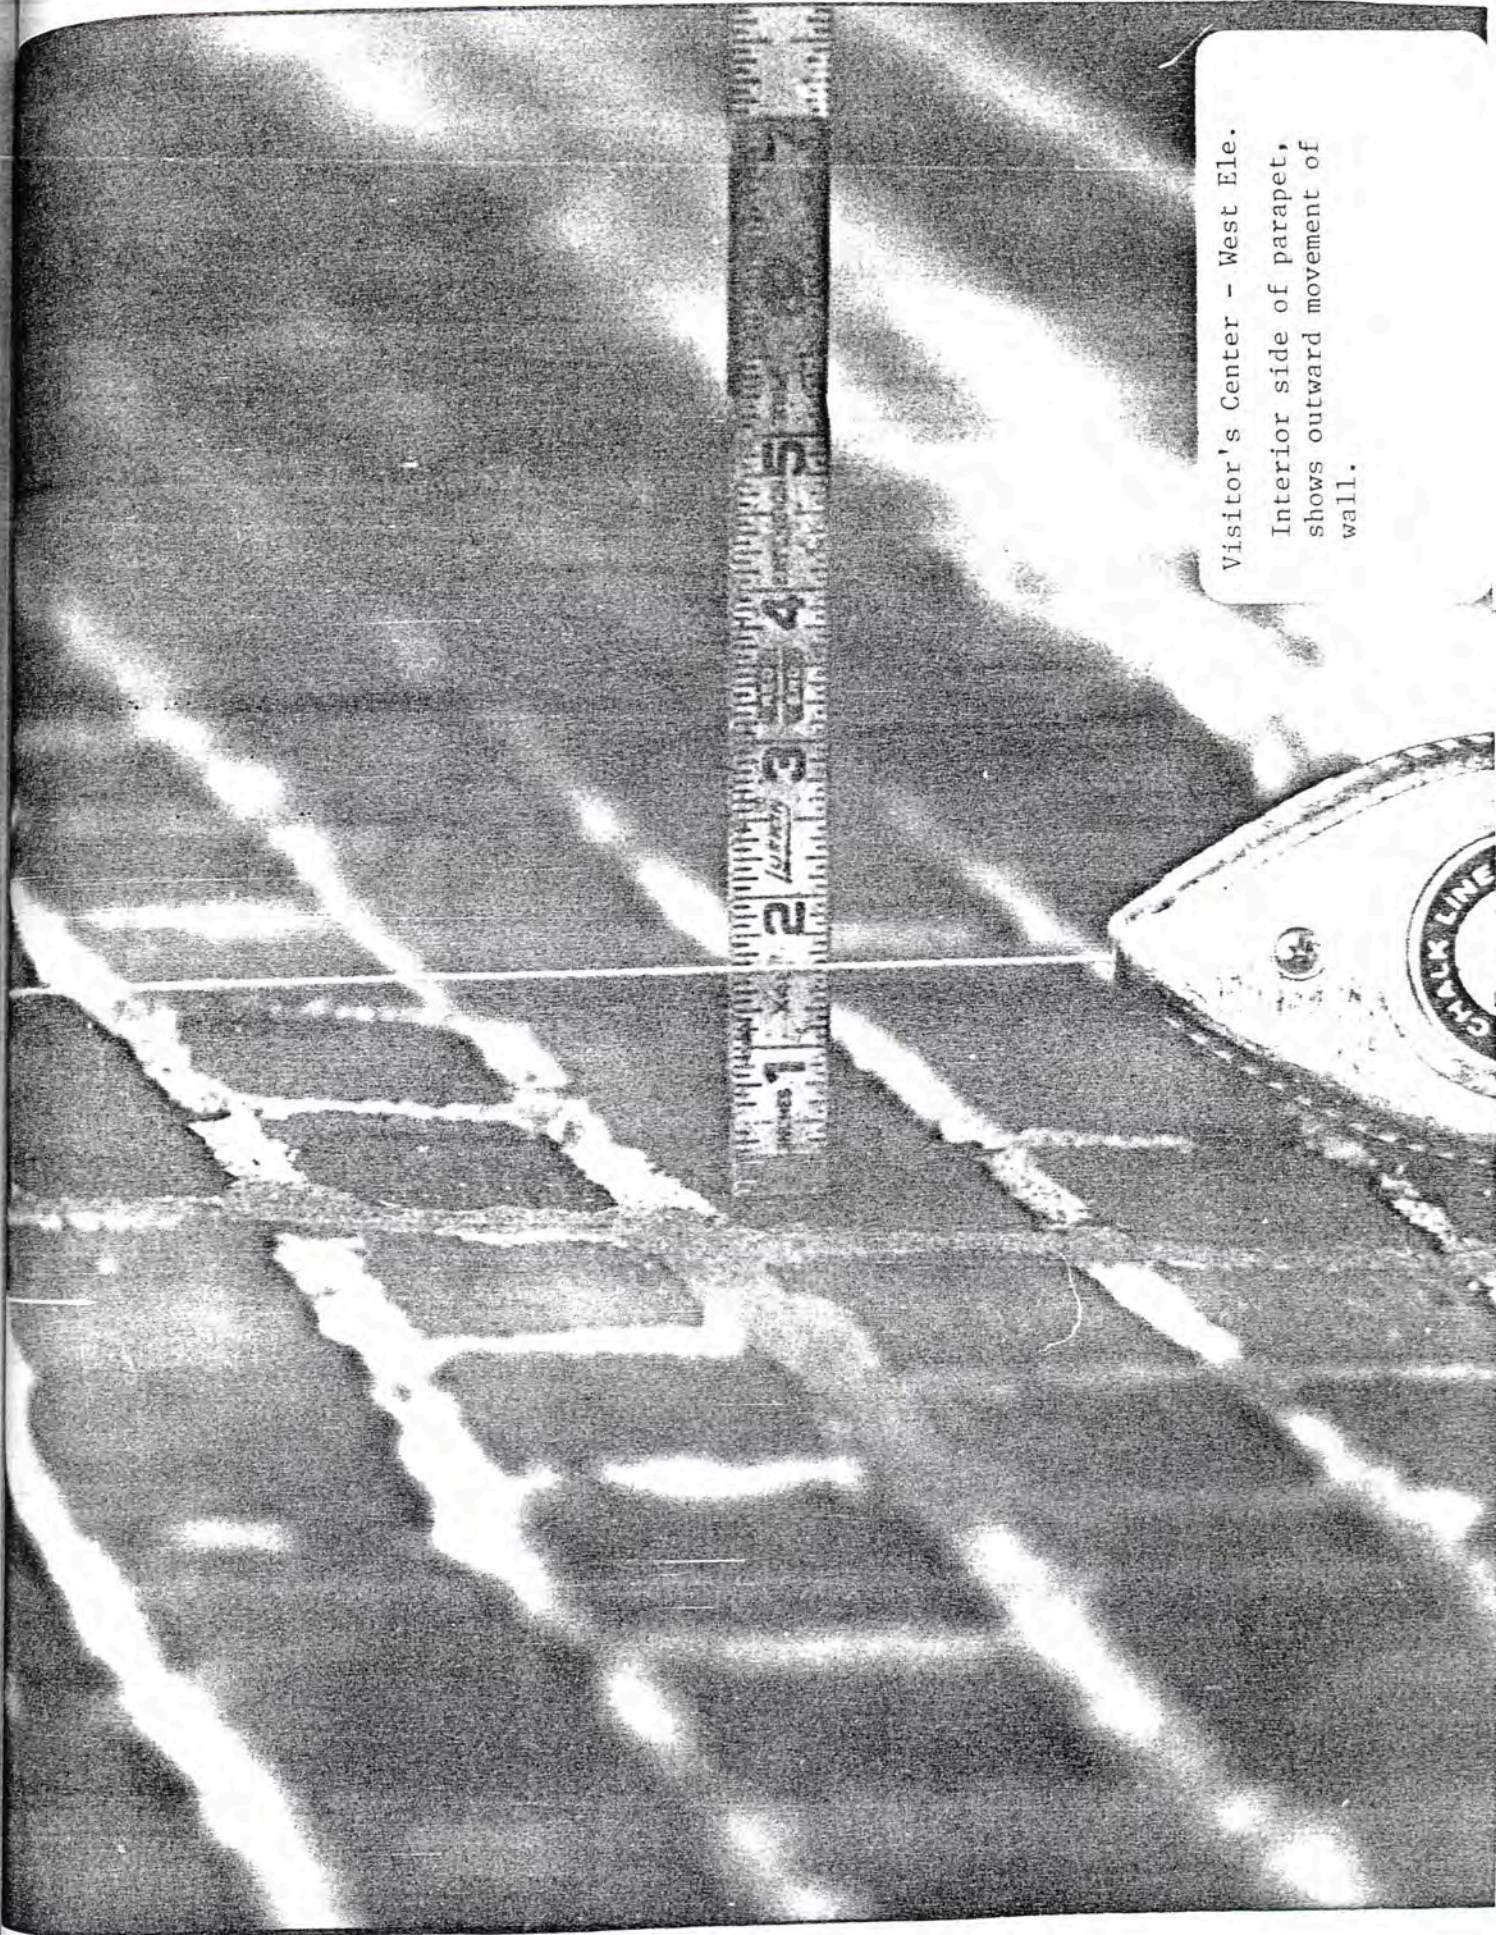
Visitor's Center - West Ele.  
Interior side of parapet,  
shows outward movement of  
wall.

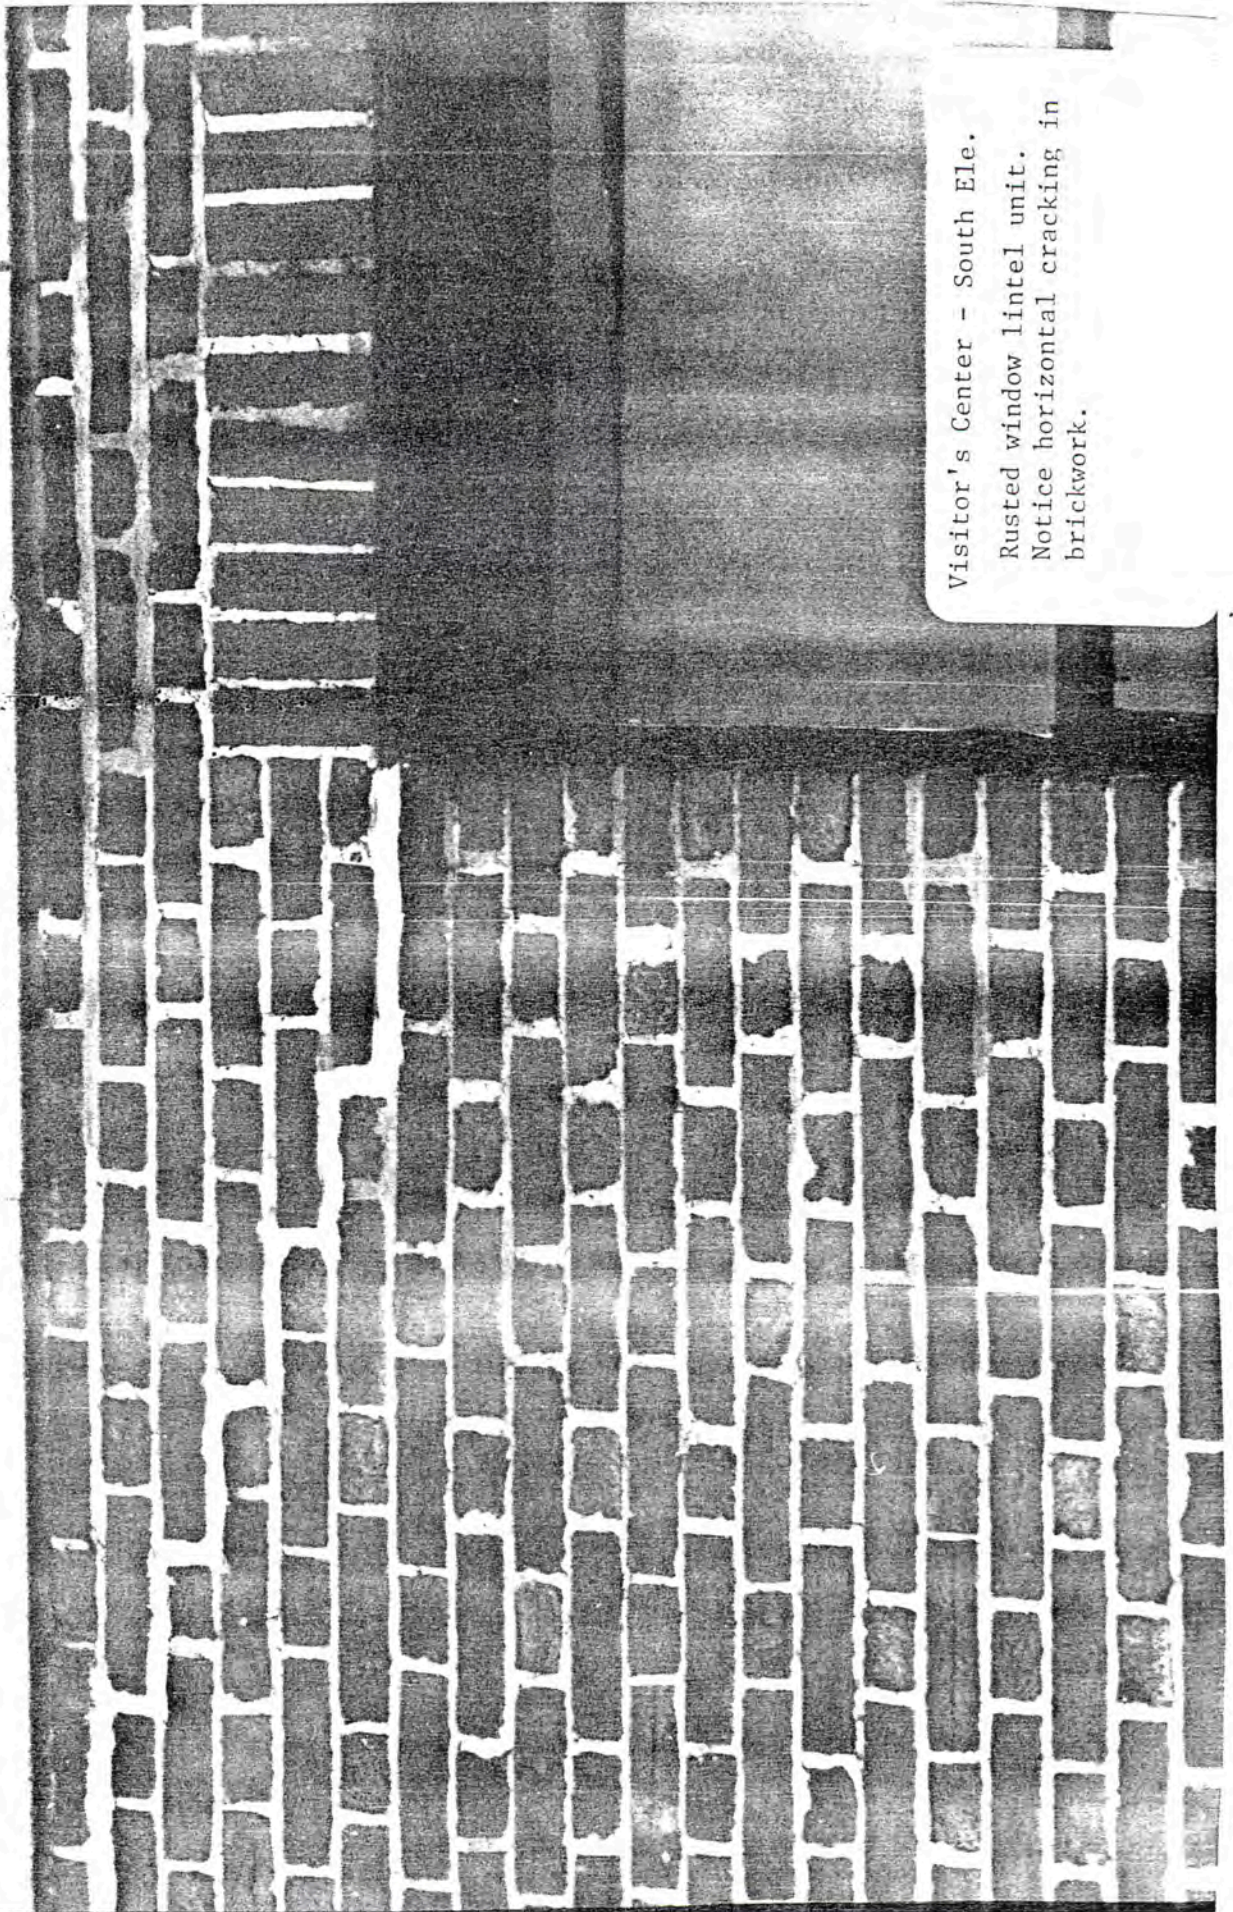
Rust Buildup on Steel Lintel.  
This condition is typical  
throughout the building.

Visitor's Center - South Ele.  
Rusted window lintel unit.  
Notice horizontal cracking in  
brickwork.
