**HIGH DEFINITION STREAM SURVEY OF  
TALLAPOOSA RIVER FOR THE HORSESHOE BEND  
NATIONAL MILITARY PARK, ALABAMA, USA**

Prepared for The U.S. National Park Service  
November 28, 2020

## **TRUTTA ENVIRONMENTAL SOLUTIONS, LLC**

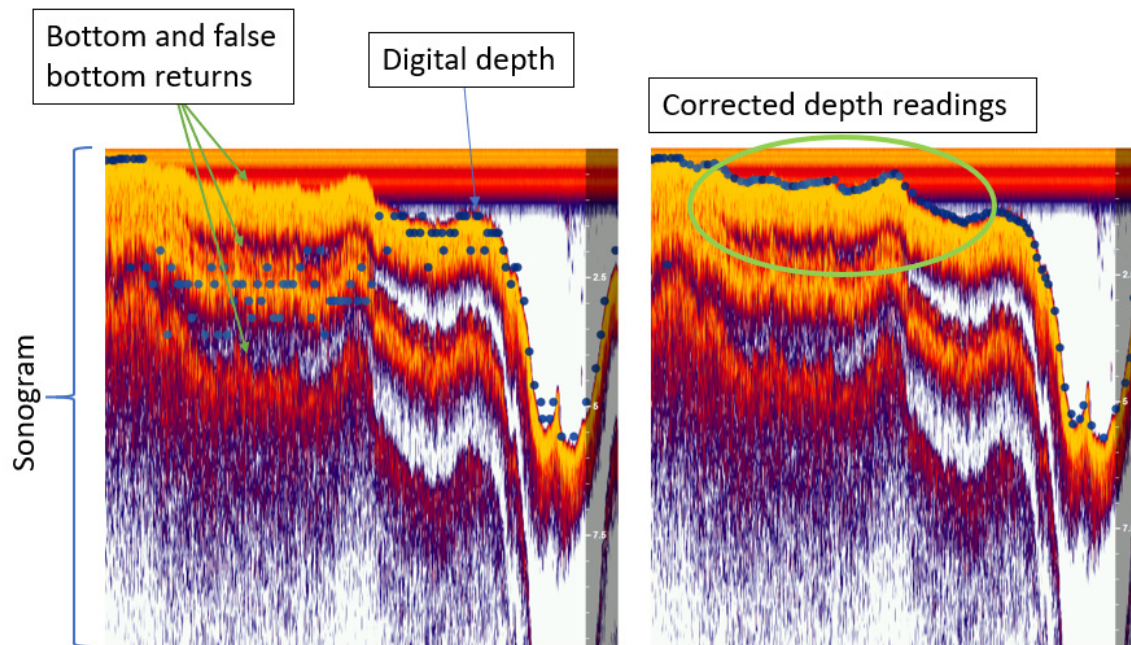
Figure 4: An example of an anomalous depth reading, highlighted in green, collected by the Humminbird Helix 9 G2N sonar.

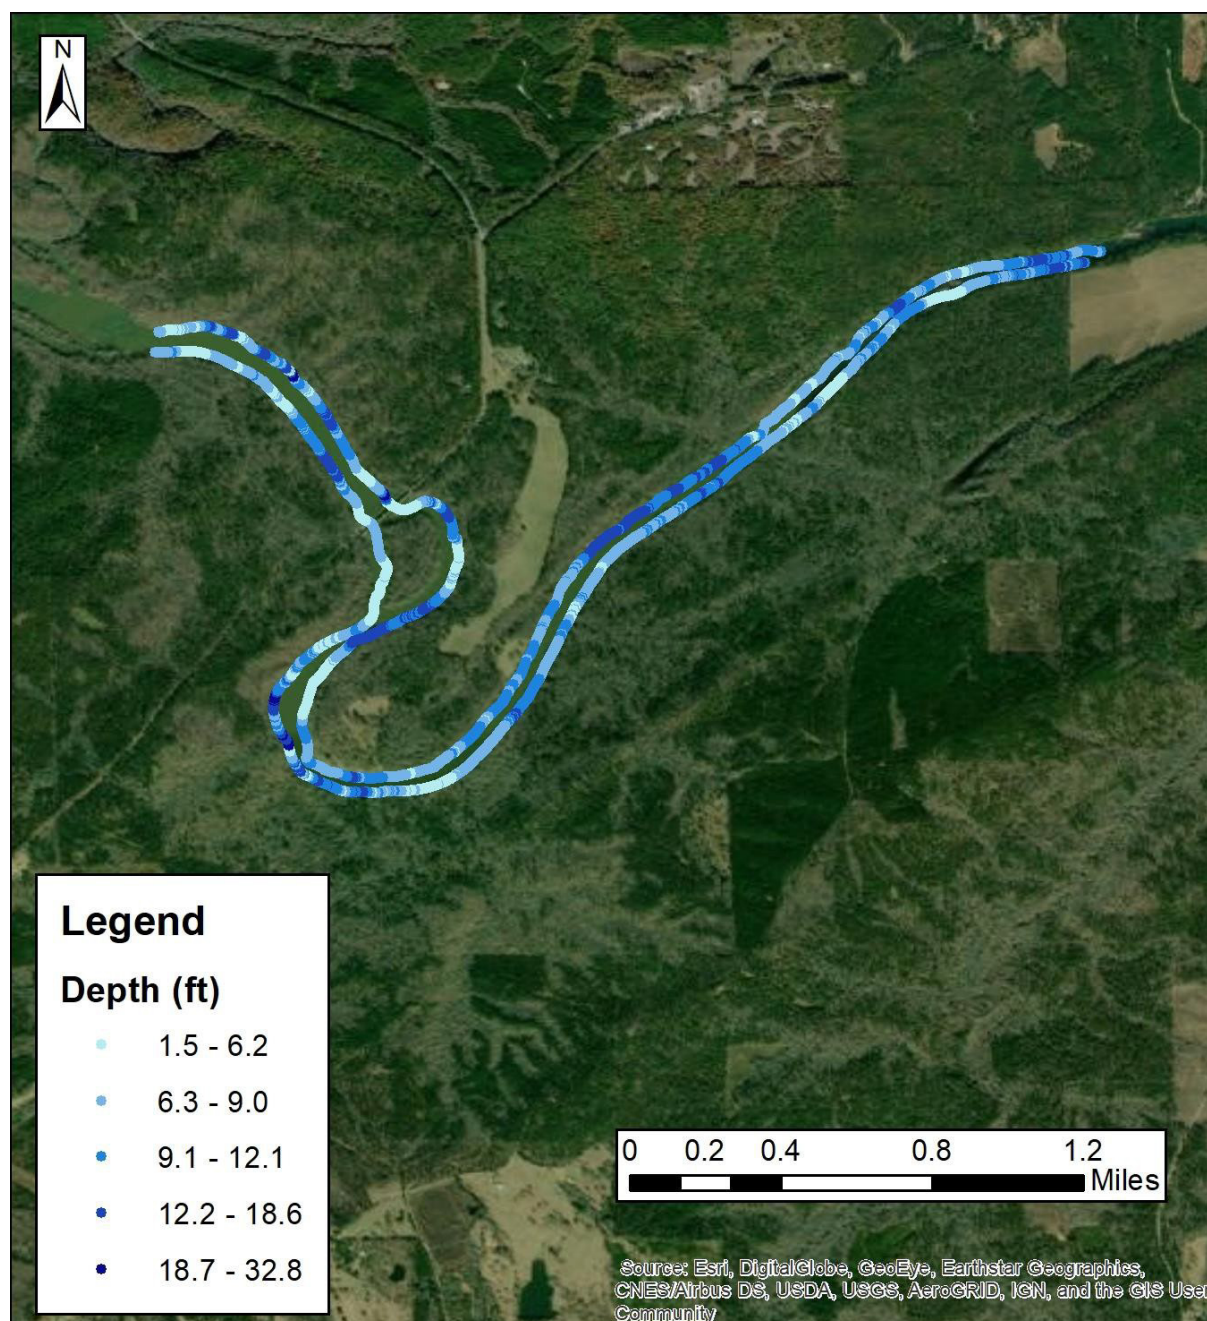
The average water depth showed no specific longitudinal pattern (Figure 14). Shallow areas were present throughout the survey segment; however, the right track around the island was relatively shallower than the left track. The deepest water depths were observed in the outside of Horseshoe Bend pool. Point data for water depth

Figure 11: Water depth for left and right tracks for the Tallapoosa River, adjacent to HOBE. Depth classes shown were to aid in visualization and were not analysis groups.

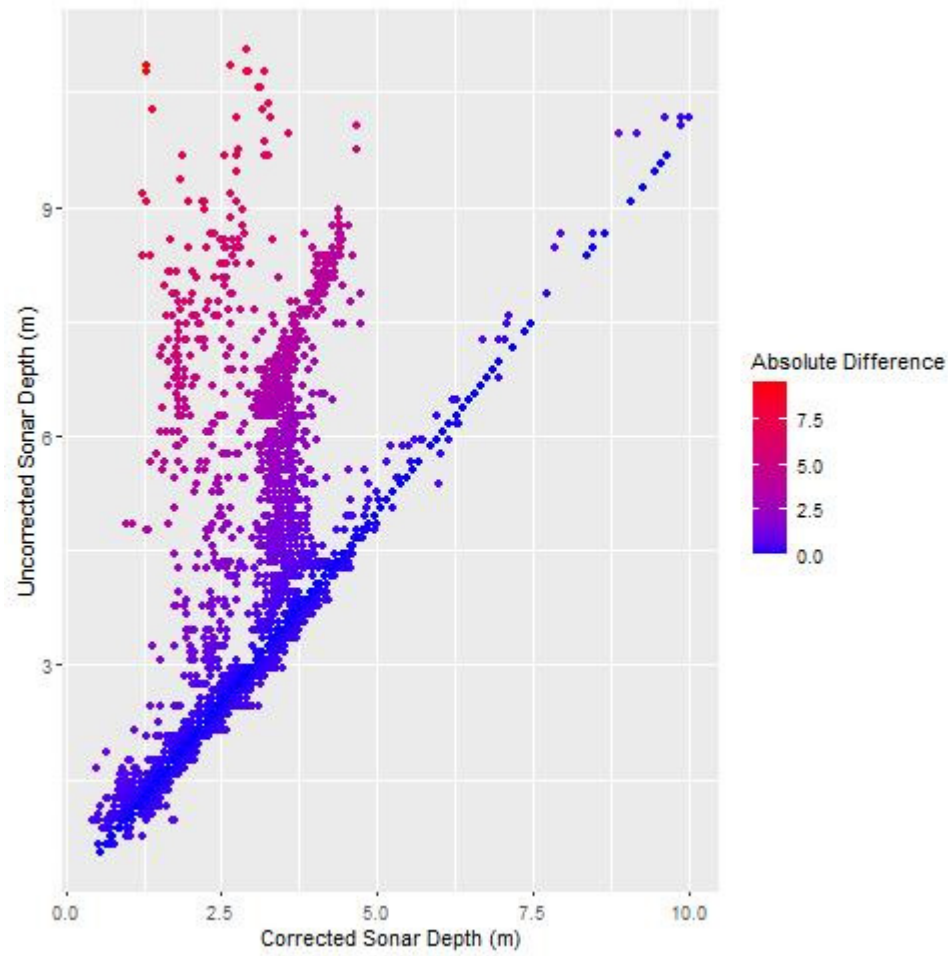
There were 9,229 sonar recordings in the comparison dataset with 0.433m mean difference between the uncorrected and corrected water depth readings (Table 4). Most of the differences between the uncorrected and corrected were associated with a loss of bottom tracking at deeper depth readings (Figure 13). At water depths about 3m the Humminbird sonar appeared to have trouble holding the first sonar return and often found the next deepest sonar return (second echo) and substituted that depth reading for the echo instead of the depth for the first sonar return. The process of double-checking the digital depth readings against the sonograph proved to be an effecting approach to ensuring accurate depth data. Without the record of the sonograph, it would have been difficult to verify if the deep section shown in Figure 14 was an accurate representation of the river's depth or an erroneous depth associated with the loss of bottom tracking by the sonar unit.

Figure 13: Plot of corrected vs. uncorrected digital water depth readings from the full dataset (N=9,229).

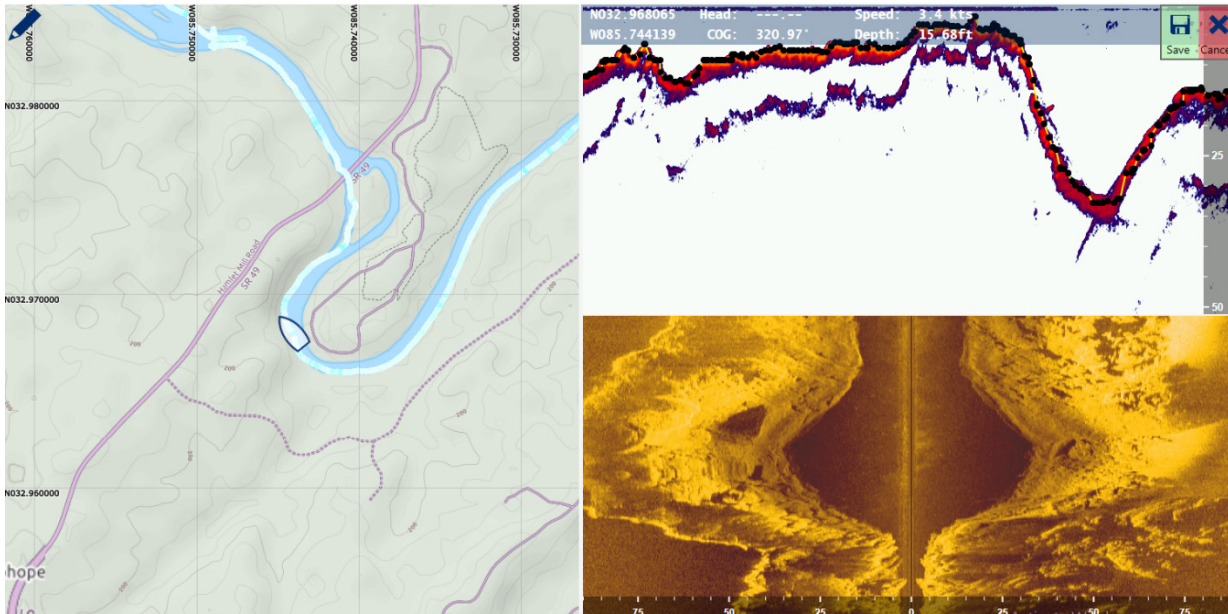
Figure 14: An example of the use of the sonograph and sidescan imagery to make sure the digital depth readings are valid. In this image the deep spot in the river is valid and not an issue with incorrect bottom tracking by the sonar unit.

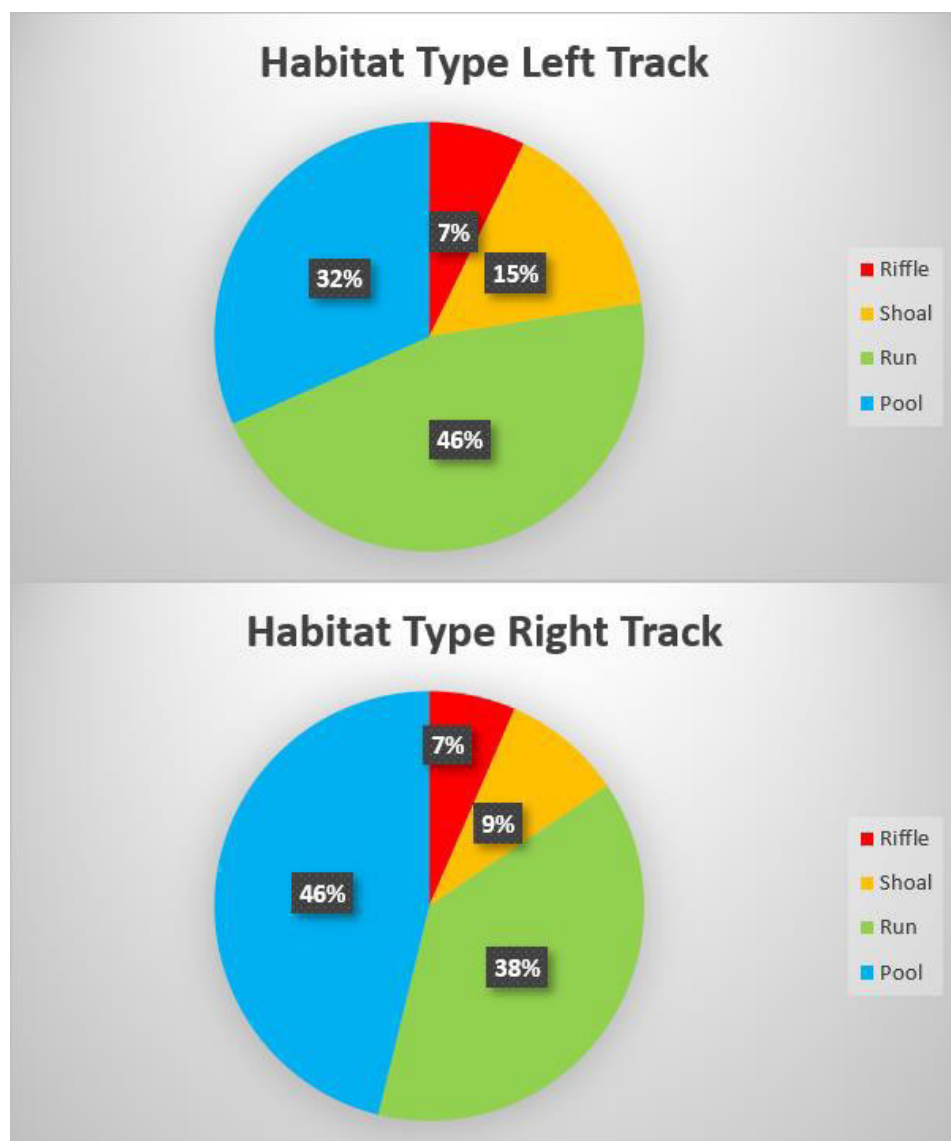
Figure 15: Proportional distribution of habitat types for the Tallapoosa River near HOBE.

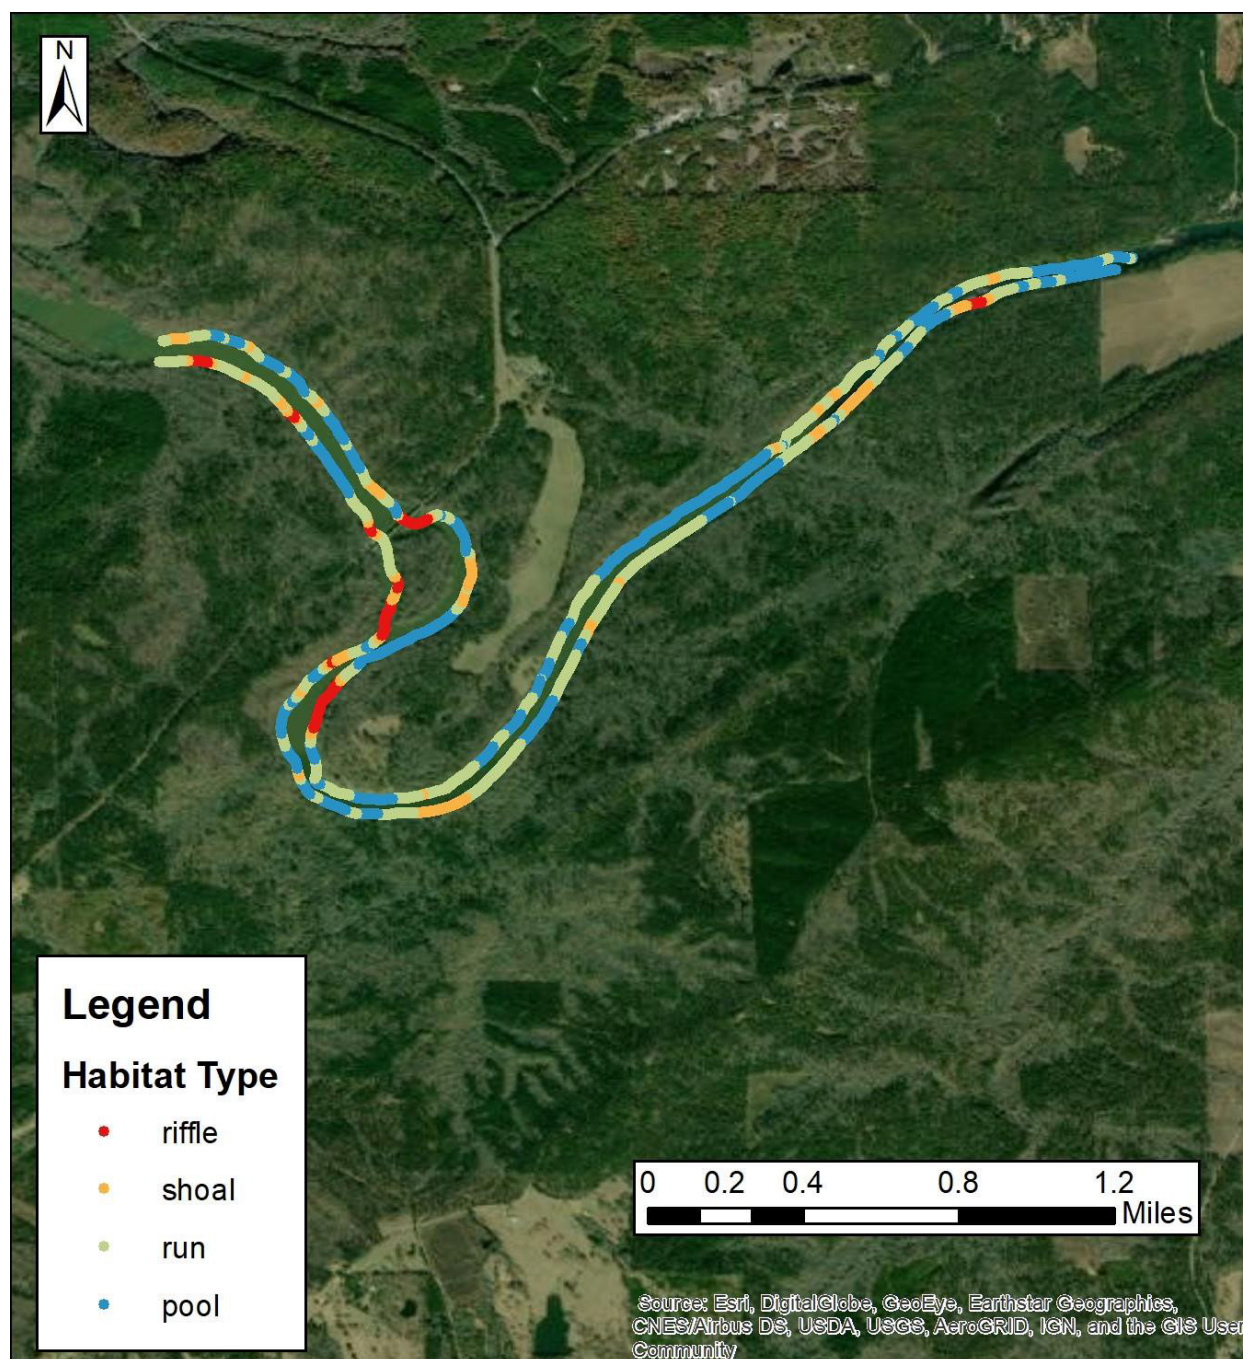
The habitat types most frequently observed were runs and pools, although approximately 20% of the river was classified as either riffles or shoals (Figure 15). As expected, outside bends were generally deeper than inside bends of the river and the shoals and riffles were relatively widely distributed (Figure 16). One reason why we have moved from a strictly visual classification of habitat type to one based on quantitative characteristic is highlighted on the Tallapoosa River survey. As previously discussed, the Tallapoosa River has large and frequent change in discharge as a result of upstream dam releases. Visual habitat type classifications are highly dependent of river discharge as at higher discharges much of the visual signatures of habitat types are underwater and not visible (e.g. exposed rocks in a riffle at low flow are underwater at higher flows). The use of proportional depth measures and smoothed depths to characterize bottom shape trends, allows the habitat types to be determined with some independence of discharge. The shallow exposed riffles at low flow are still the shallowest areas at high flow. As an example, the habitat type classification in Figure 17 shows a close up of the habitat type classification and how it changes through an exposed rocky riffle area just upstream of the Hwy 49 Bridge. The image and the data were not collected at the same time or discharge, but it is still appear where and why the habitat type units are changing. This highlights the usefulness of a quantitative classifications system.

Figure 16: Habitat Type classification for the Tallapoosa River near HOBE.

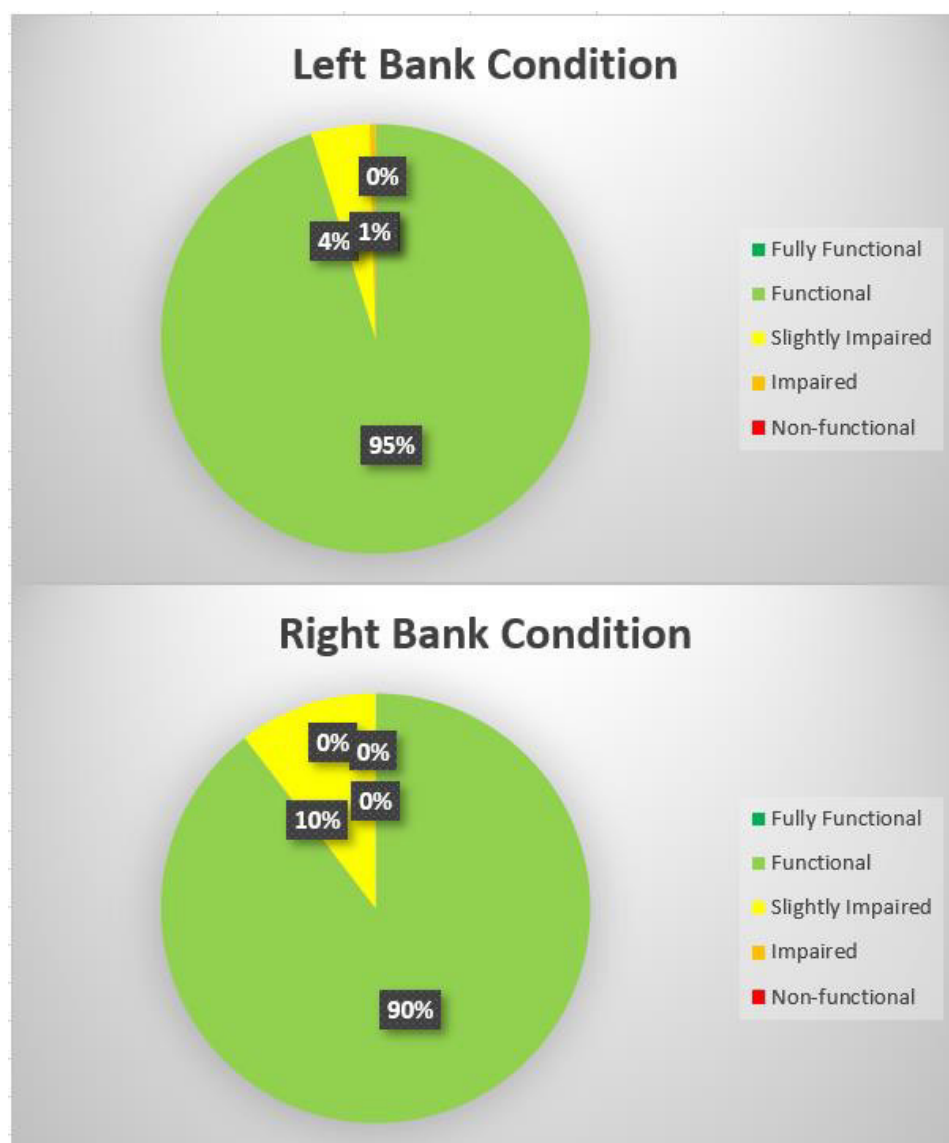
Streambanks were classified into one of five condition categories and one of three type categories. Condition categories represented the extent of impairment (fully functional (1) to non-functional (5)) on the streambank. In general, streambank conditions were in functional condition near the HOBE (Figure 18 & Figure 19). The majority of streambanks classified as functional and less than 10% was in the slightly impaired category. Only 1% of the streambanks were considered impaired and none were classified as non-functional. From a streambank function perspective, most of the river has intact riparian zone extending up to the upper lip of the streambank. There was vegetative cover on most of the banks and the banks were neither overly high nor steep considering the size of the river. We also reviewed the tributary confluences within the area including Soapstone Creek, Miller Creek, and an unnamed creek all on the left side of the river and none were causing observable issues.

Figure 18: Riverbank Condition for the Tallapoosa River near HOBE.
