# NPS Wildfire Risk Assessments Assessment Locations

## DEVA - Death Valley National Park - Overview

DEVA - Eureka Valley - Overview

# NPS Wildland Fire Risk Assessment - Facility Assessment

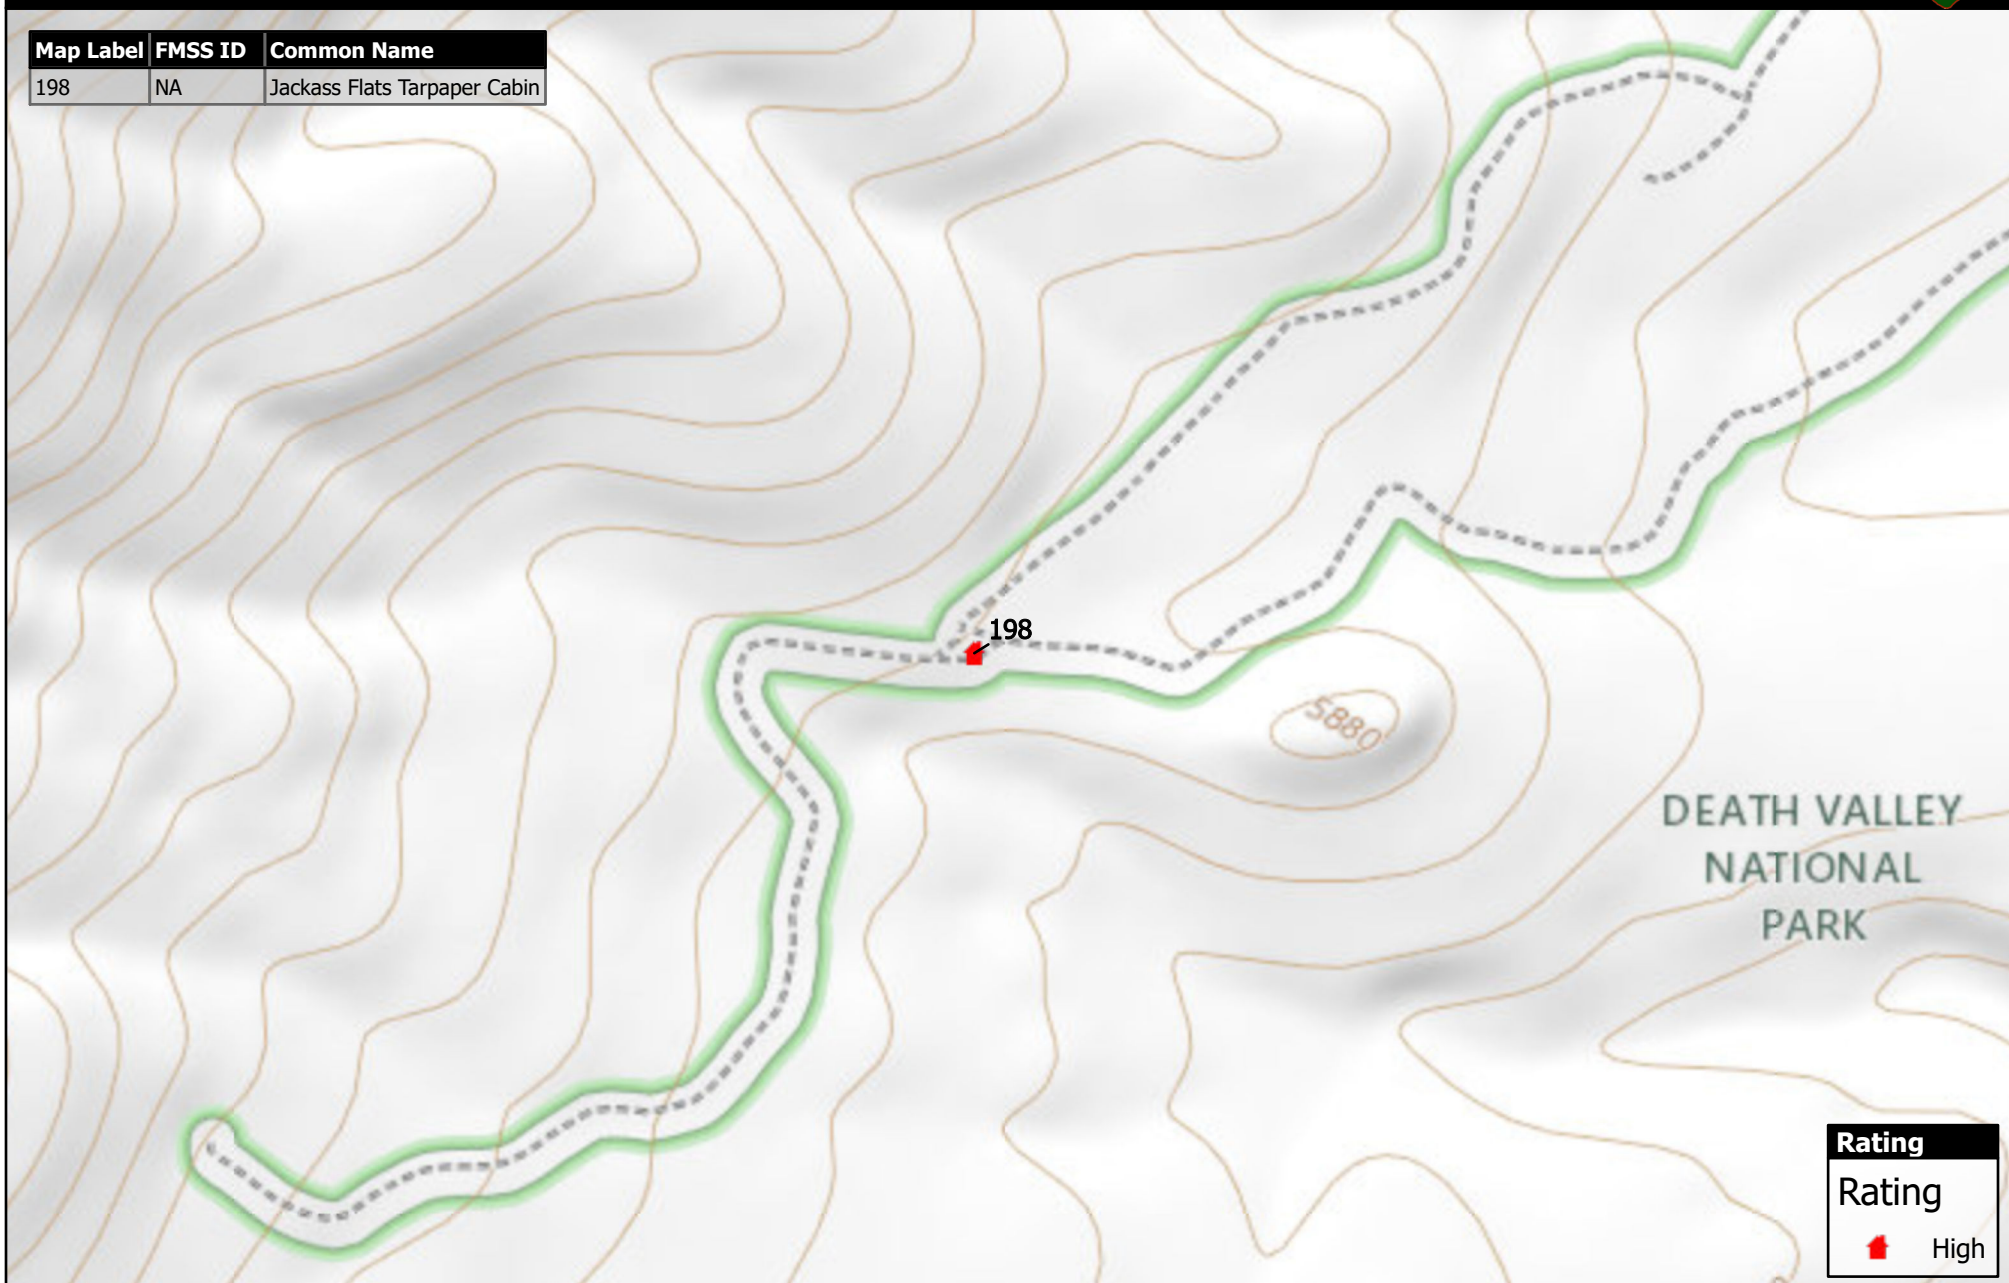
| Map Label | FMSS ID | Common Name |
|---|---|---|
| 198 | NA | Jackass Flats Tarpaper Cabin |

| Rating |
|---|
| High |

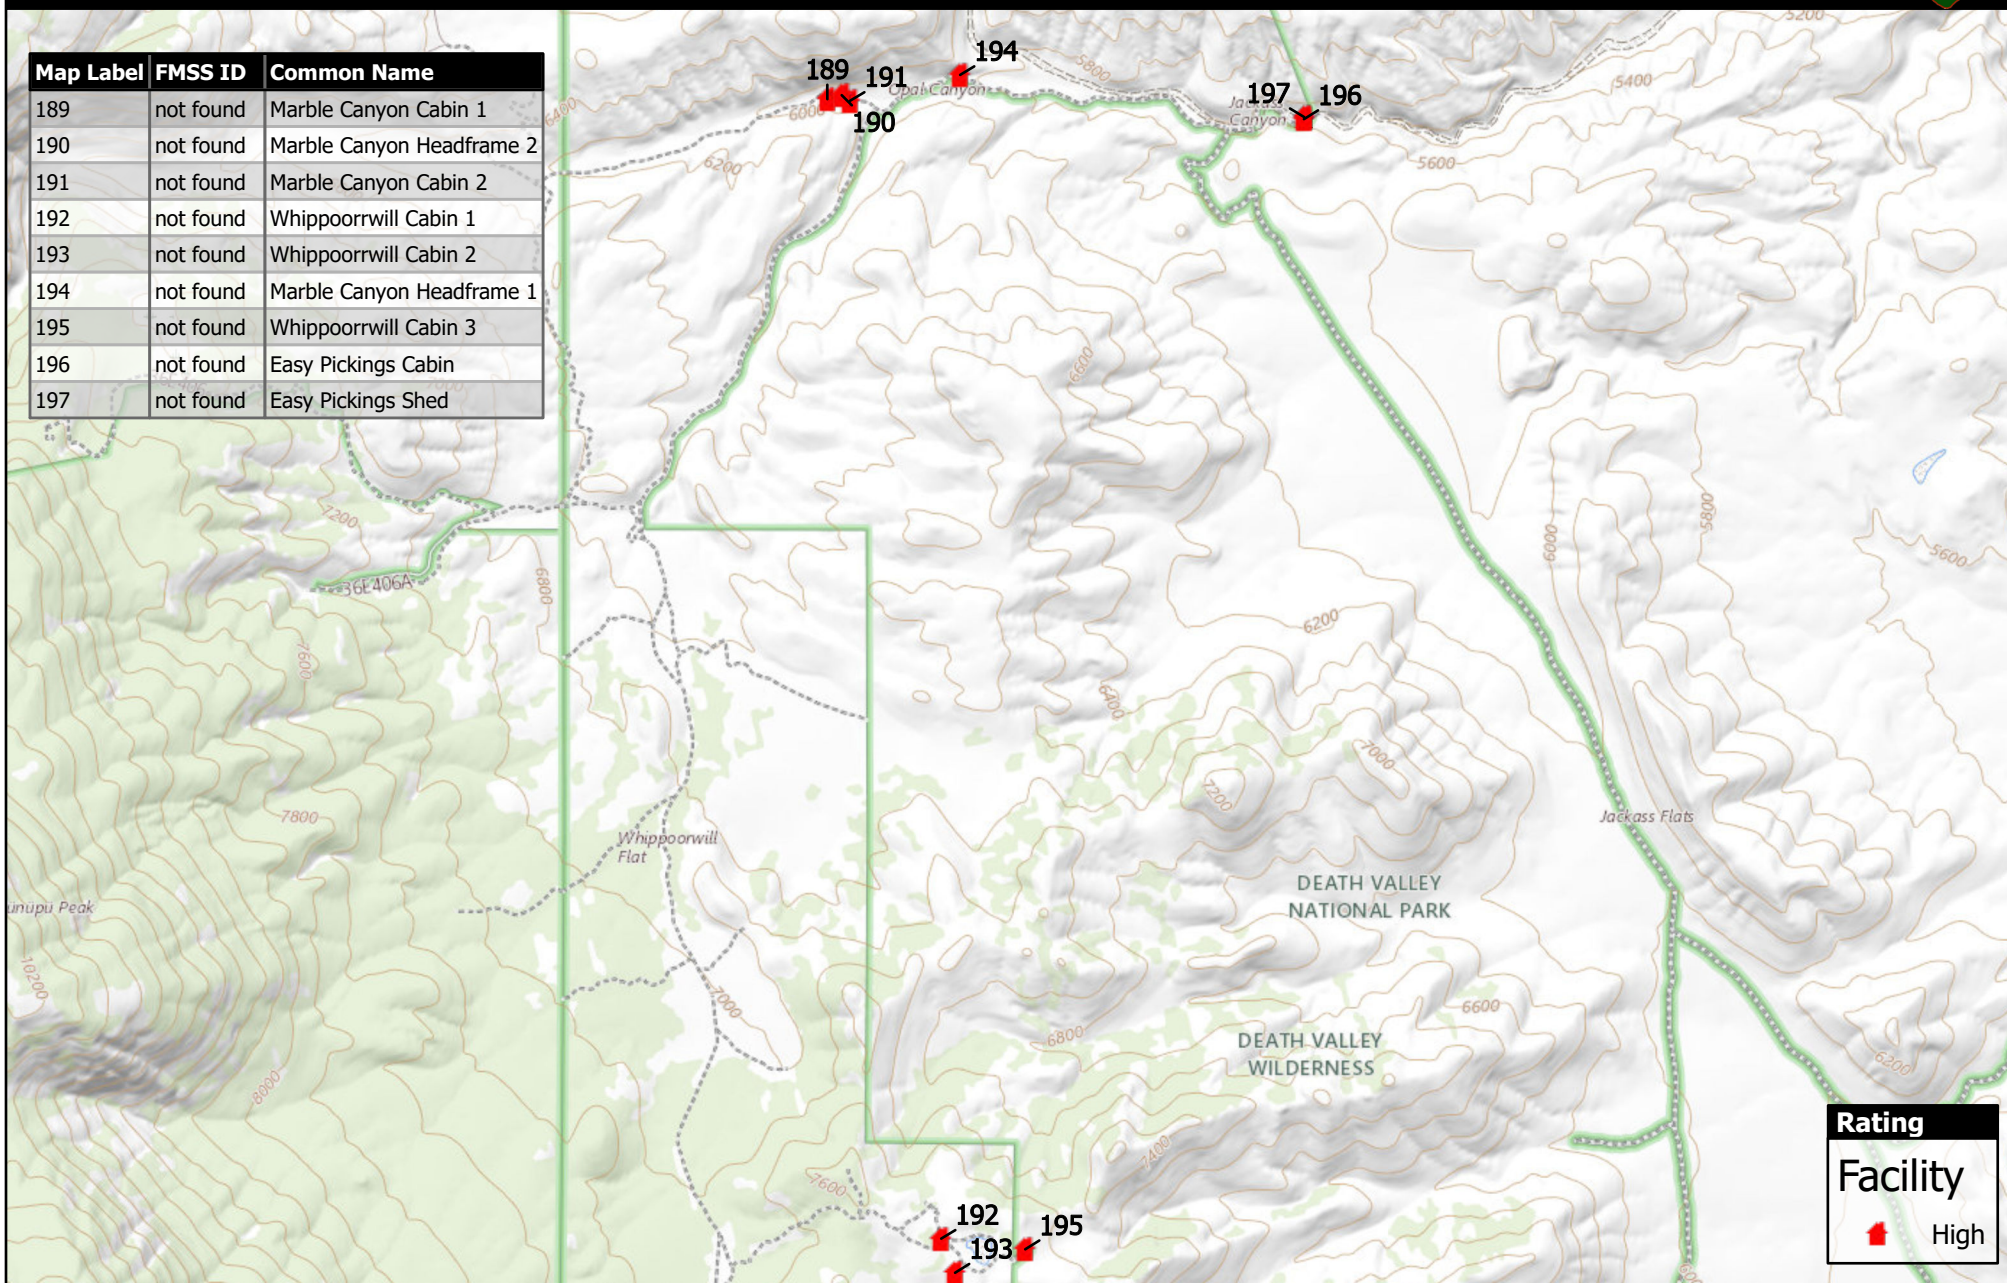
# Marble Canyon

**Rating**  
**Facility**  
High
