# NPS Wildfire Risk Assessments Assessment Locations

## Cane River Creole National Historic Park - Overview

# Magnolia Plantation

## CARI - Cane River Creole National Historical Park

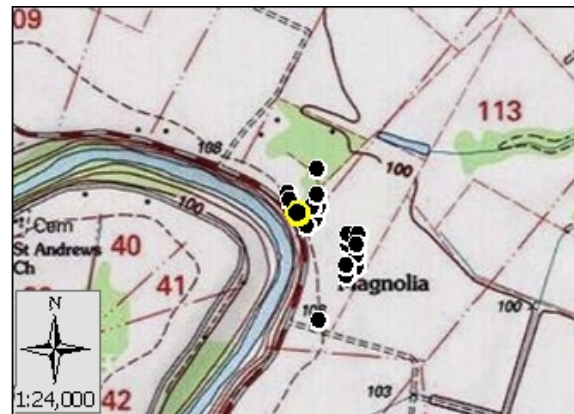
2021\_CARI\_74425\_Corn Crib, Magnolia Plantation\_Front.jpg

Score: 48  
Rating: Moderate

**Primary Access:** Road  
**Ingress/Egress:** Two or more roads in/out  
**Access Width:** 2 lanes (>24ft)  
**Access Condition:** Surfaced-paved, grade<5%

**Bridge Condition:** None/nonflammable,load limit will not limit response  
**Access & Turnarounds:** Access is <300 ft from facility w/turnaround  
**Facility Number/Sign:** Marked and clearly visible

**Roof Material:** Noncombustible or not applicable  
**Siding Material:** Wood or open sided  
**Foundation:** Open or deck  
**Fences/Decks:** Combustible, adjacent, clear of veg/debris

**Firewood:** None  
**Propane Tanks:** None  
**Water Supply:** Pressurized hydrant(s) or fixed sprinkler system  
**Overhead Hazards:** No overhead hazards

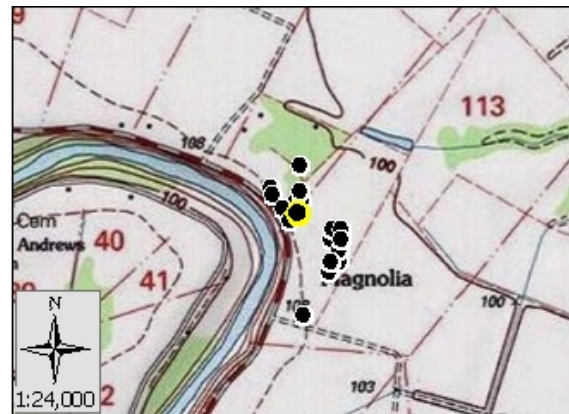
2021\_CARI\_78736\_Cotton Picker Shed  
(Magnolia)\_Front.jpg

Score: 26  
Rating: Low

**Primary Access:** Road  
**Ingress/Egress:** Two or more roads in/out  
**Access Width:** 2 lanes (>24ft)  
**Access Condition:** Surfaced-paved, grade<5%

**Bridge Condition:** None/nonflammable,load limit will not limit response  
**Access & Turnarounds:** Access is <300 ft from facility w/turnaround  
**Facility Number/Sign:** None or not clearly visible

**Roof Material:** Noncombustible or not applicable  
**Siding Material:** Wood or open sided  
**Foundation:** Open or deck  
**Fences/Decks:** Combustible but separated from facility

**Firewood:** None  
**Propane Tanks:** None  
**Water Supply:** Pressurized hydrant(s) or fixed sprinkler system  
**Overhead Hazards:** No overhead hazards

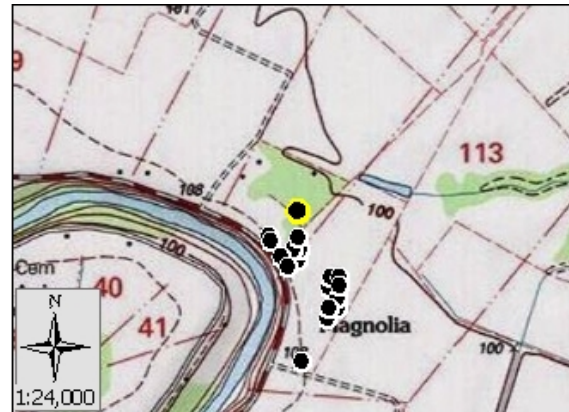
2021\_CARI\_not found \_"Cooks" Cabin\_Front.jpg

**Score:**  
**Rating:**  
PVTNotSurveyed

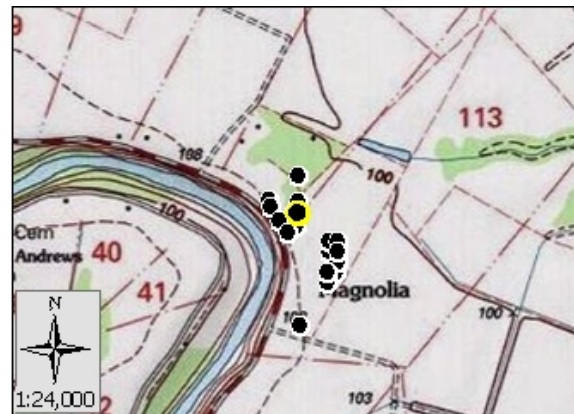
2021\_CARI\_74404\_Overseers House - Slave Hospital (Magnolia)\_Front.jpg

**Score: 20**  
**Rating: Low**
