# Dog Canyon

## NPS Wildfire Risk Assessments

# NPS Wildand Fire Risk Assessment - Facility Wildfire Risk Assessment Summary

## Unit - Location: GUMO - Dog Canyon

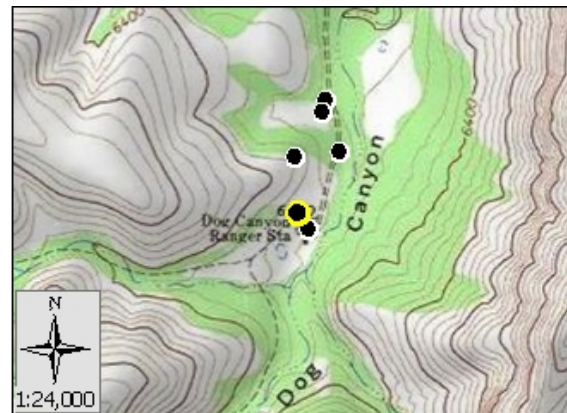
2021\_GUMO\_72264\_DC BLDG263 PUMP CONTROLS CHLORINE STORAGE\_Front.jpg

Foundation: Closed, 6in to 30in masonry exposed

Score: 57  
Rating: Moderate

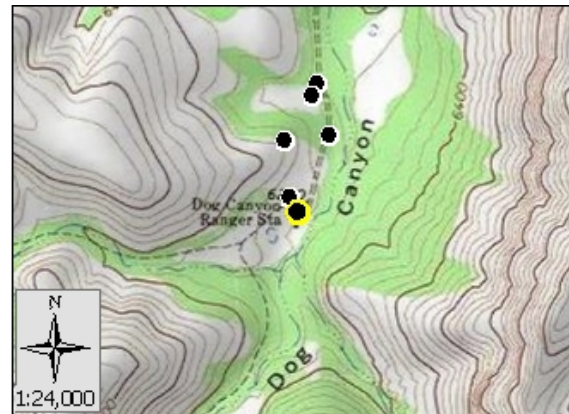
2021\_GUMO\_72261\_DC BLDG261 BARN\_Front.jpg

Foundation: Closed, 6in to 30in masonry exposed

Score: 57  
Rating: Moderate

| Label # | Facility/Community Name | Assessment Scale | Site Visit Type | Firewise Zone | Treatment | Treatment Description | Person Hours |
|---|---|---|---|---|---|---|---|
| 5 | DC BLDG261 BARN | Individual Facility | Initial | 1 | Firewood should be moved at least 50 ft from the facility and 15 horizontal feet from tree canopies | | 1.0 |
| | | Individual Facility | Initial | 1 | Open crown spacing 10 to 30 feet depending on slope | | 1.0 |
| | | Individual Facility | Initial | 1 | Remove dead or dying component of shrubs and trees | | 1.0 |

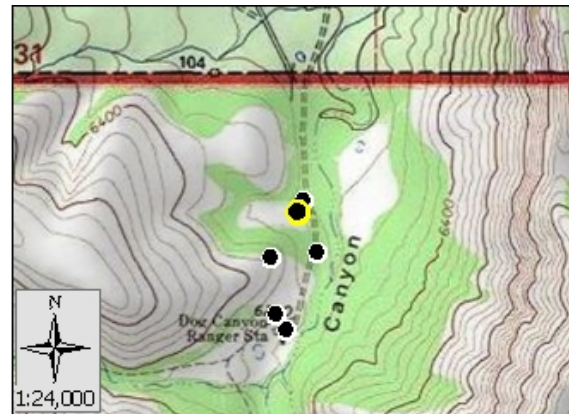
2021\_GUMO\_72246\_Q-361 DC APARTMENT  
BLDG\_Front.jpg

Foundation: Closed, < 6in masonry exposed

Score: 34  
Rating: Low
