# NPS Wildfire Risk Assessments Assessment Locations

## Tuzigoot National Monument

# NPS Wildand Fire Risk Assessment - Facility Wildfire Risk Assessment Summary

## Unit - Location: TUZI - Tuzigoot National Monument

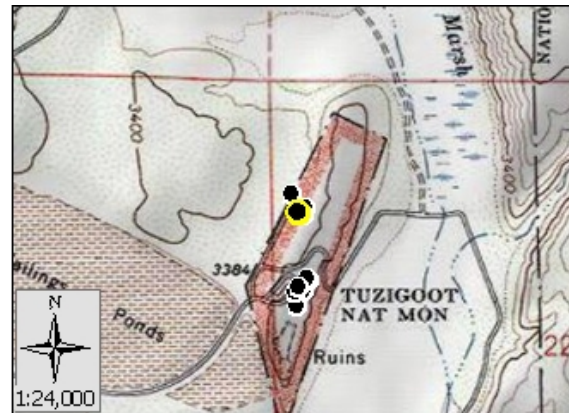
2020\_TUFrontL\_13716\_Quarters 7\_Front

**Score: 49**  
**Rating: Moderate**  
**Asset Priority Index (API): 20**

| Facility/Community Name | Assessment Scale | Triage Category | Tactic Description | Person Hours | Equipment Description | Equip. Qty |
|---|---|---|---|---|---|---|
| Quarters 7 | Individual Facility | PrepHold | Fuels reduction - Fuels in zones 2 and 3 need treated to FireWise standards. Flammable materials should be moved away from outbuilding. Would recommend cutting grass and brush w/ a potential threat to the structure. Would recommend an engine on scene (A hydrant is on the Alpha side of the building, which is fed from a 50,000 gal. tank for drafting). Would recommend a sprinkler kit w/ pump to help protect the structure. | 12.0 | - | |
| | | | Engine on scene - Engine should be on scene during fire event. Would recommend cutting grass and brush w/ a potential threat to the structure. Would recommend an engine on scene (A hydrant is on the Alpha side of the building, which is fed from a 50,000 gal. tank for drafting). Would recommend a sprinkler kit w/ pump to help protect the structure. | 3.0 | - | |

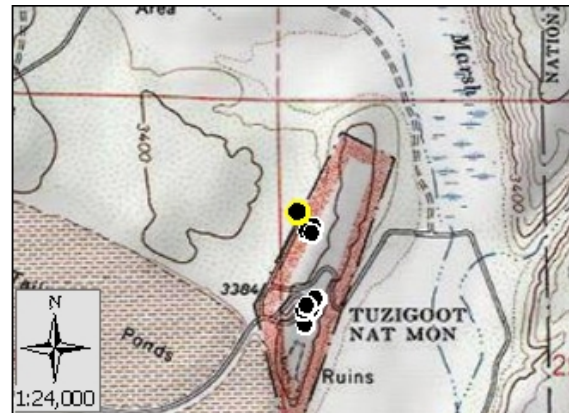
2020\_TUFrontI\_26621\_Storage Building\_Front

**Score: 52**  
**Rating: Moderate**  
**Asset Priority Index (API): 32**

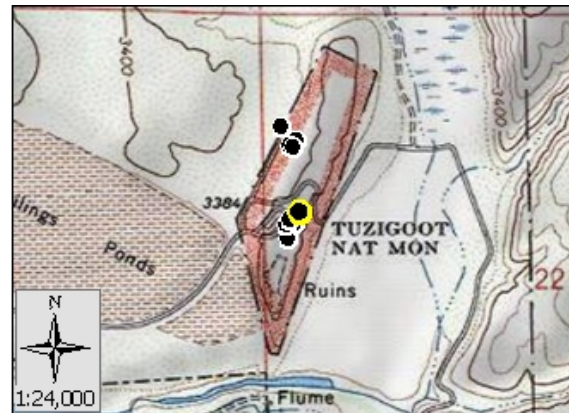
Photo 1.jpg

**Score: 55**  
**Rating: Moderate**
