# NPS Wildfire Risk Assessments Assessment Locations

## CHCU - Chaco Culture National Historical Park Overview

NPS Wildfire Risk Assessment Project

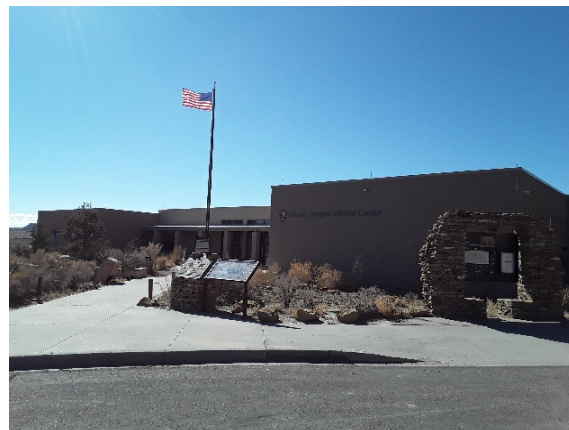
2021\_CHCU\_Visitor Center\_Front.jpg

**Score: 45**  
**Rating: Moderate**

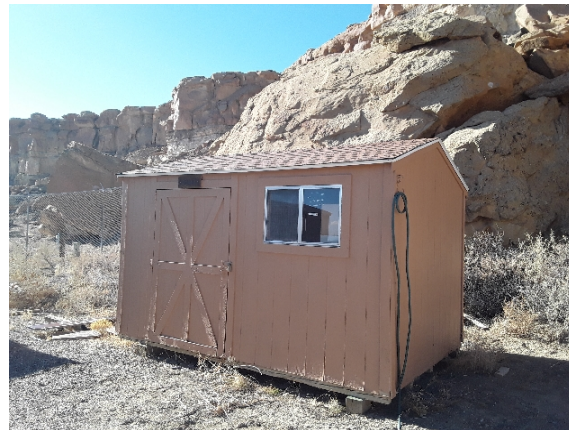
2021\_CHCU\_111414\_Admin Storage\_Front.jpg

**Score: 55**  
**Rating: Moderate**

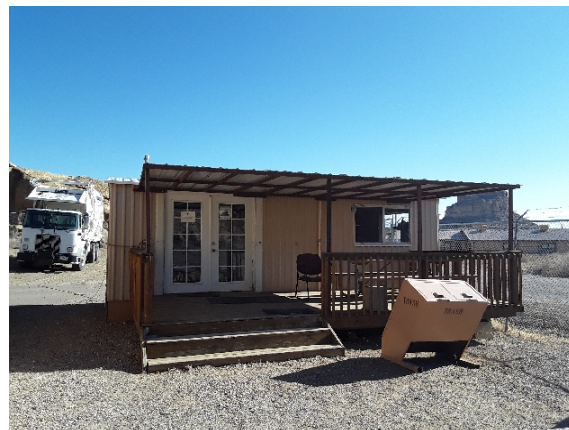
2021\_CHCU\_114368\_VIP Campground Kitchen\_Front.jpg

**Score: 50**  
**Rating: Moderate**

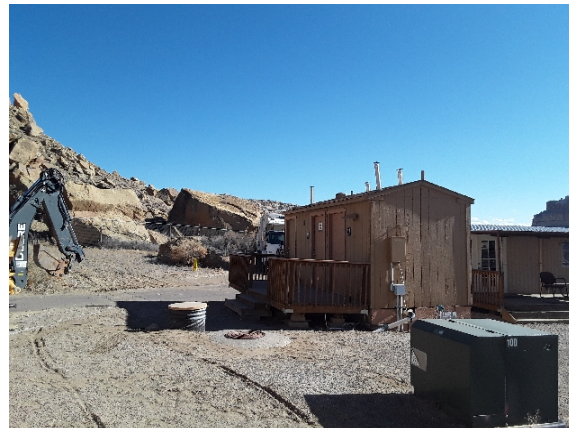
2021\_CHCU\_114370\_VIP Campground  
Restroom\_Front.jpg

**Score: 51**  
**Rating: Moderate**  
**Asset Priority Index (API): 42**

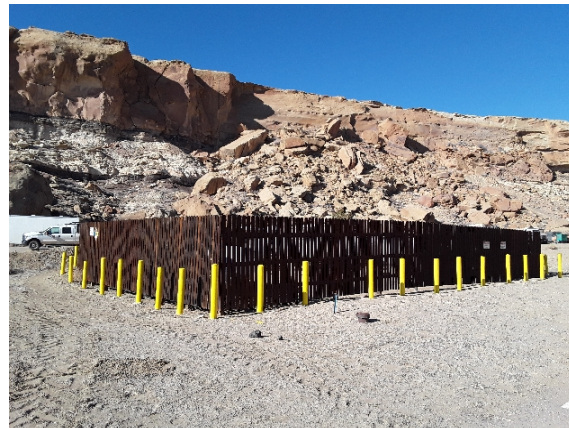
2021\_CHCU\_92309\_Ast. Propane Tank Group\_Front.jpg

**Score: 39**  
**Rating: Low**

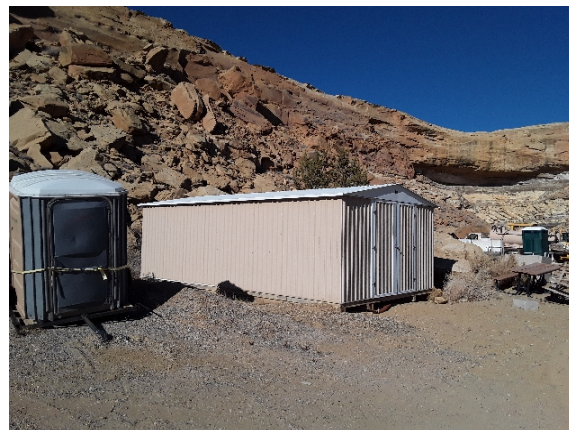
2021\_CHCU\_not found \_Administration Storage\_Front.jpg

**Score: 49**  
**Rating: Moderate**  
**Asset Priority Index (API):**  
N/A

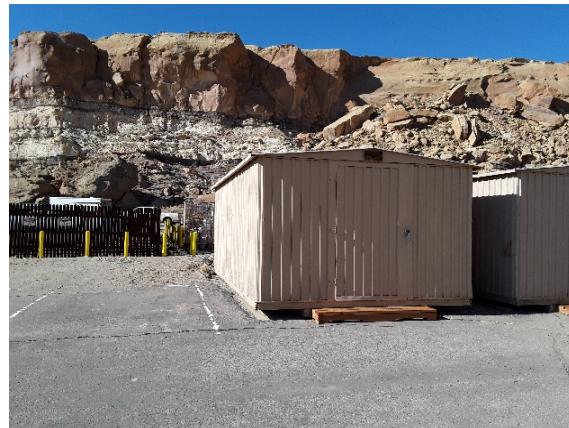
2021\_CHCU\_111416\_Plumbing Shed\_Front.jpg

**Score: 42**  
**Rating: Low**

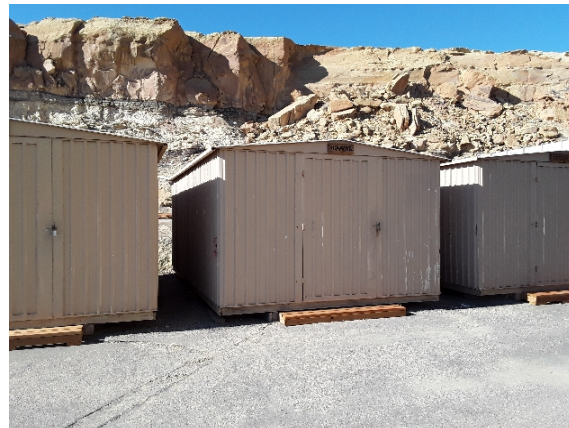
2021\_CHCU\_111412\_Housing Storage Shed\_Front.jpg

**Score: 42**  
**Rating: Low**

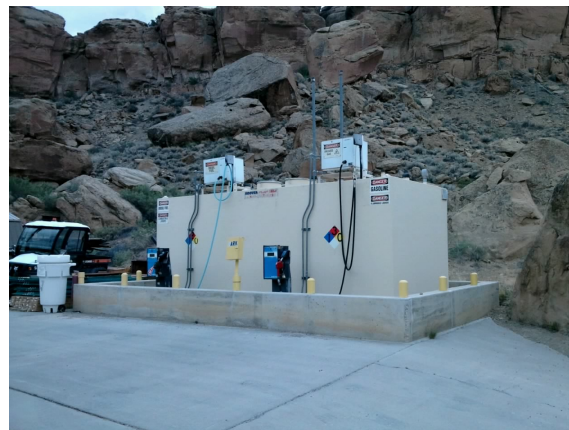
2018\_CHCU\_72077\_Diesel Fueling Tank\_Front.jpg

**Score: 45**  
**Rating: Moderate**

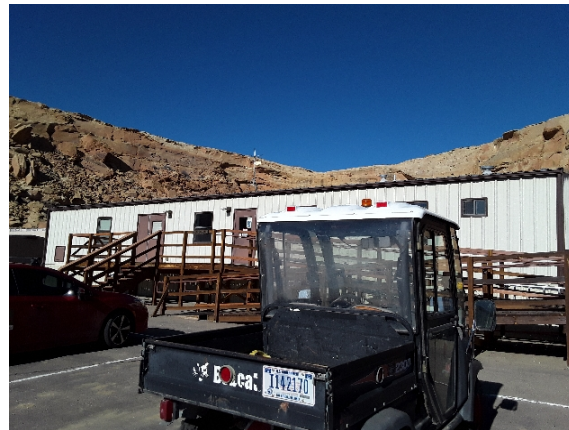
2021\_CHCU\_116144\_Maintenance/Curation Building\_Front.jpg

**Firewood:** None  
**Propane Tanks:** Present and fuels clearance  
**Water Supply:** Limited or dependent on electricity  
**Overhead Hazards:** No overhead hazards

**Safety Zones:** No safety zone(s) in area  
**Additional Obstacles:** Hazmat, UXO,etc. , PLEASE COMMENT  
**Triage Category:**  
**Hazmat:**  
**Assessment Comments:**

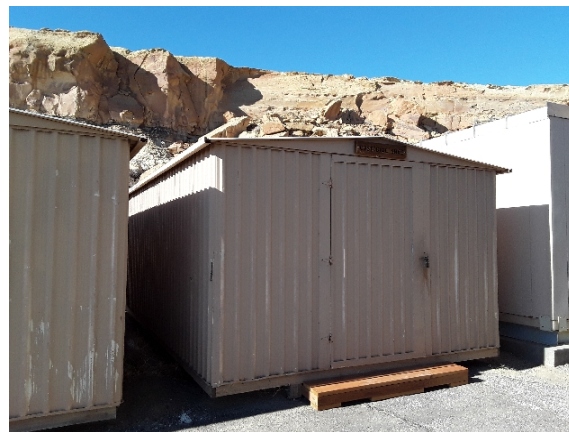
2021\_CHCU\_111410\_Custodial Shed\_Front.jpg

**Roof Material:** Noncombustible or not applicable  
**Siding Material:** Rock, concrete, metal  
**Foundation:** Open or deck  
**Fences/Decks:** None or noncombustible

**Firewood:** None  
**Propane Tanks:** None  
**Water Supply:** Limited or dependent on electricity  
**Overhead Hazards:** No overhead hazards  
**Safety Zones:** No safety zone(s) in area

**Additional Obstacles:** Hazmat, UXO,etc. , PLEASE COMMENT  
**Triage Category:**  
**Hazmat:**  
**Assessment Comments:**

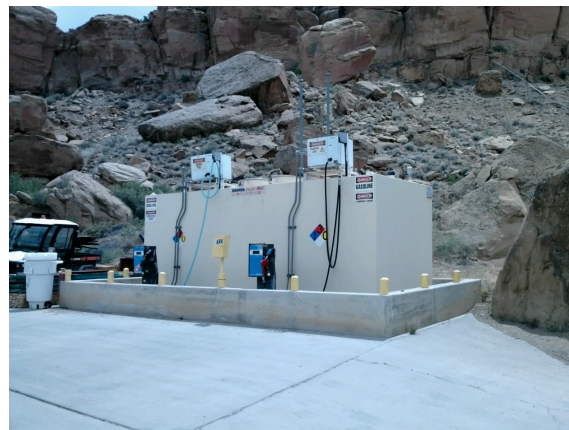
2018\_CHCU\_72073\_Gas Fueling Tank\_Front.jpg

**Roof Material:** Noncombustible or not applicable  
**Siding Material:** Rock, concrete, metal  
**Foundation:** Closed, >30in masonry exposed or N/A

**Fences/Decks:** None or noncombustible  
**Firewood:** None  
**Propane Tanks:** None  
**Water Supply:** Limited or dependent on electricity  
**Overhead Hazards:** No overhead hazards

**Safety Zones:** No safety zone(s) in area  
**Additional Obstacles:** Hazmat, UXO,etc. , PLEASE COMMENT  
**Triage Category:**  
**Hazmat:**  
**Assessment Comments:**

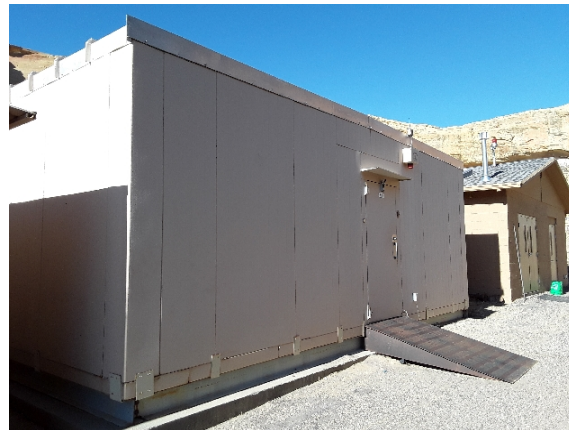
2021\_CHCU\_92288\_Bally Storage\_Front.jpg

**Roof Material:** Noncombustible or not applicable  
**Siding Material:** Rock, concrete, metal  
**Foundation:** Open or deck  
**Fences/Decks:** None or noncombustible

**Firewood:** None  
**Propane Tanks:** Present and fuels clearance  
**Water Supply:** Limited or dependent on electricity  
**Overhead Hazards:** No overhead hazards

**Safety Zones:** No safety zone(s) in area  
**Additional Obstacles:** Hazmat, UXO,etc. , PLEASE COMMENT  
**Triage Category:**  
**Hazmat:**  
**Assessment Comments:**

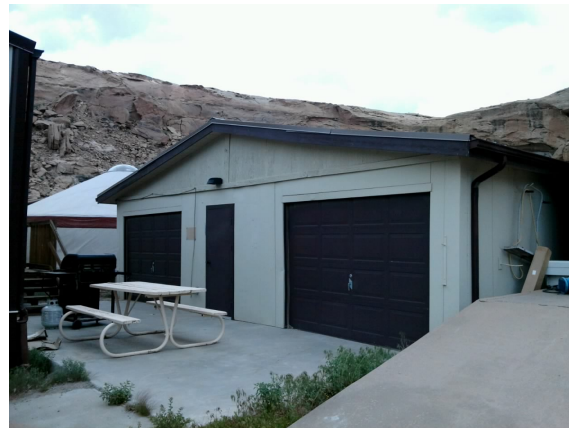
2018\_CHCU\_\_Maintenance Building\_Front.jpg

**Roof Material:** Noncombustible or not applicable  
**Siding Material:** Rock, concrete, metal  
**Foundation:** Closed, >30in masonry exposed or N/A

**Fences/Decks:** None or noncombustible  
**Firewood:** None  
**Propane Tanks:** None  
**Water Supply:** Limited or dependent on electricity  
**Overhead Hazards:** No overhead hazards

**Safety Zones:** No safety zone(s) in area  
**Additional Obstacles:** Hazmat, UXO,etc. , PLEASE COMMENT  
**Triage Category:**  
**Hazmat:**  
**Assessment Comments:**

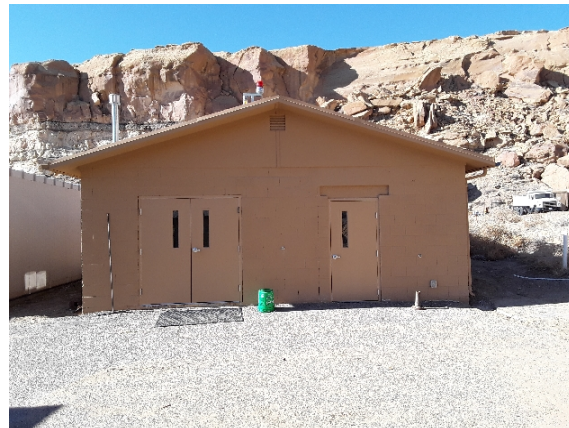
2021\_CHCU\_71942\_Well House\_Front.jpg

**Roof Material:** Noncombustible or not applicable  
**Siding Material:** Rock, concrete, metal  
**Foundation:** Closed, >30in masonry exposed or N/A

**Overhead Hazards:** No overhead hazards  
**Safety Zones:** No safety zone(s) in area  
**Additional Obstacles:** Hazmat, UXO,etc. , PLEASE COMMENT  
**Triage Category:**

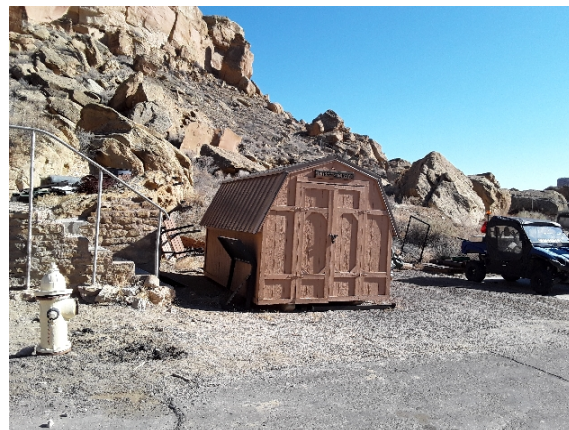
2021\_CHCU\_111453\_Interpretive Barn\_Front.jpg

**Roof Material:** Noncombustible or not applicable  
**Siding Material:** Wood or open sided  
**Foundation:** Open or deck  
**Fences/Decks:** None or noncombustible

**Firewood:** None  
**Propane Tanks:** None  
**Water Supply:** Limited or dependent on electricity  
**Overhead Hazards:** No overhead hazards  
**Safety Zones:** No safety zone(s) in area

**Additional Obstacles:** Hazmat, UXO,etc. , PLEASE COMMENT  
**Triage Category:**  
**Hazmat:**  
**Assessment Comments:**

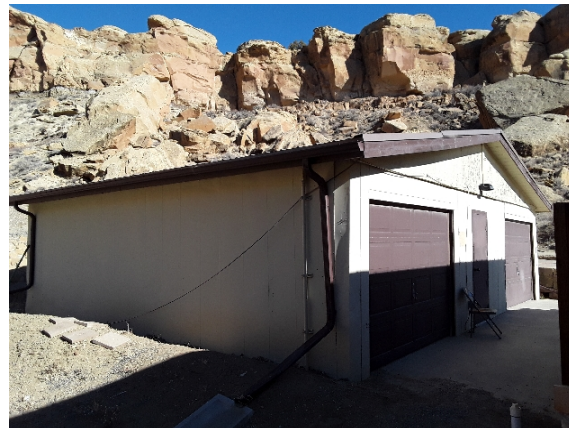
2021\_CHCU\_71973\_Lumber Storage Shop\_Front.jpg

**Roof Material:** Noncombustible or not applicable  
**Siding Material:** Wood or open sided  
**Foundation:** Closed, < 6in masonry exposed  
**Fences/Decks:** Combustible, adjacent, clear of veg/debris

**Firewood:** None  
**Propane Tanks:** Present and fuels clearance  
**Water Supply:** Limited or dependent on electricity  
**Overhead Hazards:** No overhead hazards

**Safety Zones:** No safety zone(s) in area  
**Additional Obstacles:** Hazmat, UXO,etc. , PLEASE COMMENT  
**Triage Category:**  
**Hazmat:** Propane tanks and Oxygen

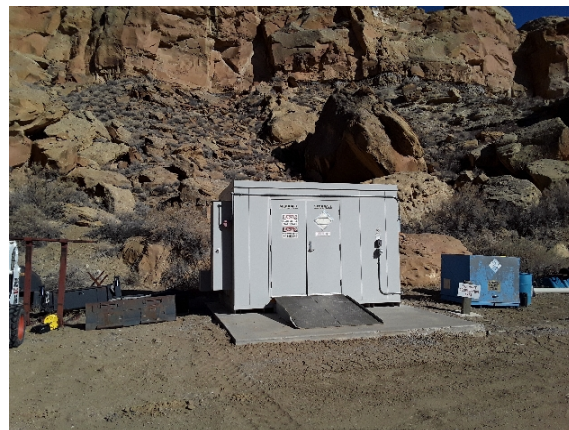
2021\_CHCU\_111451\_Flammable/Hazmat Storage\_Front.jpg

**Roof Material:** Noncombustible or not applicable  
**Siding Material:** Rock, concrete, metal  
**Foundation:** Closed, >30in masonry exposed or N/A

**Fences/Decks:** None or noncombustible  
**Firewood:** None  
**Propane Tanks:** None  
**Water Supply:** Limited or dependent on electricity  
**Overhead Hazards:** No overhead hazards

**Safety Zones:** No safety zone(s) in area  
**Additional Obstacles:** Hazmat, UXO,etc. , PLEASE COMMENT  
**Triage Category:**  
**Hazmat:** hazmat storage

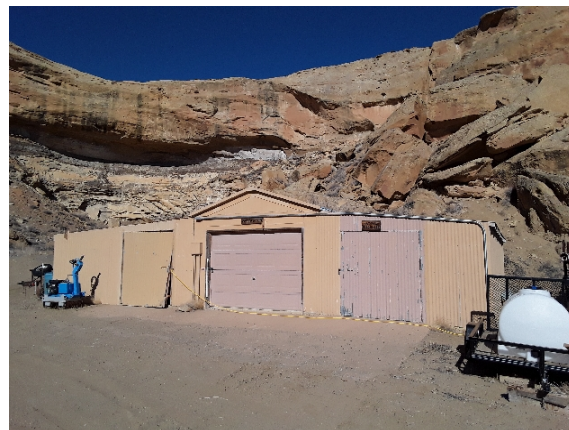
2021\_CHCU\_11452\_Preservation Storage\_Front.jpg

**Firewood:** None  
**Propane Tanks:** None  
**Water Supply:** Limited or dependent on electricity  
**Overhead Hazards:** No overhead hazards  
**Safety Zones:** No safety zone(s) in area

**Additional Obstacles:** Hazmat, UXO,etc. , PLEASE COMMENT  
**Triage Category:**  
**Hazmat:**  
**Assessment Comments:**
