# Clarno Unit

## JODA - John Day Fossil Beds National Monument

# NPS Wildand Fire Risk Assessment - Facility Assessment

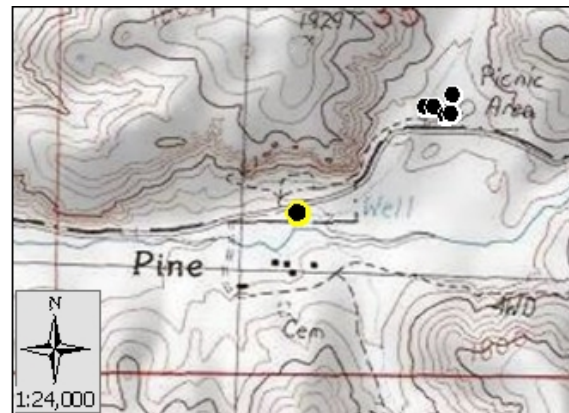
2022\_JODA\_28799\_CL BLDG Office\_Front.jpg

**Roof Material:** Noncombustible or not applicable  
**Siding Material:** Wood or open sided  
**Foundation:** Open or deck  
**Fences/Decks:** Combustible but separated from facility

**Firewood:** None  
**Propane Tanks:** None  
**Water Supply:** No reliable water source nearby  
**Overhead Hazards:** No overhead hazards  
**Safety Zones:** Potential safety zone(s) in area

**Score: 50**  
**Rating: Moderate**  
**Asset Priority Index (API): 92**

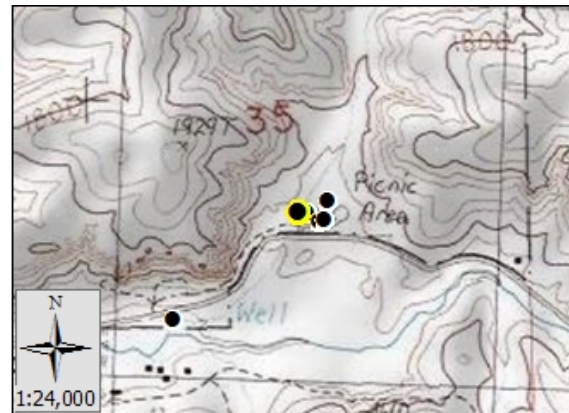
2022\_JODA\_237637\_CL BLDG Picnic Shelter 1\_Front.jpg

**Roof Material:** Combustible or no roof  
**Siding Material:** Wood or open sided  
**Foundation:** Closed, >30in masonry exposed or N/A  
**Fences/Decks:** None or noncombustible

**Firewood:** None  
**Propane Tanks:** None  
**Water Supply:** Reliable water source nearby  
**Overhead Hazards:** No overhead hazards  
**Safety Zones:** Potential safety zone(s) in area

**Score: 63**  
**Rating: High**

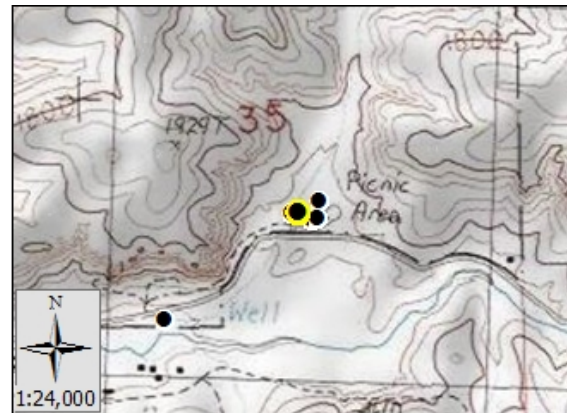
2022\_JODA\_237645\_CL BLDG Picnic Shelter 2\_Front.jpg

**Roof Material:** Combustible or no roof  
**Siding Material:** Wood or open sided  
**Foundation:** Closed, >30in masonry exposed or N/A  
**Fences/Decks:** None or noncombustible

**Firewood:** None  
**Propane Tanks:** None  
**Water Supply:** Reliable water source nearby  
**Overhead Hazards:** No overhead hazards  
**Safety Zones:** Potential safety zone(s) in area

**Score: 63**  
**Rating: High**

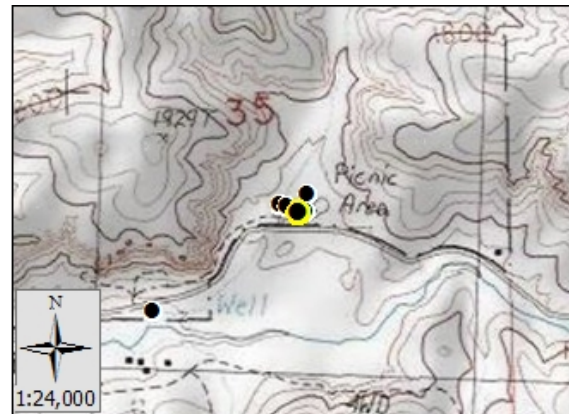
2022\_JODA\_237646\_CL BLDG Picnic Shelter 3\_Front.jpg

Foundation: Closed, >30in masonry exposed or N/A

Score: 63  
Rating: High
