# NPS Wildfire Risk Assessments Assessment Locations

## BLCA - Black Canyon Of the Gunnison National Park

# Diversion Dam Area

# NPS Wildand Fire Risk Assessment - Facility Assessment

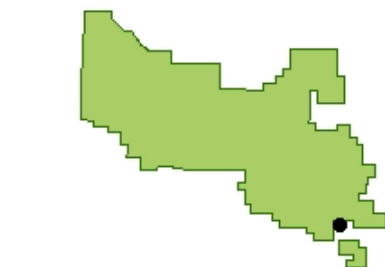
2022\_BLCA\_not found\_Caretakers Residence\_Front.jpg

**Siding Material:** Wood or open sided  
**Foundation:** Closed, < 6in masonry exposed  
**Fences/Decks:** None or noncombustible  
**Firewood:** None  
**Propane Tanks:** None

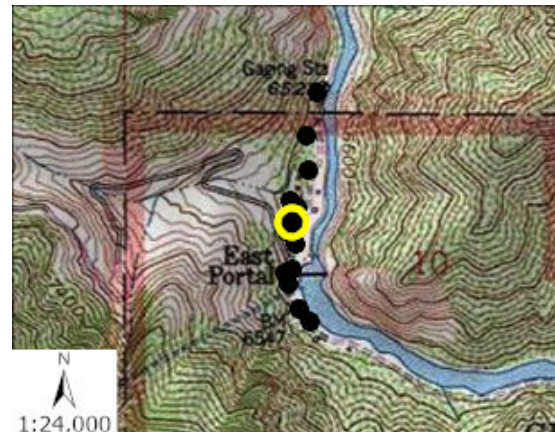
2022\_BLCA\_75184\_East Portal Garage / Storage Bldg\_Front.jpg

**Score: 61**  
**Rating: Moderate**

**Assessment Comments:** Water Supply: River is right there. Bridge Const. Material: Wood siding. Driveway Grade: Steep road down there. Turnaround: Dead end road. Ignition Potential: Attic vents. Overhead Hazards: High wires in area.

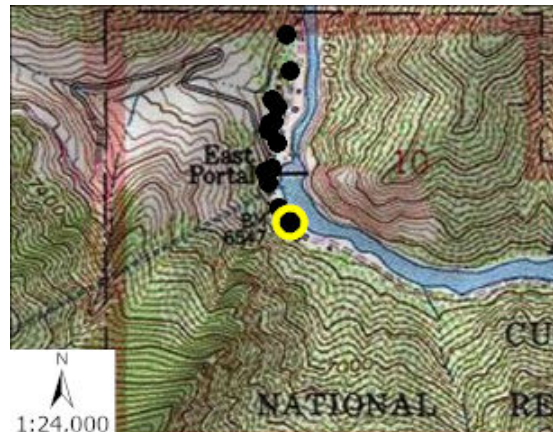
2022\_BLCA\_75198\_East Portal Picnic Area Comfort Station\_Front.jpg

**Score: 50**  
**Rating: Moderate**
