# NPS Wildfire Risk Assessments Assessment Locations

## Bent's Old Fort National Historic Site

# NPS Wildand Fire Risk Assessment - Facility Wildfire Risk Assessment Summary

## Unit - Location: BEOL - Bent's Old Fort

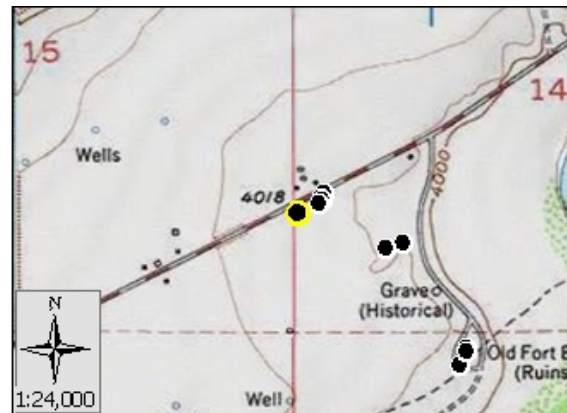
Access Condition: Surfaced-paved, grade<5%

Bridge Condition: None/nonflammable, load limit will not limit response

Foundation: Closed, >30in masonry exposed or N/A

Overhead Hazards: No overhead hazards

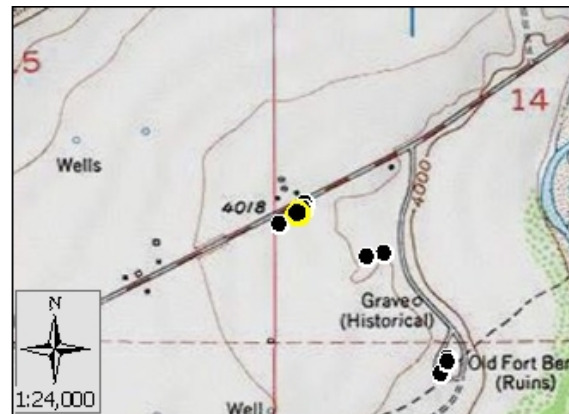
Access Condition: Surfaced-paved, grade<5%

Bridge Condition: None/nonflammable,load limit will not limit response

Foundation: Closed, >30in masonry exposed or N/A

Overhead Hazards: No overhead hazards

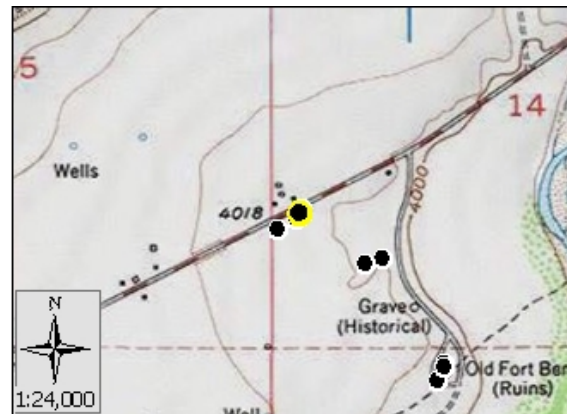
2021\_BEOL\_not found \_Shed\_Front.jpg

**Access Condition:** Surfaced-paved, grade<5%

**Bridge Condition:** None/nonflammable,load limit will not limit response

**Foundation:** Closed, >30in masonry exposed or N/A

**Overhead Hazards:** No overhead hazards

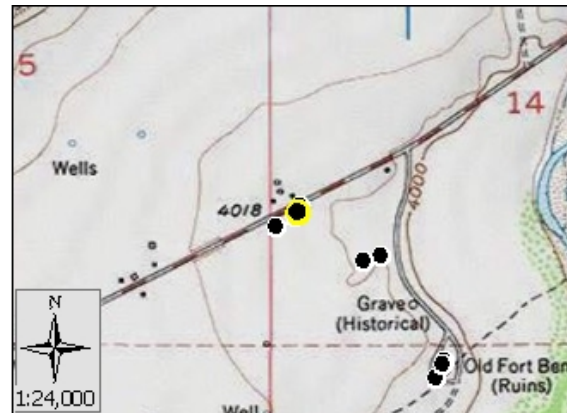
2011\_BEOL\_not found\_Shed\_Front.jpg

**Access Condition:** Surfaced-paved, grade<5%

**Bridge Condition:** None/nonflammable,load limit will not limit response

**Foundation:** Closed, >30in masonry exposed or N/A

**Overhead Hazards:** No overhead hazards

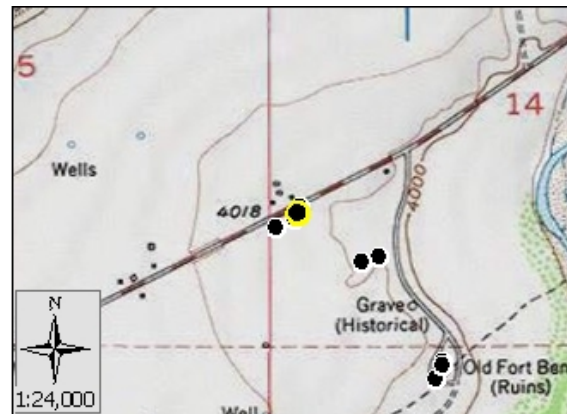
Access Condition: Surfaced-paved, grade<5%

Bridge Condition: None/nonflammable,load limit will not limit response

Foundation: Closed, >30in masonry exposed or N/A

Overhead Hazards: No overhead hazards

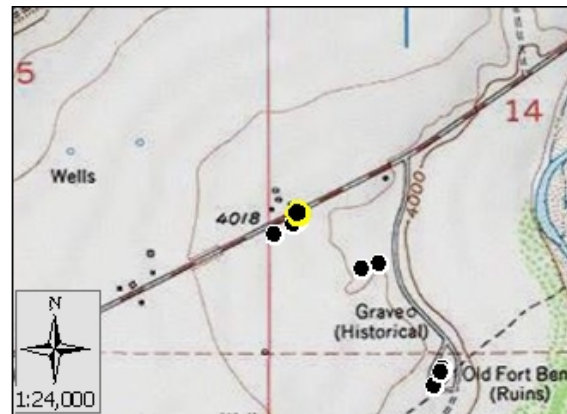
**Primary Access:** Road  
**Ingress/Egress:** Two or more roads in/out  
**Access Width:** 2 lanes (>24ft)  
**Access Condition:** Surfaced-paved, grade<5%

**Bridge Condition:** None/nonflammable,load limit will not limit response  
**Access & Turnarounds:** Access is <300 ft from facility w/turnaround  
**Facility Number/Sign:** None or not clearly visible

**Roof Material:** Fire resistant- tar,rubberized  
**Siding Material:** Rock, concrete, metal  
**Foundation:** Closed, >30in masonry exposed or N/A  
**Fences/Decks:** None or noncombustible

**Firewood:** None  
**Propane Tanks:** None  
**Water Supply:** Pressurized hydrant(s) or fixed sprinkler system  
**Overhead Hazards:** No overhead hazards

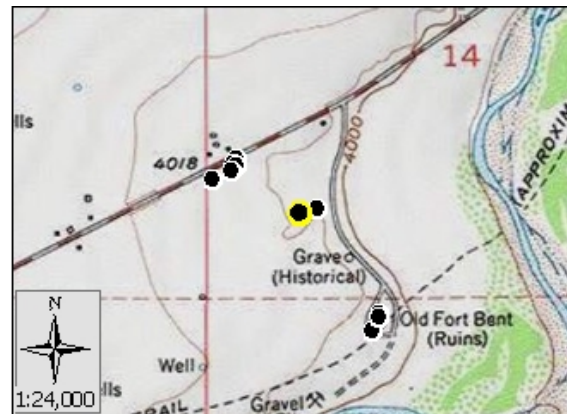
Access Condition: Surfaced-paved, grade<5%

Bridge Condition: None/nonflammable,load limit will not limit response

Foundation: Closed, >30in masonry exposed or N/A

Overhead Hazards: No overhead hazards

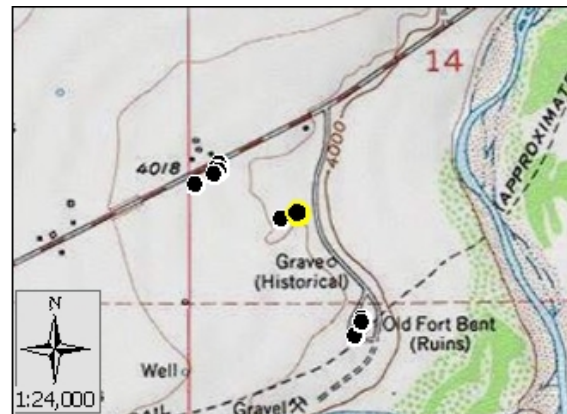
**Primary Access:** Road  
**Ingress/Egress:** Two or more roads in/out  
**Access Width:** 2 lanes (>24ft)  
**Access Condition:** Surfaced-paved, grade<5%

**Bridge Condition:** None/nonflammable,load limit will not limit response  
**Access & Turnarounds:** Access is <300 ft from facility w/turnaround  
**Facility Number/Sign:** None or not clearly visible
