# Golden Spike National Historical Park

## GOSP - Golden Spike National Historic Site

# NPS Wildland Fire Risk Assessment - Facility Assessment

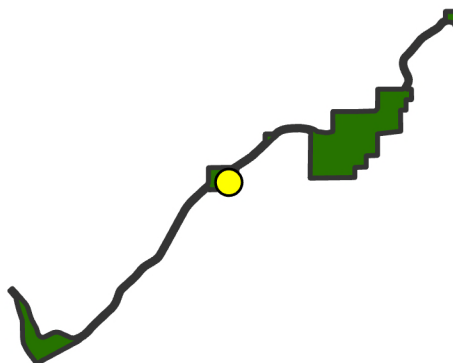
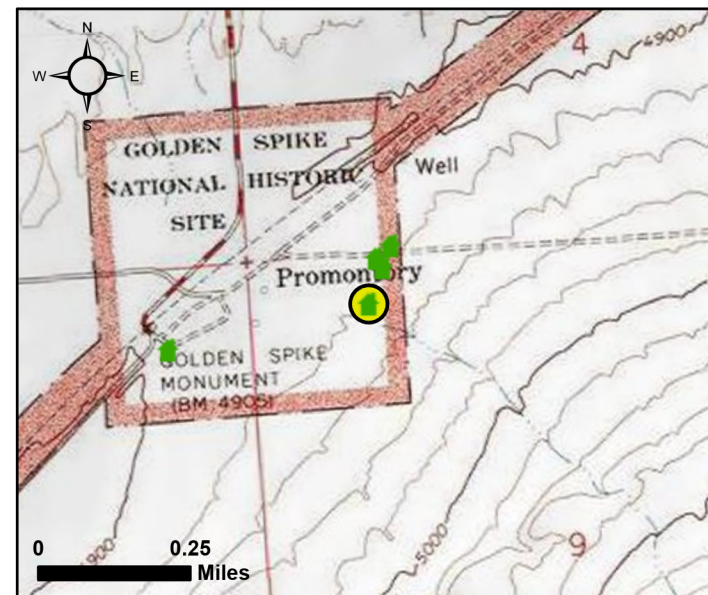
**Primary Access:** Road  
**Ingress Egress:** 2 or more roads in/out  
**Access Width:** 2 lanes (Greater than 24')  
**Access Condition:** Surfaced-paved, gradeLess than 5%  
**Bridge Condition:** Less than 300 ft with turnaround  
**Access and Turnarounds:** Less than 300 ft with turnaround  
**Facility Number or Sign:** None or not clearly visible  
**Fuel Type:** Grass and shrub, hardwood litter  
**Fuel Load:** Moderate  
**Defensible Space:** 30 ft treated  
**Topography:** Slope Less than 5%  
**Roof Material:** Noncombustible or not applicable  
**Siding Material:** Wood or open sided  
**Foundation:** Closed, 6in to 30in masonry exposed  
**Firewood:** None  
**Water Supply:** Pressurized hydrant(s) or fixed sprinkler system  
**Propane:** Present and fuels clearance  
**Overhead Hazards:** No overhead hazards  
**Comments:** Detached garage FMSS ID 236390
