# Hydrological Interviews & Observations in Dyea, AK 2021-2024

*A Klondike Gold Rush National Historical Park – Natural Resources Management Data Record*

November, 2024

C. E. Furbish, NRM Volunteer

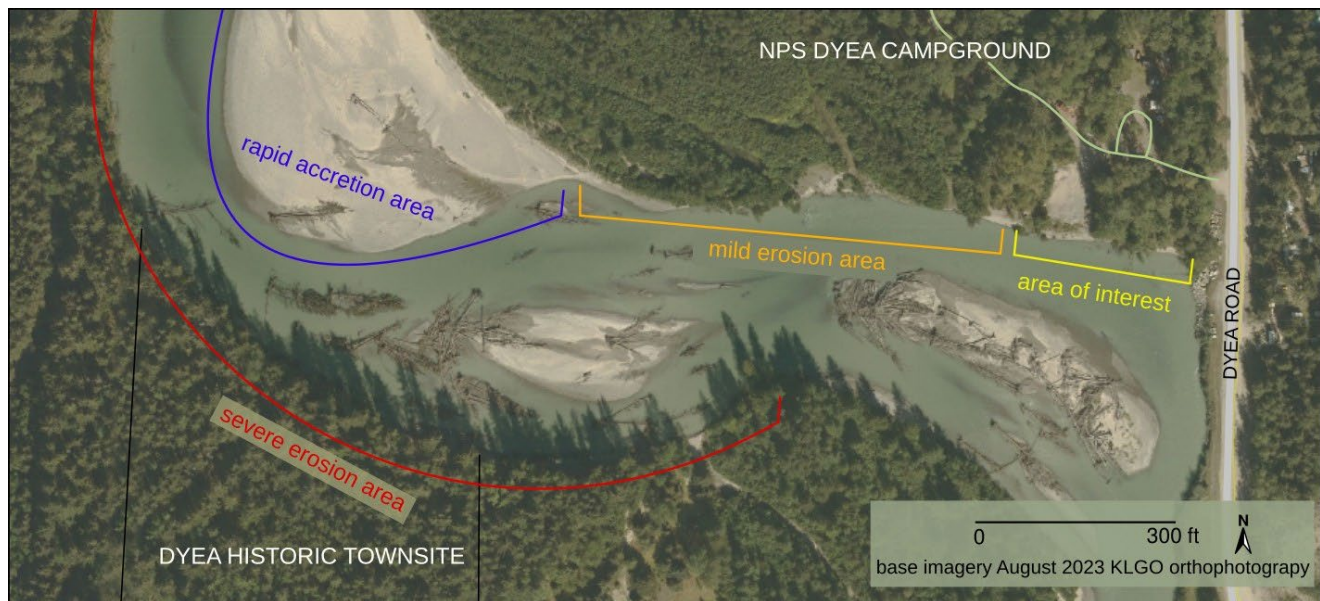
The data indicate that the western half of the “area of interest” experienced bank steepening and material loss, but not enough to remove 4 sentinel vegetative features used to track change. Mild bank erosion was discernable in the eastern half of the area of interest. In the “mild erosion area” to the west, where 2 relic river channels connect with the main channel, shoreline recession and bank erosion was observed but not tracked. However, the overall extent of shoreline change in that vicinity was mild compared to the severe erosion and rapid accretion change areas further west.

In summary, the time period of this photo record included a high frequency of flood events and the most severe flood since 1967. However, the record shows that no substantial erosion occurred at the shoreline area of interest from 2021 to 2024.

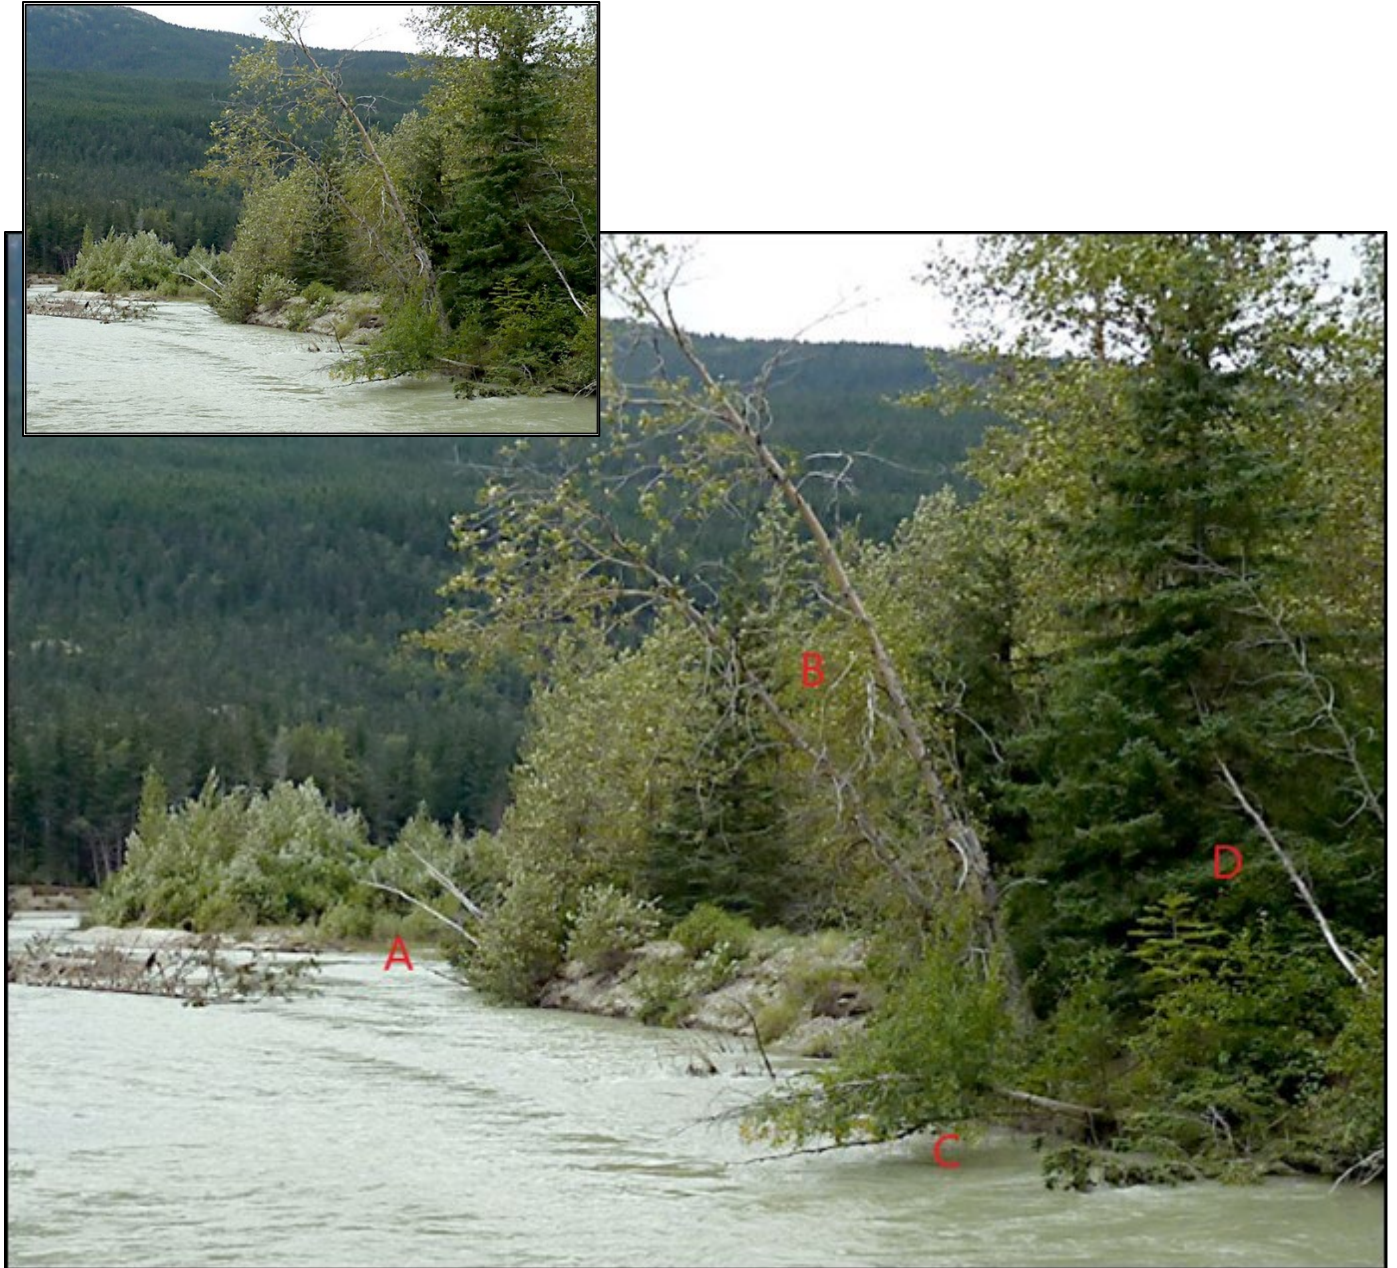
**Example of photo record tracked features, view point and digital zoom** – the photos in this record are of high resolution, allowing digital zoom to view details. If you are reading a printed version of this document, please obtain the digital version to see this effect.

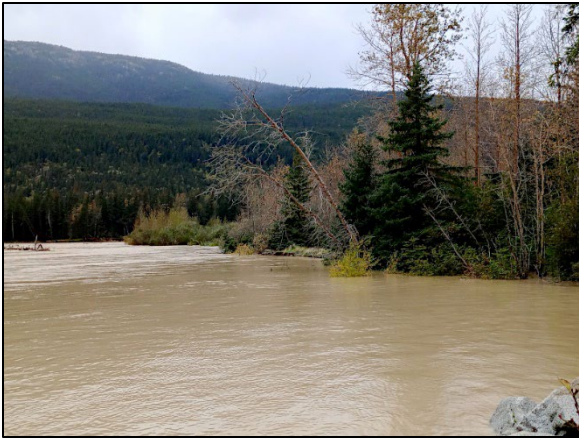
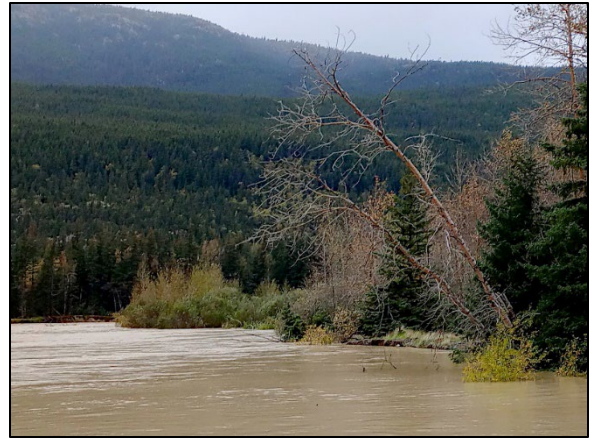
2022 sept 26  
at 5pm  
(near peak flow)

----- 18.84 ft on 09/26/2022 -----

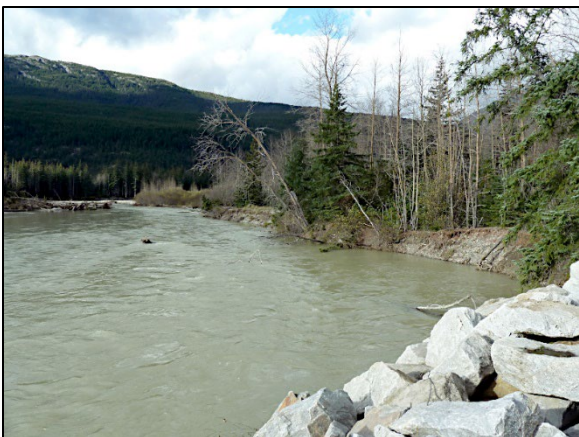
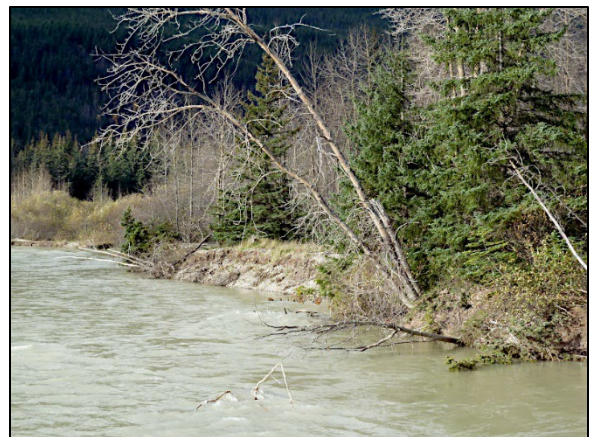
2022 october 16

----- 20.11 ft on 10/13/2022 -----

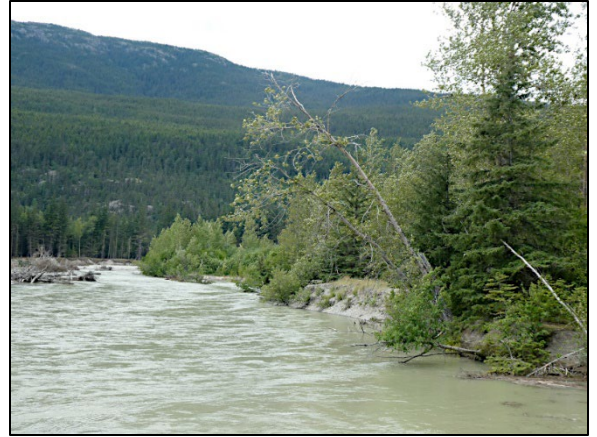
2024 june 30

2024 october 19 – site visit: all 4 vegetative features were still present.

Between the features:  
some material removed, berm steeper.

Within area of interest, to the east of the features and the road:  
some material removed.

To the west of the area of interest (away from the road) past the indicator features, in front of a picnic area, and including the mouths of two intermittentl-flowing creeks formed from relic river channels:  
some material removed, berm steeper, shore receded near creek mouths.

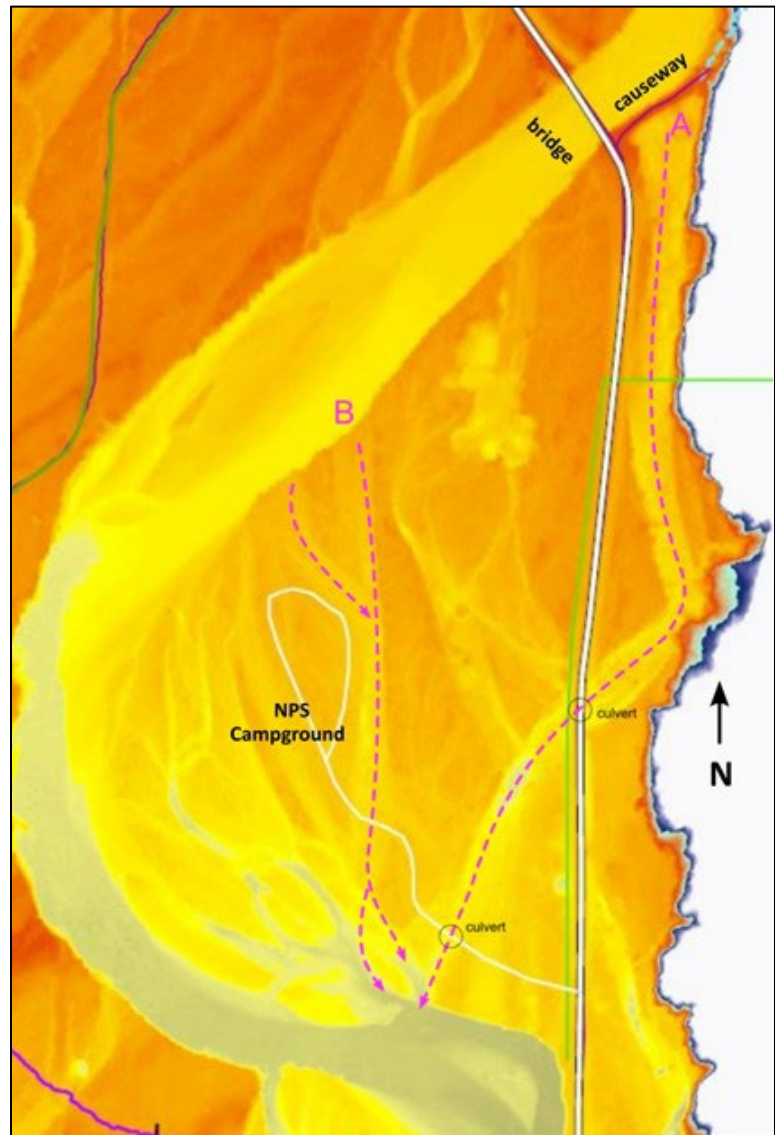
NPS Dyea campground area map of relic river channels.

Orientation map: NPS campground entrance area and the two relic river channels that most often activate during flood events (dashed pink lines). Base imagery is 2003 lidar land-water surface elevation, with color ramp from gray (low elevation) to yellow-orange-red (higher elevation).

Channel A is cut off from the river at the causeway near the bridge, passes under a large culvert at Dyea Road, and passes under a small culvert at the campground road.

During rapid, higher level flood events, both channels will initially backfill with muddy water from the main river channel near the campground entrance. Groundwater and hillside runoff will later develop enough head to push against the backfill. Eventually, as river levels drop, the channels will drain with clear water.

During very high flood events, channel B as well as all other remnant channels except channel A, may experience direct inflow from the river along the western berm from the bridge to the point bar. All of the low channels west of Dyea Road, including the pond complex at the north end, showed signs that they received direct overwash flow from the river during the 20.11ft flood on 13 October 2022.

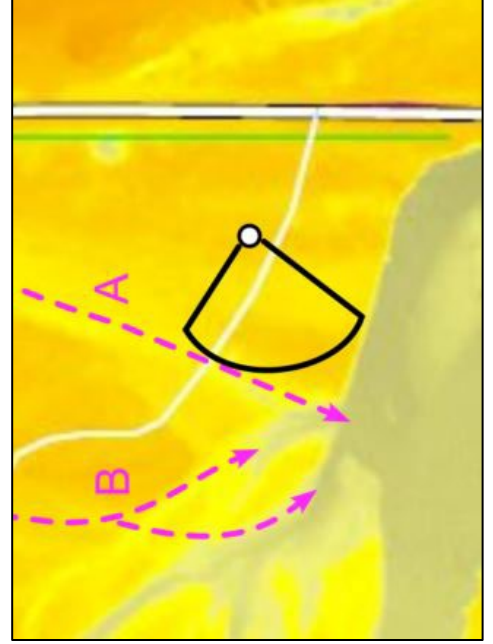
26 September 2022 flood (18.84ft) at about 5pm – near peak flow.

Muddy river flood water has entered the channels from the south, and is covering the campground road and surrounding area.

Clear water from channel A is flowing from the north and is being pushed to the east onto the campground road and the entrance parking area.
