## Large Barnum Boat House, Small Barnum Boat House, and Johns Log Cabin

### Historic Property Project Documentation and Treatment Plan

PMIS 333132A

April 2025

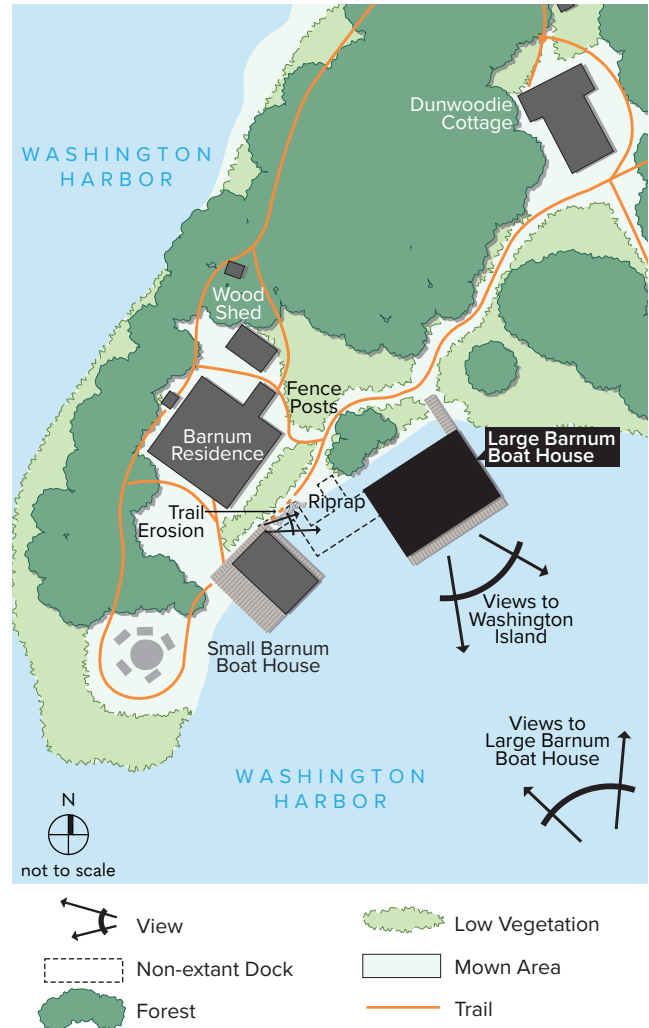
Figure 2-1. Large Barnum Boat House Cultural Landscape Condition (source: Mundus Bishop, 2024).

The site is in generally fair condition. Its condition is impacted by shoreline erosion and the establishment of a narrow, eroding trail between Large Barnum Boat House and Small Barnum Boat House.

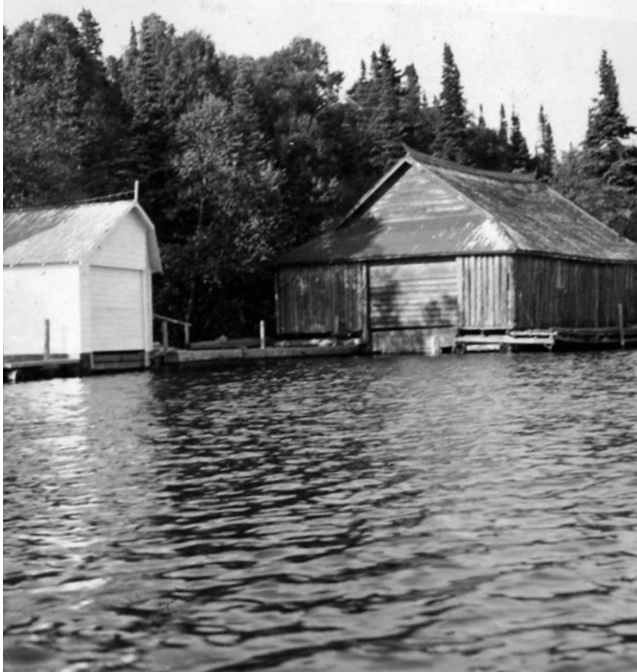
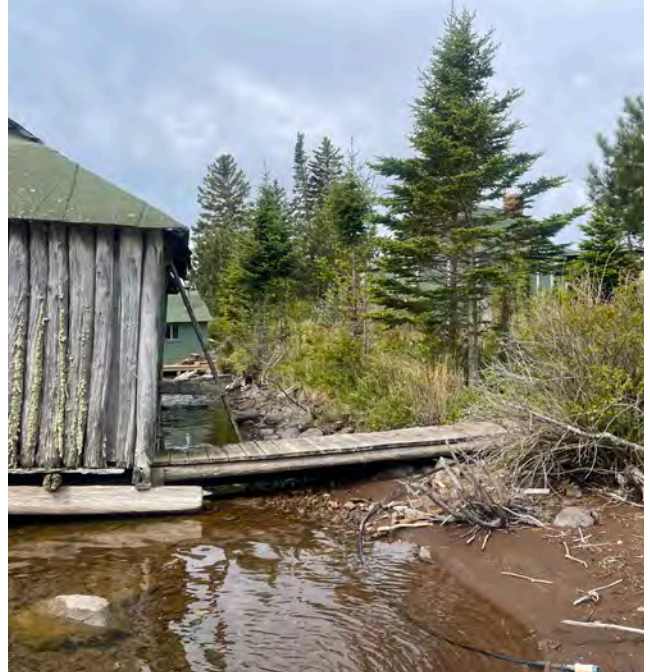
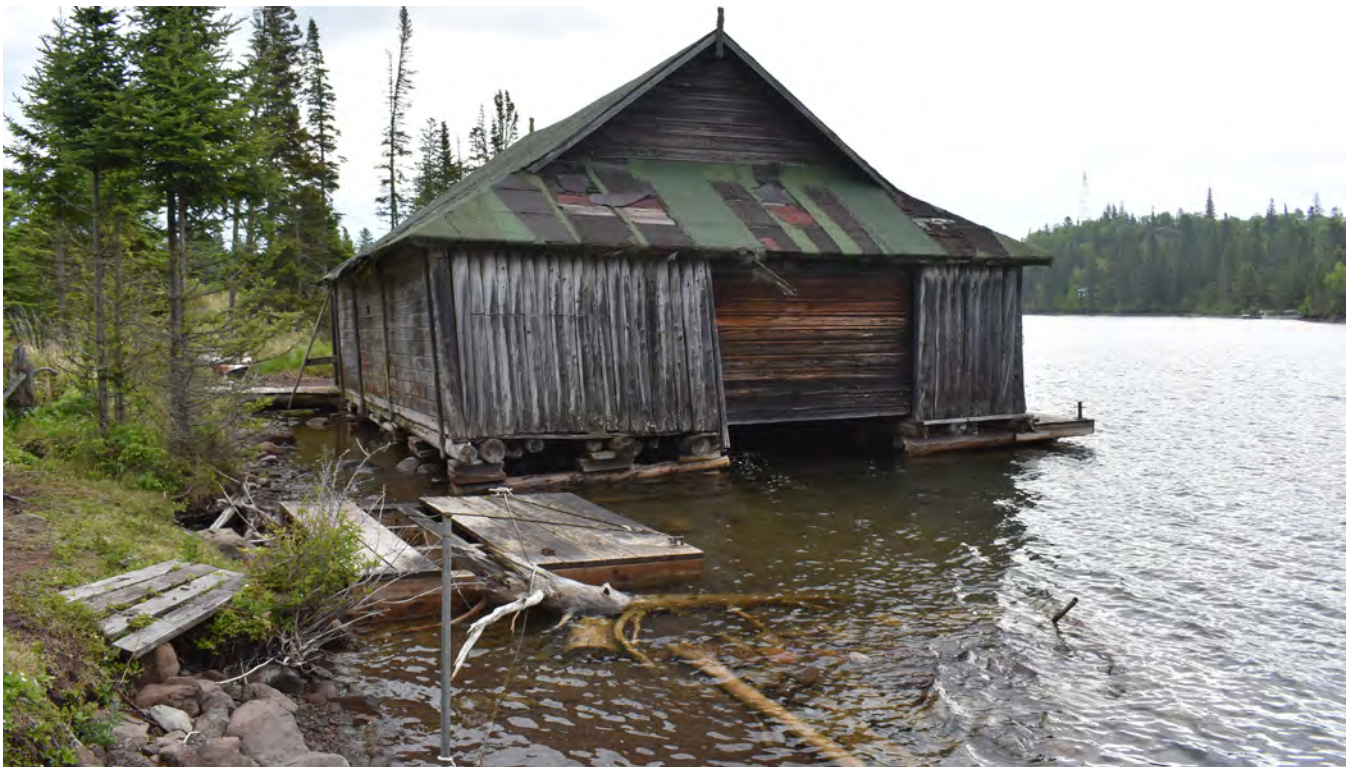
Figure 2-2. Large Barnum Boat House's spatial organization has been modified due to the removal of the original dock that once connected the two boat houses and due to the shoreline having less dense vegetation (upper left image source: ISRO Archives, 1935; upper right and bottom image source: Mundus Bishop, 2024).

- Consider riprap and native riparian vegetation for shoreline protection. Select locally sourced riprap compatible with the scale of Large Barnum Boat House. Ensure materials are of a material and color that harmonizes with the historic setting and aesthetic.

- Provide a boardwalk connection between Large Barnum Boat House and Small Barnum Boat House (re: circulation treatment).

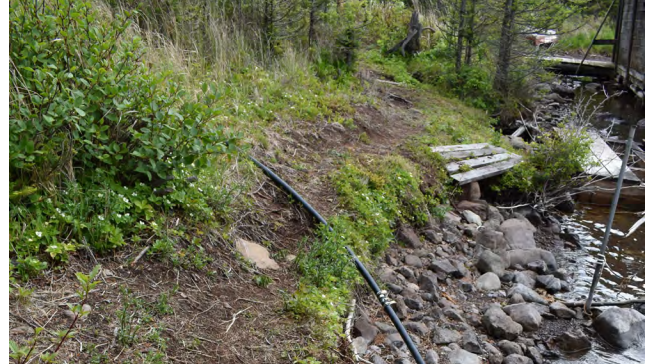
Figure 2-4. An informal trail was established after the loss of the boardwalk between Large and Small Barnum Island Boat Houses. The trail contributes to shoreline erosion (source: Mundus Bishop, 2024).

- Provide a boardwalk between Large Barnum Boat House and Small Barnum Boat House. Ensure the boardwalk does not impact the historic setting. Design the boardwalk to be compatible in scale with Large Barnum Boat House and materials are of a material and color

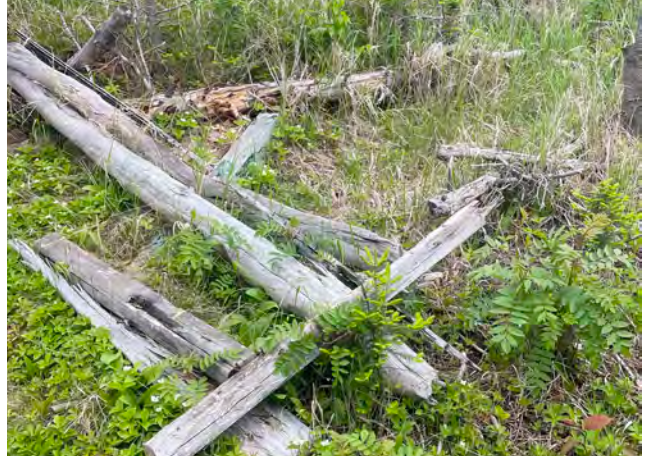
Figure 2-6. Downed fence posts north of Large Barnum Boat House (source: Mundus Bishop, 2024).

- Preserve discarded fence posts, remnants of a wheelbarrow, and other materials associated with the boat houses and surrounding cottages.
- Allow infrastructure needed to support storage and visitor day uses, including signage and interpretive information. Ensure infrastructure is of a scale, material, and color that harmonizes with the historic setting and aesthetic. Minimize the number of features and ensure their placement does not detract from the historic setting, is subordinate to Large Barnum Boat House, and does not diminish or obstruct historic views or relationships between features.

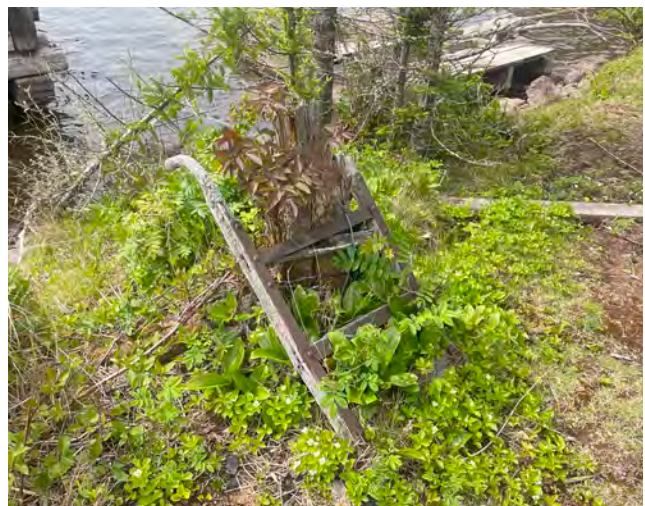
Figure 2-7. Remnants of a wheelbarrow north of Large Barnum Boat House (source: Mundus Bishop, 2024).

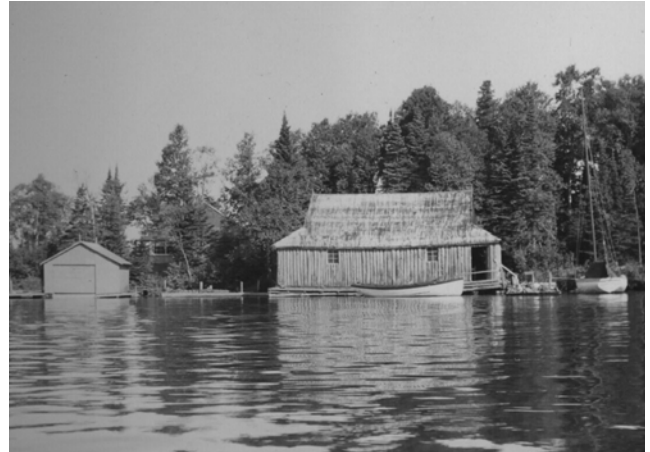
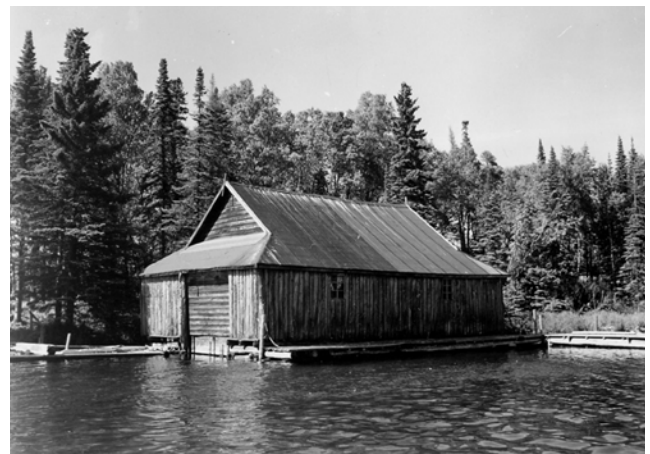
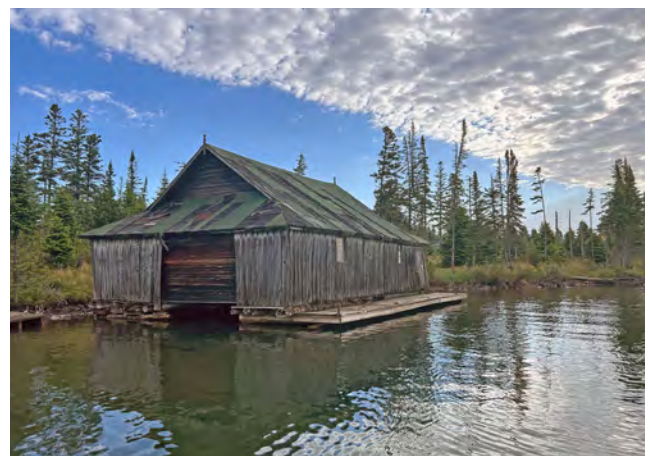
Figure 2-8. Historic patterns have been modified by changes in the extent and density of vegetation along the shoreline of Barnum Island (top image source: <https://www.isleroyalefamilies.org/archive/archive0606.htm>, undated; middle image source: ISRO Archives, 1952; bottom image source: Mundus Bishop, 2024).

- Consider establishing native riparian plant species to stabilize the shoreline, prevent erosion, and prevent the establishment of invasive species.
- Consider maintaining a 10' fire buffer clear of vegetation around Large Barnum Boat House to protect the building.
- Re-evaluate vegetation management practices periodically to incorporate the best available science, lessons learned from internal experience and external resources (NPS, USFWS, other jurisdictions, etc.), and new weather change research, trends, and mitigation strategies.

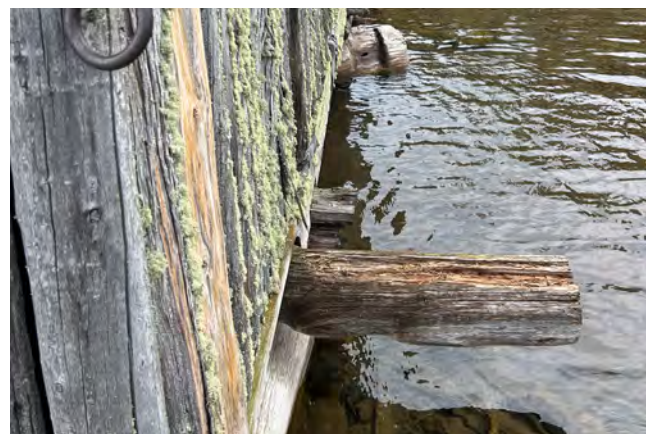
Figure 2-15. Lichen and bio-growth on west exterior wall (source: Anderson Hallas, 2024).

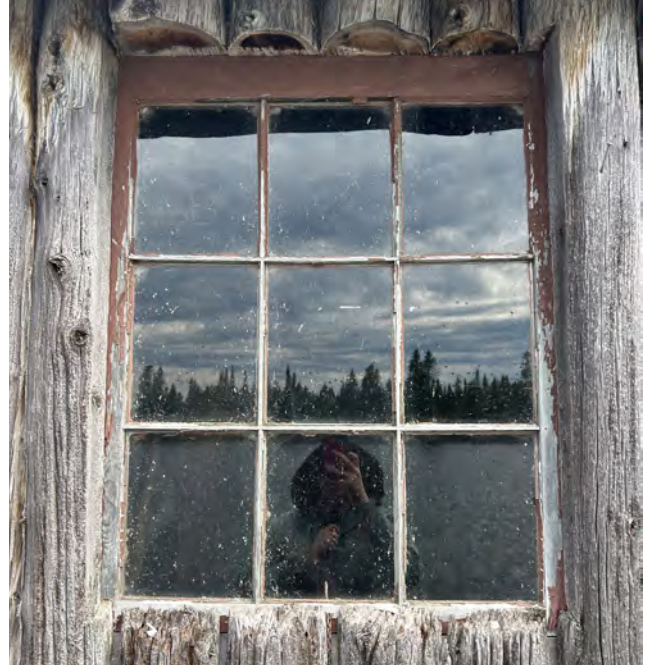
Figure 2-16. Window exterior on south façade (source: Anderson Hallas, 2024).

Rehabilitate the window, cleaning glazing, replacing all glazing putty, and repainting the sash. Apply high quality latex primer and topcoats. Conduct a historic paint analysis to determine appropriate paint selection.

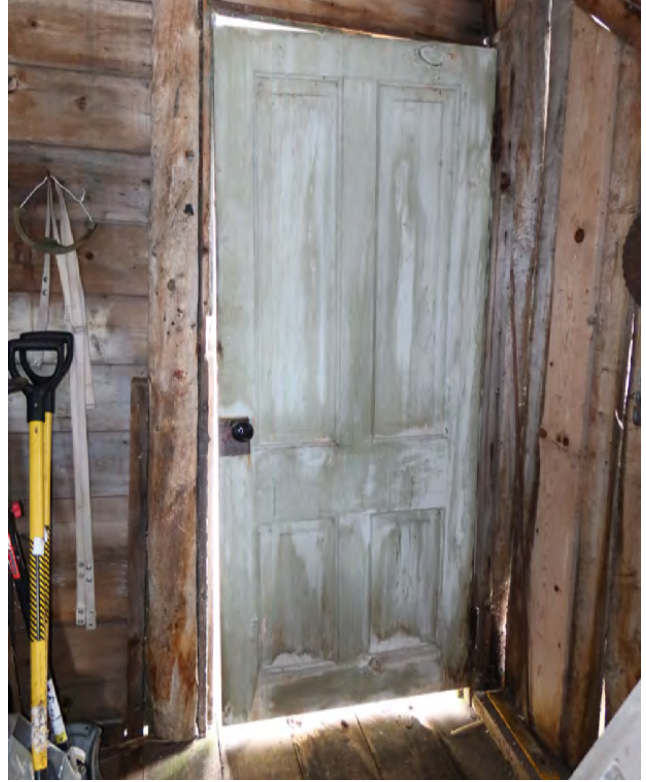
Figure 2-17. North door, interior face (source: Anderson Hallas, 2024).

At the north door, provide a full rehabilitation of the door, including replacement of deteriorated wood near the base and expansion to achieve ABAAS minimum clear width. Expand the door and opening two inches to provide 32 inch clear width. Currently, level change at the threshold is one to two inches. Replace exterior decking at an increased elevation to match the finish

floor at the entry. Visitor access should be limited to the northeast corner of the space where floor is level. Non-permanent stanchions are recommended for delineating extent of visitor access without impacting historic material.

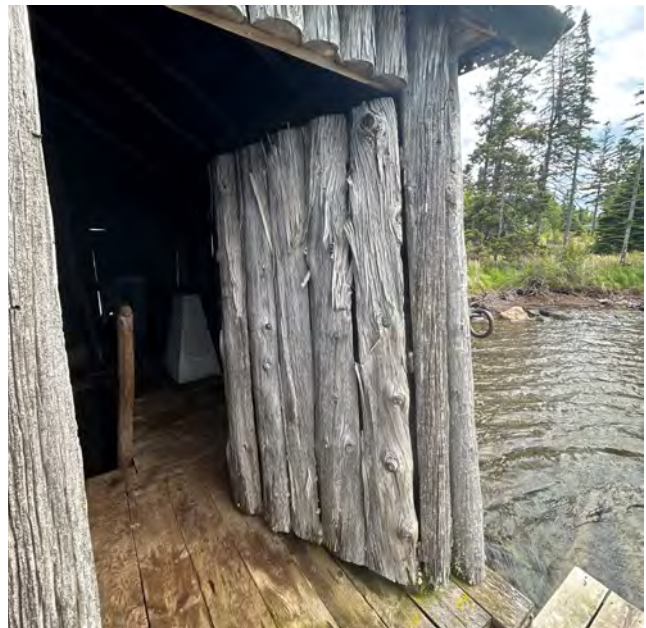
Figure 2-18. South door (source: Anderson Hallas, 2024).

Rehabilitate both doors. The following treatment includes recommendations for providing ABAAS-compliant entry at the north door.

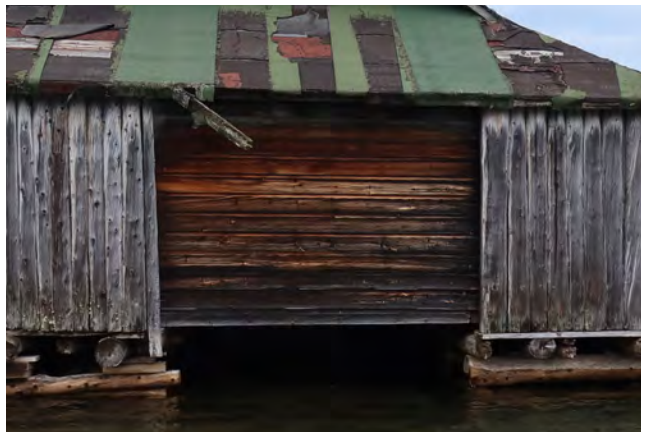
Figure 2-20. Boat door on west façade (source: Anderson Hallas, 2024).

Oil the hardware to improve operation. Provide an in-kind replacement of significantly weathered exterior boards towards the base of the door (assume 3 boards replaced).

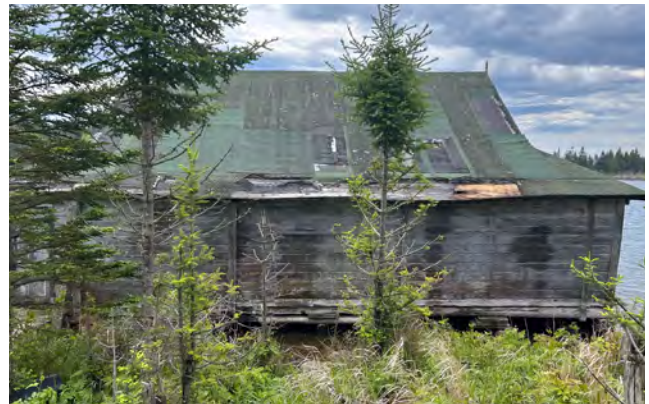
Missing roof covering, particularly above the north wall, has led to water infiltration, deterioration of sheathing, and deterioration of wood elements below. Overhanging roof covering at the eaves is in poor condition with wrinkles and tears.

Figure 2-23. Roofing covering missing at north eave (source: Anderson Hallas, 2024).

Replace the roofing assembly in whole. Remove all roofing and associated underlayments and accessories (refer to Structural Roof Construction Treatment Guidance for treatment of exposed rafters and new plywood sheathing).

Replace the current roofing with a cedar shingle assembly.<sup>2.2</sup> Provide a cedar breather layer for improved ventilation over the sheathing. Provide ice and water shield for eave protection, changes in roof pitch, and at wall-to-roof connections at the gable ends. New roof flashing is essential. Provide prefinished metal drip edge flashings at eave and rake. Install assembly in accordance with guidance provided by the Cedar Shingle and Shake Bureau (CSSB). Two options for treated shingles include the following.

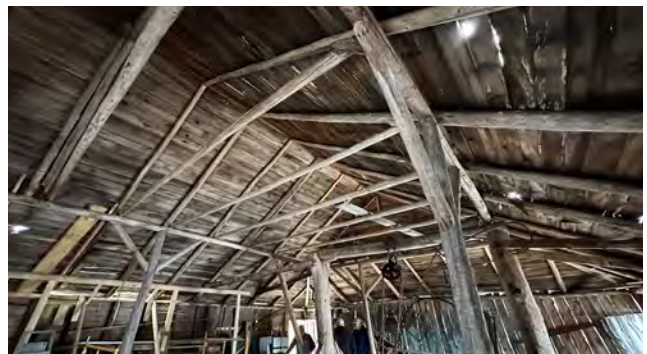
Roof framing is in poor condition. The existing roofing system has failed in many places, allowing direct access of the elements to the framing members. The roof structure is showing signs of distress such as deterioration, rafter deflection, and ridge sagging. The majority of the 1x board roof sheathing is significantly deteriorated with the worst conditions at the eaves and the southern pitch of the roof. The roof framing members are significantly overstressed and could not withstand code required snow loads. They will require comprehensive strengthening particularly if the building will be available for winter use. Multiple log rafters are fractured, and others were previously sistered with new framing.

Figure 2-31. Roof framing (source: JVA, 2024).

Replace undersized roof beams (assume 2 full-length 8" diameter logs for estimating purposes).

Install rafter ties where missing (assume 2 rafter ties for estimating purposes).

Replace deteriorated board sheathing in kind (assume 1000 SF  $\pm$  10% for estimating purposes).

Install a layer of panel sheathing atop the existing board sheathing (assume 1400 SF  $\pm$  10% for estimating purposes).

Provide adequate anchorage from the roof framing to the wall framing (assume cold formed steel clips at each roof rafter, as well as gable walls, 50 clips  $\pm$  10% for estimating purposes).

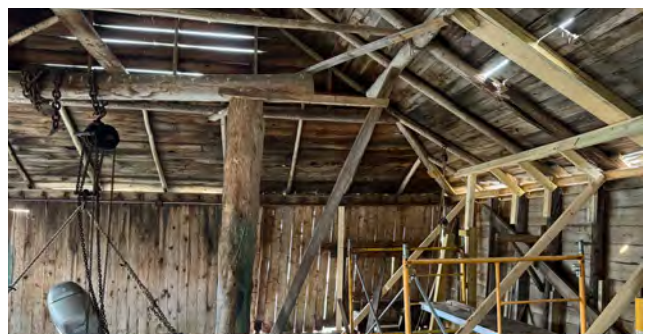
Figure 2-32. Broken rafters and shoring (source: JVA, 2024).

Replace broken rafters in kind (assume 4 rafters for estimating purposes).

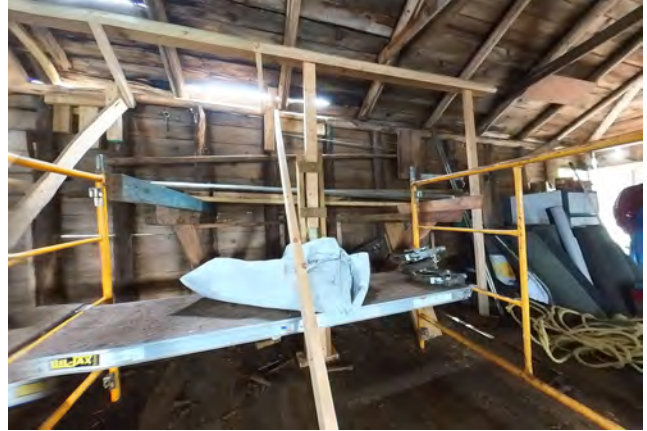
Exterior walls are in poor condition. Several of the perimeter walls are leaning and racking in different directions due to foundation movement and inadequate roof structure. Framing at the base of the walls is significantly deteriorated around the perimeter.

Figure 2-33. North wall framing (source: JVA, 2024).

Replumb walls and replace deteriorated members (assume 100% of framing at north wall and 20% at south, east, and west walls for estimating purposes).

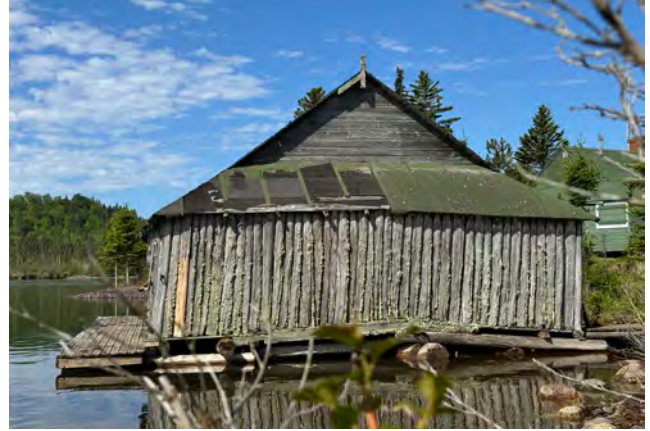
Figure 2-39. East wall elevation showing significant structural movement (source: JVA, 2024).

Add diagonal braces throughout to provide lateral stability to the structure (assume 100 linear feet for estimating purposes).

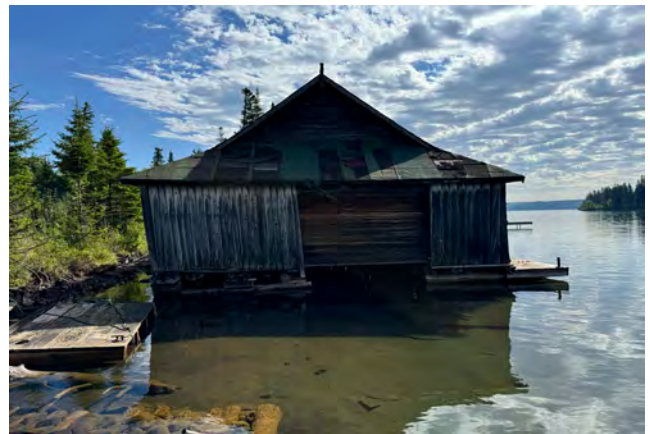
Figure 2-40. West wall elevation showing north wall leaning (source: JVA, 2024).

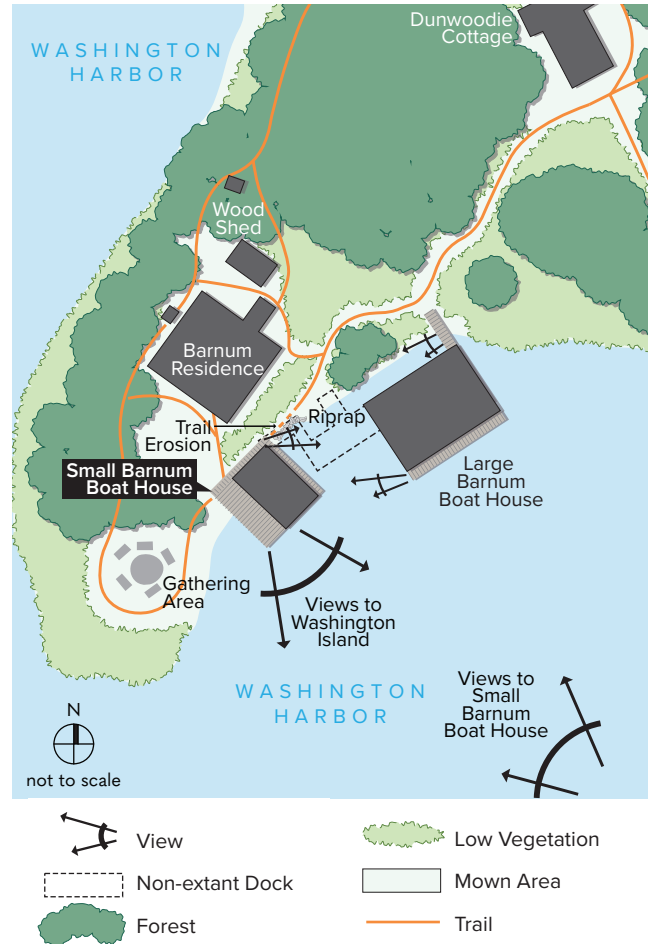
Figure 3-1. Small Barnum Boat House Cultural Landscape Condition (source: Mundus Bishop, 2024).

The site is generally in fair condition. Its condition is impacted by shoreline erosion and the establishment of a narrow, eroding trail between Large Barnum Boat House and Small Barnum Boat House.

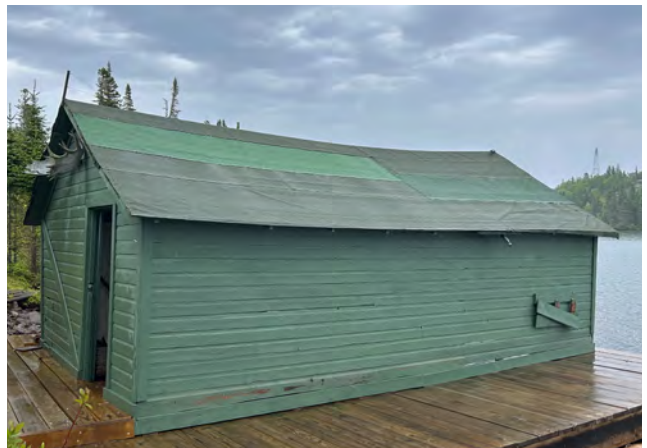
Figure 3-18. Wrinkled asphalt roll roofing, viewed from west (source: Anderson Hallas, 2024).

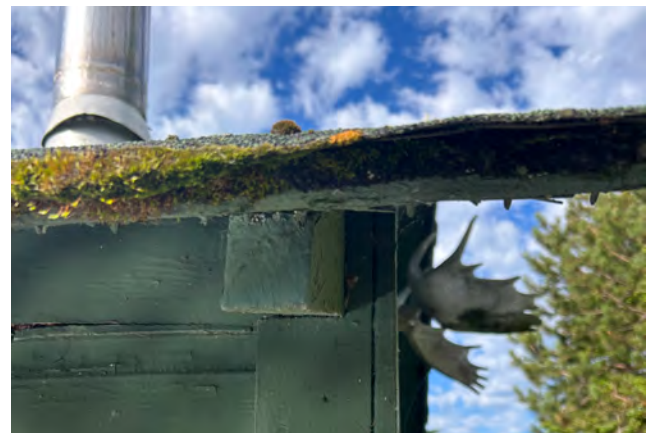
Figure 3-19. Bio-growth on sheathing at east eave (source: Anderson Hallas, 2024).

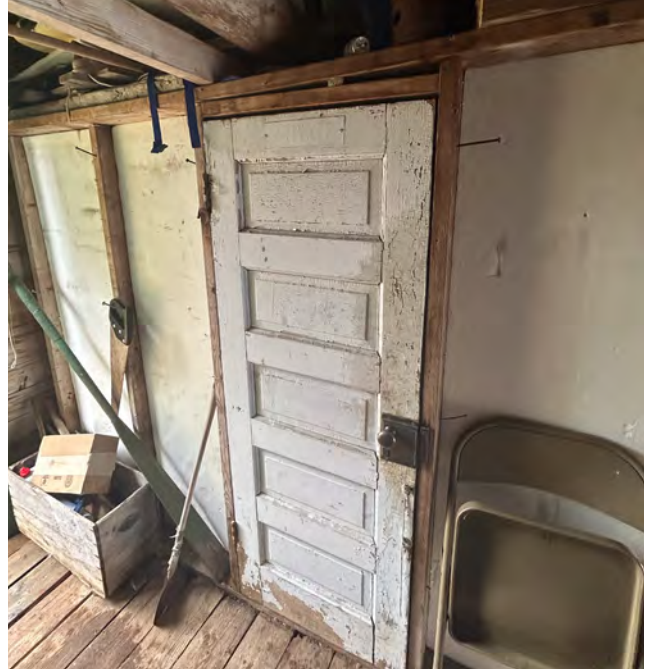
Figure 3-20. Interior door (source: Anderson Hallas, 2024).

Rehabilitate the interior door. Repair the door panel and remove the diagonal batten. Prep and repaint the door and rehabilitate hardware for smooth operation.

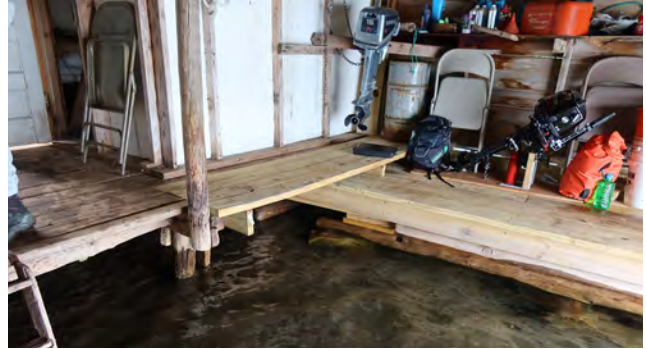
Decking is typically weathered, particularly where exposure is greatest such as near the north door or along the west side of the boat slip. Though coated with debris, the newer rubberized flooring in the sauna room is in fair condition.

Figure 3-23. Exposed floor decking; looking northwest from southeast corner (source: Anderson Hallas, 2024).

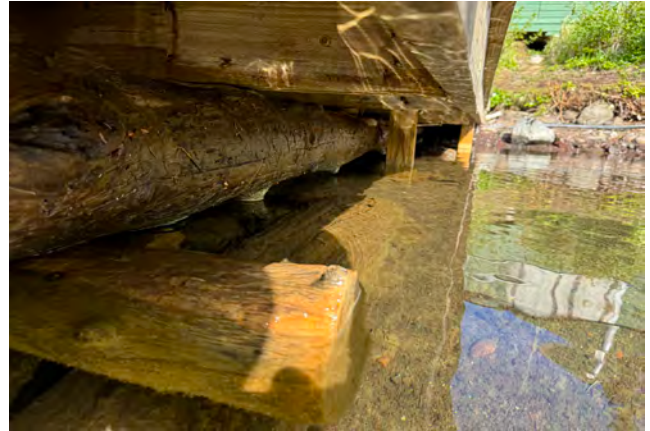
Floor framing is in overall fair to good condition with several newly reconstructed areas, mainly at the northeast and southwest. Access to areas of floor framing toward the north was limited due to the water level, however, the framing appears to consist of piecemeal repairs and likely is not adequately supported.

Figure 3-29. Dimensional-lumber floor framing on log cribs (source: JVA, 2024).

Repair/replace deteriorated floor framing members and rework irregular framing at northeast corner to verify/establish a load path to the cribs and piers (assume 10% of framing members for estimating purposes).

Provide anchorage of floor framing to the cribs with fasteners suitable for a marine environment (assume 300 fasteners for estimating purposes).

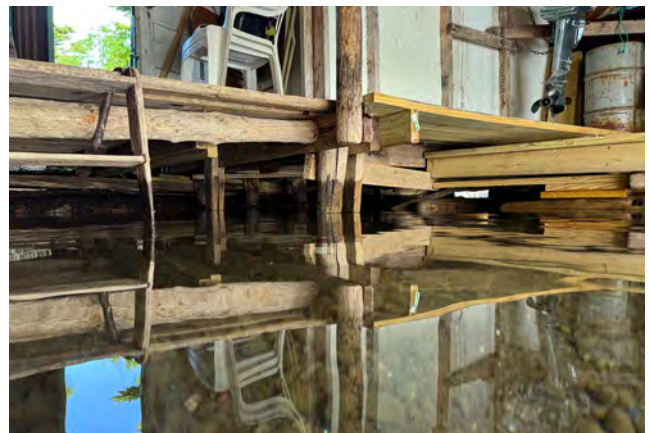
Figure 3-30. Floor framing at the north supported on cribs and posts (source: JVA, 2024).

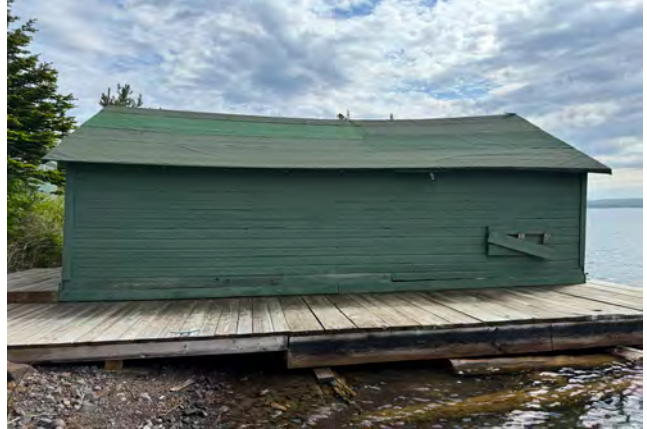
Roof framing is in poor condition. It is showing signs of distress such as rafter deflection and ridge sagging. Rafters are also significantly overstressed and could not withstand code required snow loads.

Figure 3-31. West elevation showing ridge sagging (source: JVA, 2024).

Sister all rafters and replace deteriorated portions of existing rafters (assume 20 rafters for estimating purposes).

Shore ridge to a level condition prior to adding rafter ties at each rafter pair on top of wall connected to rafter and wall top plate (assume 10 rafter ties for estimating purposes).

Install a layer of panel sheathing atop the existing board sheathing (assume 400 SF  $\pm$  10% for estimating purposes).

Provide adequate anchorage from the roof framing to the wall framing (assume cold formed steel clips at each rafter, as well as gable walls, 30 clips  $\pm$  10% for estimating purposes).

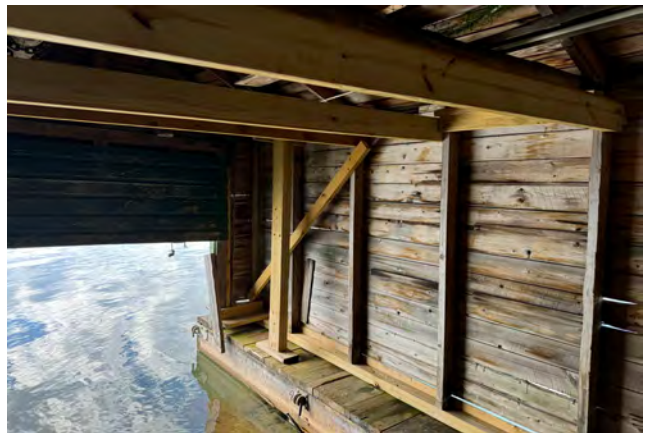
Figure 3-32. Recently installed 2x6 ties at the top of the wall framing to stabilize the roof structure (source: JVA, 2024).

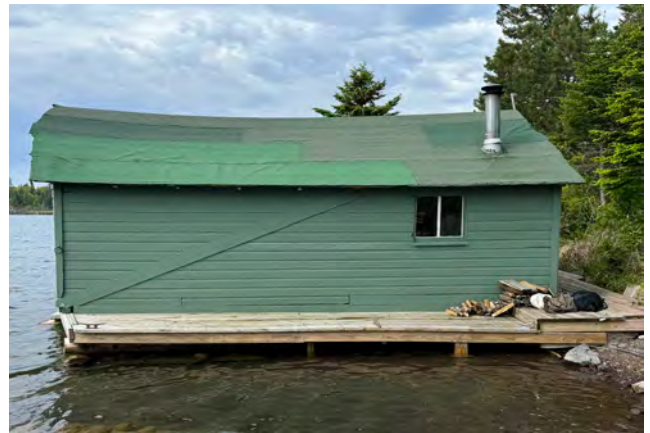
The walls are in poor to fair condition, with no major signs of wall racking or deterioration. However, the east wall is noticeably leaning toward the east due to inward foundation movement at the base and outward rafter thrust movement at the top.

Figure 3-35. East wall elevation (source: JVA, 2024).

Replumb and stabilize walls and strengthen for lateral stability. Roof and foundation treatments will aid in the stability of the wall framing.

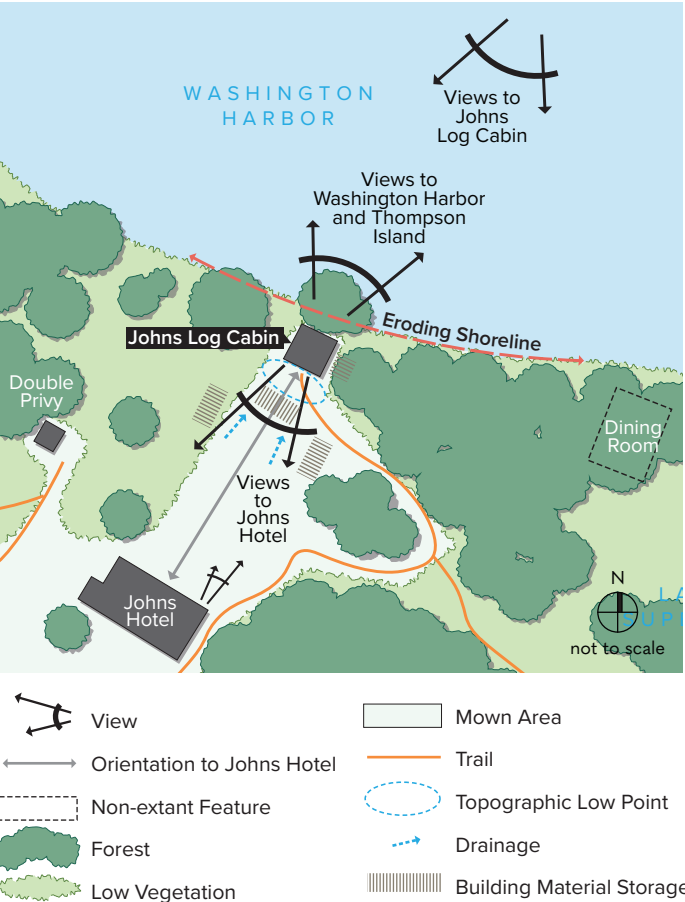
The site is generally in fair condition. Its condition is impacted by stormwater south of Johns Log Cabin. Stormwater currently flows to a low point along the south façade of the cabin. Perimeter drainage swales are needed to establish positive drainage away from the building.

Signs of past erosion are apparent along the shoreline. The lack of tension cracks, exposed soils on slopes, and the presence of vegetation are signs that erosion is not actively occurring. Undermining at the base of the shoreline could lead to a sudden failure of the slope during a storm event.

Figure 4-1. Johns Log Cabin Cultural Landscape Condition (source: Mundus Bishop, 2024).

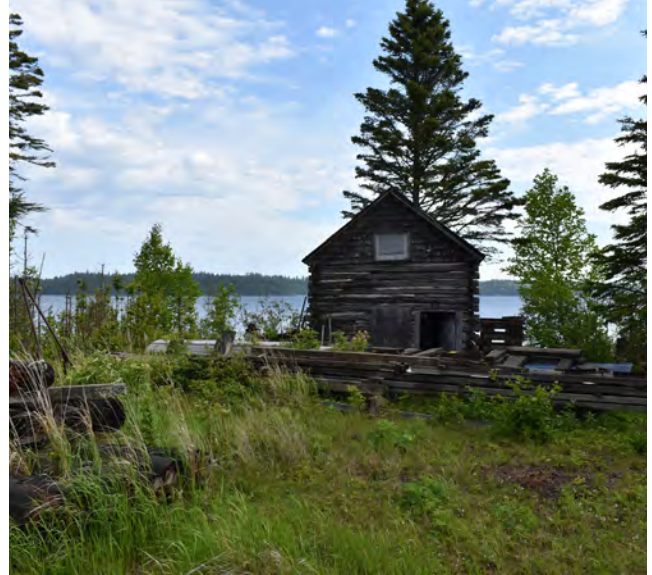
Figure 4-4. The historic setting is modified by the encroachment of vegetation into the clearing surrounding Johns Log Cabin and storage of building material (source: Mundus Bishop, 2024).

- Repair and maintain the original open clearing surrounding Johns Log Cabin. Maintain a 10' (minimum) fire buffer around the building. Allow removal of trees that present a hazard to the buildings.

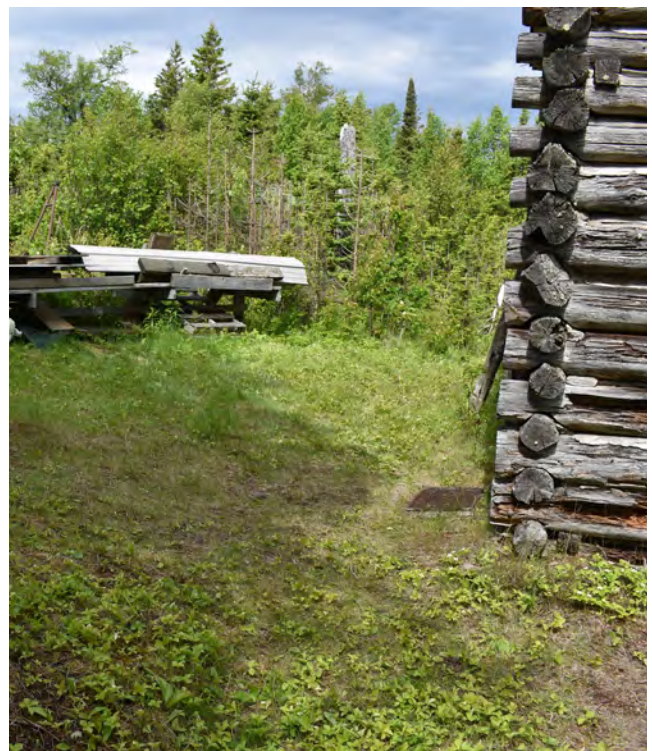
Figure 4-5. Low point along the south façade of Johns Log Cabin (source: Mundus Bishop, 2024).

- Establish and maintain positive drainage to direct surface water away from Johns Log Cabin. Ensure roof runoff is directed away from the building.
- Consider the feasibility of a future ABAAS route if docks on Barnum Island are improved for public access.

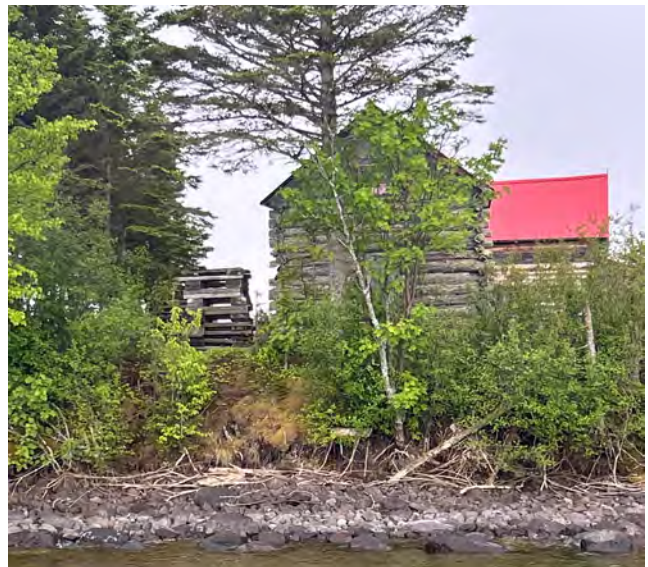
Vegetation management is needed to preserve the clearing surrounding Johns Log Cabin and views to Washington Harbor and Thompson Island. Mature trees in close proximity to Johns Log Cabin are at risk of becoming hazard trees. Trees near the top of the shoreline likely have roots stretching below the cabin that may cause significant damage to the cabin if trees fall down the slope.

Figure 4-10. Shoreline vegetation provides cliff stabilization while obstructing views from inside Johns Log Cabin to Washington Harbor and Thompson Island (source: Anderson Hallas, 2024).

- mixture of native and hardy sod-forming grasses. Allow grasses to seed periodically.
- Manage vegetation for views to and from Johns Log Cabin. Perform pruning and thinning to maintain a 10' fire buffer around the building and to prevent damage to Johns Log Cabin.
- Maintain shoreline vegetation. Consider establishing native riparian plant species to stabilize the shoreline, prevent erosion, and prevent the establishment of invasive species in areas cleared for viewshed management or fire buffers.
- Re-evaluate vegetation management practices periodically to incorporate best available science, lessons learned from internal experience and external resources (NPS, USFWS, other jurisdictions, etc.), and new weather change research, trends, and mitigation strategies.

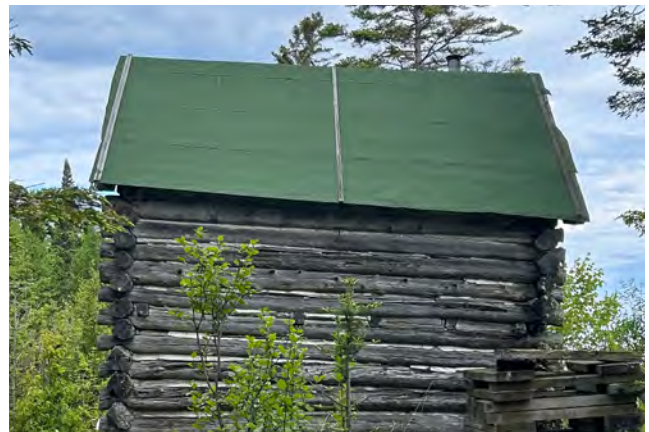
Figure 4-13. East slope of roof (source: Anderson Hallas, 2024).

A new layer of roof covering has been provided over the existing on the eastern slope but is torn at the edges, where an excessive overhang attempts to protect the wood below but is unsupported. The western slope roof covering is older and hosts biogrowth in addition to tearing at the edges.

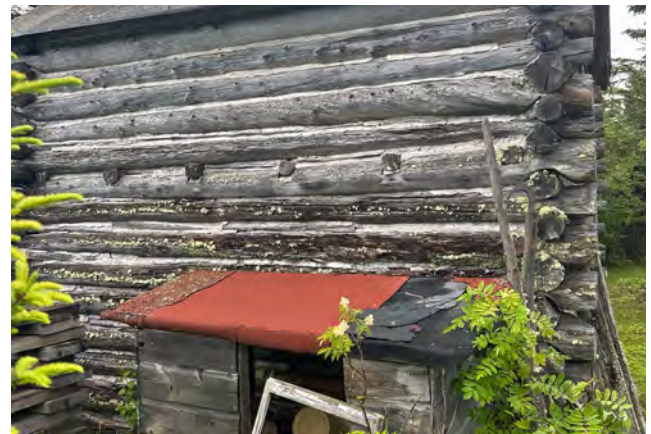
Much of the log construction is in poor condition with deteriorated logs and loose or missing wood strip fill and daubing. Extensive bio-growth was observed on the north and west façades (refer to Structural Exterior Walls section for additional analysis).

Figure 4-16. Bio-growth at west façade (source: Anderson Hallas, 2024).

Salvage wood strip fill and oakum in preparation for relocation and rehabilitation (refer to Structural Exterior Walls section for log treatment). Salvage a sample of daubing for material analysis. Provide new oakum and wood strip fill at the interior where missing (anticipate 50% replacement) and daubing over wood strips at the exterior (assume 100% replacement of daubing and exterior wood strips). New daubing should match historic in composition, color, and hardness. It is critical that daubing be no less than 1/4-inch thick at edges and sloped to drain to the exterior.

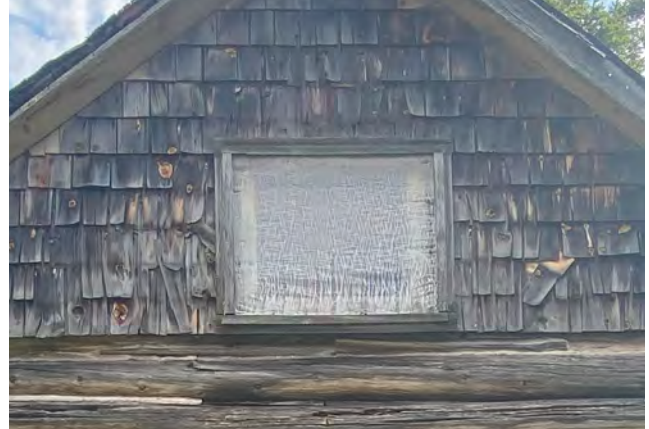
Most glazing is intact although two lites are missing from the south window on the first floor. Operability of second-floor windows was confirmed. First-floor windows could not be accessed for testing. Paint and glazing putty is cracked and partially missing. The first-floor north window is racked from structural movement, posing a risk of glazing breakage.

Figure 4-19. Second floor south window, exterior (source: Anderson Hallas, 2024).

Rehabilitation of windows to include replacement of glazing putty, squaring sash, and returning operability. Additionally, remove all loose or failing paint and provide a new latex-based primer with a latex-based topcoat. Provide new glazing where missing (two lites).

Provide new fixed exterior screens with metal insect mesh and wood frame to match historic in profile. Prep and paint wood frames with a high-quality exterior latex-based primer and topcoat. Provide new screen clips where missing (50% replacement).

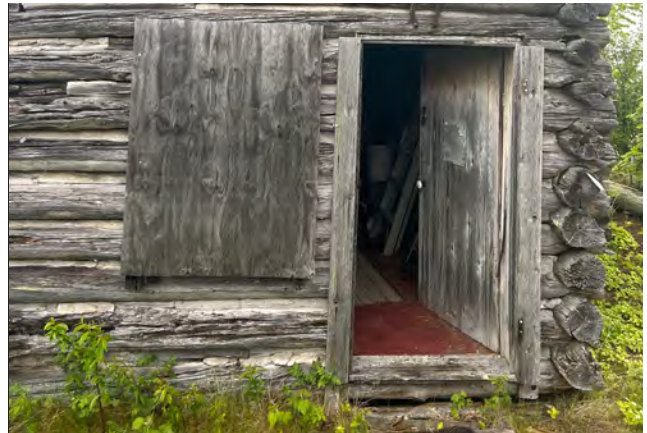
The door is operable but weathered. Without latching hardware, the door remains open unless padlocked. Hardware is rusted and wood is darkened from weather.

Figure 4-21. Entry door and boarded window at south façade (source: Anderson Hallas, 2024).

Remove and salvage the door, to be rehabilitated and reinstalled. During relocation and rehabilitation, historic log joinery for openings to be replicated. Rehabilitate hardware hinges to provide full operability. Replace existing padlock with a keyed bolt lock. Salvage the existing knob and latch and replace with an ABAAS-compliant lever latch. Color selection of new hardware (such as an aged bronze) can help to reduce visual impact. To retain the historic knob, it could be modified to remove the latch function and mounted lower or higher on the door in companion with an ABAAS-compliant lever latch.

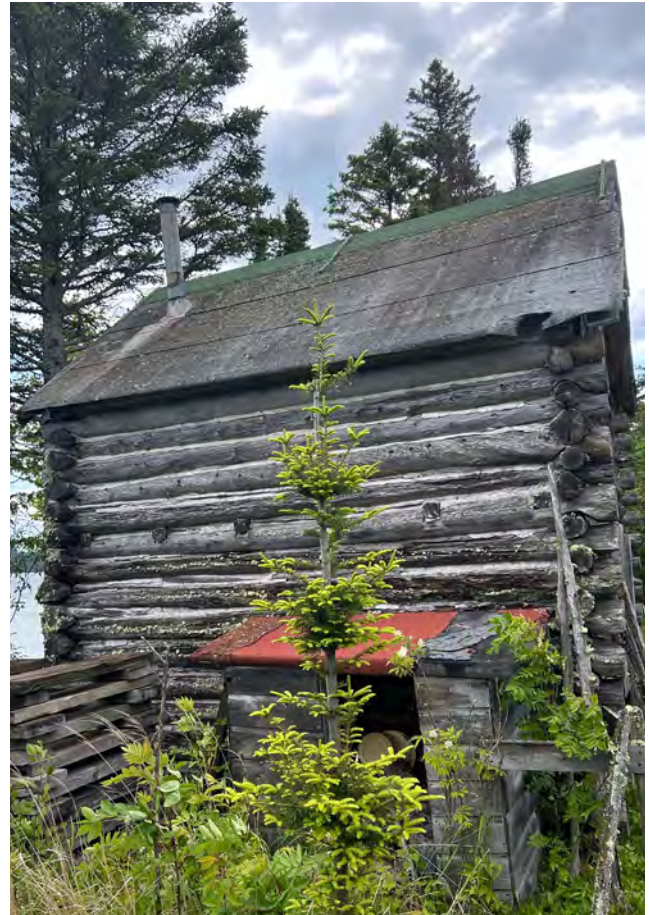
Figure 4-23. West roof slope (source: Anderson Hallas, 2024).

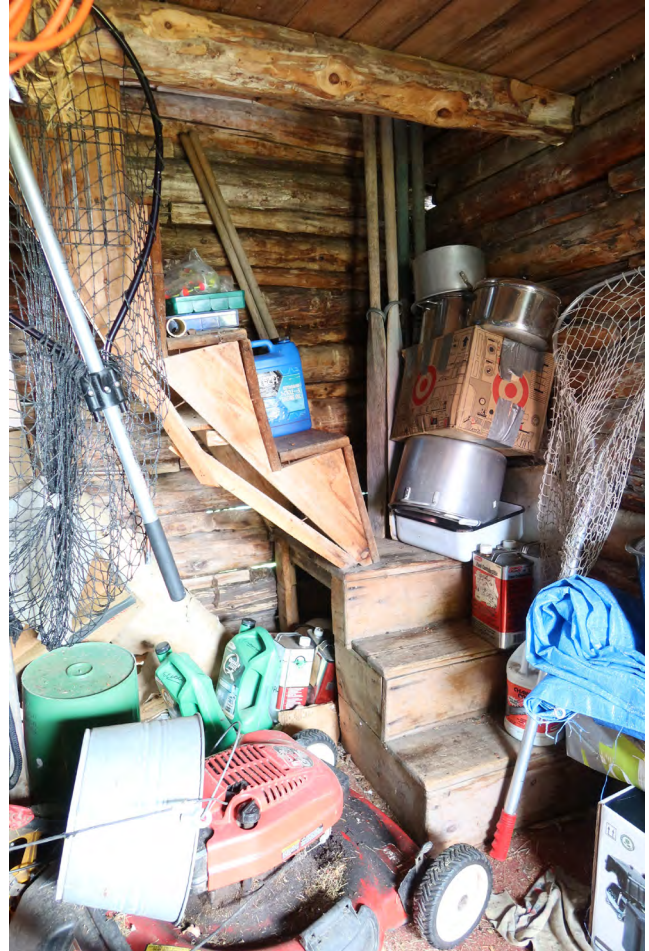
Figure 4-25. Stairs viewed from first floor (source: Anderson Hallas, 2024).

Replace broken stringers and retain the existing top run. Rebuild the bottom run and landing per IBC to act as a viewing platform of the second floor. As the top run of stairs would not be code compliant, it is recommended that public access be limited to the first floor and the bottom run of stairs.

Clean wood risers and treads. No new finish of these elements, which are currently unfinished, is recommended.

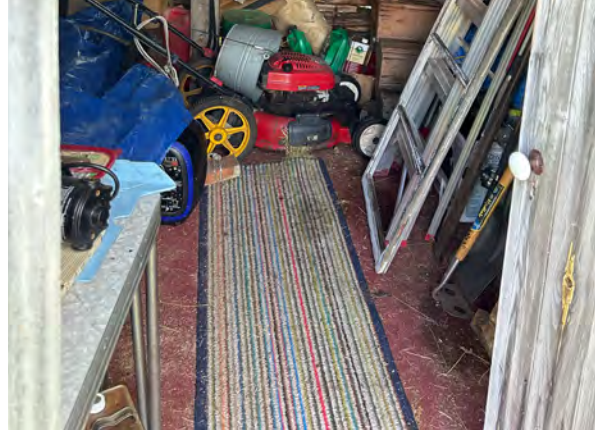
Figure 4-26. First floor carpet (source: Anderson Hallas, 2024).

Remove all carpet and stored materials. Salvage all flooring boards which do not exhibit rot or deterioration for re-installation (assume 70% salvage) and provide an in-kind replacement of remaining boards. Floorboards are currently unfinished and thus no new finish is recommended.

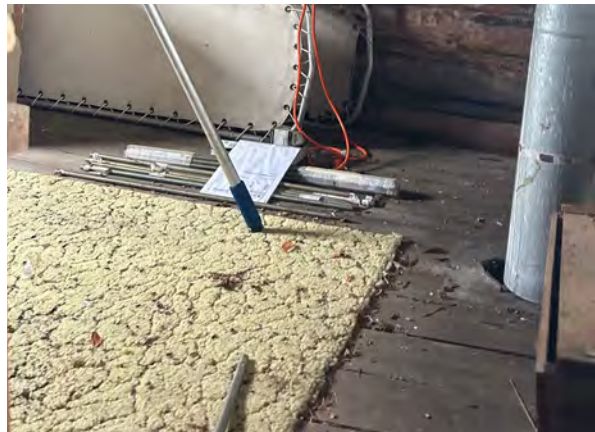
Figure 4-27. Second floor decking and carpet (source: Anderson Hallas, 2024).

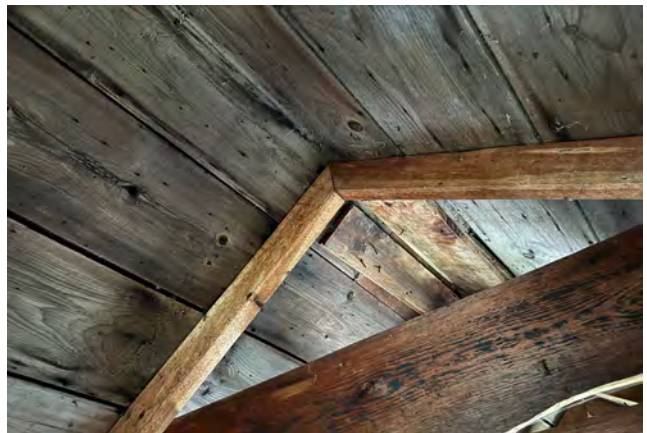
Figure 4-35. Roof rafters with a lack of ridge member (source: JVA, 2024).

Install a layer of plywood atop the existing boardsheathing (assume 180 SF  $\pm$  10% for estimating purposes).

Provide adequate anchorage from the roof framing to the wall framing (assume cold formed steel clips at each roof rafter, as well as gable walls, 20 clips  $\pm$  10% for estimating purposes).

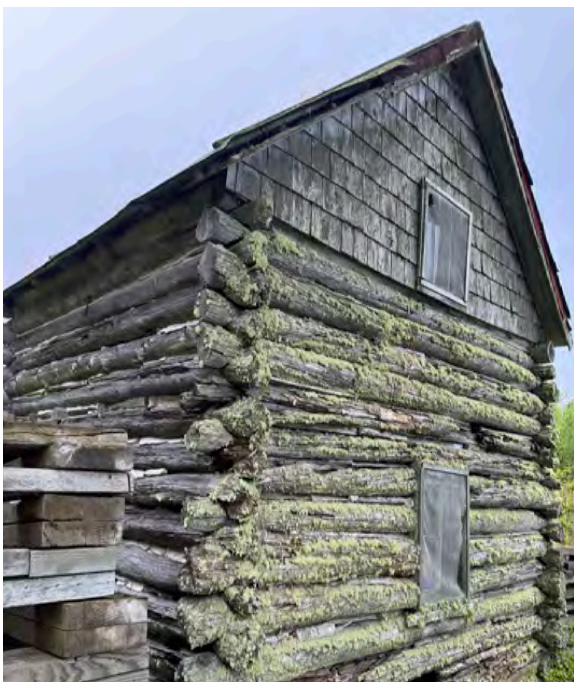
Figure 4-36. North wall elevation (source: JVA, 2024).

Disassemble structure after marking each member for reassembly. Replace deteriorated logs in kind. Verify or provide spikes or log screws between the wall logs. (assume 400 SF  $\pm$  10% for estimating purposes).

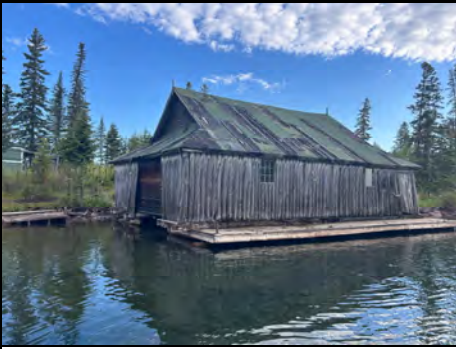
**Figure 1.** Missing and/or deteriorated roof coverings on south slope (source: Anderson Hallas, 2024).

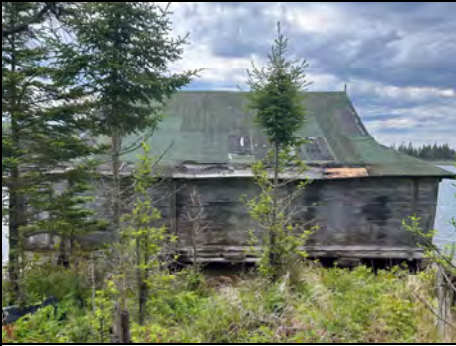
**Figure 2.** Roofing missing at north eave (source: Anderson Hallas, 2024).

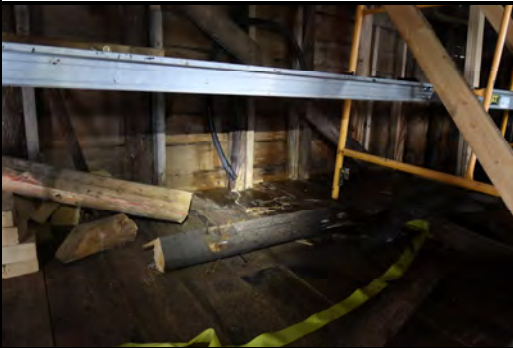
**Figure 3.** Water intrusion at base of north wall (source: Anderson Hallas, 2024).

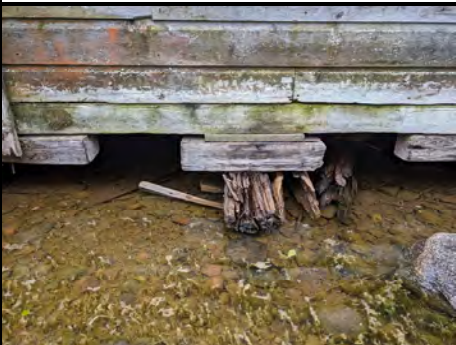
**Figure 4.** Crushed timber member (source: AMI, 2024).

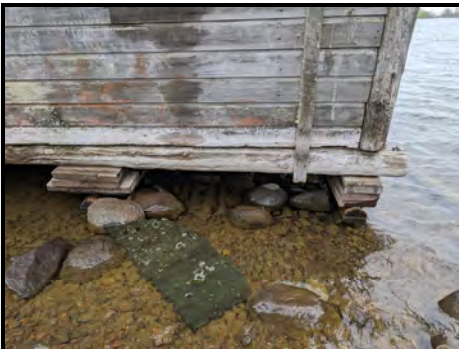
Figure 5. Tilting shims and loss of rock ballast (source: AMI, 2024).

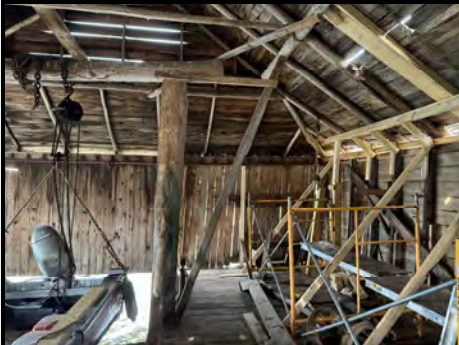
Figure 6. Broken rafters and shoring (source: JVA, 2024).
