## Large Barnum Boat House, Small Barnum Boat House, and Johns Log Cabin

### Historic Property Project Documentation and Treatment Plan

PMIS 333132A

April 2025

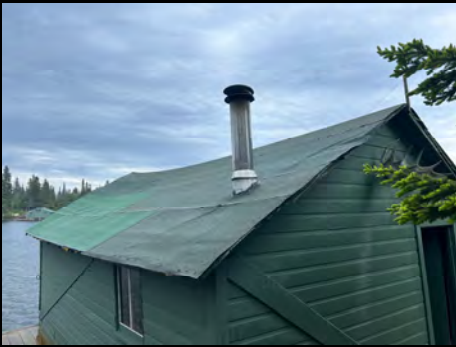
**Figure 1.** Wrinkled asphalt roll roofing, viewed from east (source: Anderson Hallas, 2024).

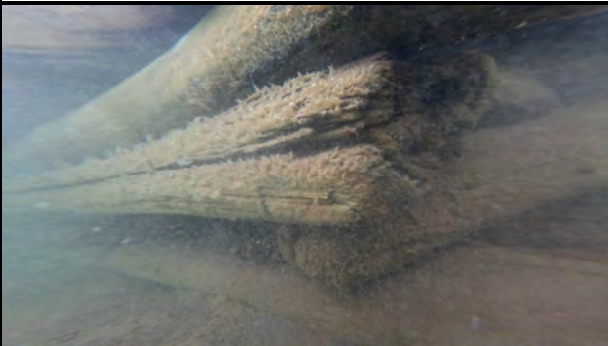
**Figure 3.** Lower crib member deterioration (source: AMI, 2024).

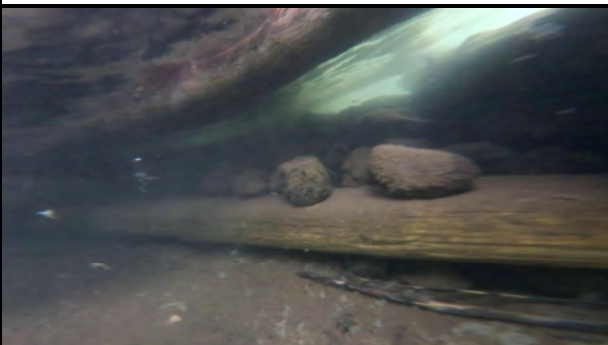
**Figure 4.** Loss of rock ballast (source: AMI, 2024).

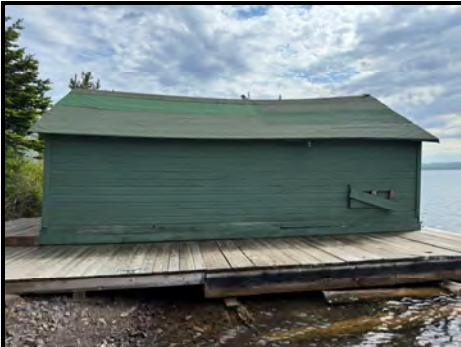
Figure 5. West elevation showing ridge sagging and wrinkled roof covering (source: JVA, 2024).

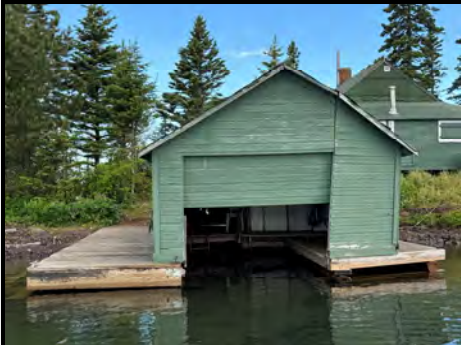
Figure 6. South wall elevation showing east wall leaning (source: JVA, 2024).

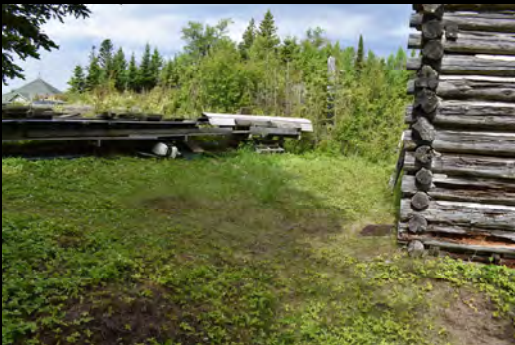
Figure 1. Low point along the south façade of Johns Log Cabin (source: Mundus Bishop, 2024).

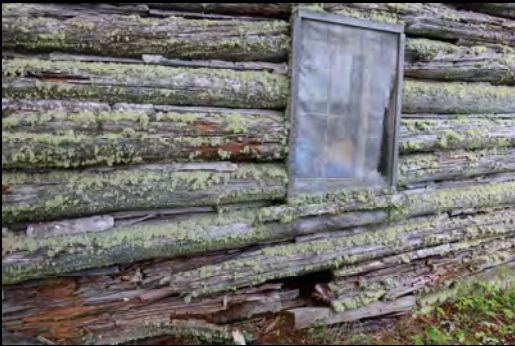
Figure 2. Deterioration at north façade (source: Anderson Hallas, 2024).

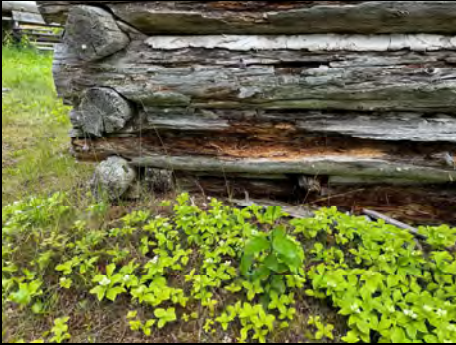
Figure 3. Lower logs in contact with soil, and no foundation (source: JVA, 2024).

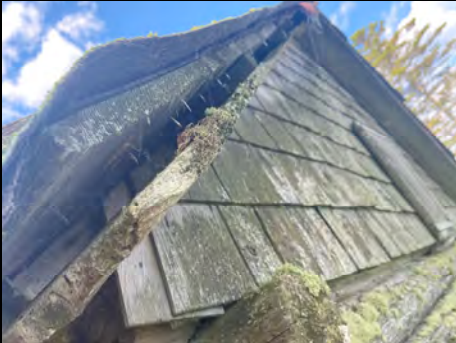
Figure 4. Soffit and missing barge board unsupported and roof covering excessively overhanging sheathing on the north rake (source: Anderson Hallas, 2024).

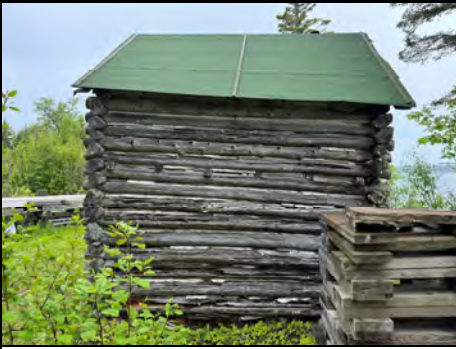
Figure 5. Distortion and roofing in poor condition at east façade (source: Anderson Hallas, 2024).

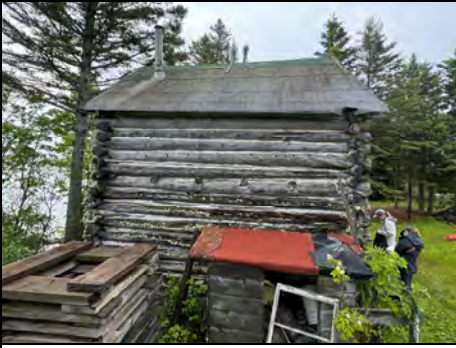
Figure 6. Distortion and roofing in poor condition at west façade (source: Anderson Hallas, 2024).

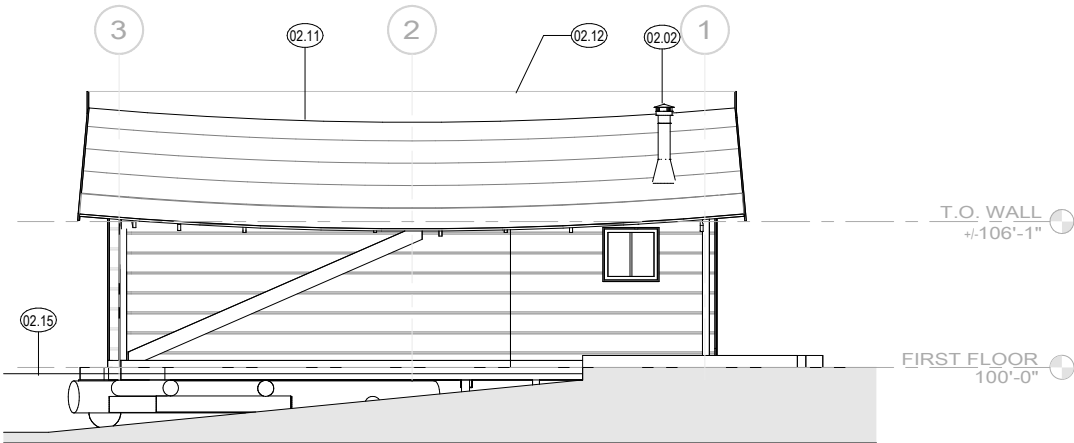
2 EAST ELEVATION  
A200 SCALE (A)

| 02.13 | EAST WALL IS SIGNIFICANTLY DISTORTED BY STRUCTURAL DISPLACEMENT. MEASURED RELATIVE TO BASE OF WALL THE TOP OF WALL IS SLANTED OUT +/- 8" |

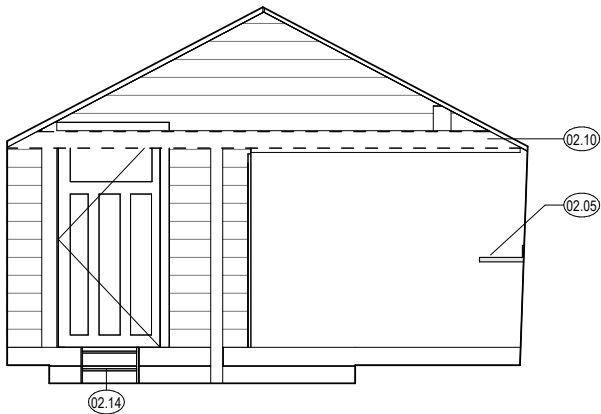
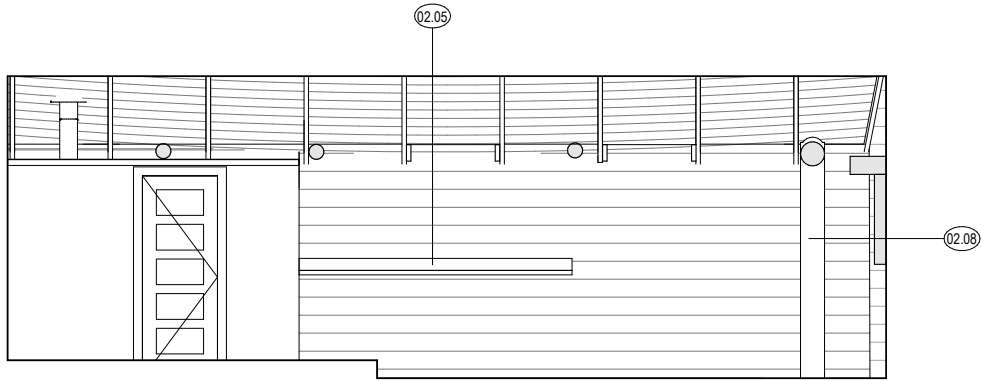
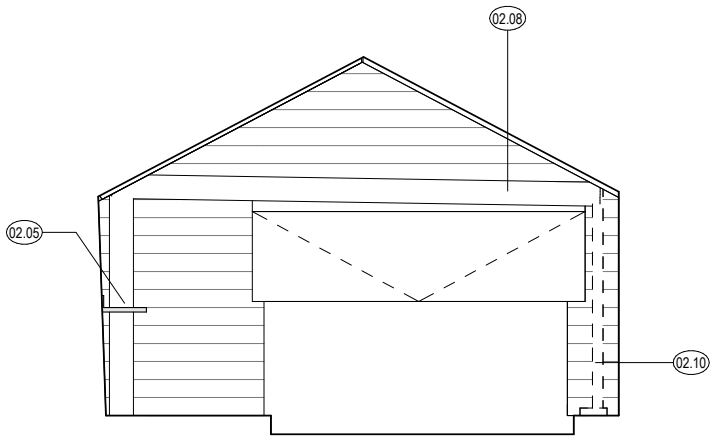
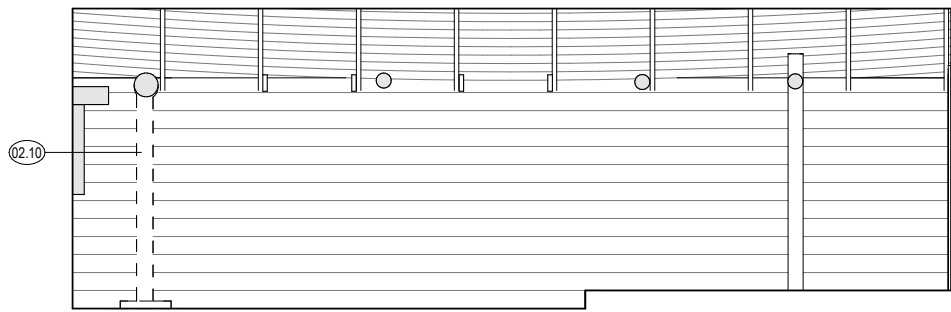
| 02.10 | <N> TEMPORARY WD SHORING ALONG NORTH SIDE OF STRUCTURE |
