## **Memorandum – Coastal Engineering Review**

### **George Washington Birthplace National Monument (GEWA) Trail Scour Mitigation**

#### **TAR 33213**

24 July 2024

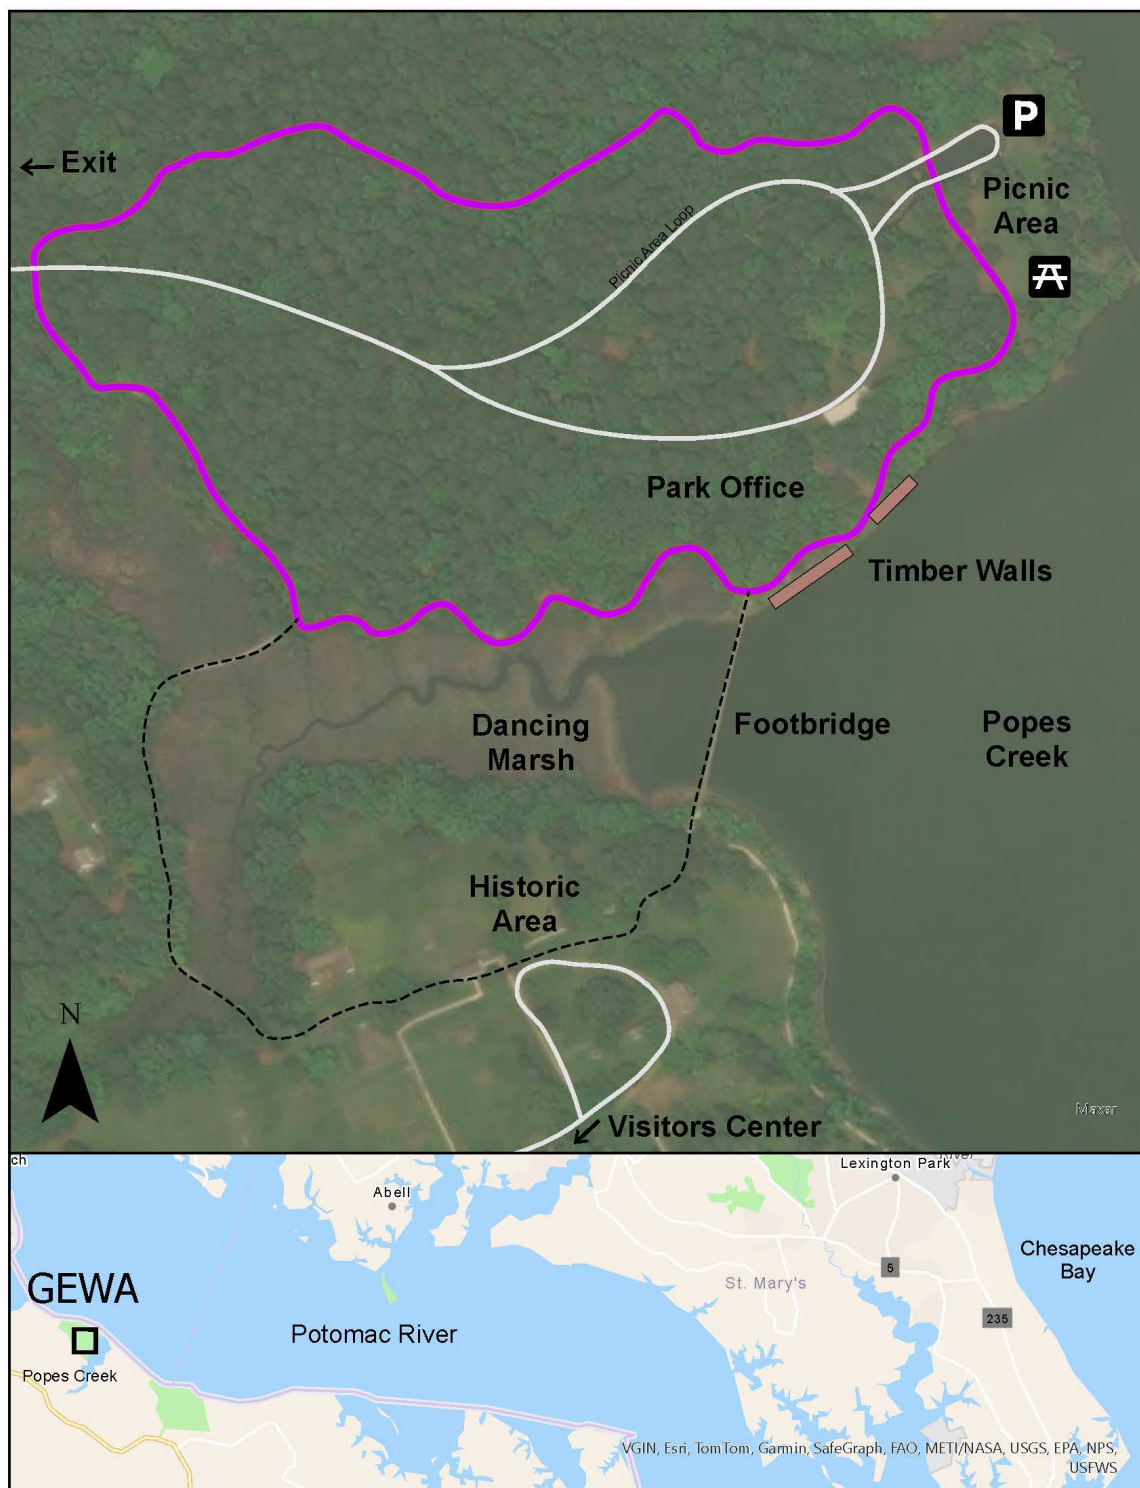
Figure 1. GEWA Trail Map

The erosion is occurring behind and between two existing sections of timber wall, one further east and one west, just south of the park office (figure 1). The walls are constructed of wooden posts lined with geotextile fabric (figures 2 and 3). GEWA staff noted that historical photographs indicate the shoreline was modified in the 1930s, and the shoreline appears to have retreated landward since that time. This is supported by the presence of an older wooden post in the creek, approximately 3 feet waterward of the current walls (figures 4 and 5). The history of these older wooden posts is not known. The current walls were installed in the 1990s. Park staff noted that during the 1990 wall installation, a backhoe was used to push the timber posts in. Gravel, bricks, and other fill material were observed behind the walls (figures 2, 3, and 5), which was likely placed during the 1990 installation although some may have been present prior. The condition of the timber walls varies, with some sections showing no signs of significant degradation (figure 6) and other sections in poor condition (figures 2, 3, 4, and 5). Shoreline erosion has resulted in portions of the trail behind the wall being lost from the formation of scour holes. The erosion varies in magnitude up to approximately 3 feet deep (figure 3) in some locations. Additionally, some areas have undercut up to 1 foot potentially leading to additional instability (figure 7). The section of the trail experiencing undercut lacks timber wall protection and has experienced more shoreline retreat.

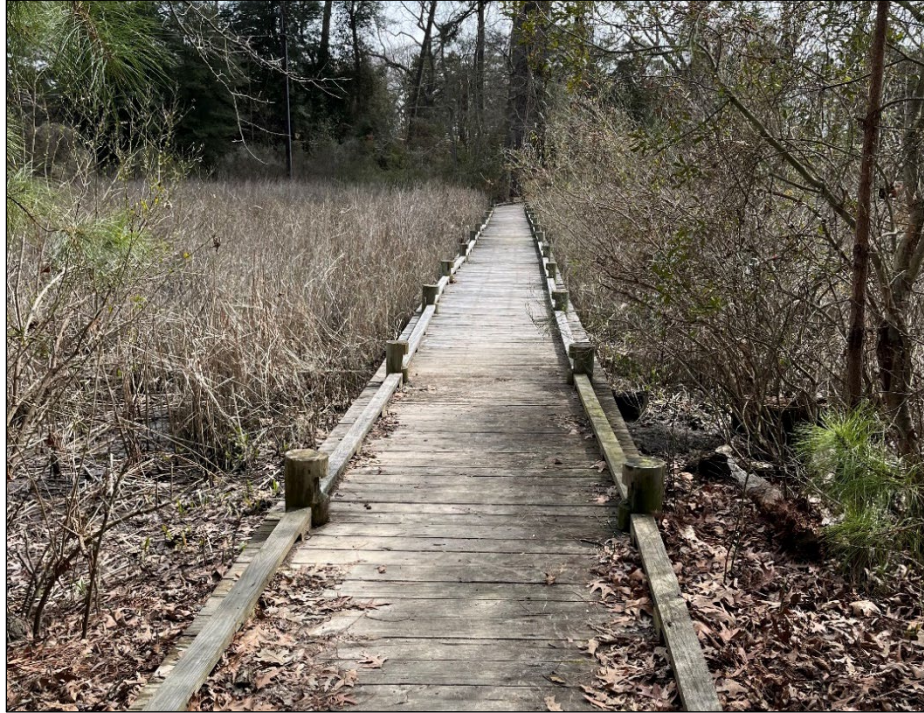
**Figure 16. Existing GEWA Free-Standing Boardwalk**

GEWA has several boardwalks already, including both free-standing and inground boardwalks, all constructed of wood. Two free-standing boardwalks were permitted and built in 2020 at a cost of around \$8,000 (figure 16). An inground boardwalk was built approximately a decade ago. The cost of a free-standing boardwalk would probably be lower than a modified wall and a revetment or gabions, while a
