# Oregon Caves

## Historic Structures Report

This Historic Structure Report was completed as partial fulfillment of the requirements for the Master of Science in Historic Preservation at the University of Oregon. It represents an individual effort by the author as a student project. It is hoped that this report will serve the National Park Service and concessionaire at the Oregon Caves National Monument as a reference guide for the treatment of the historic Chateau, a National Historic Landmark, and other similar buildings on the Monument.

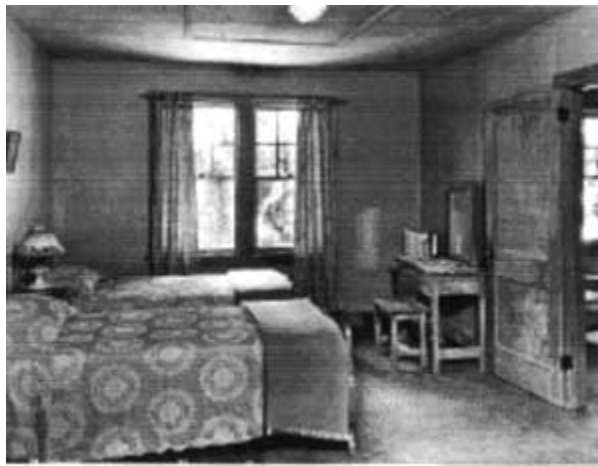
Typical Chateau guest rooms before...

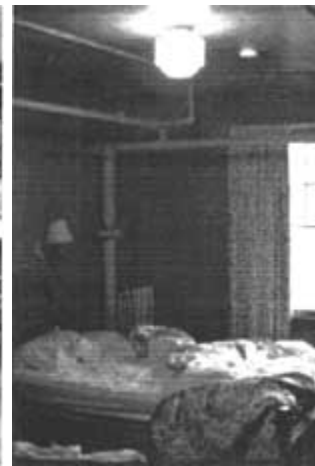
...and after the sprinkler.

Perhaps the most significant alteration to the Chateau in terms of its interior appearance was the addition of a fire sprinkler system in 1950. This system runs through the inhabitable spaces in the Chateau, instead of through wall and ceiling spaces. The visual intrusion into the guest rooms is the greatest impact of this alteration, with some rooms containing four inch mains and other feeder lines branching out from these. The system itself is nearly historic by the Secretary of the Interior's age standards, but was installed in a less than sensitive fashion. The sprinkler system was modified and added to in 1961 as well, but the extent of the work involved during this period is unclear. The entire system received new sprinkler heads during the off-season early in 1999, as required by code.

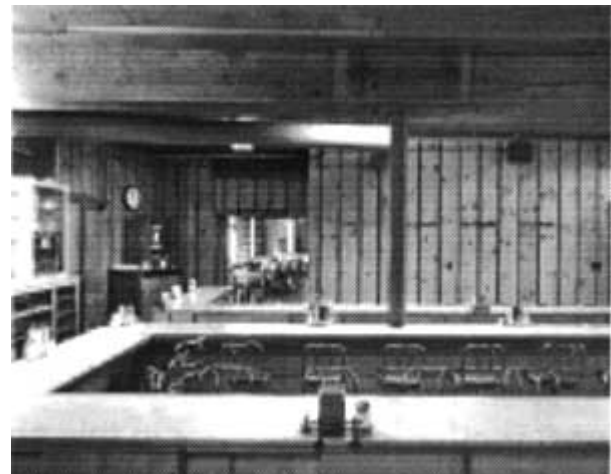
Coffee Shop after 1954 remodel. Note the steel post.

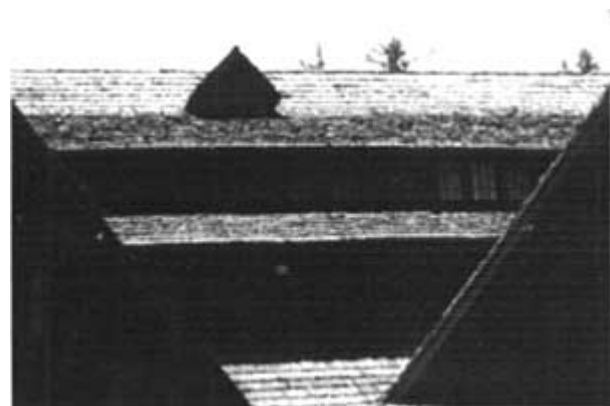
Roof, general field on the east side.

The top layer of shakes is beginning to deteriorate. While the attic has remained dry, the shake roof has steadily deteriorated. There are many missing and broken shakes, and most are curling. The exposure is larger than the recommended length of 7-1/2" as described in Architectural Graphic Standards, but the shakes have weathered fairly well. The formula for exposure is given as  $(\text{Length}-2") / 3$ , which results in the equation of  $(24-2) / 3$  or  $22 / 3 = 7.33$ . This is rounded up to the 7-1/2" dimension given on page 76. A ten inch exposure is typically reserved for vertical surfaces, according to Graphic Standards. The ridge shakes, also experiencing areas of missing and broken pieces, are cut to fit

- Within five years, the roof will need to be replaced. The number of broken and missing shakes increases every year, and while the attic is dry at this point the chance of water infiltration into the building envelope increases every year. The historic exposure, texture, and thickness should be maintained, and the ridge detail should be kept the same. A copper or galvanized ridge flashing may be installed to curtail moss and lichen growth on the roof, but will not help in areas that are under the eaves. The fungicide should be used to control the growth on the roof. Replacing the roof would be an ideal time for other work outlined above, including valley flashing inspection, repair, and painting, flashing the fascia board above the lobby entrance, and repair of the sheet metal above the chimney. This work should be completed before the roof begins to leak, compromising the building envelope. The roof should be replaced in-kind, with resawn shakes.

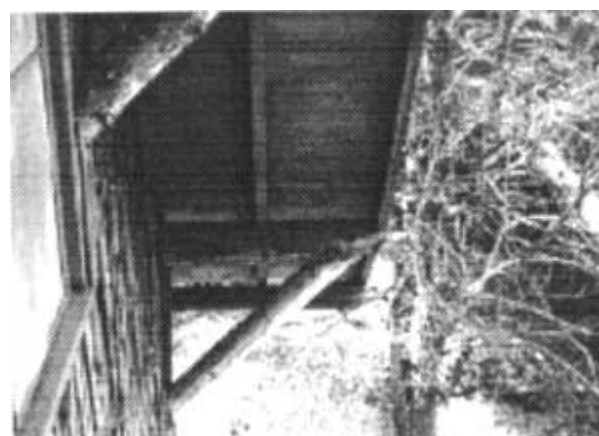
Gable end bracket, northwest gable.

The rot at the ends of the brackets extends back toward the building past the intersection with the verge boards. The brackets and verge boards are notched to accommodate one another, and water is allowed to puddle at this point, decaying both members. This intersection is also directly above the intersection of the diagonal and horizontal members of the bracket. The end grain of the diagonal member is vulnerable at this point, and in some cases the member has begun to decay.

- The horizontal members of the log brackets are all in need of replacement. Excessive decay has rendered them useless as structural elements, and has diminished their decorative importance. The brackets should be removed from the building with care in order to perform this work, so the historic siding will be protected. The diagonal members should also be inspected at this time, and the decayed members should be replaced. The number of diagonal members needing replacement will not be known until the horizontal member is removed and the end grain can be inspected.

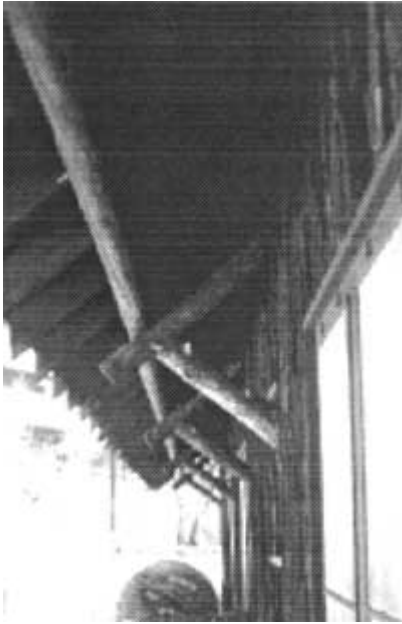
Purlin and brackets, north side.

The peeled log purlins are present under the eaves, tying the rafters together. These members are painted to match the sheathing under the eave, and are in good condition throughout the building. They are supported by triangular brackets, and support the exposed rafter tails. The purlin brackets are peeled logs, left unpainted. The purlins are notched to receive the rafter tails.

- The under eave purlins are all in good condition. These peeled logs must retain the integrity of their paint coating to remain useful to the structure. The paint should be inspected on a yearly basis and repainted as necessary.

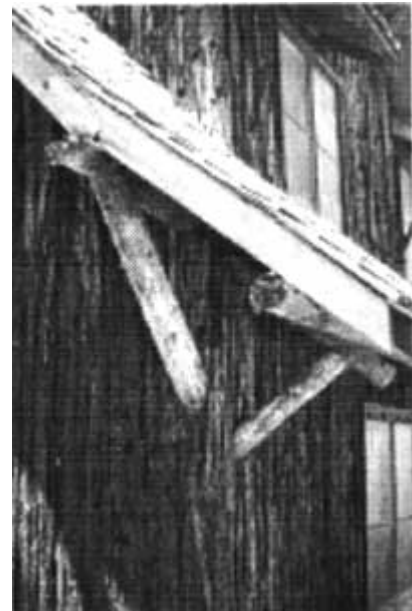
8" dimensional lumber. These members meet at the peak of the gable, and are painted a reddish color that slightly offsets the color of the Port Orford cedar bark siding. These members are compromised only where they intersect the brackets, and there are pockets of decay at all bracket intersections. These pockets vary in size and severity throughout the

building. The paint on the verge boards has failed, allowing excess moisture into the boards.

Verge board and brackets.

- All verge boards suffer from a compromised paint coating. They should all be scraped and painted in situ, while the brackets are removed for repair. Any areas of decay at the intersection of the verge boards with the brackets should be repaired using a "dutchman" repair in which only a small portion of the board is replaced. This will protect the historic fabric from unnecessary removal from the building.

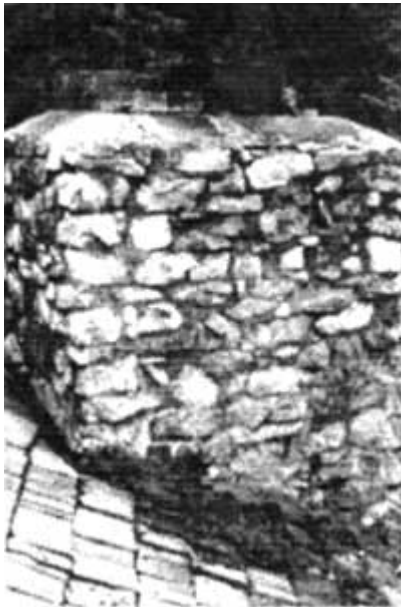
North side of chimney.

The squared marble is laid up with a fairly hard mortar. Some minor cracking is apparent in the mortar joints, but none are larger than 1/32". The uneven surface of the marble has allowed a limited amount of moss to grow on the mortar, primarily on the east and north sides.

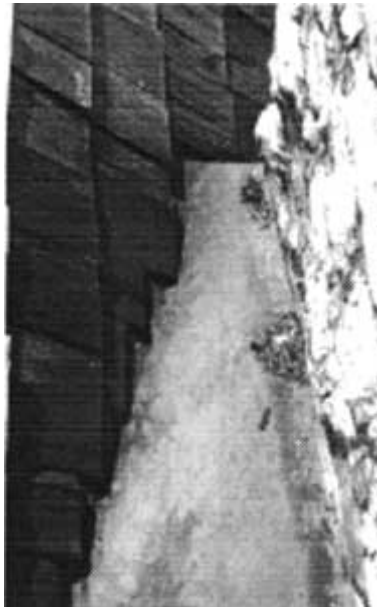
Just south of the hatch and chimney is a large area of sheet metal roofing that is woven under the step flashing of the chimney. The sheet metal was originally galvanized, but over the years the zinc galvanizing has worn off, leaving

Sheet metal at south end.

protect the metal. The material, galvanized steel, is still sound, but neglect could result in further decay of this system, allowing water to infiltrate the attic space. The joints between the sheets should be inspected to make sure they are weathertight before the area is painted. If repair is necessary, the work should be done prior to painting.

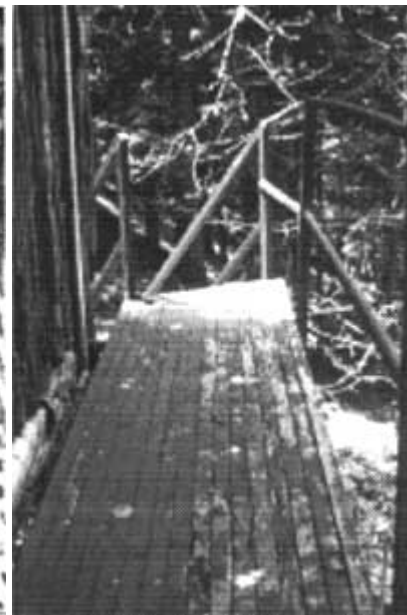
Catwalk pedestrian surface.

The catwalks replaced the wooden verandas in 1958. These are steel frame structures bolted to the building with wood deck material. The walking deck surface is 2" x 4" lumber turned on edge and assembled in such a way that every other board is missing to allow water to run through the catwalk. These are also painted brown to match the fire escape, but the paint coating has been worn away on the wood walking surface.

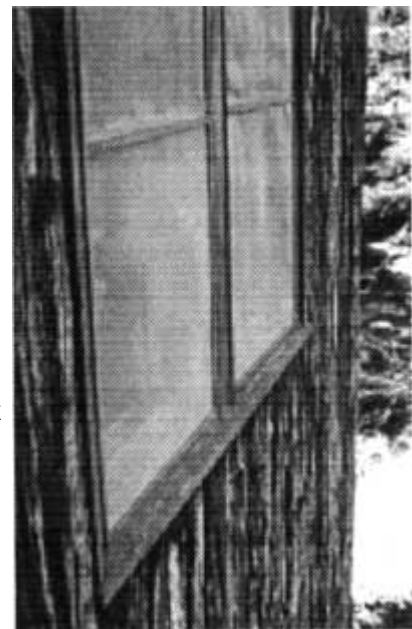
Even though the majority of the screens are intact, a few have been damaged. Damage includes the separation of the frame members, holes in the metal screening, and damage to the frame from the installation process or from the screen coming loose from the eye bolts. There are a number of screens on the sixth floor windows that are lying on the roof itself, having come loose from their attachment points.

Typical exterior sill and screen.

The window sills are formed by dimensional lumber set on an angle to shed water away from the building (i.e. they are weathered). No drip edge is present on the bottom side of the sills, and they project out from the building to varying degrees due to the irregular nature of the cedar bark siding. The sills and surrounds are all painted, but the paint coating is beginning to fail in the majority of cases. One sill is missing altogether. At the west end of the north wing on the second floor, there are three rooms used for employee housing. The center room is missing the sill from the southern window, allowing a great deal of air into the structure and making the space very hard to heat during the cold winter months.

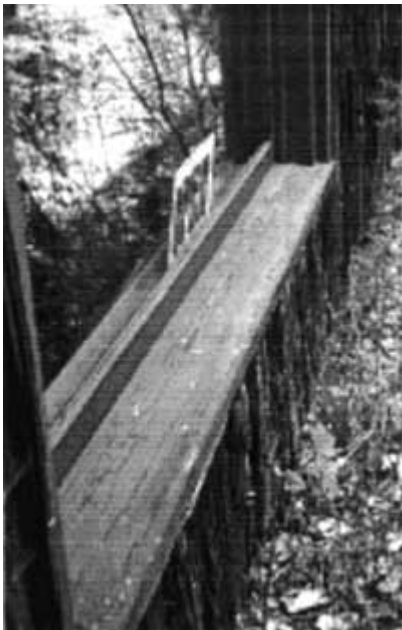
Sill north of the Coffee Shop door.

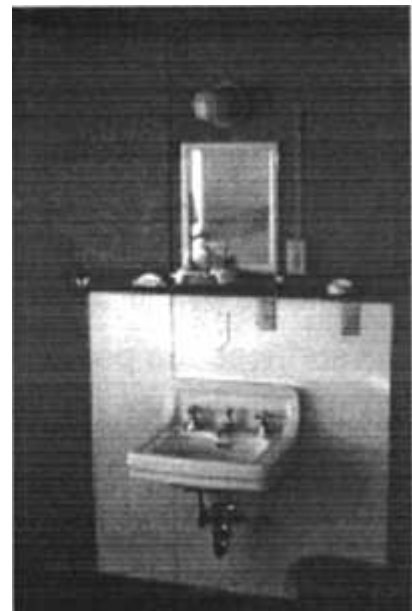
Painted sink surround, 6th floor.

- Re-attach all sagging and loose historic Nu-Wood using small (4d) finish nails to replicate the original installation.
- If replacement becomes necessary, remove pieces from the non-public areas of the building that have already been stripped of some of their historic fabric to supply the public portions of the building.

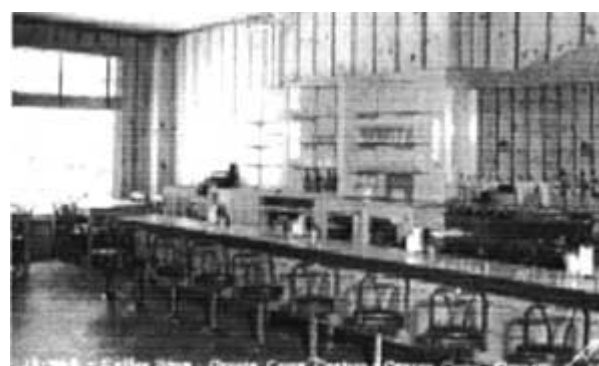
Knotty pin in the Coffee Shop.

The coffee shop, adjacent to the kitchen on the third floor, holds the second of these three finishes. Knotty pine paneling is used on all of the walls in this room. Eight-inch wide boards are laid vertically, with beaded moldings incised into the edge of each board to enhance the decorative character of the pine. The boards run from floor to ceiling, and are covered at the base by a 12" molding, installed after the 1964 flood stained the walls. These panels are in excellent condition, with only minimal signs of wear.

These three wall finishes are in good condition overall, and should be maintained to ensure the longevity of the historic fabric. The plaster in the kitchen should be patched with a three-coat system and finished to match the historic fabric surrounding the patch. The knotty pine and wainscot should receive maintenance as required, but furniture should be kept a short distance (approximately one foot) from the wall to avoid potential abrasion.

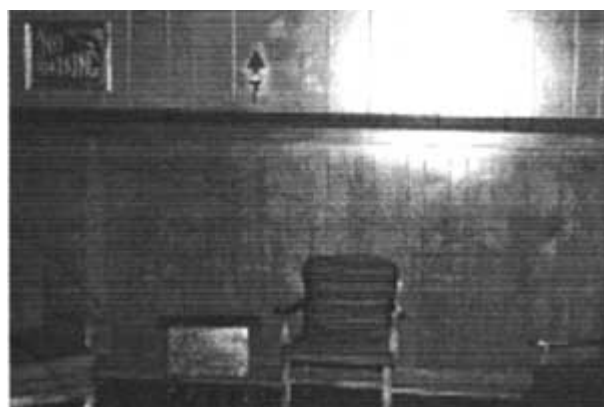
Replacement wainscot in the dining room.

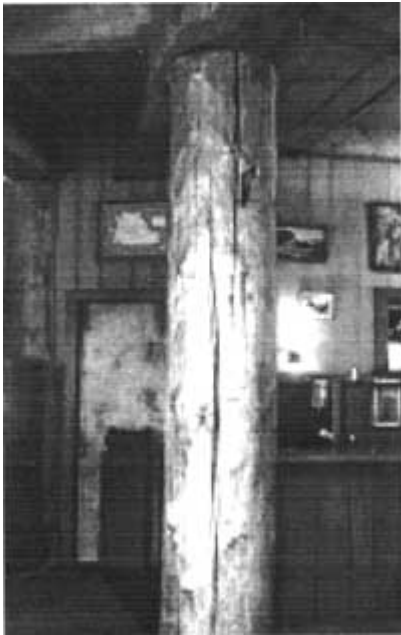
Typical heavy timber column.

Taken as a whole, the heavy timber system is sound. There are only three areas of concern in the system, based on a visual inspection. In the dining room, the columns at the north end near the creek diversion are experiencing potentially serious checking. There is no lateral displacement of the overhead beams at this location, but the check runs almost all the way through the column and is approximately 3/4 of an inch wide at the outside edge. The beam above this column running to the east is also experiencing moderate checking.

Where the column was replaced in the coffee shop, there is lateral displacement of the main beams. These beams seem to be shifting on the steel plate, and not bearing evenly. The beam to the west of this column has been bolted together, as it was seriously checked. The third area of concern is in the lobby. At the north end of the reception desk, the beam to the east of the column at the corner of the desk is checking moderately.

A final note on the heavy timber in the lobby is that the columns are experiencing slight checking, but are suffering more from abrasion damage by chairs and objects carried through the space.

- An engineer should be employed to inspect the three locations where moderate to serious checking is occurring. These are located in the dining room and lobby, as mentioned above. The members should be analyzed to determine if they are performing as they should, and are able to carry their load. The members may need to be repaired or reinforced as required, possibly by bolting. The bolts in the coffee shop beams are intrusive and non-historic, and should have been installed in a more sensitive fashion. Recessing the bolt heads and inserting wood plugs over the bolt heads would make them less intrusive.
- The columns in the lobby should be protected from abrasion, as it is destroying the historic finish on these members. Chairs should not be placed near the columns, and objects such as ladders and other maintenance equipment should not be leaned on the columns to rest.

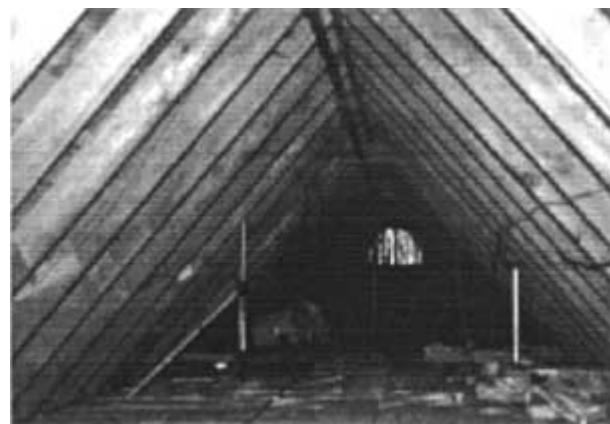
The main attic space.

The roof framing and ceiling structure of the sixth floor are visible in the main attic. The rafters are full dimension 2" x 6" rough cut lumber, 24" on center. The rafters meet at the ridge, and there is no ridge member. The joists are 2" x 6" lumber as well, but spaced at 16" on center. The gaps between the joists have been filled with R-19 fiberglass insulation to hold the heat in the building.

Two small dormers project from the east and west sides of the main attic space. These are framed with modern 2" x 4" planed lumber, and were added with the sprinkler system in 1950. The east dormer houses a loudspeaker, and the west dormer houses a large floodlight. The openings in the dormers are louvered panels, without screens.

The ends of the main gable have triangular openings, also covered with louvered panels. Wasp nests on the rafters and sheathing are apparent at both

the north and south ends of the building, as the insects are able to enter the attic space through the louvered panels.

The lower attic spaces are constructed in the same fashion, but meet vertical wall surfaces. The diagonal members are tied into the wall studs. Where the main attic space lacks flooring, the lower attics accessed from the small doors in the sixth floor hallway have rough lumber serving as a floor surface, allowing storage within the spaces. All of the attic spaces are dry, and show no signs of water infiltration.

- Place screening over the louvered vents in the small dormers and gable ends to prevent insects from entering the building and constructing nests.
- Develop a hinge system for the main attic hatches. The hatches, especially the one at the south end of the hall, are being marred by the conduit near the opening. Hinging the hatches would protect the historic fabric and reduce the likelihood of accidental damage to the hatch cover.

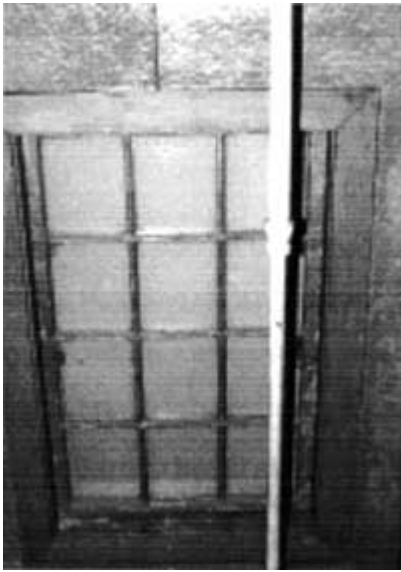
There are a number of attic spaces in the Chateau due to its complex roof forms. Lower attics are accessible through small doors in the ends of the sixth floor hallway, doors in rooms 305 and 311, and also through the bath rooms in rooms 305, 311, and 312. The main attic above the sixth floor ceiling is accessible through either of two hatches in the hallway ceiling. The hatches are recessed in the ceiling, and have the appearance of multi-pane skylights. However, the top side of the hatches are covered with plywood painted a dark gray so that the attic is not visible from the hall. The hatches have no hinge or latch mechanism, and must be lifted off of the frame and slid into the attic space for access. An electrical conduit just west of the hatch openings has caused abrasion damage and marring on the underside of the hatch, as it gets slid over the conduit and out of the way.

The south attic hatch.

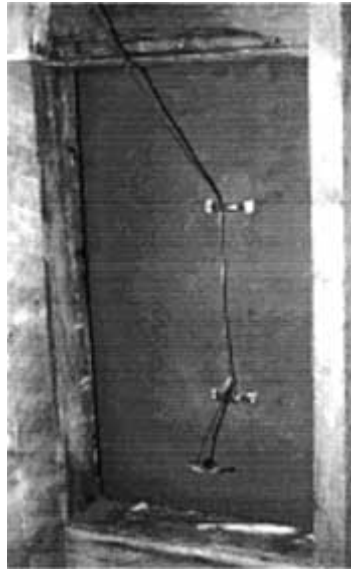
Roof access hatch wired to sprinkler.

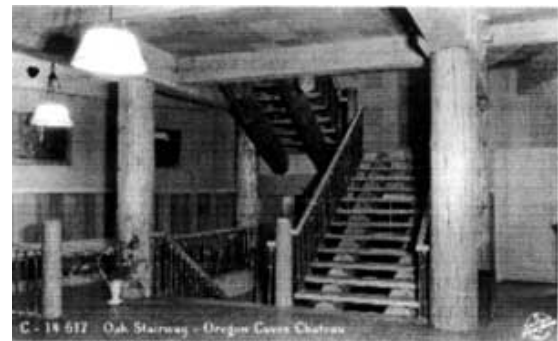
Historic view of the main staircase.

The staircase is in good condition. Miscellaneous dutchman repairs have been made to the treads over the years, and the lower portions of the madrone and fir baluster were replaced after the 1964 flood. The stringers are all checked to some degree, but none are serious enough to warrant replacement or reinforcement. The treads are showing signs of wear from 65 years of use, but are far from needing replacement.

The main staircase is in sound condition, and requires no preservation work. If maintenance be comes necessary, it should be performed not only in accordance with the Secretary of the Interior's Standards, but should also be carried out with the care and precision of the earlier dutchman repairs and baluster replacement.

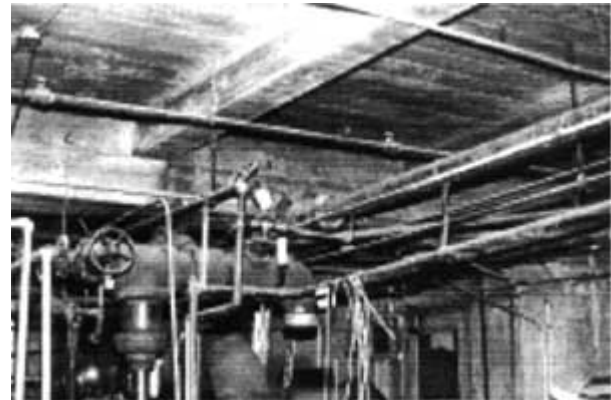
On the first floor, concrete also forms the boiler room ceiling and floor. The reinforcing bars are exposed at spalls in two locations, revealing the size but not the spacing or arrangement of the rebar. The ceiling is reinforced with #5 bar (5/8" diameter), and the projecting engaged columns supporting the heavy timber structure above are reinforced with #7 bar (7/8" diameter). The size of the rebar in the walls is unknown, as none are exposed. The ceiling is a monolithic slab, with larger concrete beams as part of the same pour running east-west. These two primary concrete beams are supported by engaged columns at both ends, and four freestanding columns in the east end of the room.

Boiler room ceiling structure.

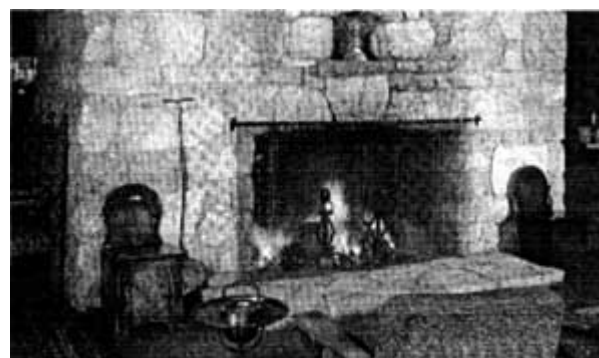
The eastern lobby fireplace.

The fireplace structure appears sound from all four sides. There are, however, two locations where small cracks appear in the chimney structure. On the west side, just north of the firebox opening, a crack is present along the edges of the mortar joints traveling vertically for approximately four feet. The crack has no separation to speak of; the bond between the mortar and the marble has been lost. The north side of the chimney houses another crack in the mortar, near the center of that elevation. Minor separation is occurring within this crack, up to 1/16".

- The east firebox should be cleaned out and reconstructed, using the historic fire brick. The narrow mortar joints in the historic assembly should be replicated in the reconstruction. This will avoid potential problems with the chimney later, and cleaning the brick should coincide with chimney sweeping.
- Both flues should be periodically swept to avoid chimney fires. This is especially important at the east firebox, which is more heavily used.
- The cracks on the west and north sides of the chimney should be monitored to see if the cracks are continuing to separate, or if they are stable. If separation continues, a masonry consultant should be utilized to remedy the situation.

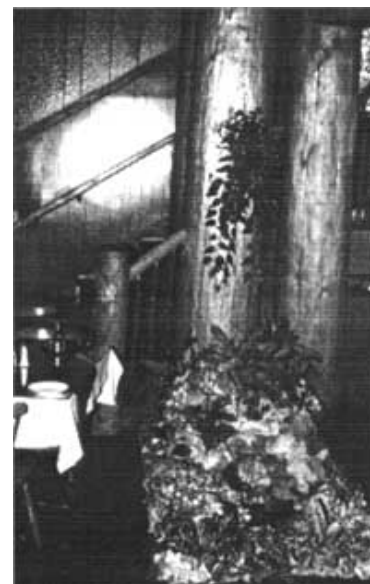
The diversion of Caves Creek through the dining room is a signature element of the building. A culvert brings the water from the lower pond through the dining room, where it is seen as an open trickle of water flowing over rocks and around ferns. This aspect of the building brings the natural world into the structure, providing a link with the surrounding landscape. The link is reinforced by the enormous picture windows in the west wall of the space. The concept of running a small mountain stream through a building and bringing the outdoors inside was not unique, but it was unusual and noteworthy. Laura Soullière Harrison, in her National Historic Landmark nomination, notes that "considering that the Chateau predates Wright's house 'Falling Water' by two years leads me to think that the use of the stream running through the building was an honest response to the site, and not a choice made because the designer saw it in an architectural magazine and felt it would work here." (389) The creek exits the building through a drain pipe in the west wall, running down below grade and emptying into Caves Creek below.

The Caves Creek diversion in the dining room.
