# United States Department of the Interior

## NATIONAL PARK SERVICE

November 4, 2013

Subject: Trip report detailing assessment of a hydraulic drop structure at the confluence of the Paria River and Water Canyon

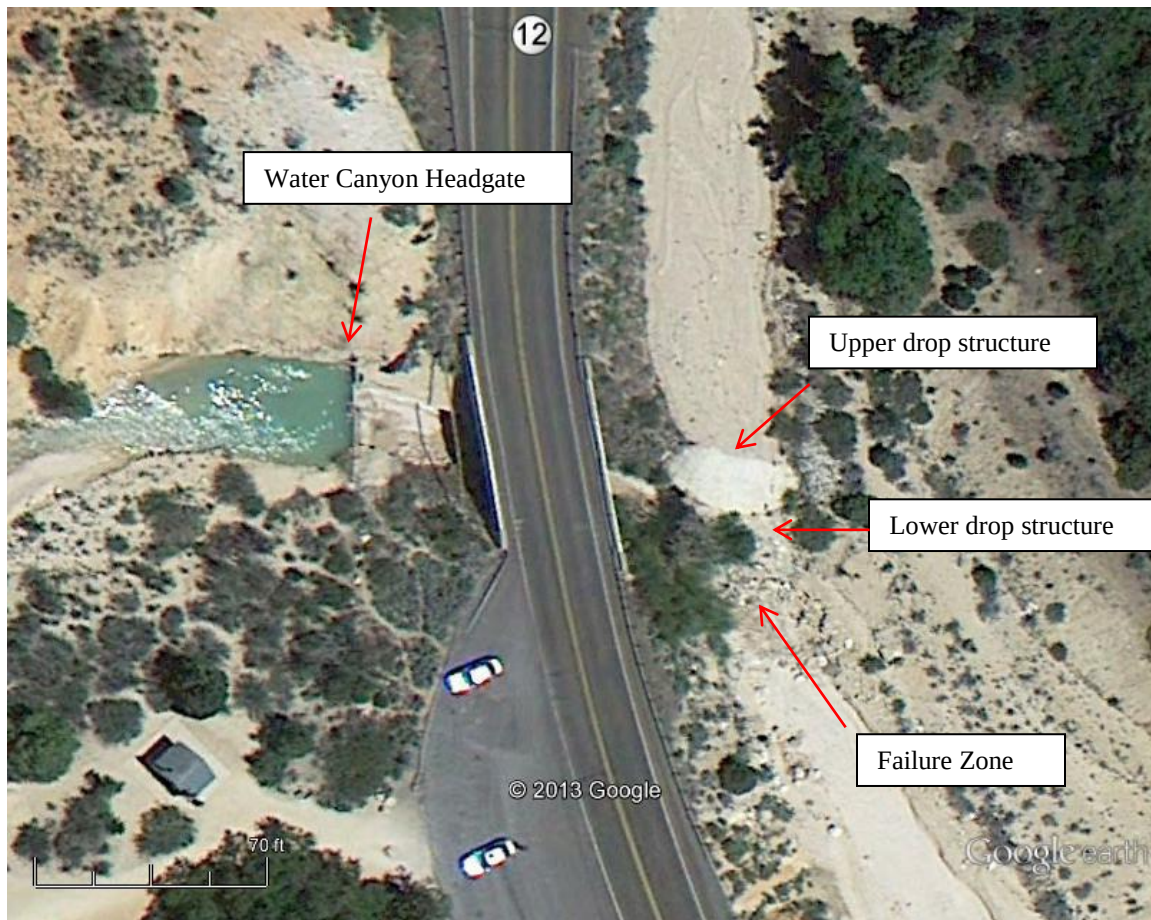
It is at this precise location, the confluence of Water Canyon and the Paria River where the drop structure in question was constructed. About half of the structure is above the confluence and about half is below (Figure 1). The buried conveyance pipe passes under the upper portion of the drop structure. Also located at this site is a bridge crossing and road grade for State Highway 12. The highway bridge, which crosses Water Canyon is a standard two-lane span about 70 feet long with two sets of piers. The piers and abutments are protected with gabion structures and grouted rip-rap. Some of the bridge protection has undergone erosion and some has been recently replaced.

**Figure 1 - Google Earth image of the site at the confluence of the Paria River and Water Canyon. The Paria River channel runs north-south and Water Canyon enters from the west. Note the drop structure adjacent to the bridge crossing, all of the visible water is being diverted into an underground pipe, but on a regular basis, the system is “flushed” of sediment by diverting the imported water directly into the Paria River.**
