## NATIONAL PARK SERVICE

November 21, 2017

Subject: Evaluation of Erosion Issues along Ike Smith Stream.

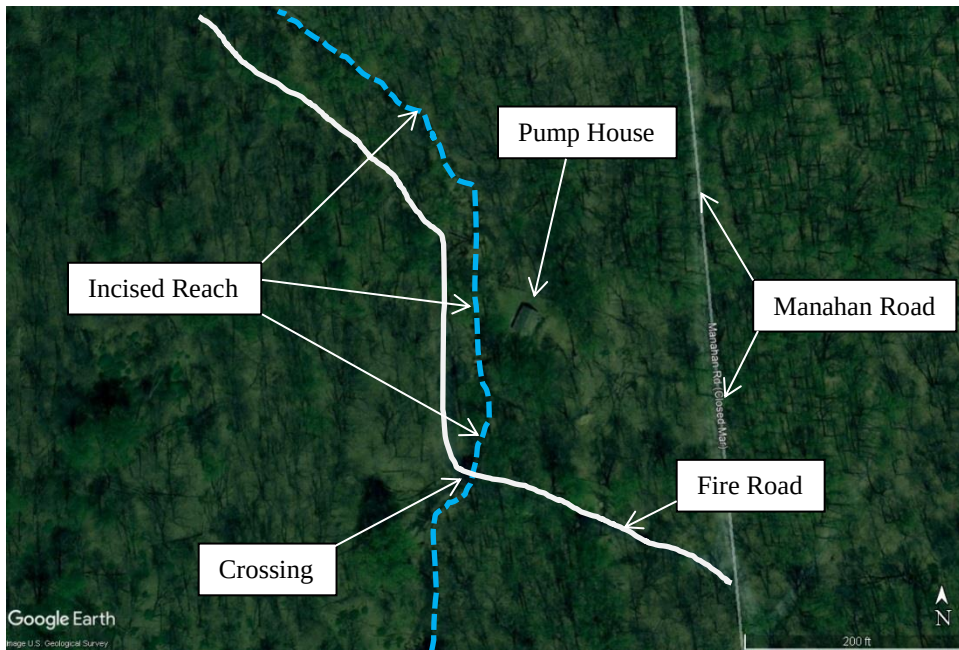
**Figure 1** - Google Earth image (February, 2007) showing area around Ike Smith Pump House. Ike Smith Stream alignment is depicted as a dashed blue line with flow from south to north. The fire road is depicted as a solid grey line crossing the creek.
