EMERALD CREEK LANDSLIDE REHABILITATION (Site 81-6)  
Summary of Heavy Equipment and Labor Intensive Costs

## STATUS OF THE EMERALD CREEK LANDSLIDE, REDWOOD NATIONAL PARK

REHABILITATION SITE 78-2  
HARRY WIER (EMERALD) CREEK, 1981-6

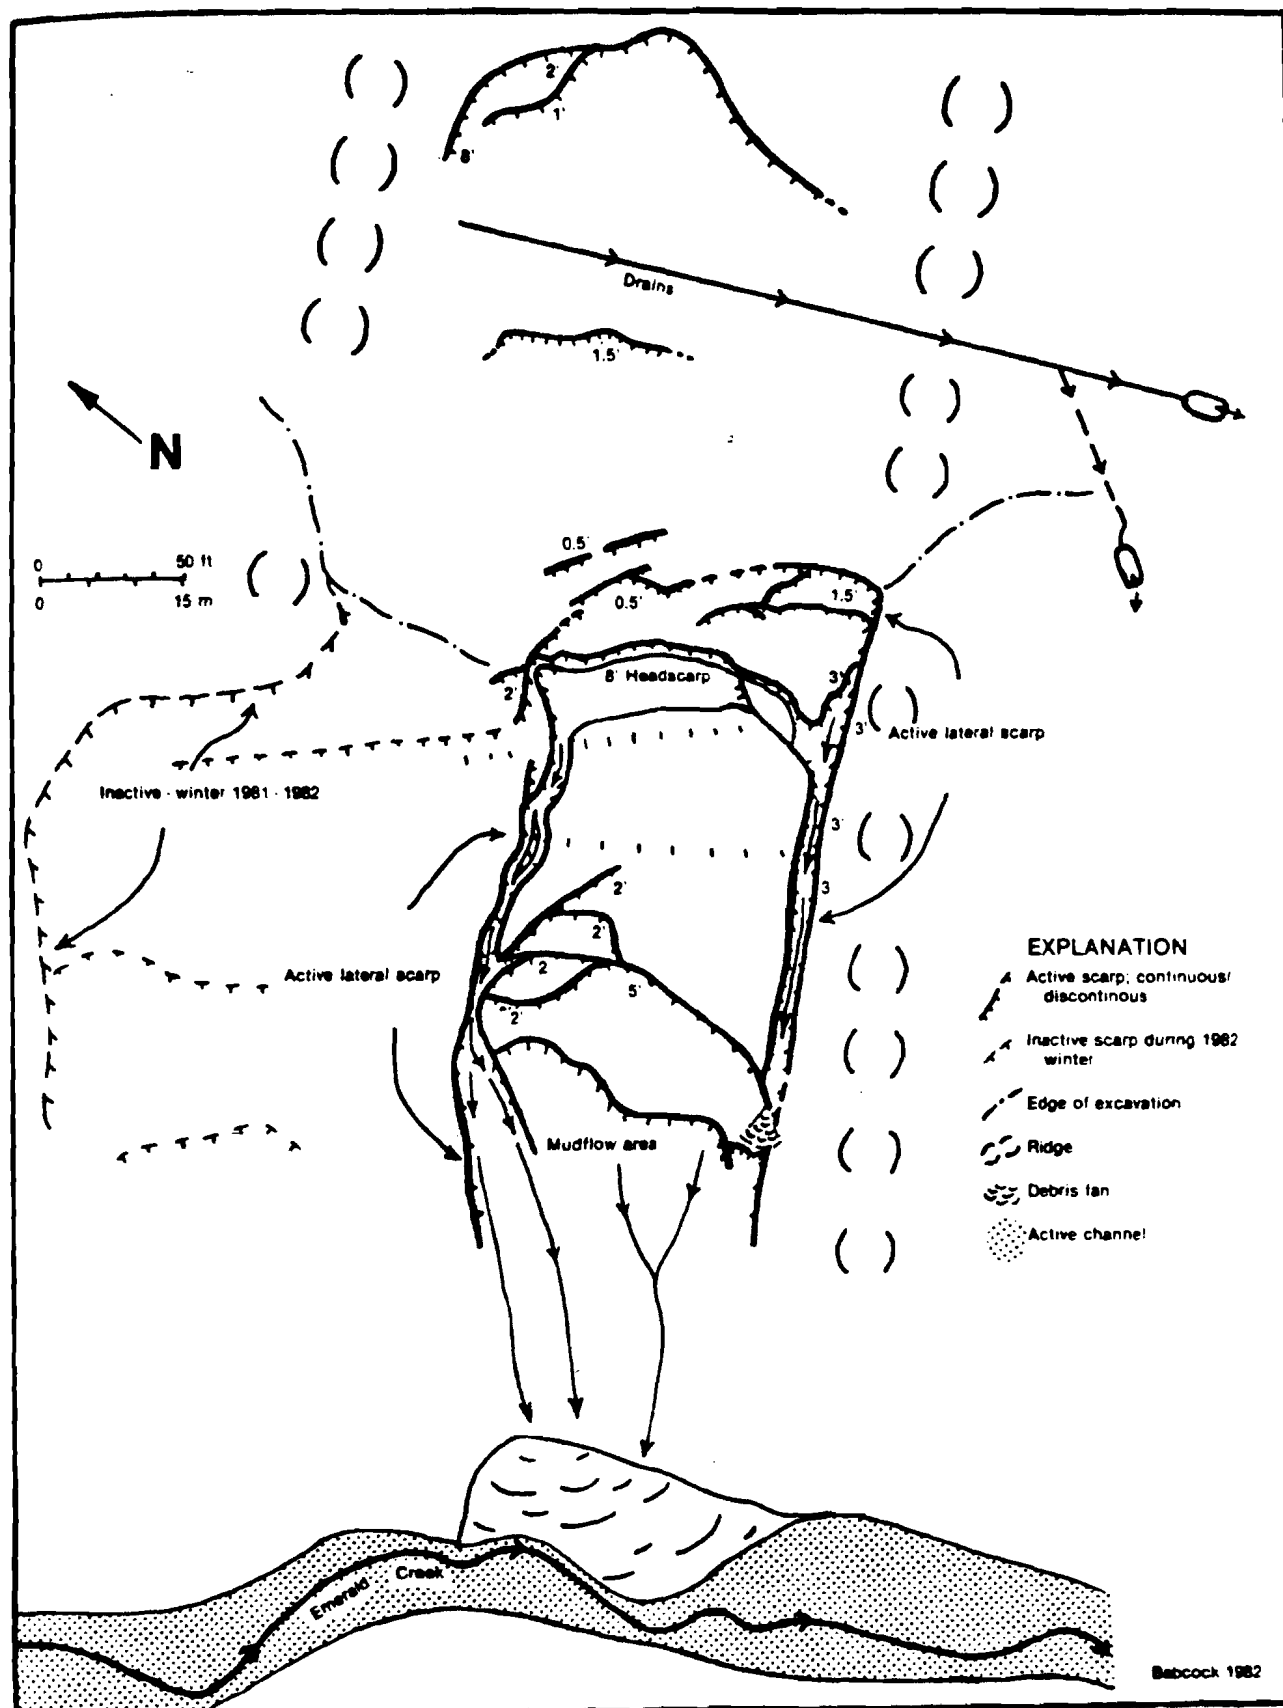
Figure 7

By February, 1982, after 75 in of rain, blocks of material downslope of the new headscarp and above the mudflow area moved 13 ft or more according to surveyed monuments. The final scarp map (Fig. 7) and the map of monument movement after the winter (Fig. 8) illustrate overall slide changes. No measurable displacement occurred at the old headscarp. A new headscarp had formed and migrated slightly uphill. The south lateral scarp became continuous and well-defined up to the new headscarp. No change occurred on the north lateral scarp. The major movement was translational, downhill sliding of blocks (Fig. 9) in part defined by pre-existing scarps (Fig. 2). Maximum total movement was 21.2 ft horizontally and 10.6 ft vertically. The magnitude of distance moved was probably influenced by the relatively wet winter (25 in above the basinwide average). The mudflow area was altered by fluvial processes, but showed no mass movement. In 1981, the slide mass seems to include a smaller area than before treatment.

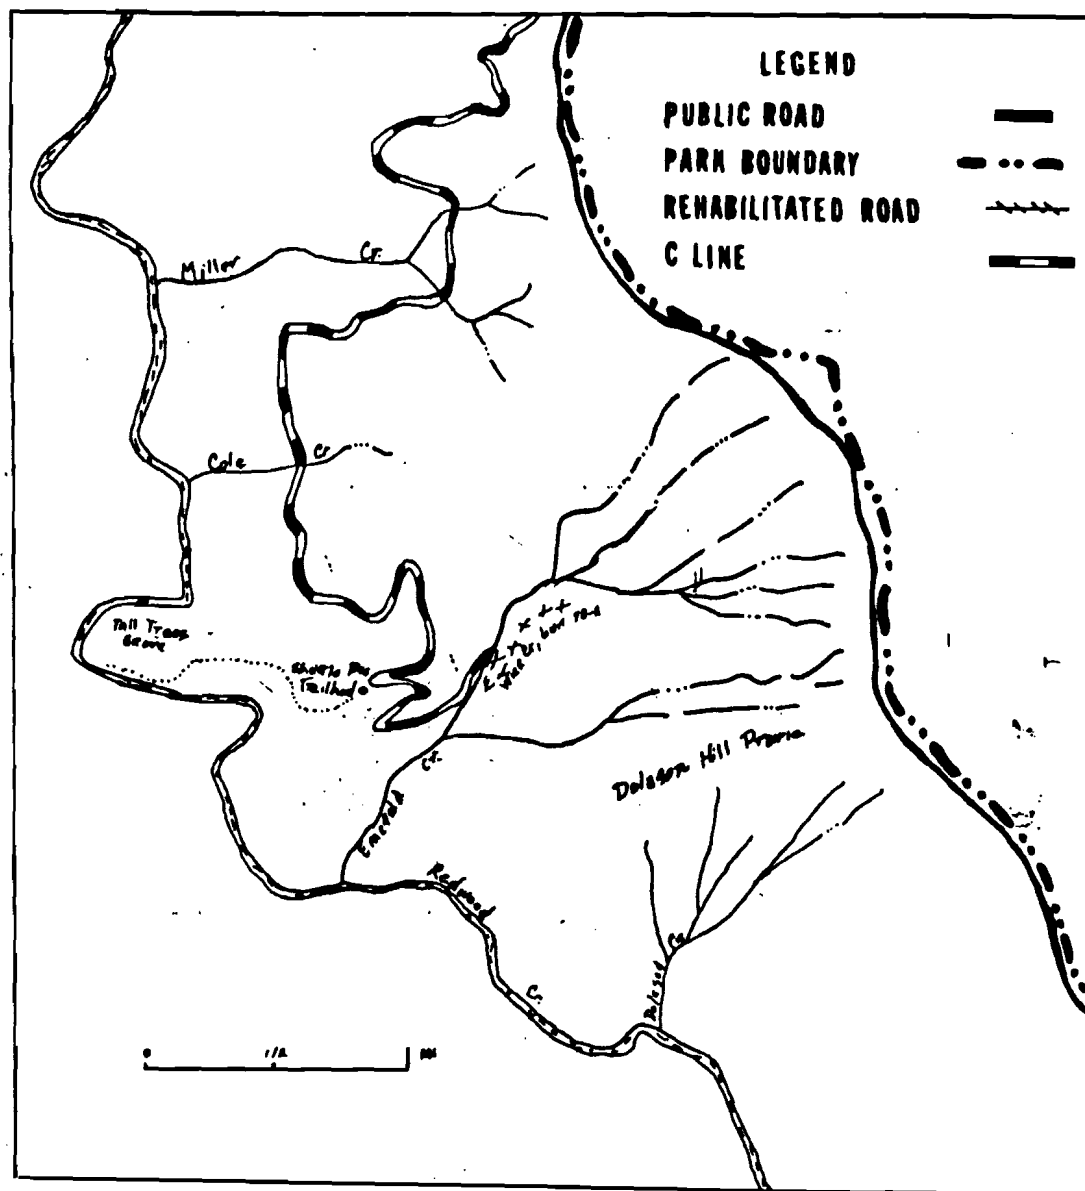
Fig. 1. Rehabilitation Site 78-2, Harry Wier (Emerald) Creek, 1981.

Harry Wier Creek, originally rehabilitated in 1978, is on a west-facing aspect at an elevation of 400 to 800 feet (Figure 1). From the end-haul landing to the bridge is one-half mile. In September, 1981, it was necessary to return to the site for additional heavy equipment work due to a large, active stream-side landslide. Seven thousand cubic yards of fill material was removed from the slide to the end-haul landing. This material, a clay-textured, grey subsoil (blue-goo), was redistributed and outslowed on the landing.
