GEOTECHNICAL REPORT  
PHASE II STUDY AND  
EVALUATION OF  
TSAILE DAM, APACHE CO.,  
ARIZONA

20 July 1981

ENGINEERS TESTING  
LABORATORIES, INC.

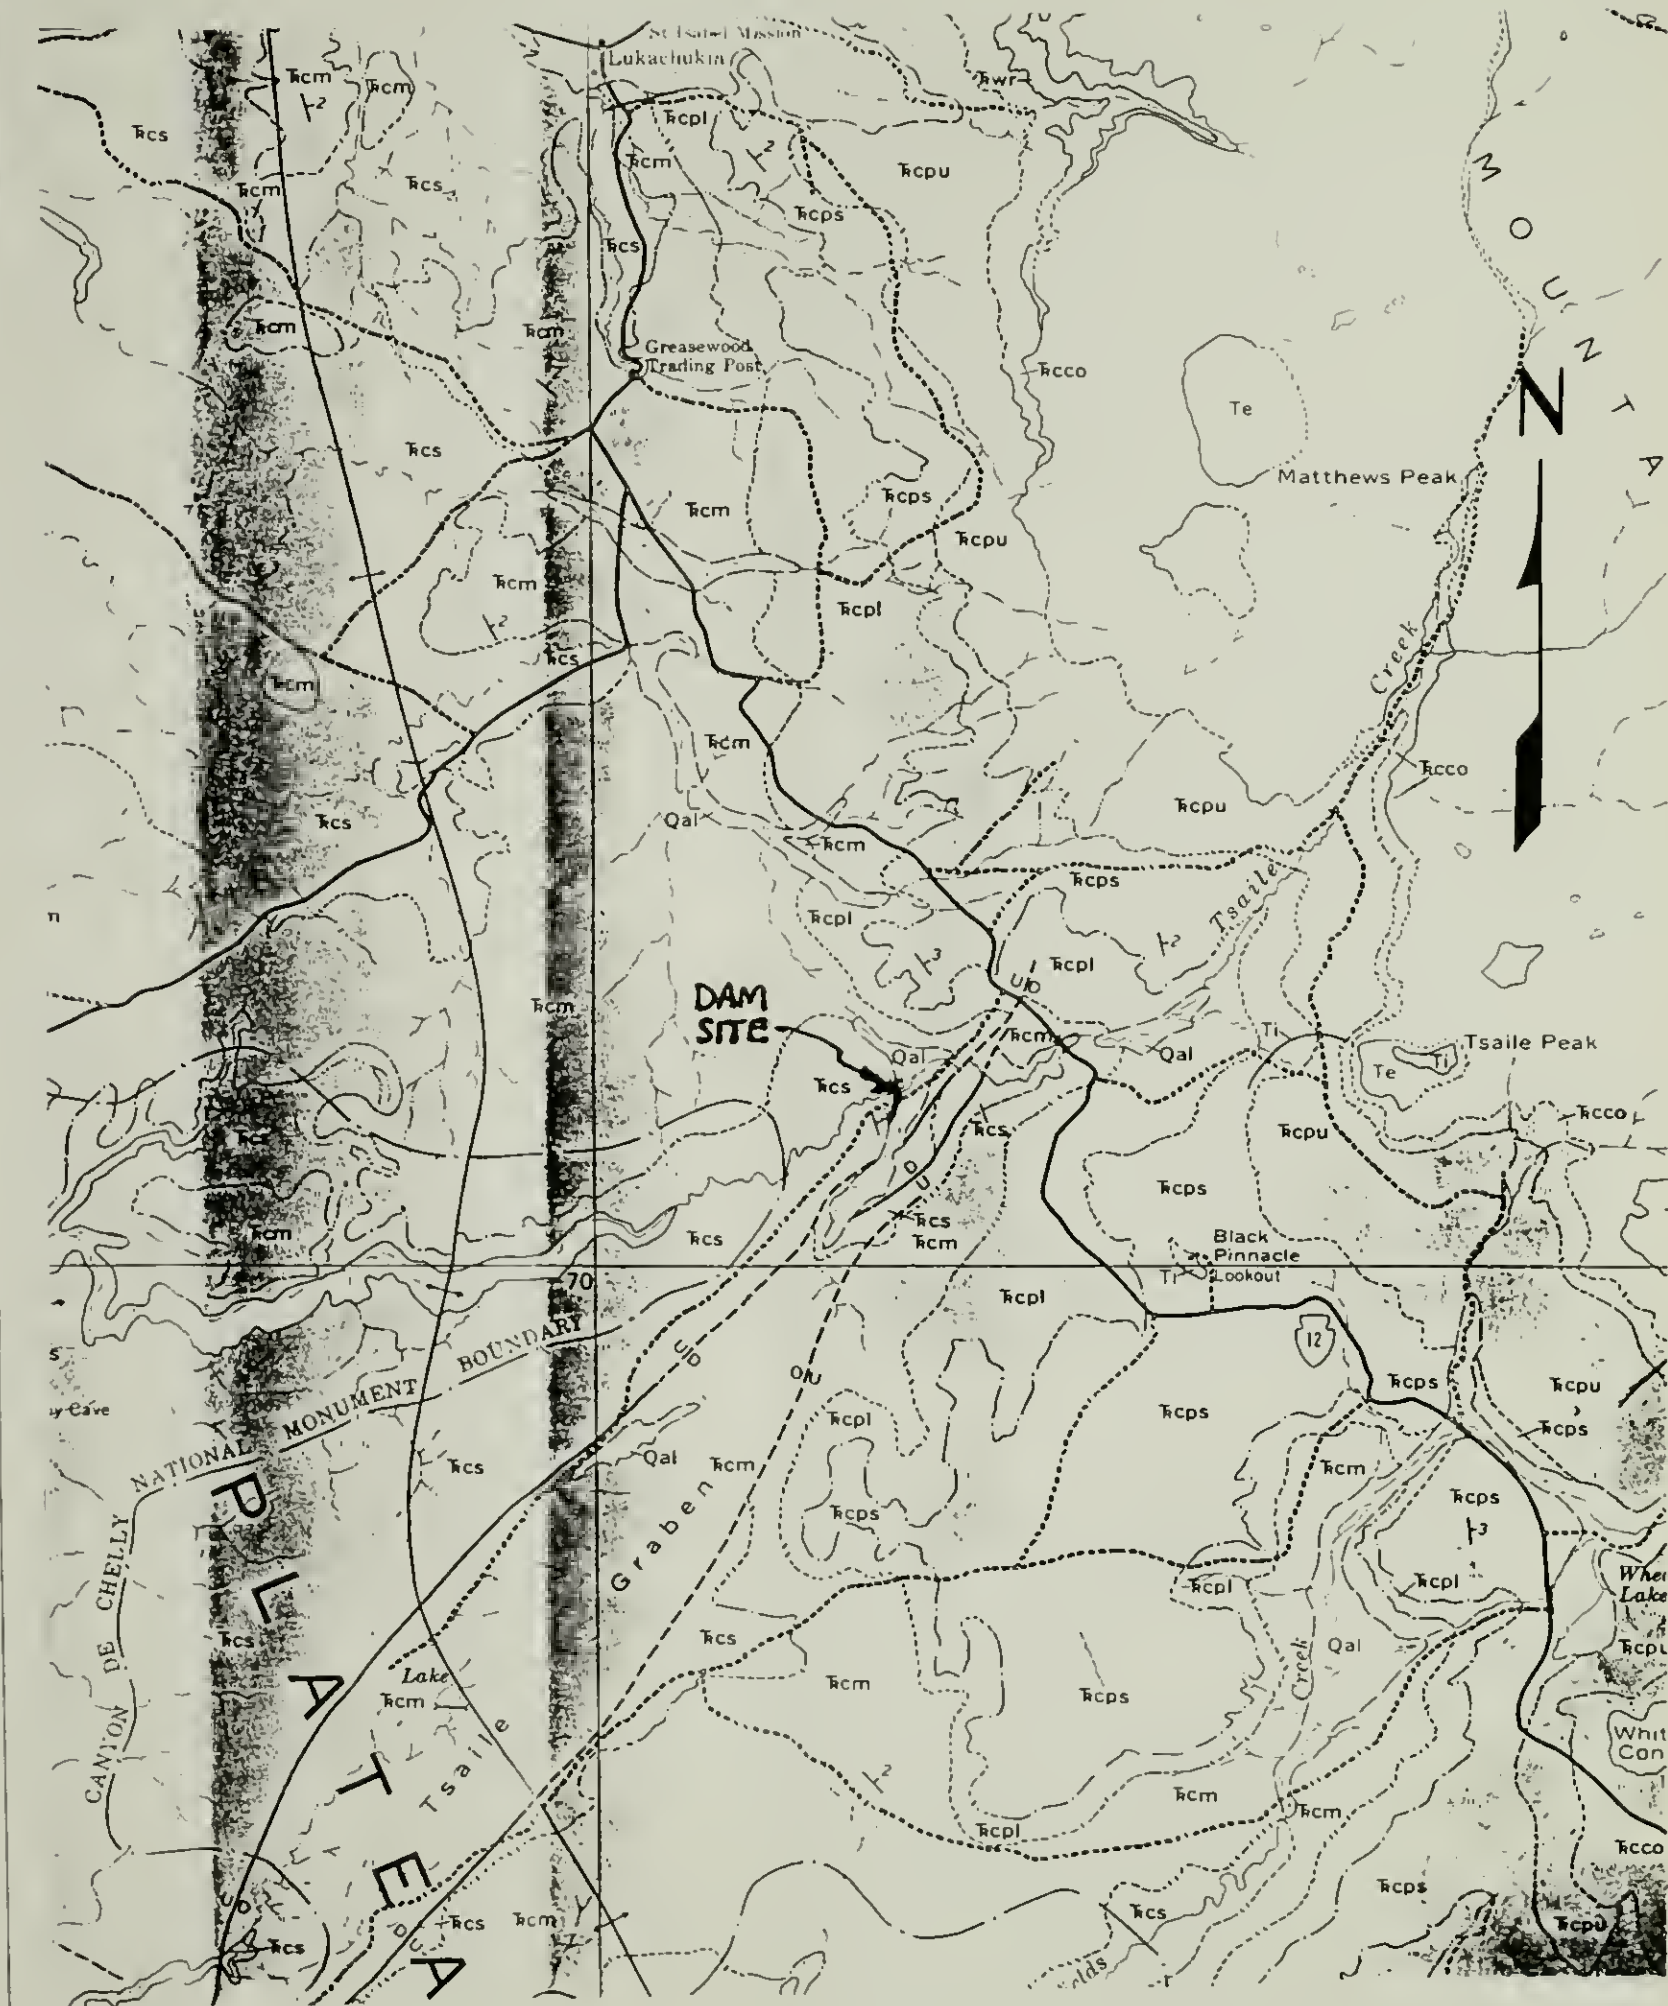
SITE PLAN/TEST BORING LOCATION

maintained open by means of 7 inch OD hollow stem augers. The boring logs are presented in Appendix A, and the locations of all borings are shown on the Site Plan (Figure 2).

The dispersive potential of the fine grained materials was assessed by 4 pinhole dispersion tests (reference 7) performed on representative samples of the cohesive embankment materials from the downstream slope area (Figure 2). Results of these tests indicate that the low plasticity sandy clay and clayey sand soils comprising the downstream embankment zone are somewhat dispersive (D2 or D2/ND4), while the higher plasticity silty clay soils are nondispersive (classified ND1 and ND2).

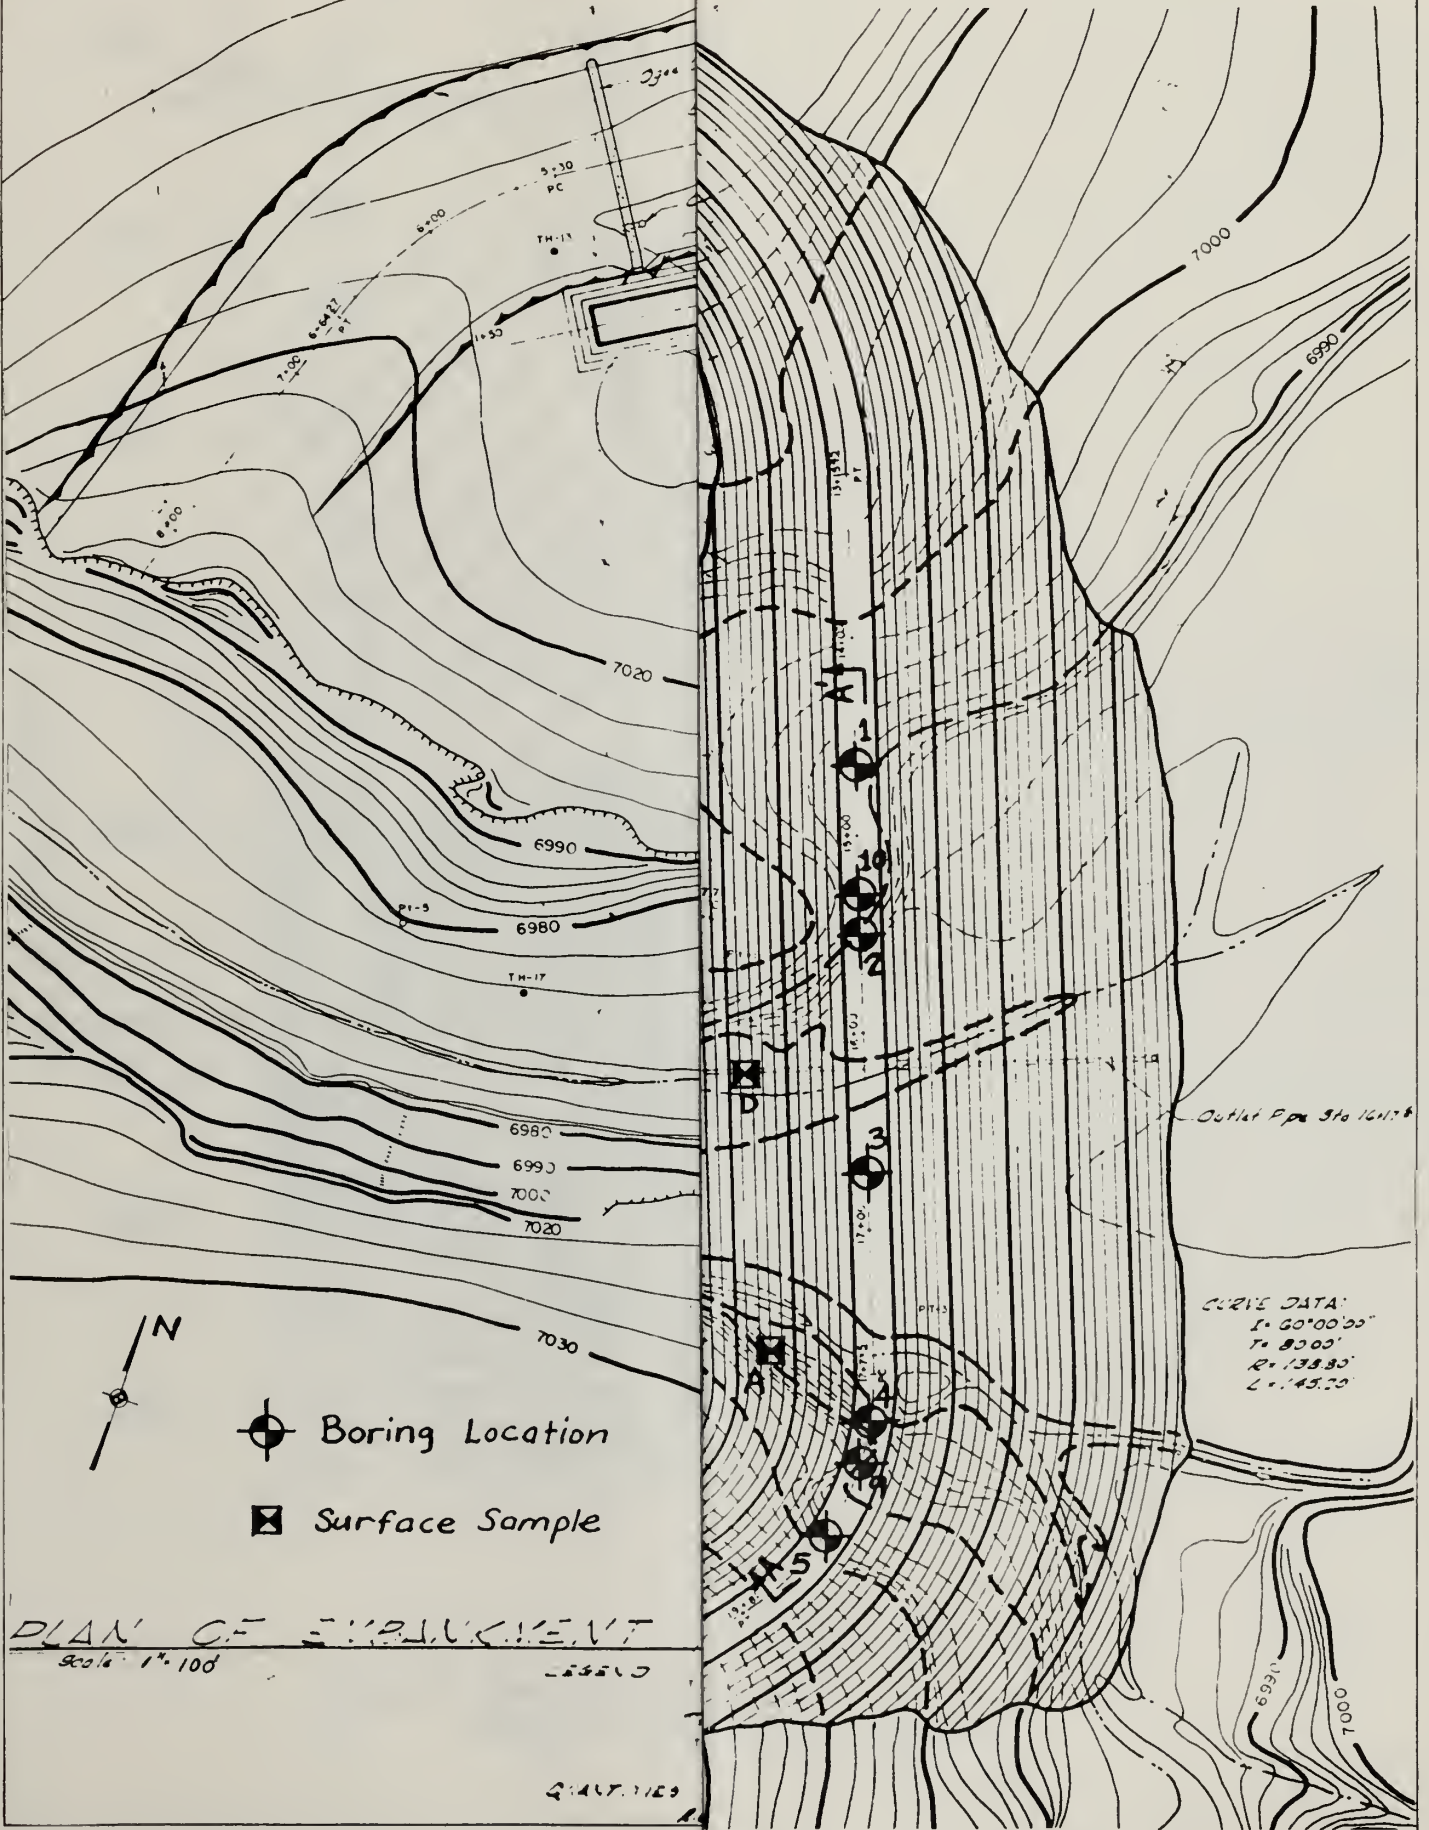
above. At the level of the valley floor, overhang areas (with overall heights of 5 to 7 feet) are present below the nearly vertical portion of the rock abutment areas. The lower 4 to 6 feet of these overhang areas are filled with alluvium. Geologic profile A-A', along a longitudinal center line of the dam at the maximum section, is presented in Figure 3.

D. Groundwater Conditions: Groundwater level measurements recorded during and after completion of the borings are shown on the respective borings logs and also on Figure 3. These readings indicate that the groundwater level at the time of exploration was situated at Elevation 6992 to 6998 within the abutment areas, while the groundwater level within the stream channel was situated at approximately Elevation 6988. It should be noted that the reservoir was virtually empty at the time the field exploration was performed. Fluctuations in the location of the long-term groundwater level should be anticipated depending on variations in precipitation, evaporation, surface runoff and the reservoir level.
