**Demonstration Enhancement of Pueblo Colorado Wash**

**Hubbell Trading Post National Historic Site**

**Grant No. 97-029WPF**

**FINAL REPORT**

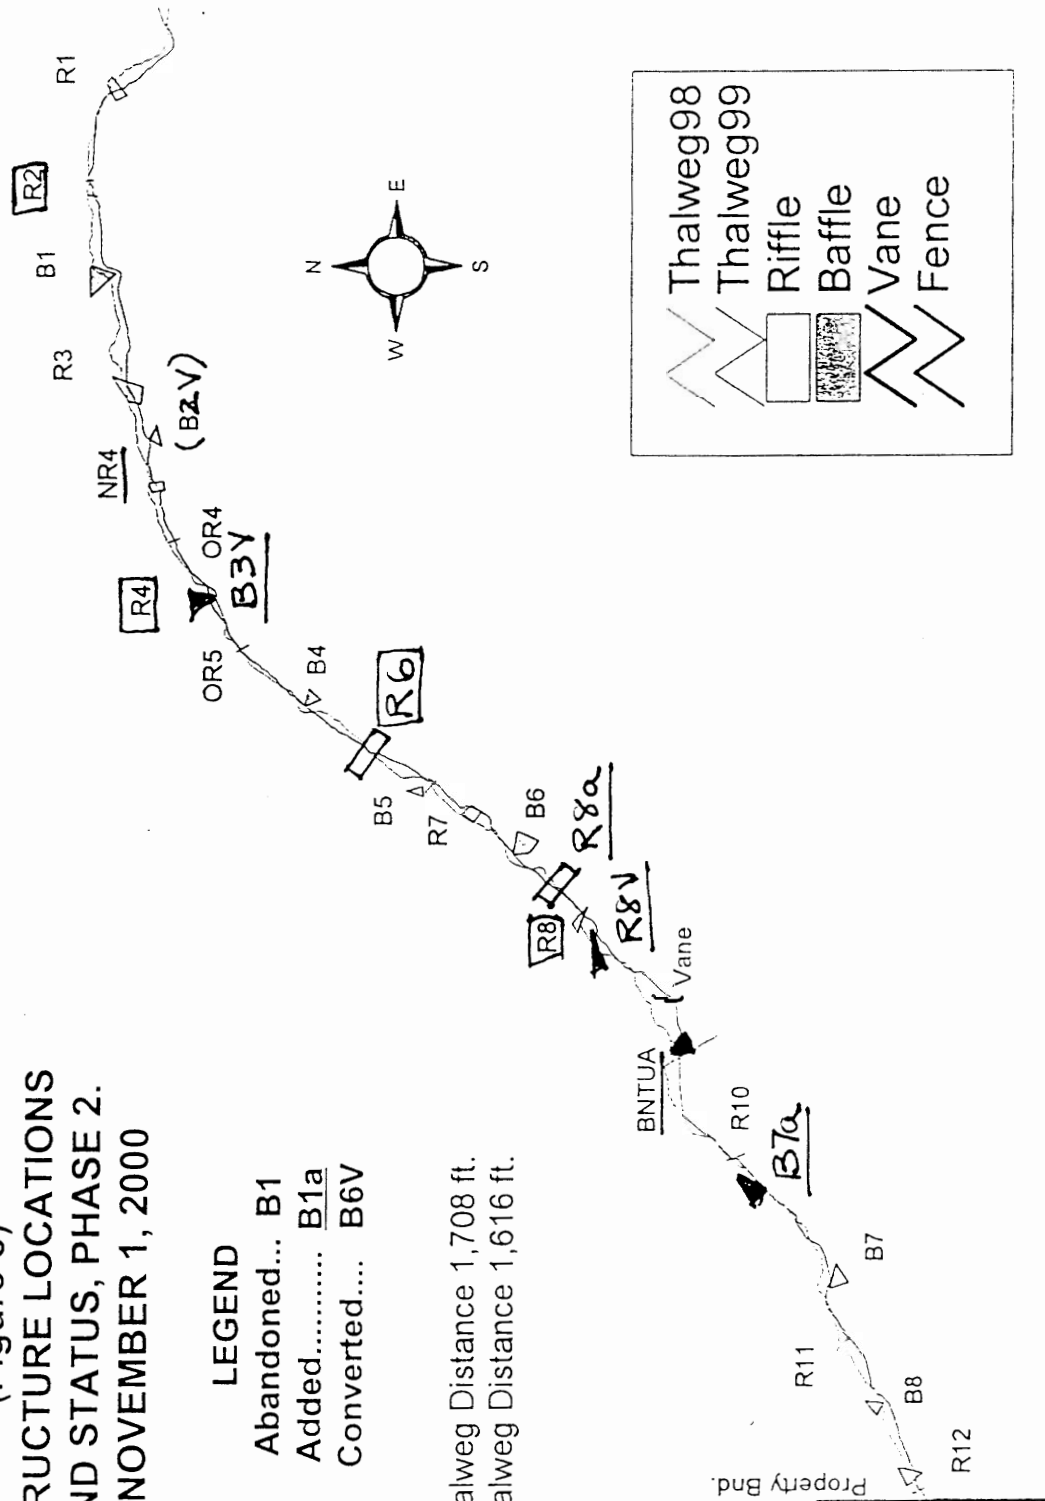
**Figure 3: Structure Locations and Status, Phase 2, November 1, 2000**

Phase 2 structure locations are displayed in Figure 3. Construction in Phase 2 Reach began in June 1998 and was nearly completed in late July when hit by the July 29 flood (800 cfs, or five times bankfull). All rock and rubble structures were damaged; some were destroyed. Baffles constructed of rock and rubble did not have sufficient resistance to withstand shear forces associated with this event. As a result, structures were re-designed and modified to increase their resistance to shear stress. Modifications consisted of adding wooden pickets (stakes) and/or wicker (stakes with interwoven tree boughs) to the margins and interior of baffles and of replacing rock only riffle-weirs with low rock and wicker weirs. Wicker weirs were built to extend from 6 to 8 inches above bed elevation and equal to channel width in length and comprised of 3 to 5 parallel wicker placements. Reconstruction was completed by September and all structures in both reaches were in good repair going into the winter of 1998-99.

Two overbank events occurred during July 2000. All structures performed well without damage and channel response was significant adding about 300 feet to channel length. All structures were maintained and in good repair prior to the Winter of 2000-2001.

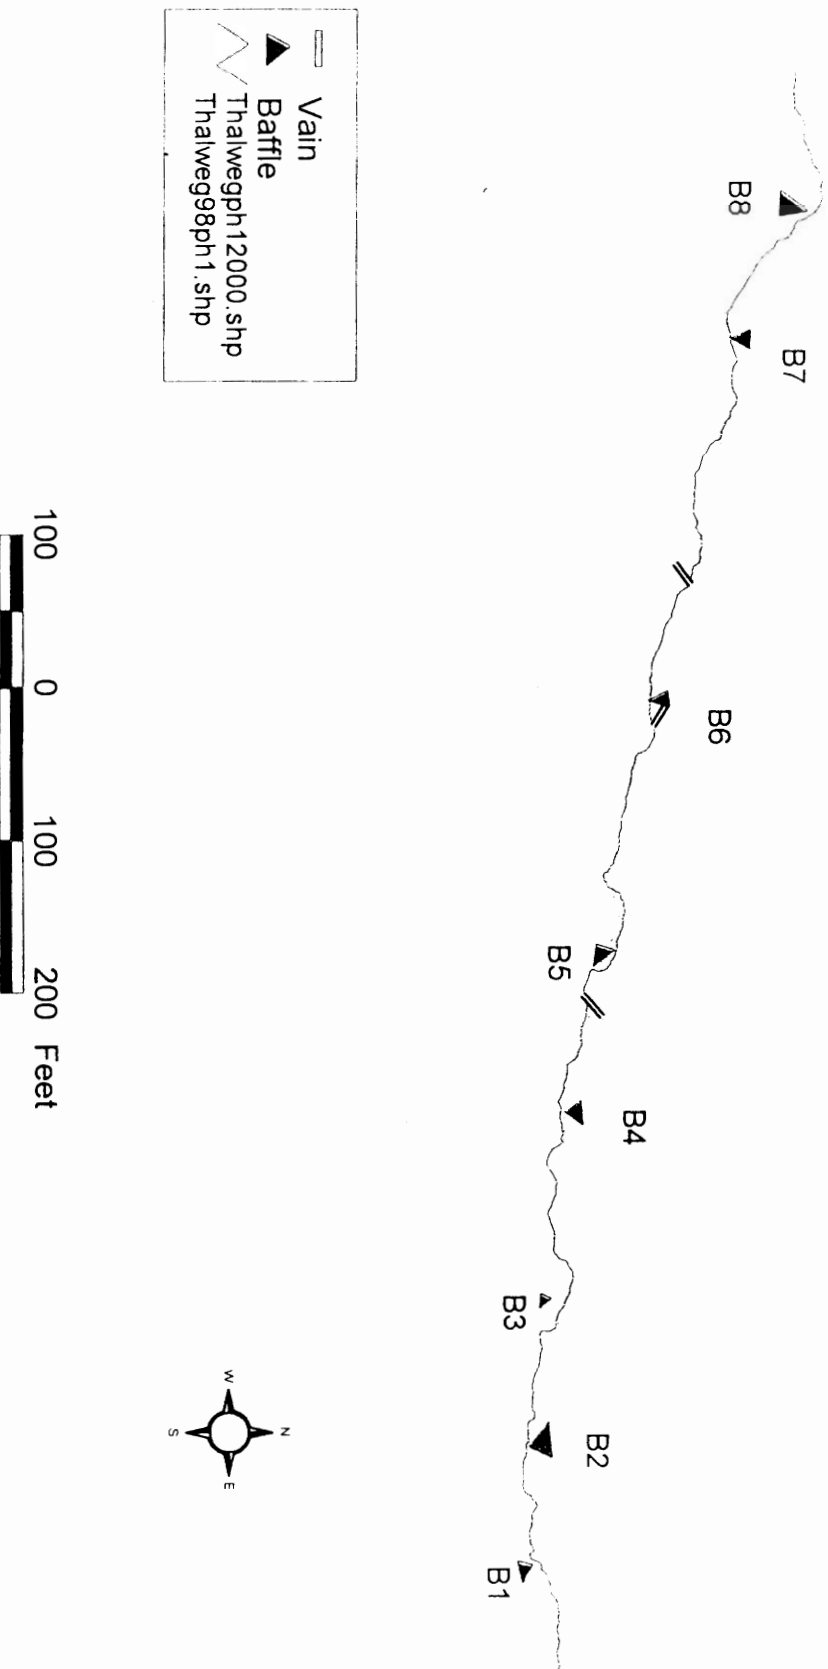
**Figure 4:     Hubbell Trading Post, Pueblo Colorado Wash Restoration Project Channel Changes, Phase 1**

Results are displayed in Table 1. In summary, change in channel morphology was more dramatic in the Phase 1 Reach where channel length increased from 1,074 to 1,466 feet (Figure 4), channel width increased from 12 to 21 feet, sinuosity increased from 1.04 to 1.41, channel slope decreased from 0.62 to 0.41% and meander length increased to 293 feet. Change in channel widths in response to structure installations is displayed in Tables 4 and 5. An obvious floodplain up to 35 feet wide has evolved in the upper 400 feet where no floodplain existed prior to treatment. One permanent pool was present in the Phase 1 Reach prior to treatment, but 9 pools were present through the year 2000 low flow period. Flood prone areas are well stocked by vigorous stands of Scirpus and an increasing diversity of other herbaceous riparian species. Overall the Rosgen channel type is F-5 with 2 short subreaches of Type E channel and one residual subreach of G. If the present trend continues, the entire reach is expected to evolve to Type E-5 within the next three years.

1998 Thalweg distance 1,204 ft.  
2000 Thalweg distance 1,466 ft.

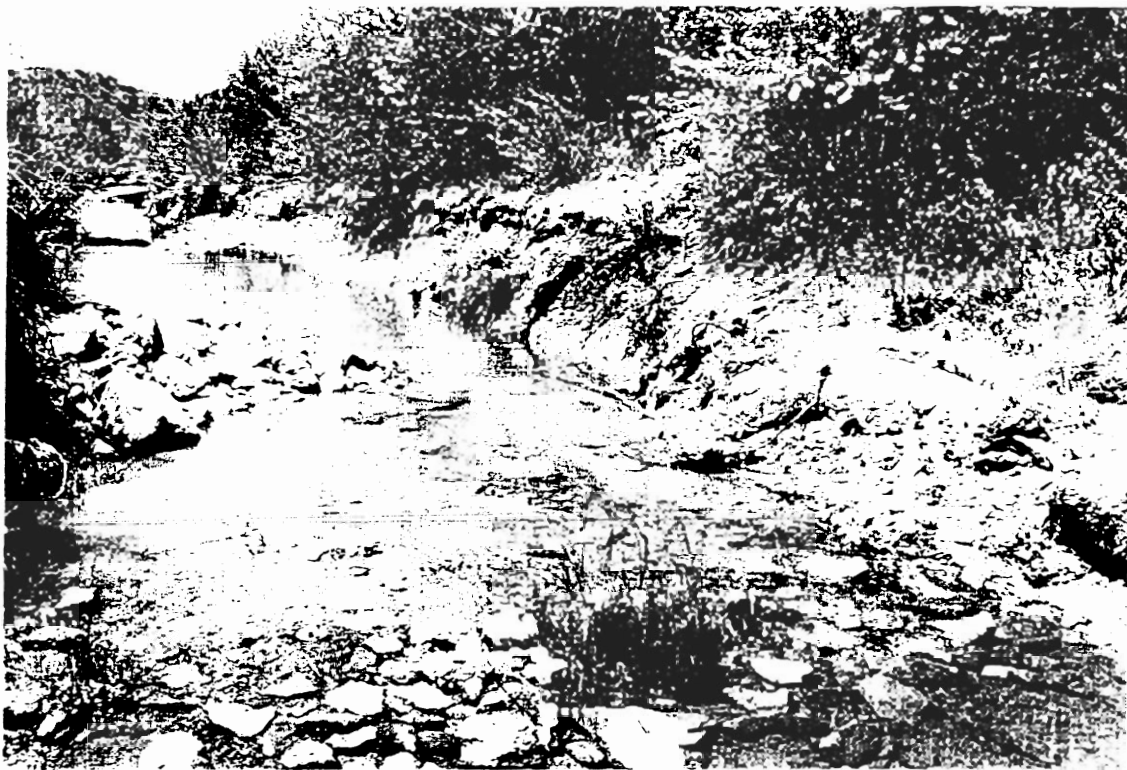
Phase 1. Riffle 4 Foreground. Baffle 5 midground, left. Both structures rock only. May 21, 1998.

Same site from opposite bank. pickets added to Baffle 5. May 25, 2000

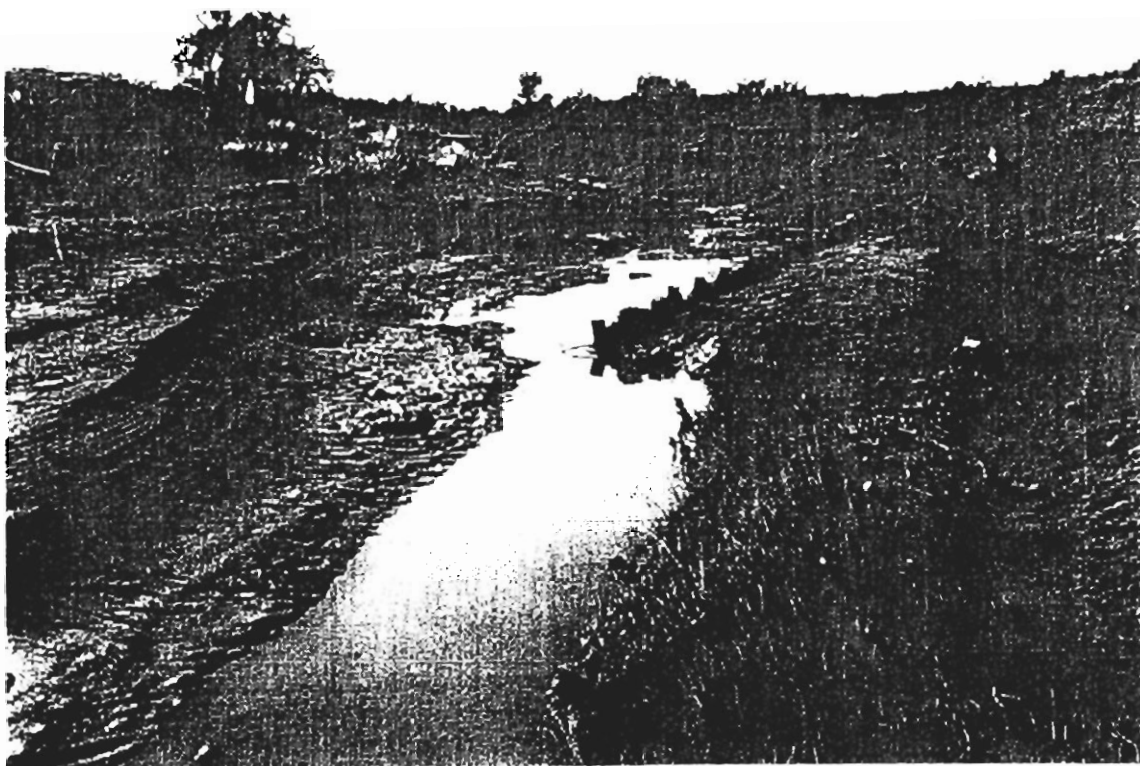
A Post Vine at site B3V, Phase 2 Reach, view west, November 2, 2000

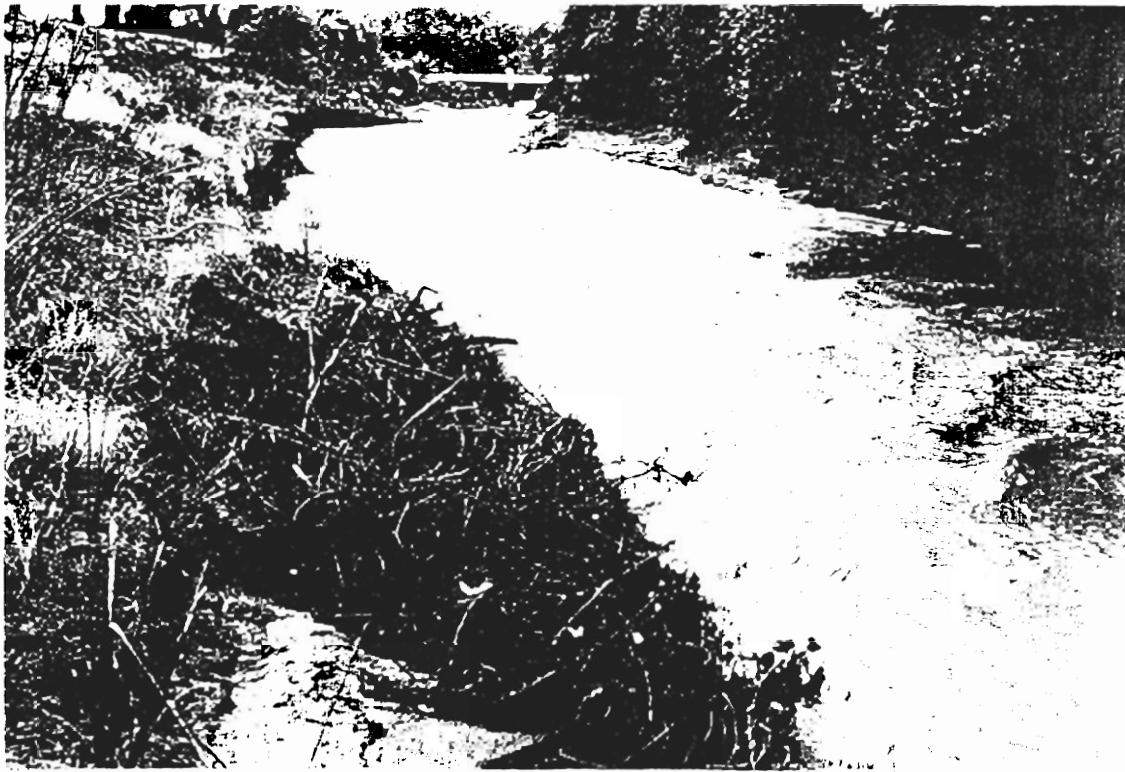
Same view. Bankful discharge July 29, 1998.

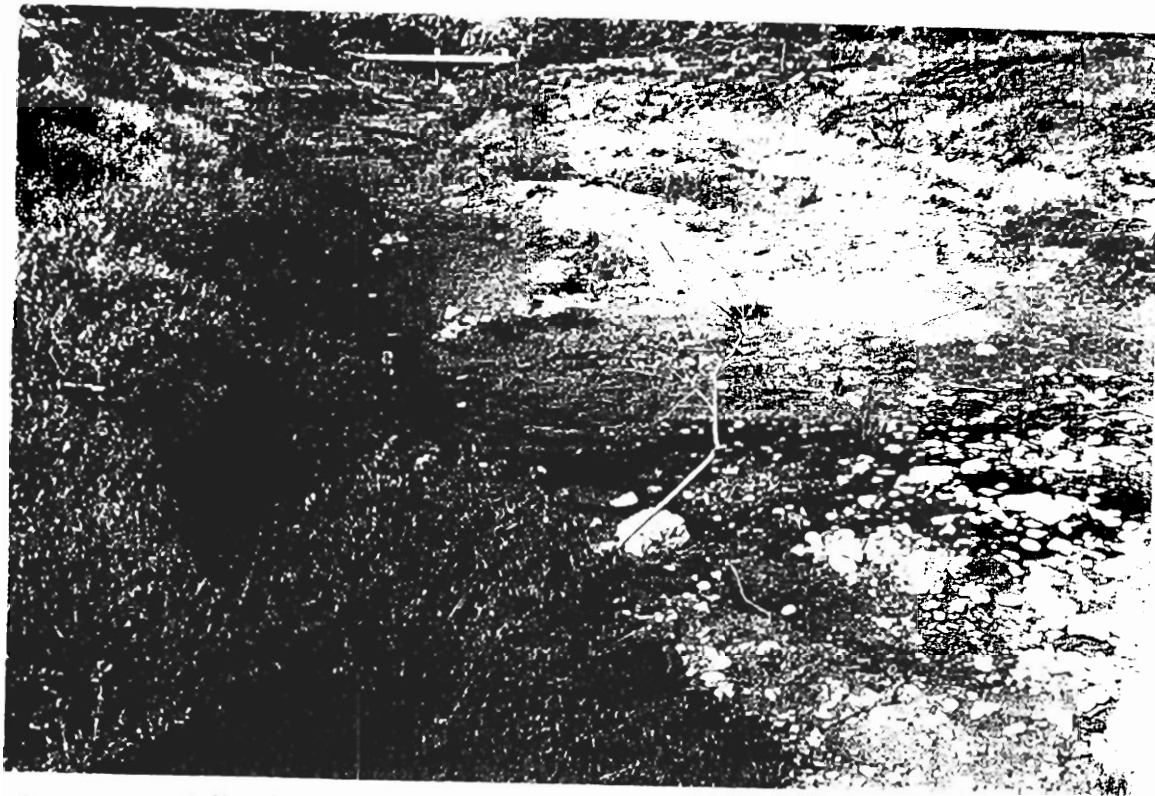
Same view. Following spring runoff 1999. June 23, 1999.
