Redwood National and State Parks

**NRPP Watershed Restoration Project:  
Removal of the B530/B560 Roads  
Lost Man Creek**

Michael B. Sanders  
February 17, 2004

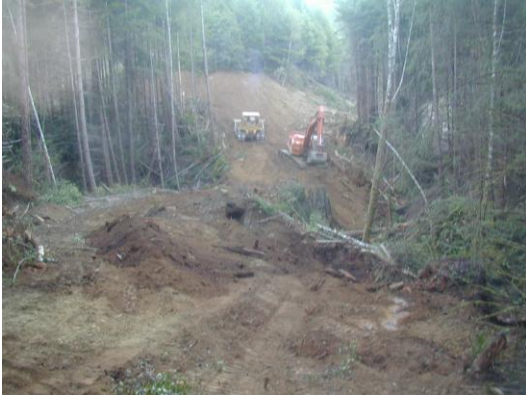
Initial work required the reestablishment of access across the old bridge. When the center stringer failed, a road-wide hole developed in the center of the crossing. In order to gain access to the fillsite and additional work on the opposite side of the crossing, the large cavity in the center of the bridge needed to be filled. This was done by first placing a large quantity of woody debris, particularly cut sections of alders from the immediately adjacent area, and then placing filter fabric over that. A bulldozer then filled in the rest of the void.

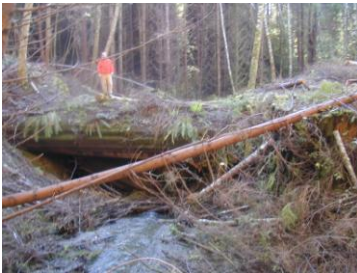
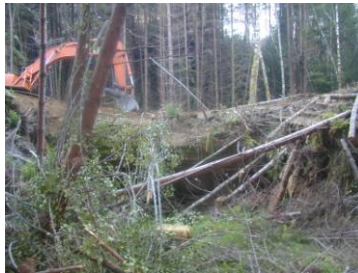
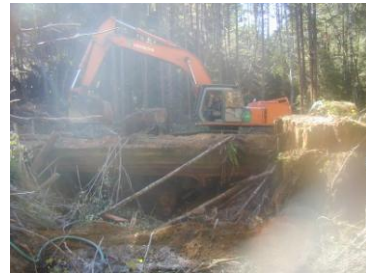
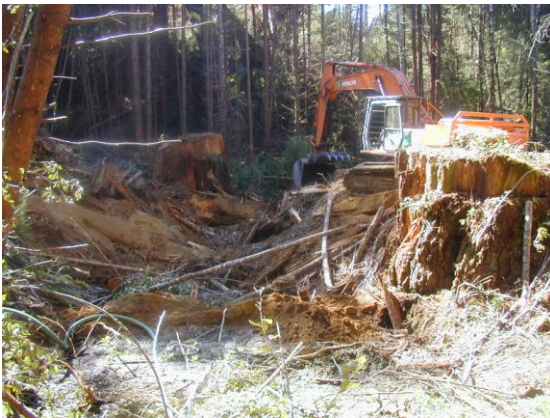
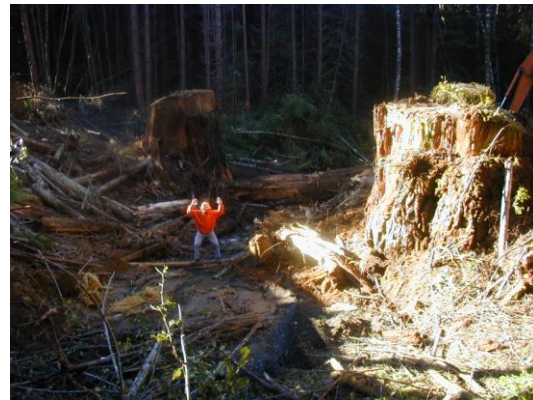
Once work on the opposite side of the crossing was completed, vegetation and woody debris were stockpiled immediately adjacent to the crossing. The equipment then started to deflate the material on top of the bridge, eventually exposing the intact remaining log stringers. These were then skidded out, with one being recovered by park staff to be used for future park projects. The other was left next to the crossing, along with a wealth of other large woody debris to help protect the slopes from future weather impacts.

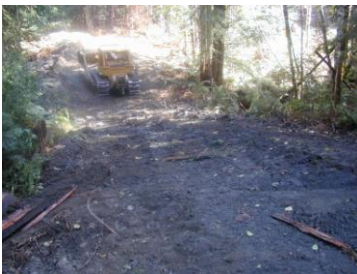
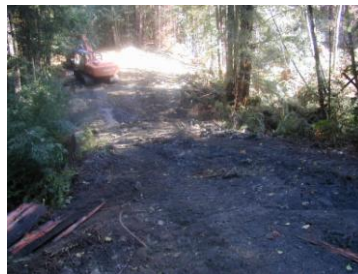
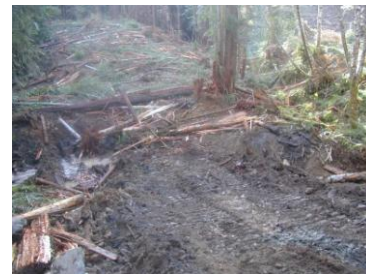
When the Bailey bridge was removed, the contractor installed a pump to divert Larry Damm Creek around the bridge site. Once the creek was diverted, the bulldozer began reconstructing access to the opposite side of the crossing and began pushing extra fill across the bridge to fillsites located to the south. In conjunction, the excavator was able to complete slope work on the remaining portion of the B550 road.

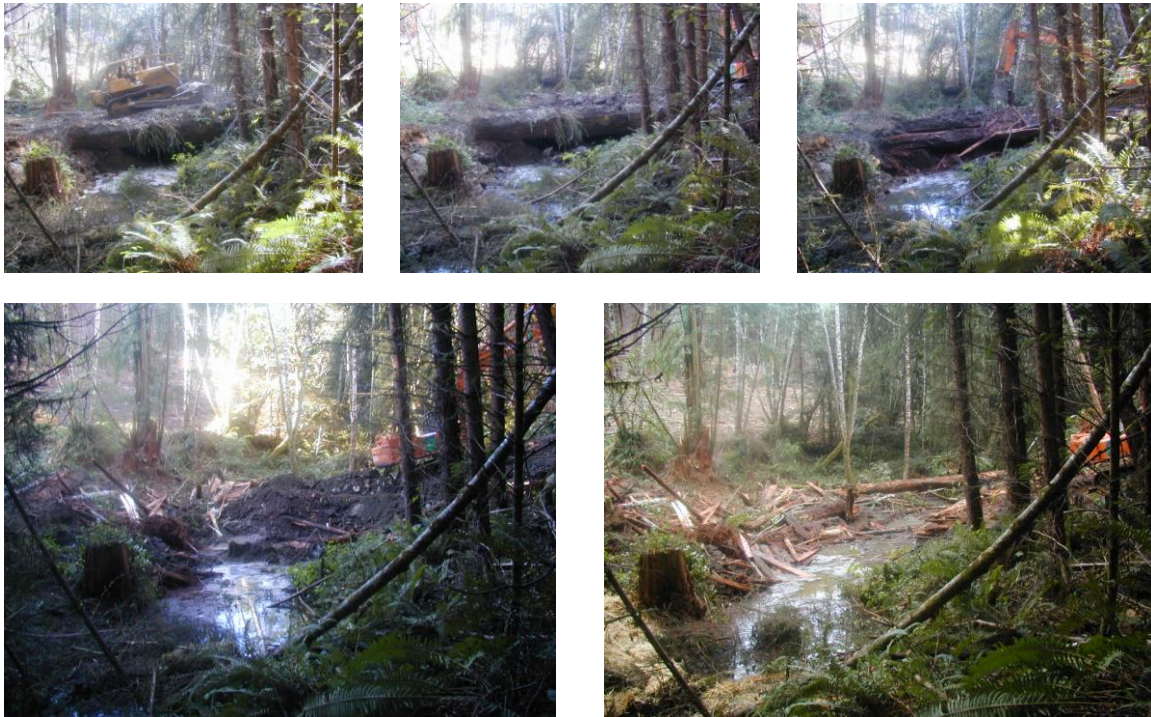
Once the south side and all roads beyond were complete, the contractor began the removal of fill and the log stringers. The pump and hose were repositioned over the completed work on the south side and equipment began removing the fill from the bridge surface and buttresses. Once the log stringers were exposed and able to be removed, these were skidded out using the bulldozer. Unlike the B530E bridge, all the stringers on the B550 Bridge were in considerably degraded shape and none were able to be utilized for any other purpose but compost. These stringers were moved just out of the work site to make room for equipment, and once the bridge and material was all removed, the log stringers (or at least what was left of them) were then pushed back to the finished work and placed on the finished slopes. The final task was to break down the pump and hosing, bust up the straw bale fish barriers and let Larry Damm Creek flow unobstructed through the work site.

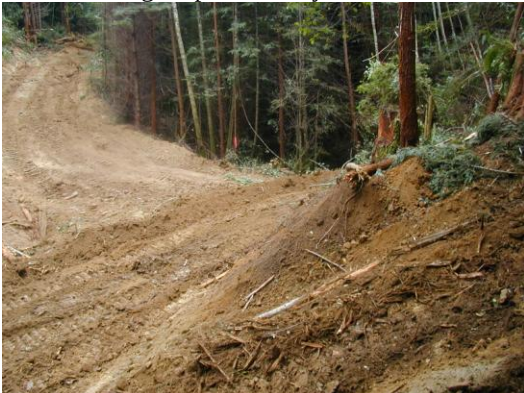
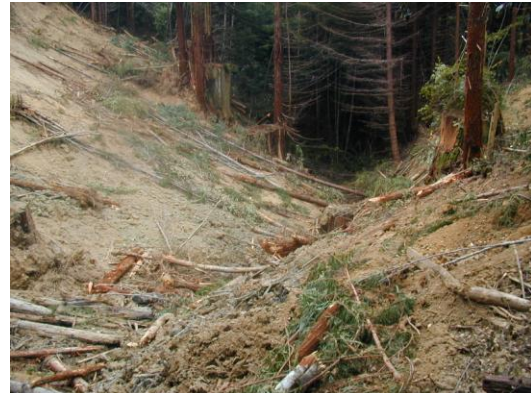
The final crossing on the northeast spur was the lower crossing, RX NES L1. This crossing also had a portion of the channel buried due to a road up the draw, but its scale was considerably less in areal extent as that of the upper crossing. In addition, larger capacity fillsites were located more proximal to the excavation. While this site allowed for more utility on the part of the bulldozer, the operators decided to have the bulldozer work another site on the northeast spur. This allowed both pieces of equipment to maintain a higher productivity.

Initial work on the lower crossing was performed by the bulldozer, which was pretty effective in reaching

the capacity of the fillsite located on the terminal side of the lower spur. This being accomplished, the bulldozer continued to export fill up the northeast spur until the excavator replaced it. At that time, the excavator completed the worksite, dressing out the fillsites and the final crossing.
