Summary Report  
Watershed Rehabilitation Unit 03-03  
Y zone and B540 Roads

Portion of road removal work in the Larry Damm Creek watershed  
(Lost Man Creek)  
Completed with Line Item Construction Funds  
Package #277

Neal Youngblood  
Redwood National and State Parks  
December 2003

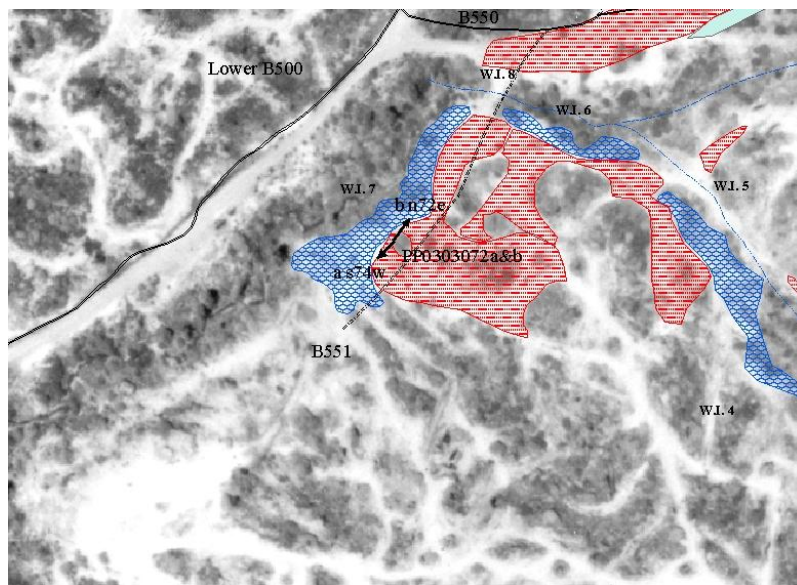
Figure 5. Location of Photo point 0303072a&b

a single point. An example would be at work item 7, where there are two photo's shot from photo point 2 (0303072a & 0303072b) (Figure 4). The bearing is given on the photo point map (figure 5) and labeled on the flagging marking the photo point site location.

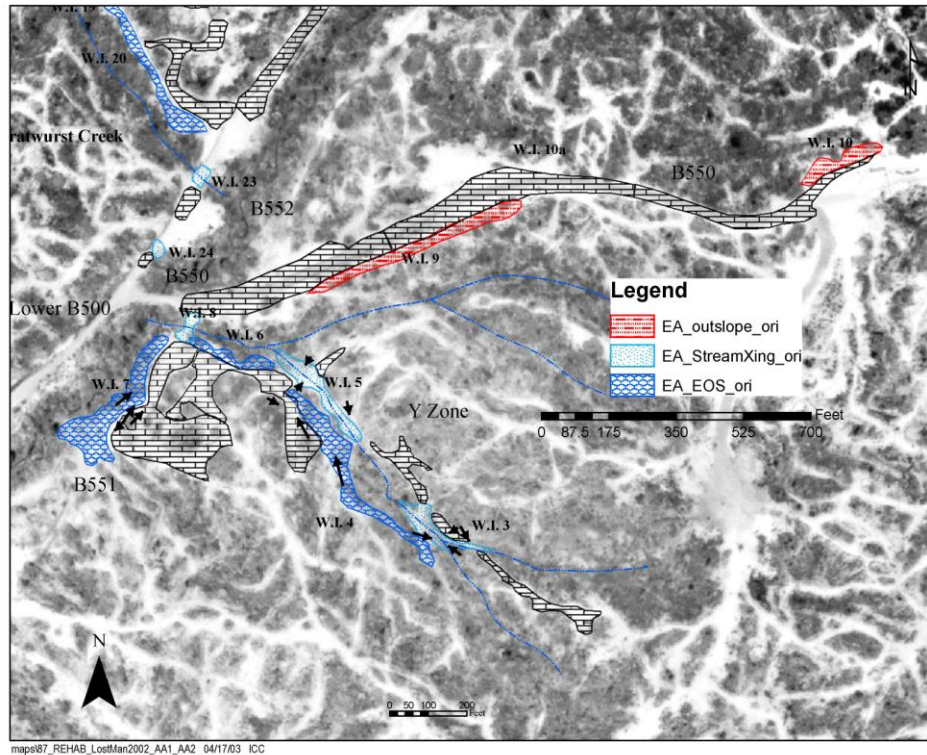
The Y zone portion of project 03-03 began on August 18, 2003. During this phase of the project, 3440 feet of haul road was either excavated or recontoured to a level that would adequately convey fluvial activity so as to restore natural drainage patterns and prevent anthropomorphic erosion, or render the site “hydrologically transparent” An additional 2343 feet of skid road was extirpated from the project area in the course of storing excavated fill from the problem road segments. Based on survey, a cumulative volume of 26951 yd<sup>3</sup> of road fill was excavated from the combined work items in the Y Zone. Three stream crossings were excavated as part of the Y Zone phase with a total of 8866 yd<sup>3</sup> of fill being removed from the associated stream channels.

Figure 8. The Y zone includes remaining portions of the B550, B551 and a critical segment of skid road to the southeast of the B550 / B551 junction.

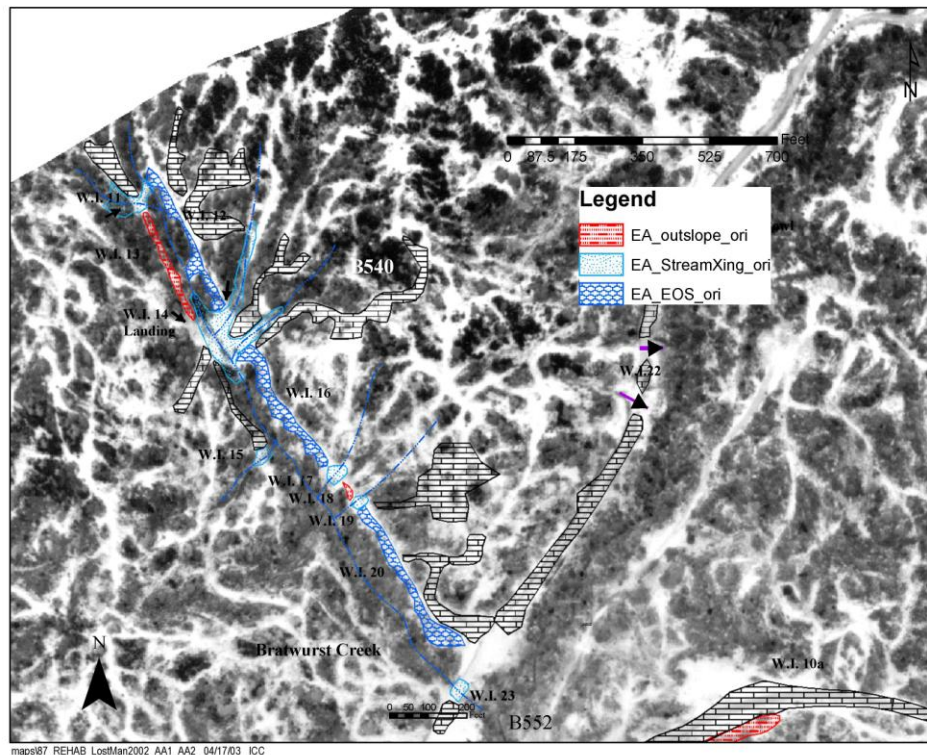
Figure 14. The B540 constructed along the left bank of Bratwurst Creek. All excavated fill from this work area remained upslope of the Lower B500.

The Geomorphology, logging style and road construction was similar to that found in PT Creek and the AA2 (road removal projects 03-01 and 02-04 respectively). The terminal landing was constructed at the confluence of three channels, burying the streams without drainage structure or means of fluvial conveyance. This landing overshadowed all aspects of project 03-03 in time, volume and cost.

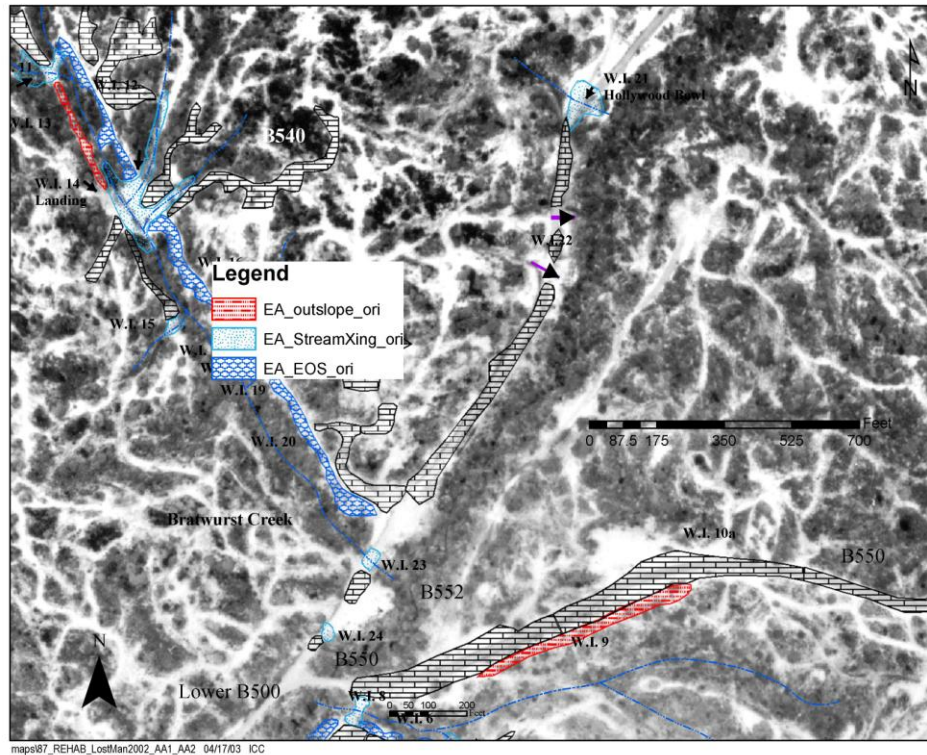
The lower B500 portion of project 03-03 treated 2125 feet of the mainline haul road. A survey volume of 7092 yd<sup>3</sup> of fill was excavated from three stream crossings in this segment of road. Two landings at the down station end of the segment were ripped and mulched to preserve as much of the riparian shade vegetation as possible.

Figure 18. The portion of the Lower B500 road treated in project 03-03 along the west bank of Larry Damm Creek. Most of this segment of road was used as a fillsite.

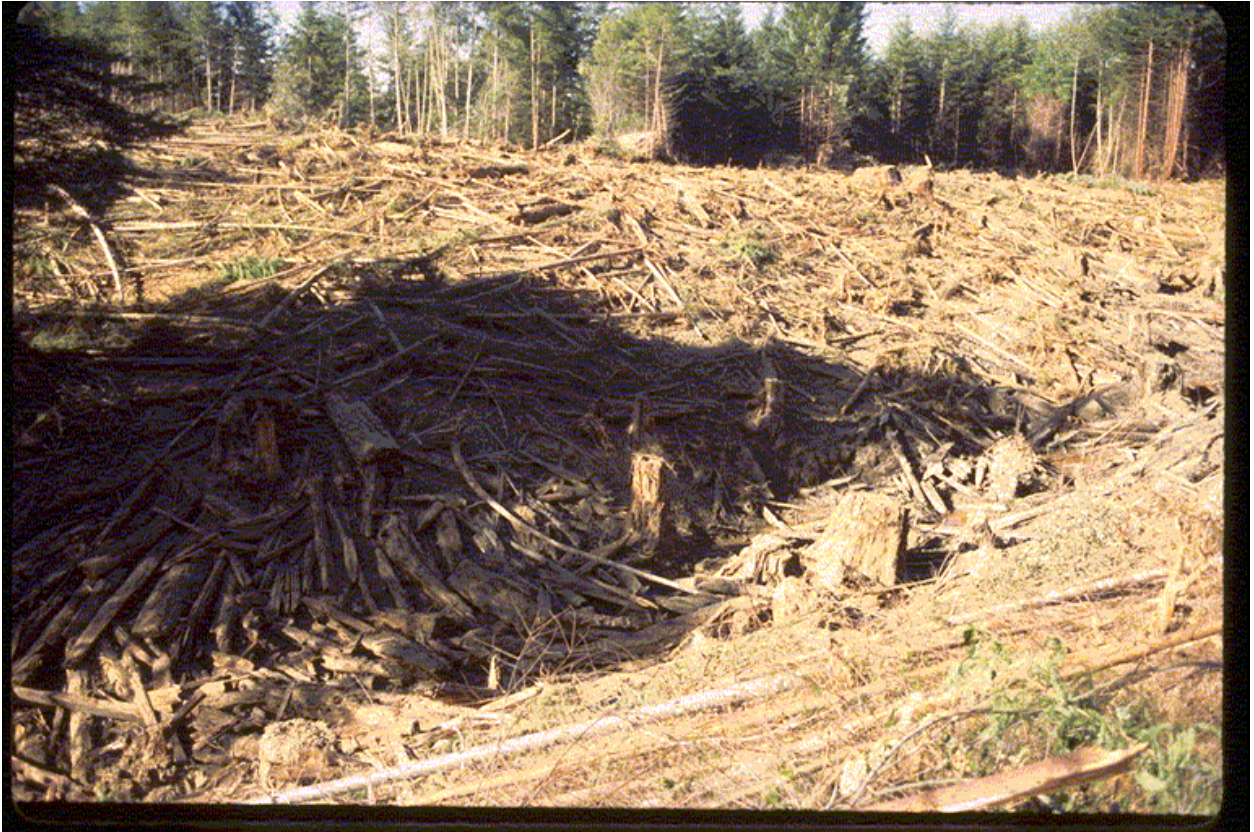
**Figure 3.** Vegetative debris mulching on excavation sideslopes provides for control of surface and fluvial erosion (this depicts a heavy rate of mulch application). Note the excavated stream channel with large woody debris placement in the foreground.

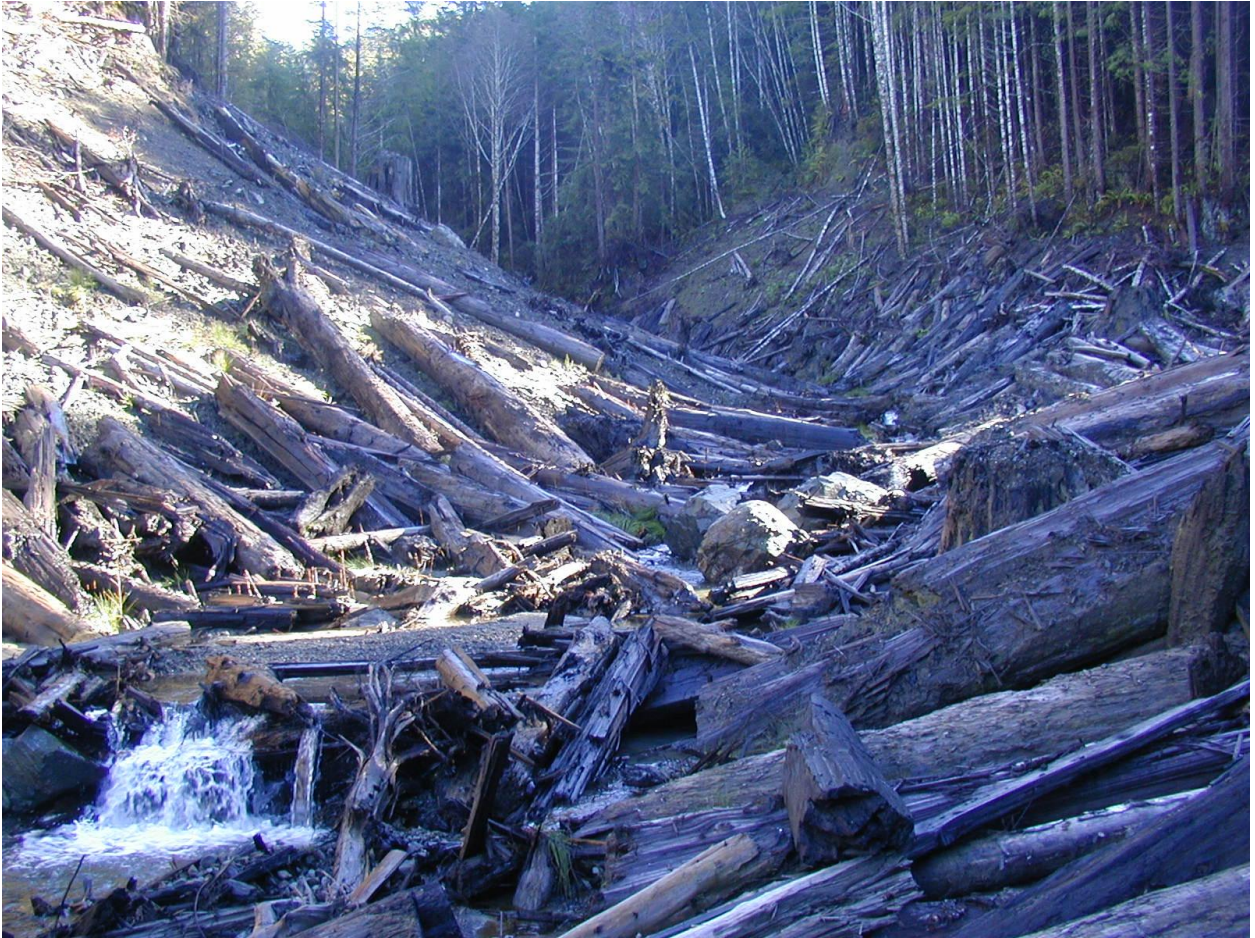
**Figure 4.** A stream crossing excavation with extensive woody debris placement. This photo was taken after the first winter following excavation.  
Adaptive Management
