Watershed Restoration Unit 02-04  
Summary Report  
AA1/AA2

Ingrid Corson  
Redwood National and State Parks  
July 2003

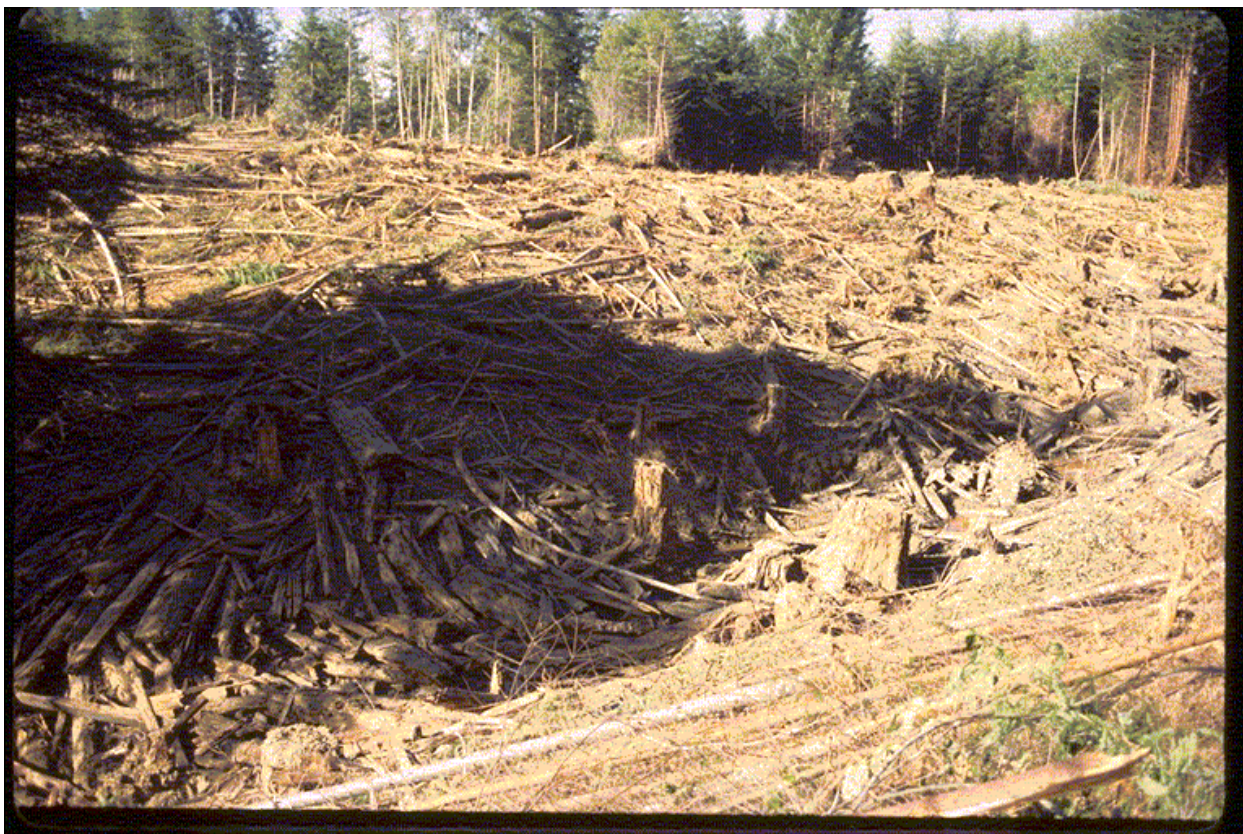
**Figure 3.** Vegetative debris mulching on excavation sideslopes provides for control of surface and fluvial erosion (this depicts a heavy rate of mulch application). Note the excavated stream channel with large woody debris placement in the foreground.

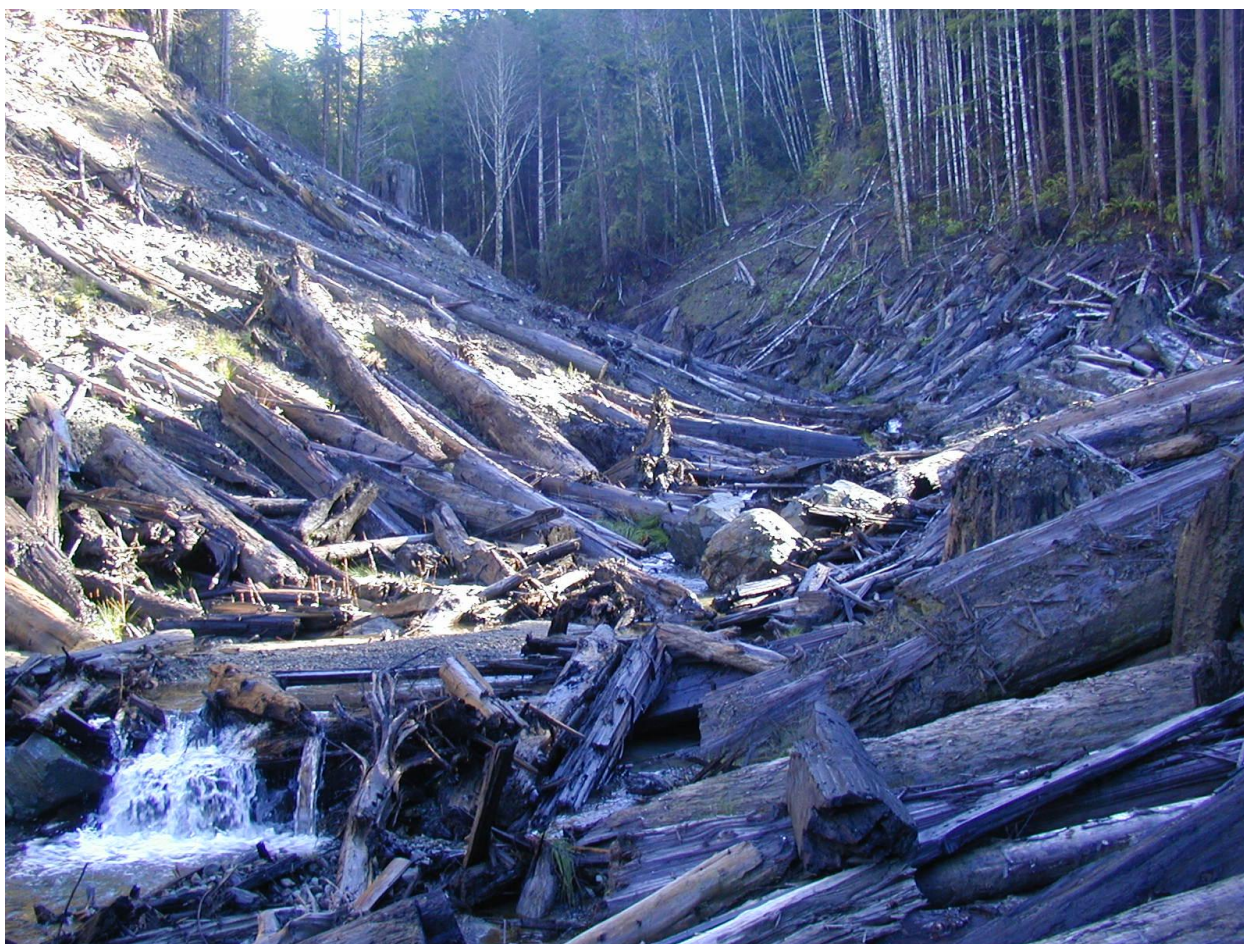
**Figure 4.** A stream crossing excavation with extensive woody debris placement. This photo was taken after the first winter following excavation.  
Adaptive Management
