**DRAFT** Summary Report

**Wetland and Stream Channel Restoration at the Arcata Redwood Co. Mill B site**

**Davison Creek Trailhead**

**A Redwood National and State Parks, ISTEa joint**

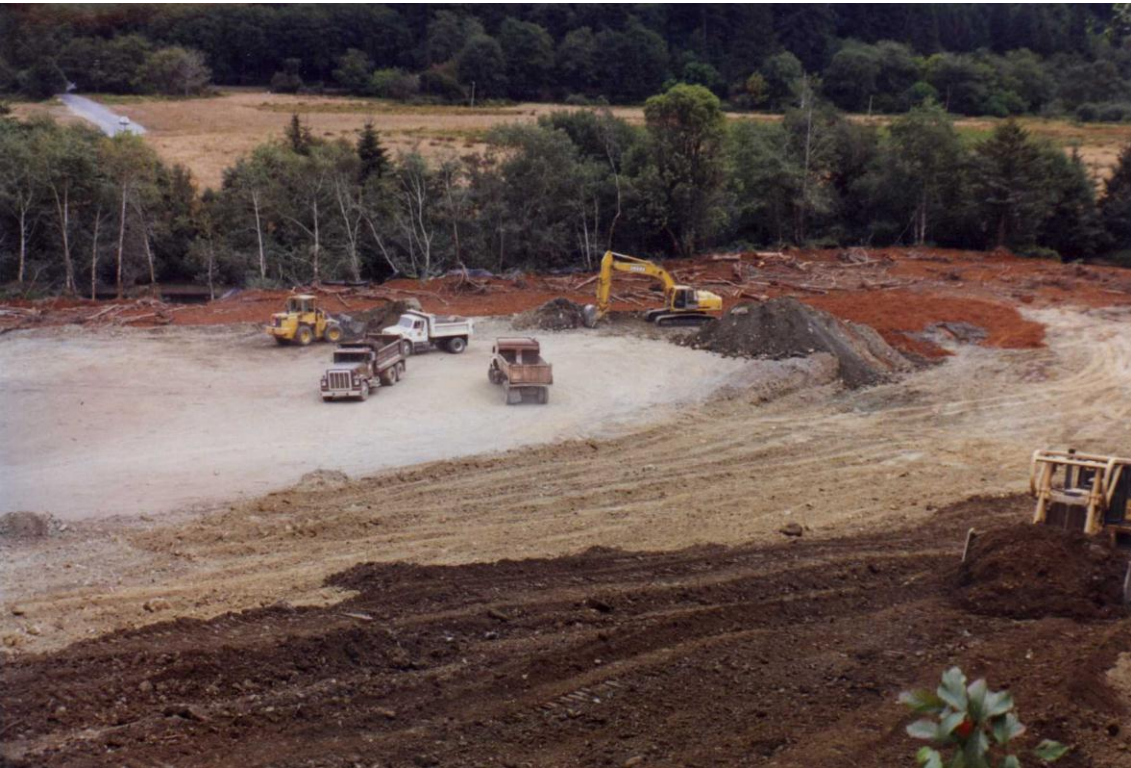
Photo 1. Trucks end hauling fill to parking lot site.

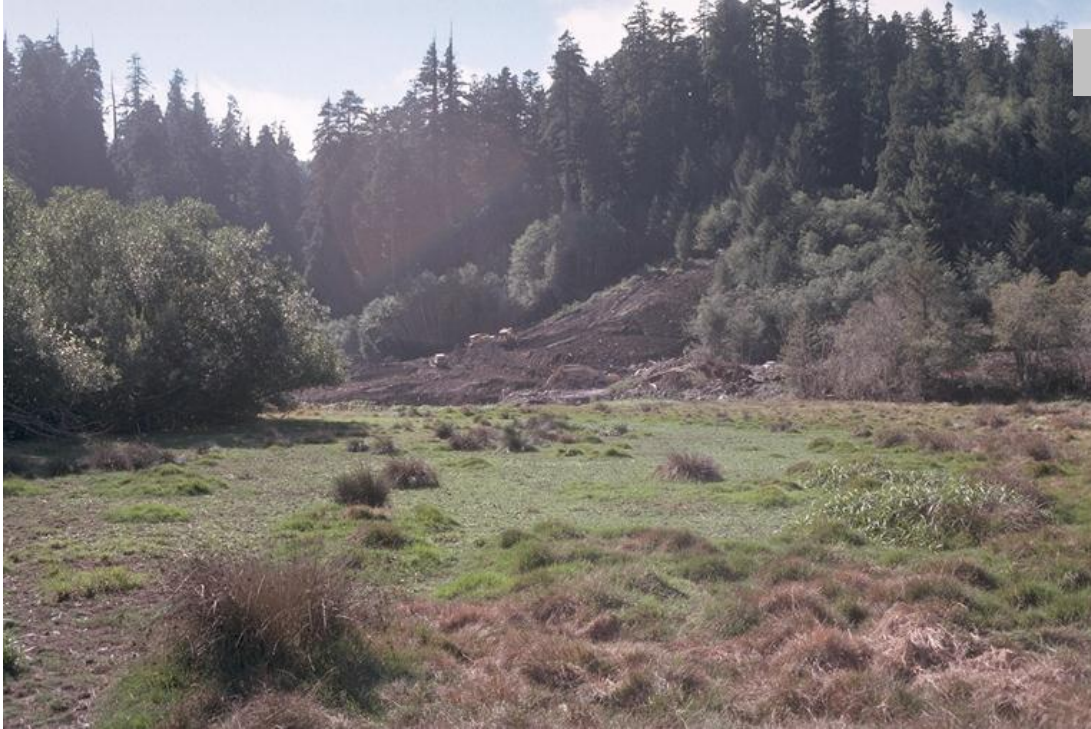
Photo 3. 'Representative wetland' north east of excavation site.

The expected morphology was based on the current condition of the adjacent wetland to the north east. As the actual morphology became apparent during excavation, a number of factors that were not previously considered came into play. For thirty years the representative wetland had been alcoved between Davison Ranch / Road and the lower deck, creating an artificial impoundment of the Prairie Creek floodplain. The impounded condition would create slower water during submerged periods, increasing deposition. The increased deposition would, in turn, fill in some of the depressional features. In addition, since the area had been pasture land, it may well have been mechanically leveled to enhance grazing quality.
