# Erosion Assessment for Montezuma Castle and Tuzigoot National Monuments

Natural Resource Technical Report NPS/SODN/NRTR—2010/281

January 2010

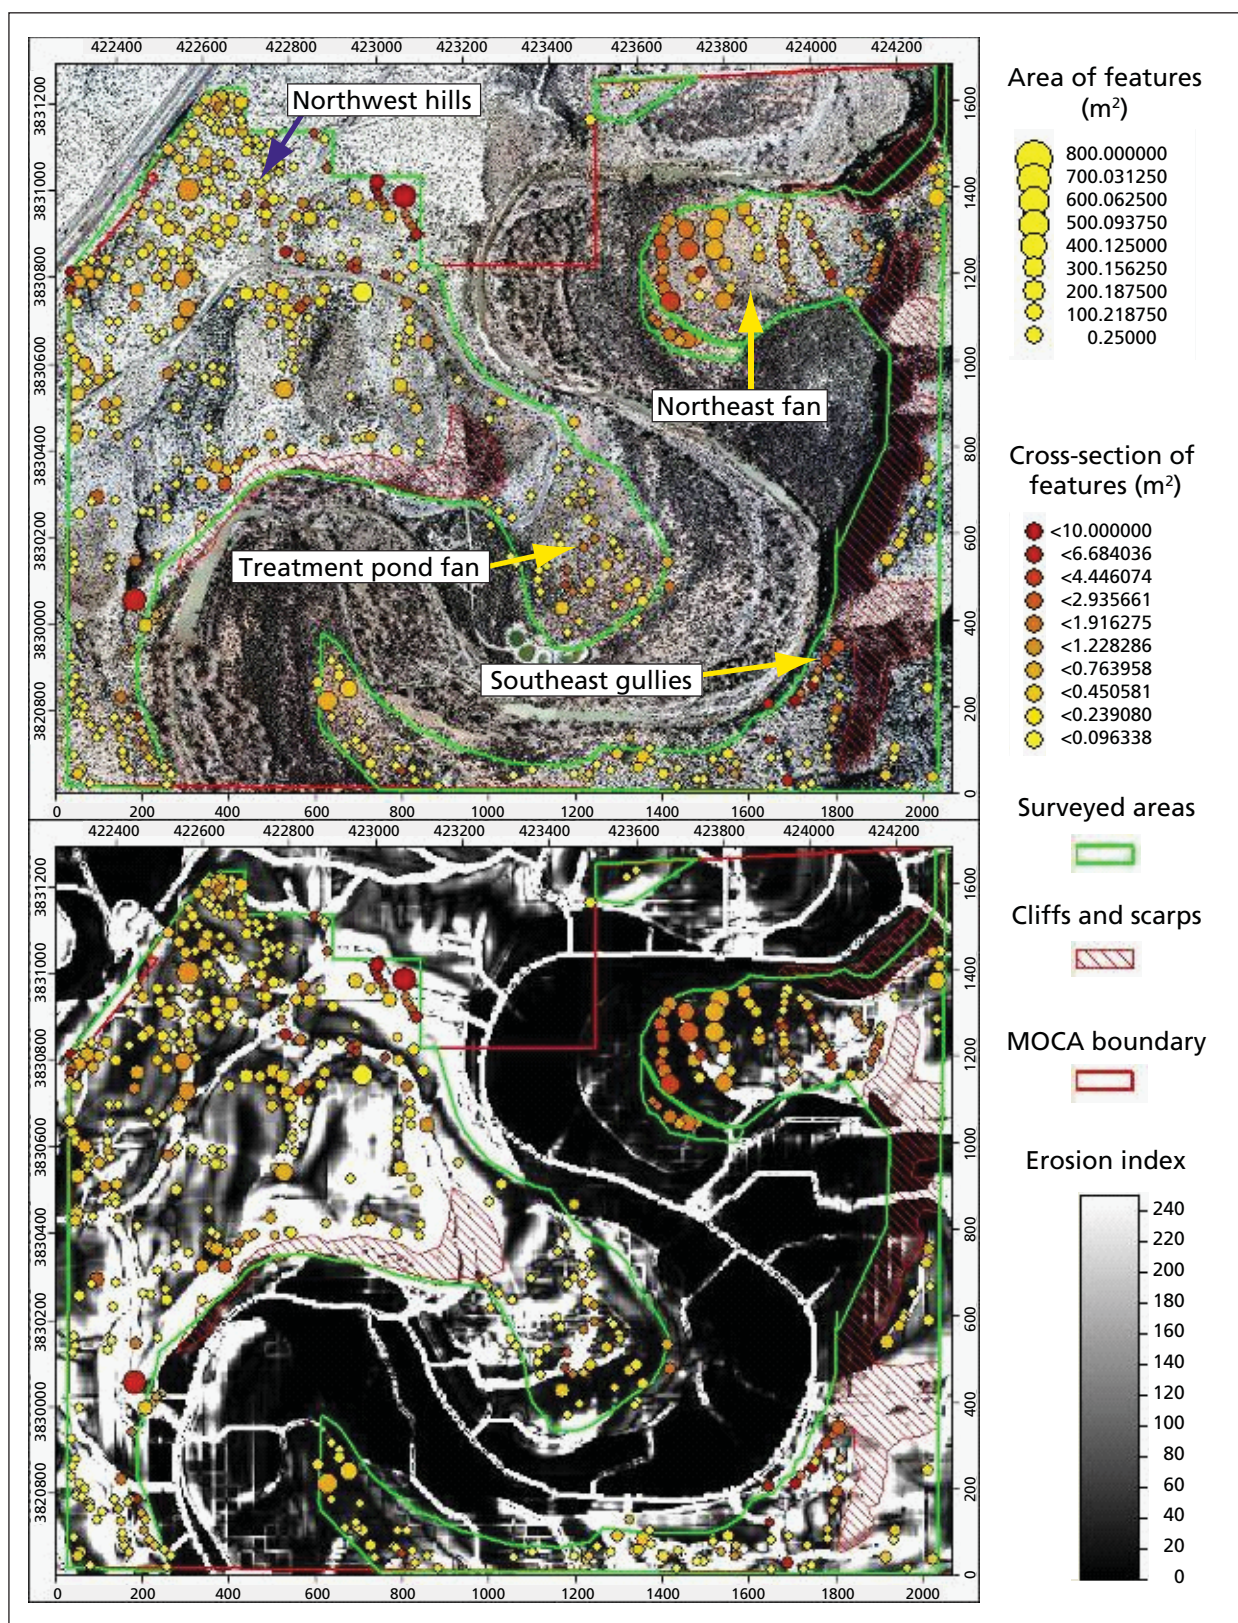
From the points taken, unique features were identified by combining points with the same feature ID. These unique features included 225 areas of sheet erosion, 165 rills, and 96 gullies. Total estimated soil loss from mapped features was 10,951 m<sup>3</sup>. Estimated contribution from different feature types included 1,584 m<sup>3</sup> from sheet areas, 810 m<sup>3</sup> from rills, and 8,557 m<sup>3</sup> from gullies. See Figure 3.1 for a complete map of features.

Although steeper areas along the Beaver Creek floodplain have high geologic erosion rates due to gravitational colluvial movement and high runoff energy, field observations did not yield many signs of acceleration along these slopes. These areas (red diagonal striping in Figure 3.1) exhibit rough, ledge-ridden slopes common to the local limestone outcrops, keeping accelerated

Figure 3.1. Maps showing erosion observations draped over 0.48-meter-resolution aerial photography (top) and a USPED erosion index (bottom). Redder dots have a deeper and wider soil-loss profile. Larger dots correspond to larger areas covered by erosion features. Lighter erosion-index colors indicate higher potential for either erosion or deposition and, thus, represent areas where surface-erosion features were expected in the field. Side ticks on left and top are UTM coordinates in meters. Ticks at bottom and right are scale bars in meters.

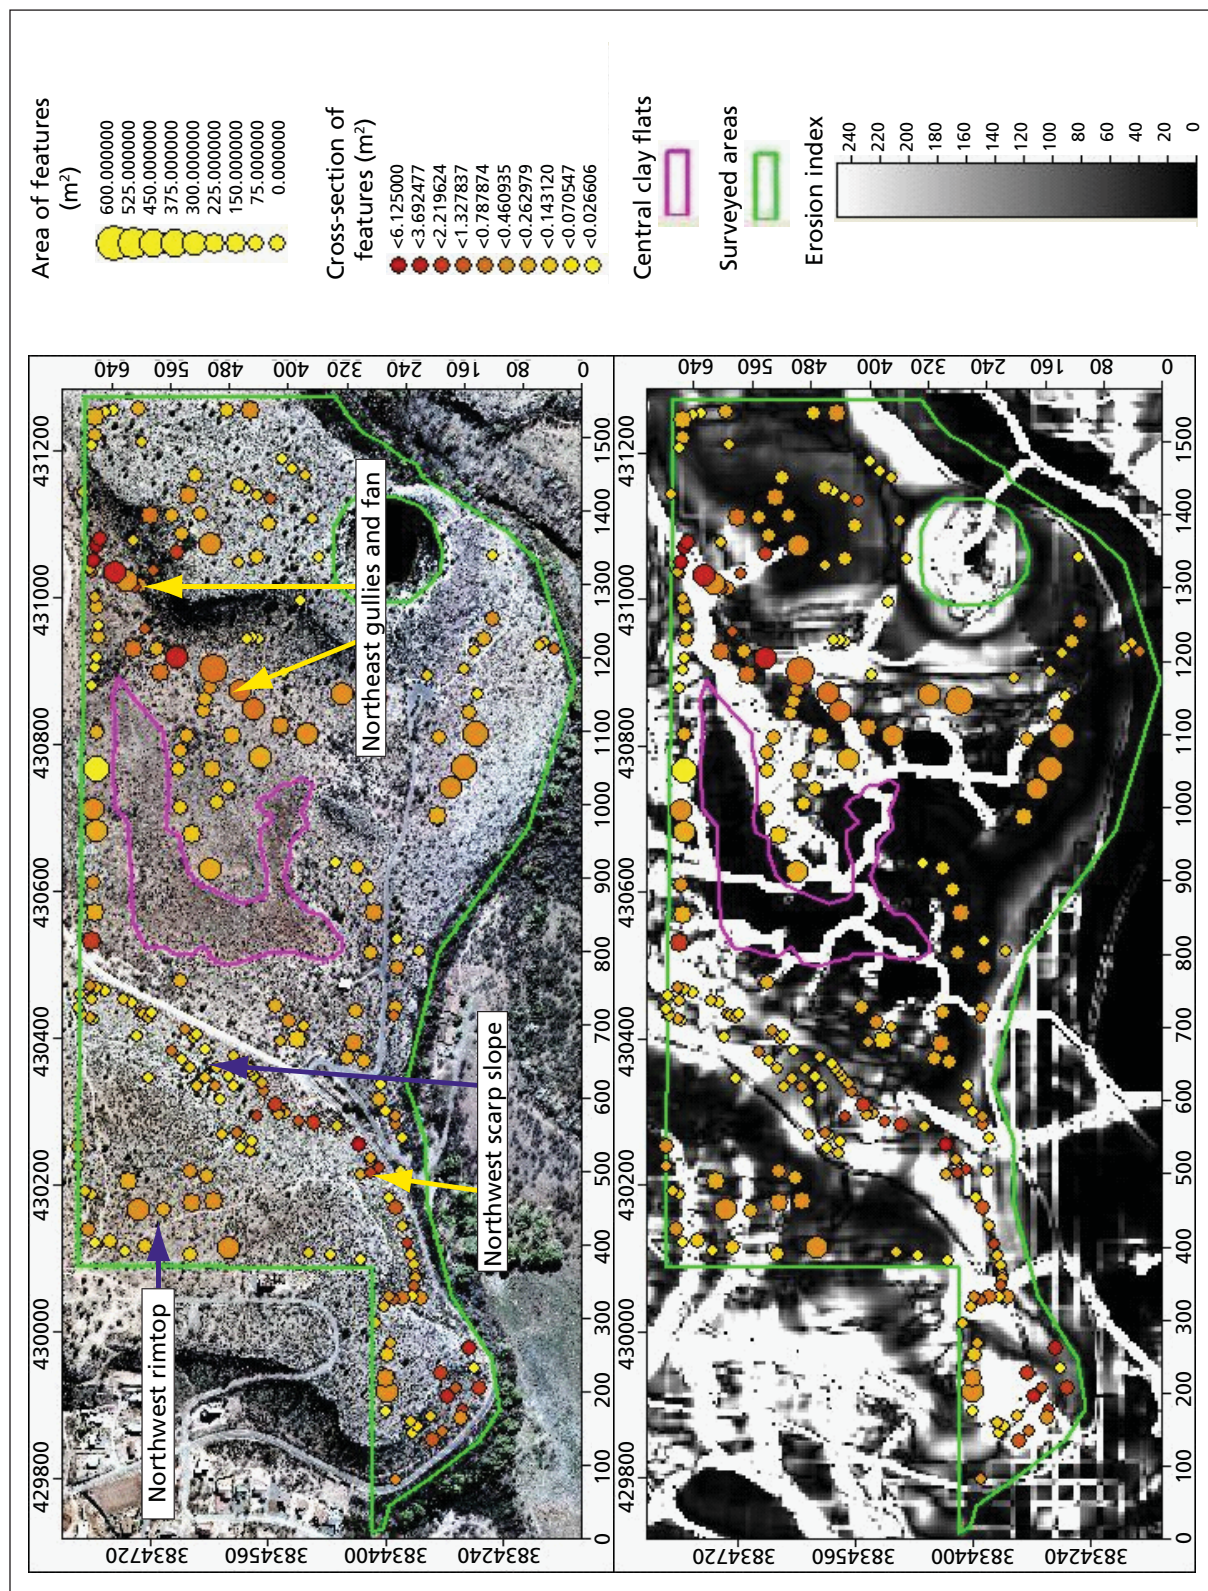
Figure 3.2. Maps showing erosion observations draped over 0.4-meter-resolution aerial photography (top) and a USPED erosion index (bottom). Redder dots have a deeper, wider soil loss profile. Bigger dots represent larger areas covered by erosion features. Lighter erosion-index colors indicate higher potential for either erosion or deposition and, thus, areas where surface-erosion features were expected in the field. Side ticks on left and top are UTM coordinates in meters. Ticks at bottom and right are scale bars in meters.

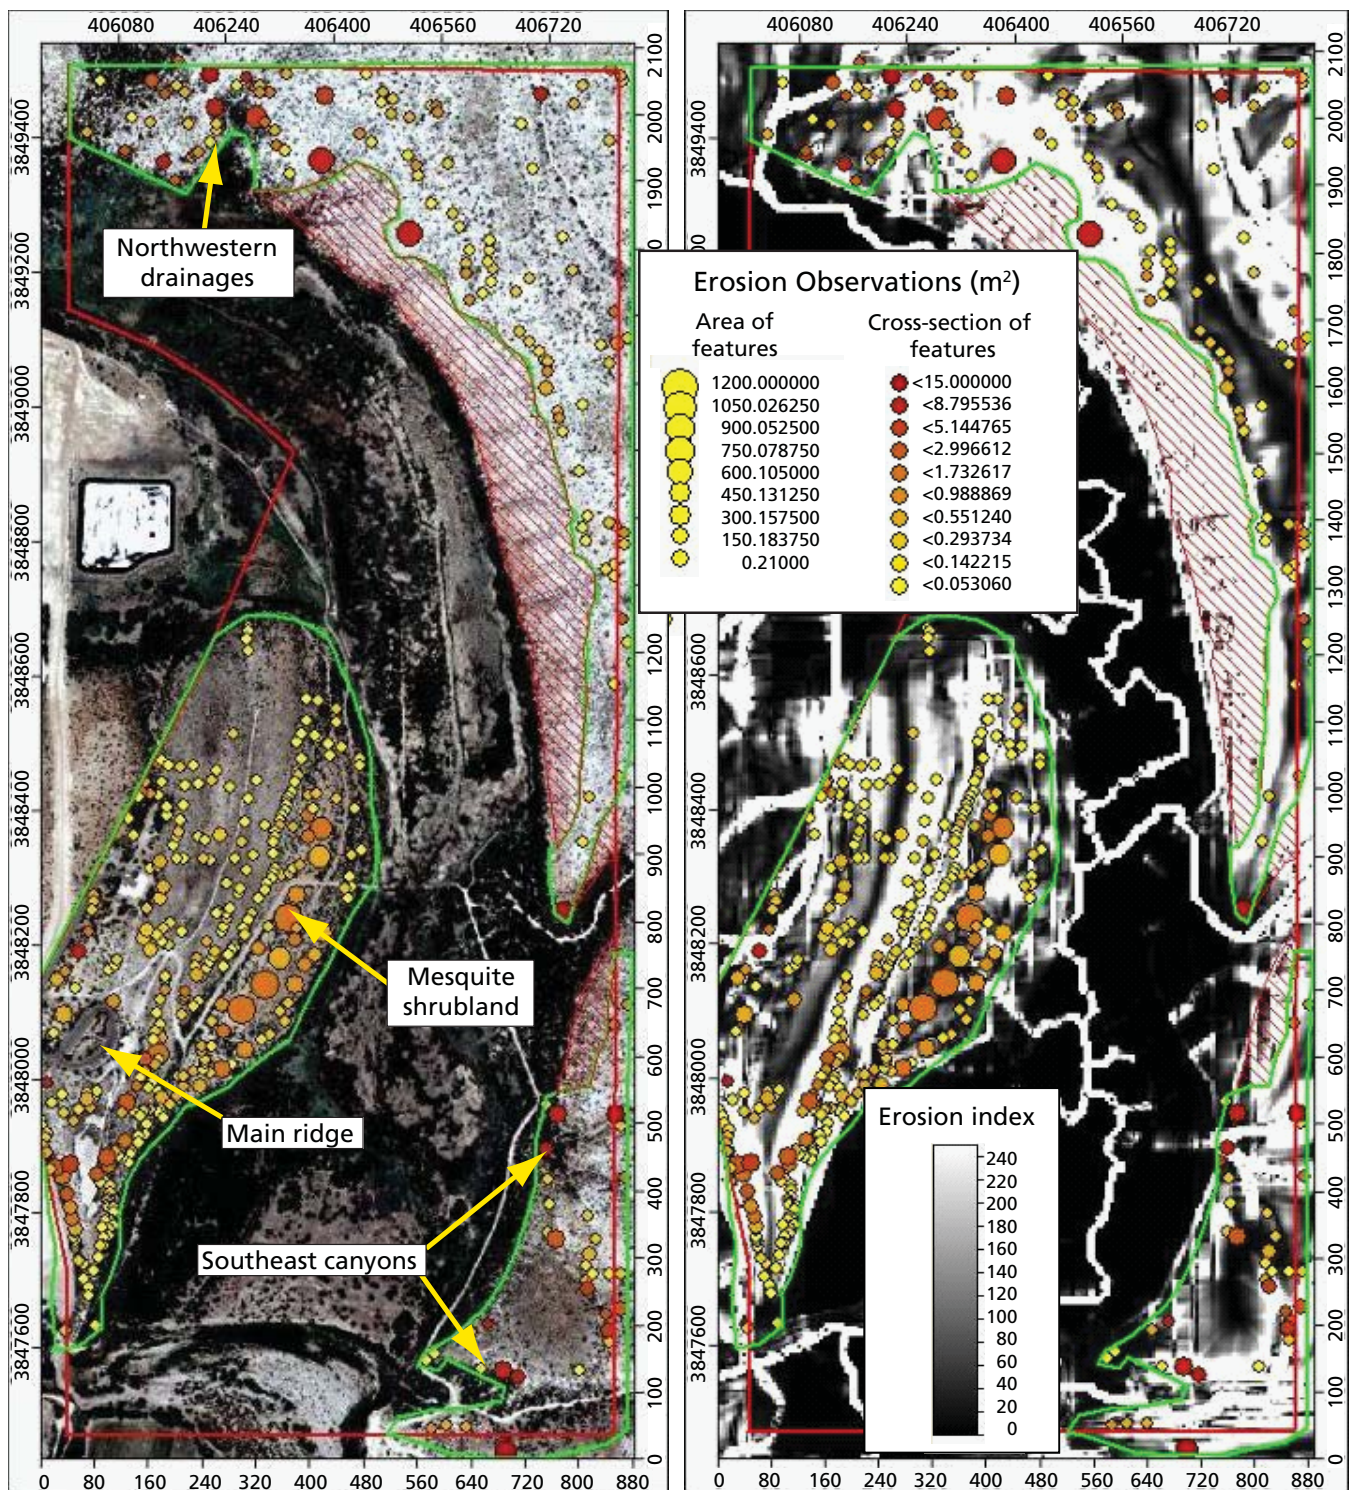
From the points taken, unique features were identified by combining points with the same feature ID. These unique features included 118 areas of sheet erosion, 250 rills, and 50 gullies. Total estimated soil loss from mapped features was 10,274 m<sup>3</sup>. Estimated contribution from different feature types included 889 m<sup>3</sup> from sheet areas, 3,426 m<sup>3</sup> from rills, and 5,959 m<sup>3</sup> from gullies. See Figure 3.3 for a complete map of mapped features.

Figure 3.3. Maps showing erosion observations draped over 1-meter-resolution aerial photography (left) and a USPED erosion index (right). Lighter erosion-index values indicate higher potential for either erosion or deposition and, thus, areas where surface-erosion features were expected in the field. Green polygons show areas surveyed. The red polygon is the TUZI legal boundary. The red diagonal fill pattern represents upland areas that were not directly surveyed due to dangerous terrain. Side ticks on left and top are UTM coordinates in meters. Ticks at bottom and right are scale bars in meters. The white meandering lines of the USPED index in the middle of the map should be ignored; they are an artifact of a flow-forcing portion of the algorithm that has problems in areas that are flat or in depressions.
