# **Hydrological Investigation at El Morro National Monument**

## **Final report**

National Park Service  
U.S. Department of the Interior

March 2007

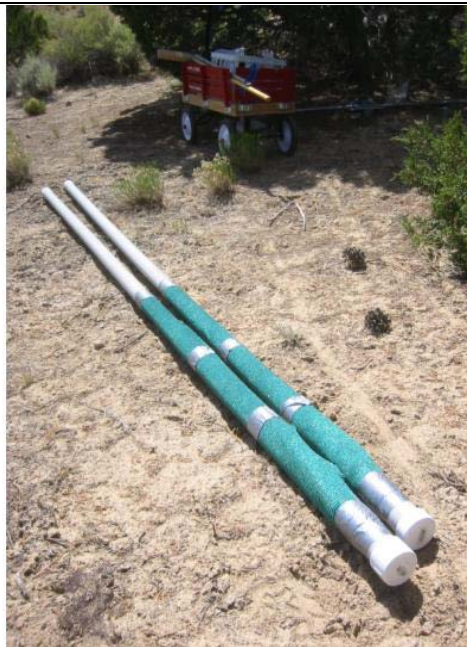
**Figure C-3:** Picture of two piezometers

- Zone of holes in PVC: 15cm-115cm above tube bottom
- 164 holes in each piezometer (5/32 inch diameter)
- Nylon mesh cloth is wrapped around to prevent sediment to enter the piezometer
- Piezometer diameter 1½ inch
- Height above ground was measured to top of white rim

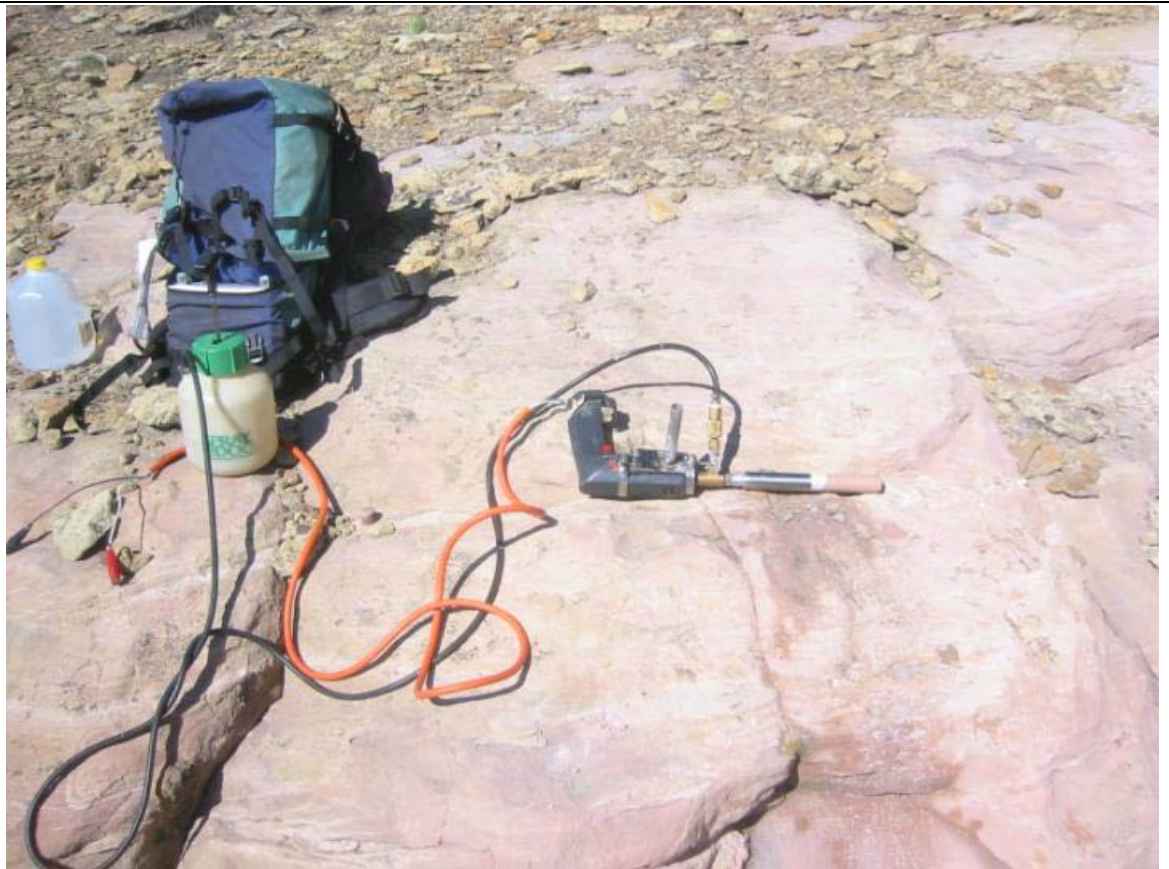
**Figure D-1.** Water-cooled, battery-powered rock core drill

Rock samples were collected using a battery-powered drill and 1 inch diameter hollow drill bit that was water cooled. It was attempted to collect samples from a range of stratigraphic layers, including different types of sedimentary bedding. Below follows a summary and a more detailed description of the cores.

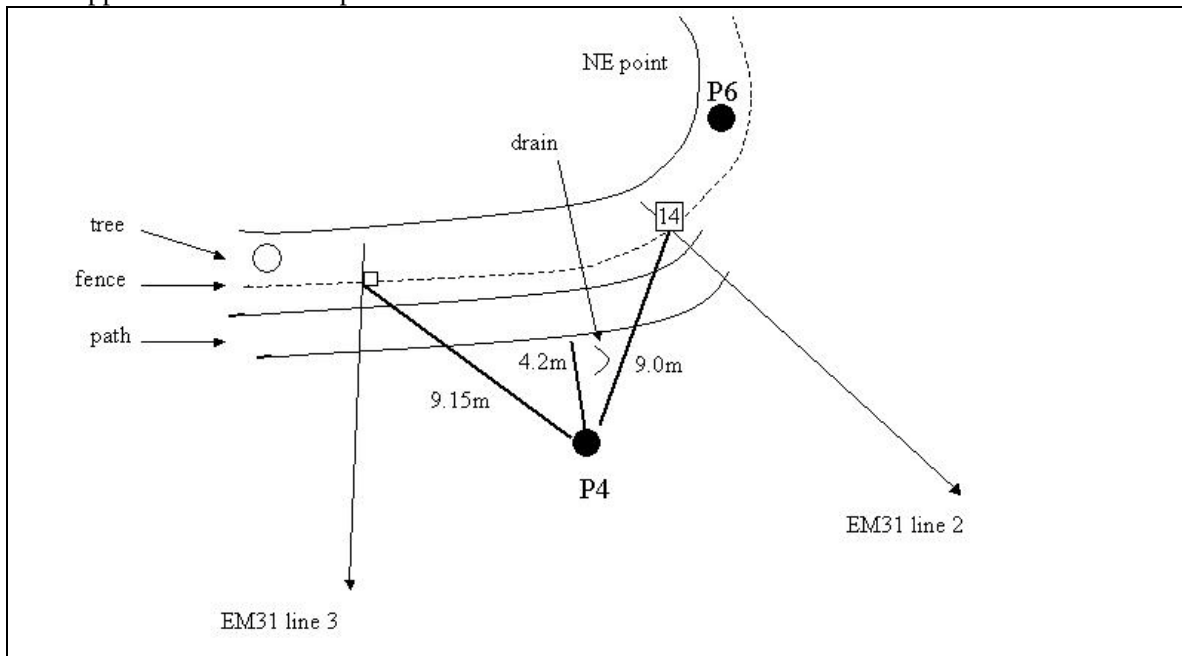
**Figure E-1.** Sketch showing location of piezometer P6 relative to cliff and other piezometers. The approximate north is up.

On 7/1/05 one piezometer (P6) has been placed at the NE point between the cliff wall and the fence lining the foot path (Figure E-1). The bore hole reached a depth of 2.9 meter (Table E-2).

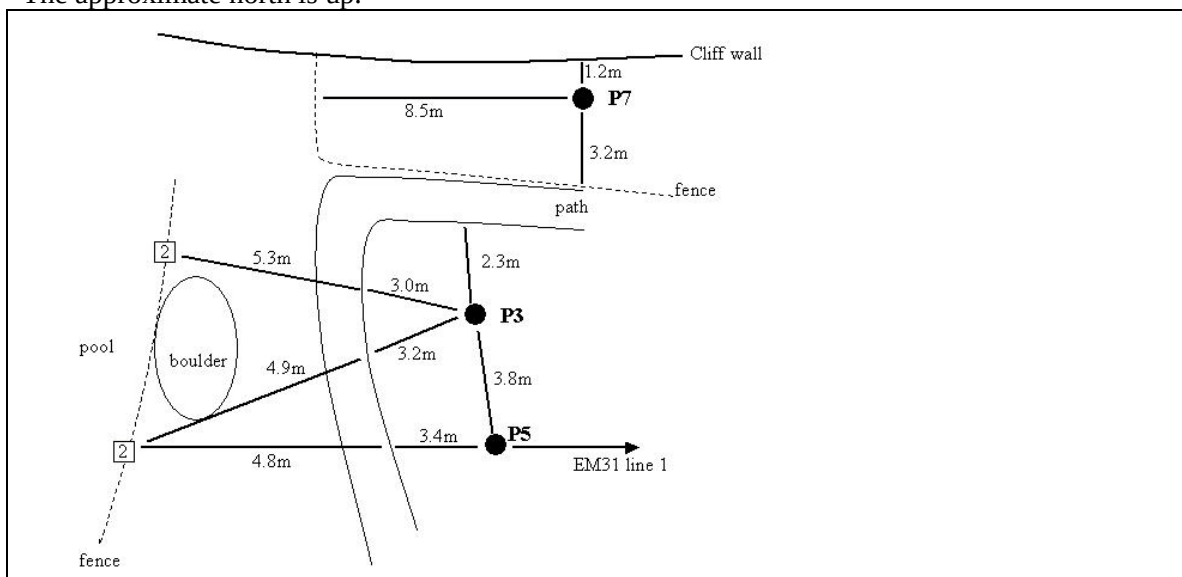
**Figure E-2.** Sketch showing location of piezometer P7 relative to cliff and other piezometers. The approximate north is up.

On 7/8/05 a second piezometer (P7) has been placed directly downstream (east) of the pool, next to the cliff wall (Figure E-2). This piezometer will be used for both monitoring of seepage water and overland flow during periods of high pool levels. The bore hole reached relatively shallow depths (Table E-3) and the sequence of material suggest that at 70-85 cm depth lies an older surface. White spots in the material between 40 and 70 cm suggest the presence of (weathered) bedrock, which may have originated in the 1930's rock fall. The material found between the surface and 40 cm depth is possibly recent fill.
