Summary Report  
WATERSHED RESTORATION UNIT 98-4  
C-LINE NORTH

Jim Howard  
Redwood National Park  
March, 1999

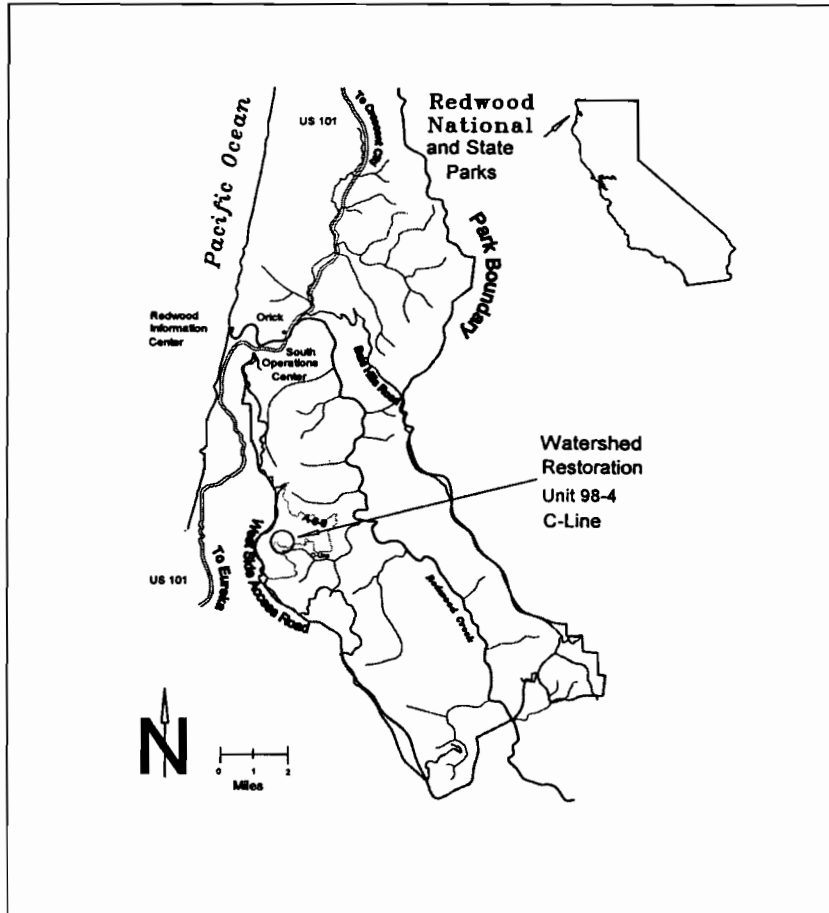
Figure 2. Location of Project Area

The project area is located fifteen miles south of Orick at an elevation of approximately 1500 feet above sea level (Figure 2). The C-Line was a major haul road constructed in approximately 1950. It was located on the west side of the Redwood Creek basin. Within the park it ran from the West Side Access Road near MP 9, along the northwest side of the Tom McDonald Creek sub-basin, to the M-Line at the mouth of Forty Four Creek. A stream crossing (C-Line Pond) was excavated in 1993, severing the C-Line into two sections: C-Line North and C-Line South.

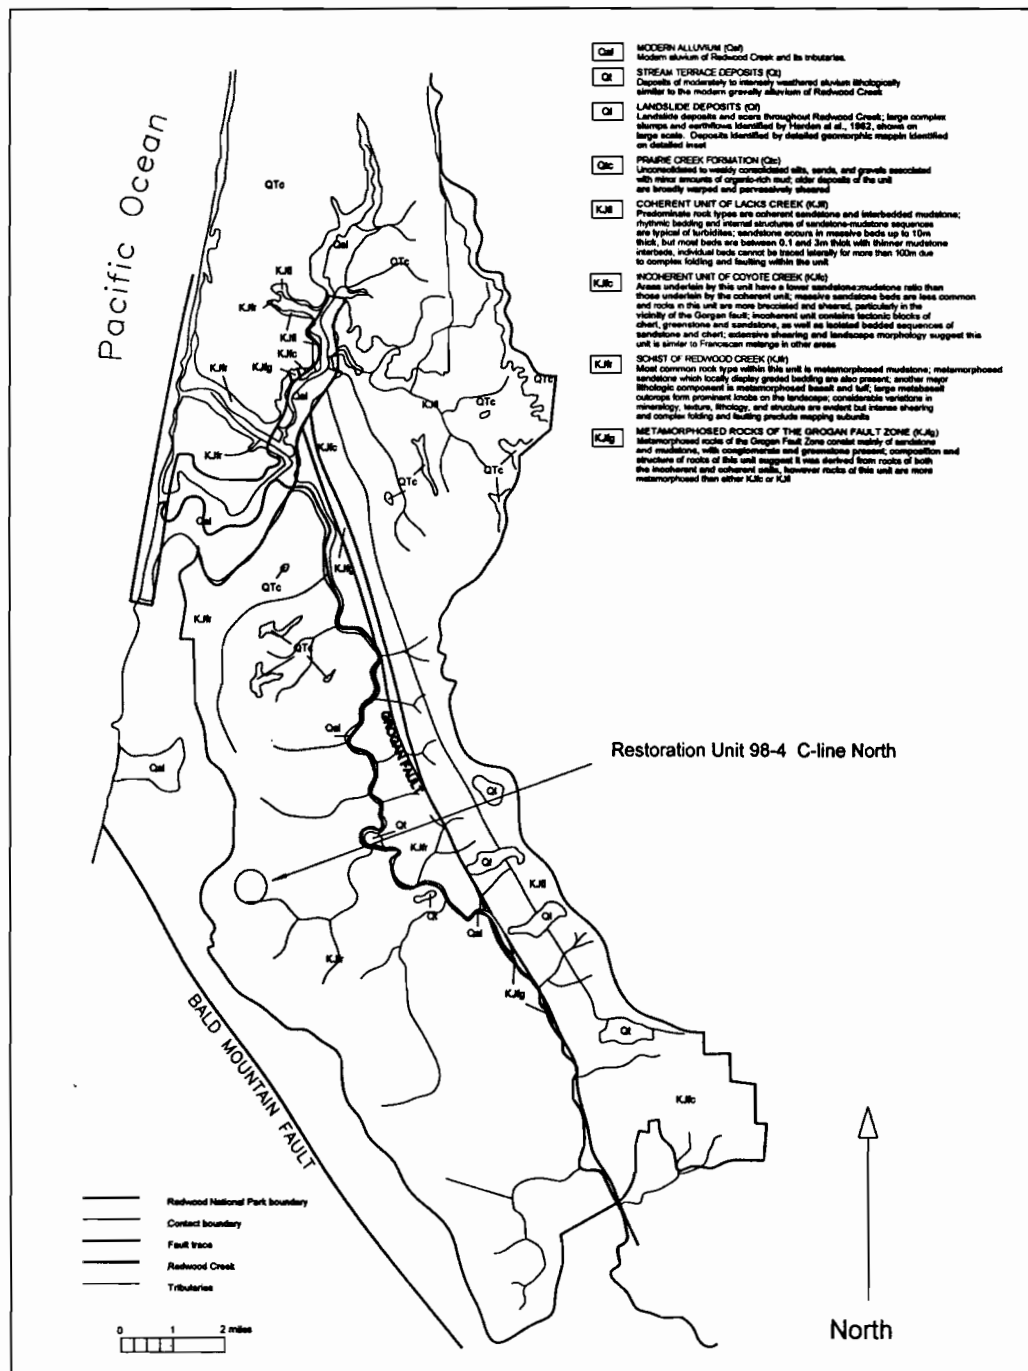
Figure 3. Geology Map

The project area is situated on the west side of the Redwood Creek basin, and is underlain by the schist of Redwood Creek (Figure 3). The most common rock type within this unit is metamorphosed mudstone. Metamorphosed sandstones, which locally display graded bedding, are also present. Another major lithologic component is metamorphosed basalt and tuff. Large

metabasalt outcrops form prominent knobs on the landscape. Considerable variations in mineralogy, texture, lithology, and structure are evident but intense shearing and complex folding and faulting preclude mapping subunits.

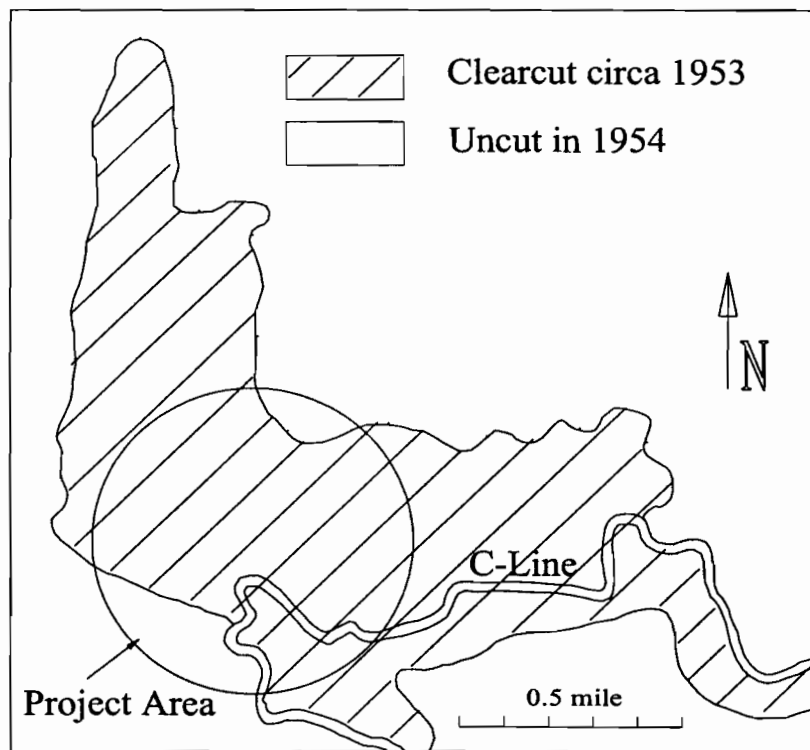
Figure 4. Timber Harvest History

The 1948 air photos covering Tom McDonald Creek show that no road construction or timber harvest had begun in the area. By 1954, the C-Line had been constructed and timber harvesting had begun (Figure 4). During the pre 1954 harvest all timber above the C-Line was tractor-yarded, and all timber below the C-Line was cable-yarded. The project area was clear cut except for a few remaining "undesirable" trees. In 1973 the project area was re entered and a few of the previously "undesirable" trees were extracted. During the re entry a few pre-existing skid trails were used, a few new ones were constructed, but negligible ground disturbance occurred.

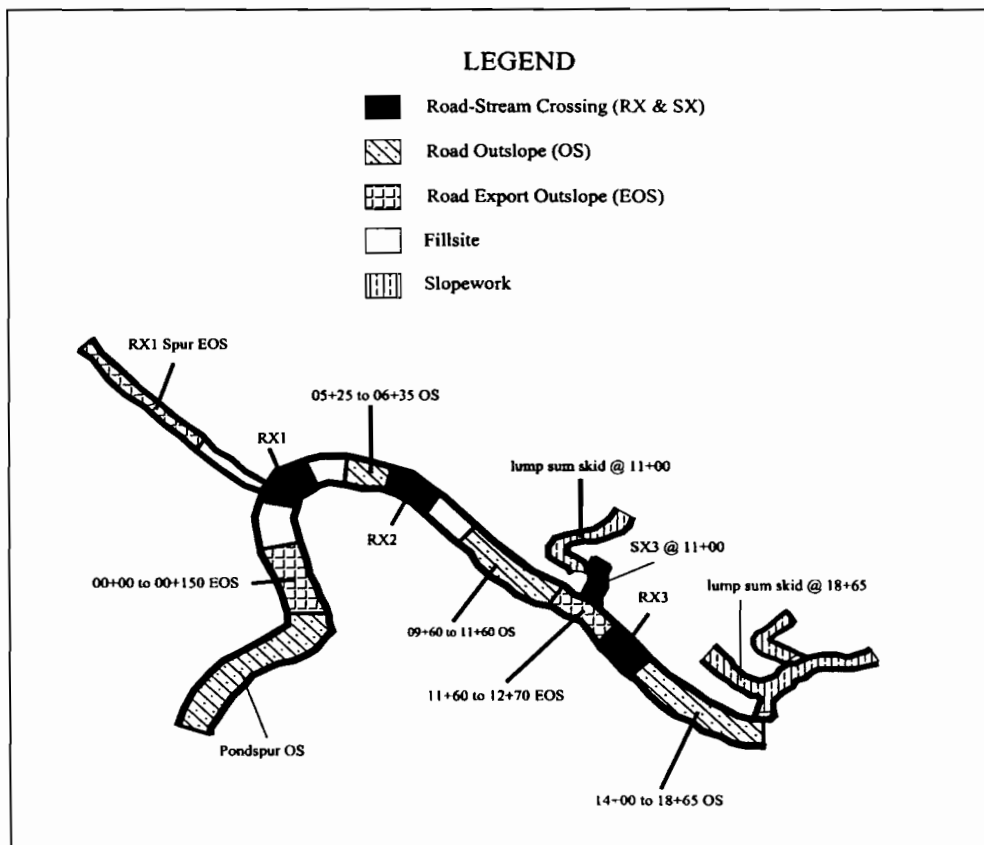
Figure 5. Treatment Prescriptions in the Project Area

The project geologist, Jim Howard, mapped geomorphic and hydrologic features, prescribed restoration treatments (Figure 5), surveyed cut and fill volumes of all worksites before and after excavation, prepared the contract, oversaw heavy equipment operations as the contracting officer's technical representative (COTR), photo documented the work, and wrote the final report. Physical Science Technicians Ingrid Corson and Kristine Leep served as site inspectors when the project geologist was not on site.
