97-2

The M-8 road is located on north east facing slopes along the inner gorge of Redwood Creek , one half mile up stream from the Tall Trees Grove (figures 1 and 2). The M-8 is 100 to 200 feet above Redwood Creek and runs to the mouth of Bridge Creek. The M-8 stay roughly on contour at an elevation of 200 feet. The slopes typically range from 25% to 90%, are densely vegetated with predominantly 35 year old second growth redwood, residual old growth redwood, maple, tan oak, alder and Douglas fir trees.

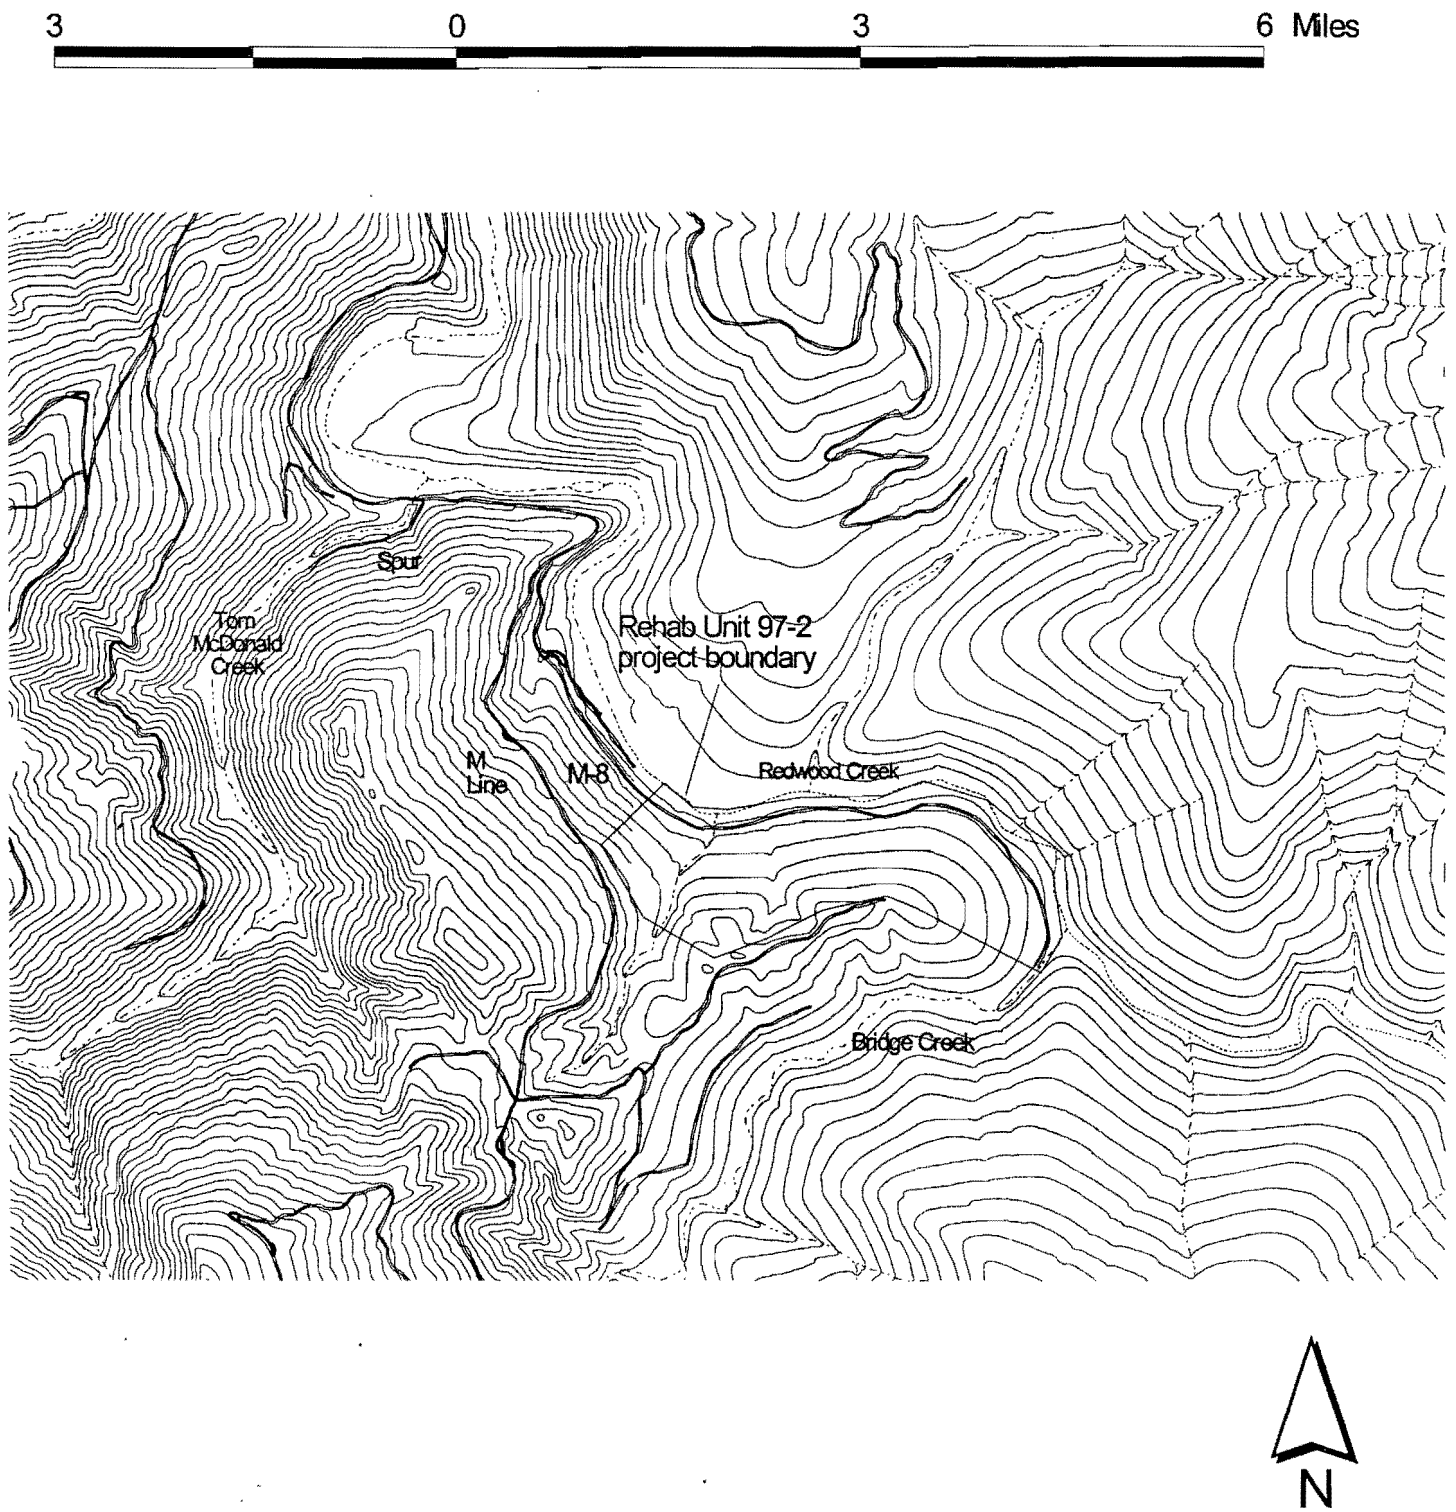
Figure 2. Project boundary for M-8 (97-2) road removal.

The slopes above and below this portion of the M-8 (outlined in fig. 2.) were also be evaluated and treated to reduce erosion and enhance ecosystem recovery. The use of tractor yarding during timber harvests resulted in a large network of skid roads and high levels of ground disturbance to these slopes. Skid trail stream crossings, diverted flow and unstable fill identified during detailed geomorphic mapping were included in this contract. Areas of primary interest will be the streams and headwater swales impacted by the skid road network.

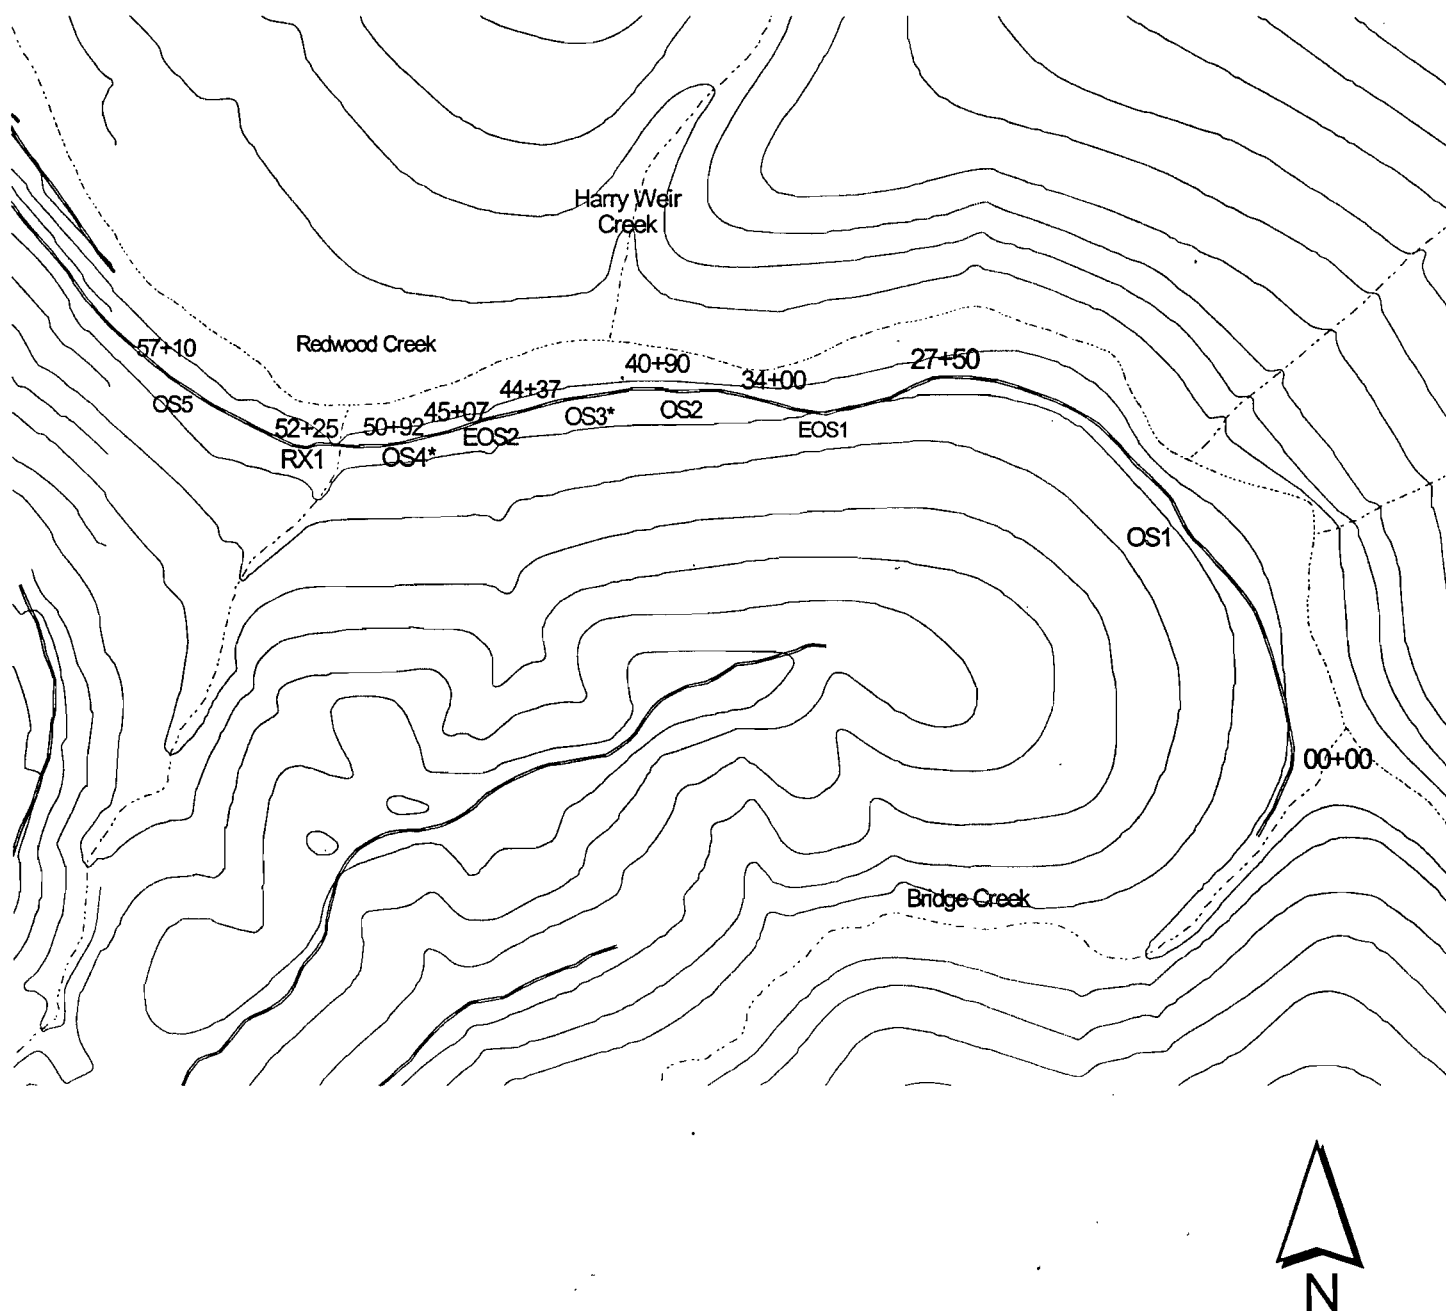
Figure 3. Project layout for M-8 (97-2) road removal.

The project was planned as nearly all outslowing or export outslowing (figure 3.). The only significant stream crossing had blown out many years prior, leaving minimal fill on the banks. The stream crossing was prescribed as an EOS, but in retrospect, should be discussed as an RX since we had to rebuild the crossing to access the M-8. Additionally, bid item 7 should be recharacterized as a RX. All crossings were excavated to original ground surfaces (as close as possible). All woody material (logs, rootwads, large slash..) exhumed during excavation along with trees cleared before excavation, were scattered across the finished surface or placed in the finished stream channel.
