SOLEDUCK VALLEY ROAD

NATIONAL PARK • WASHINGTON

# vegetation management and maintenance guide

september 1990

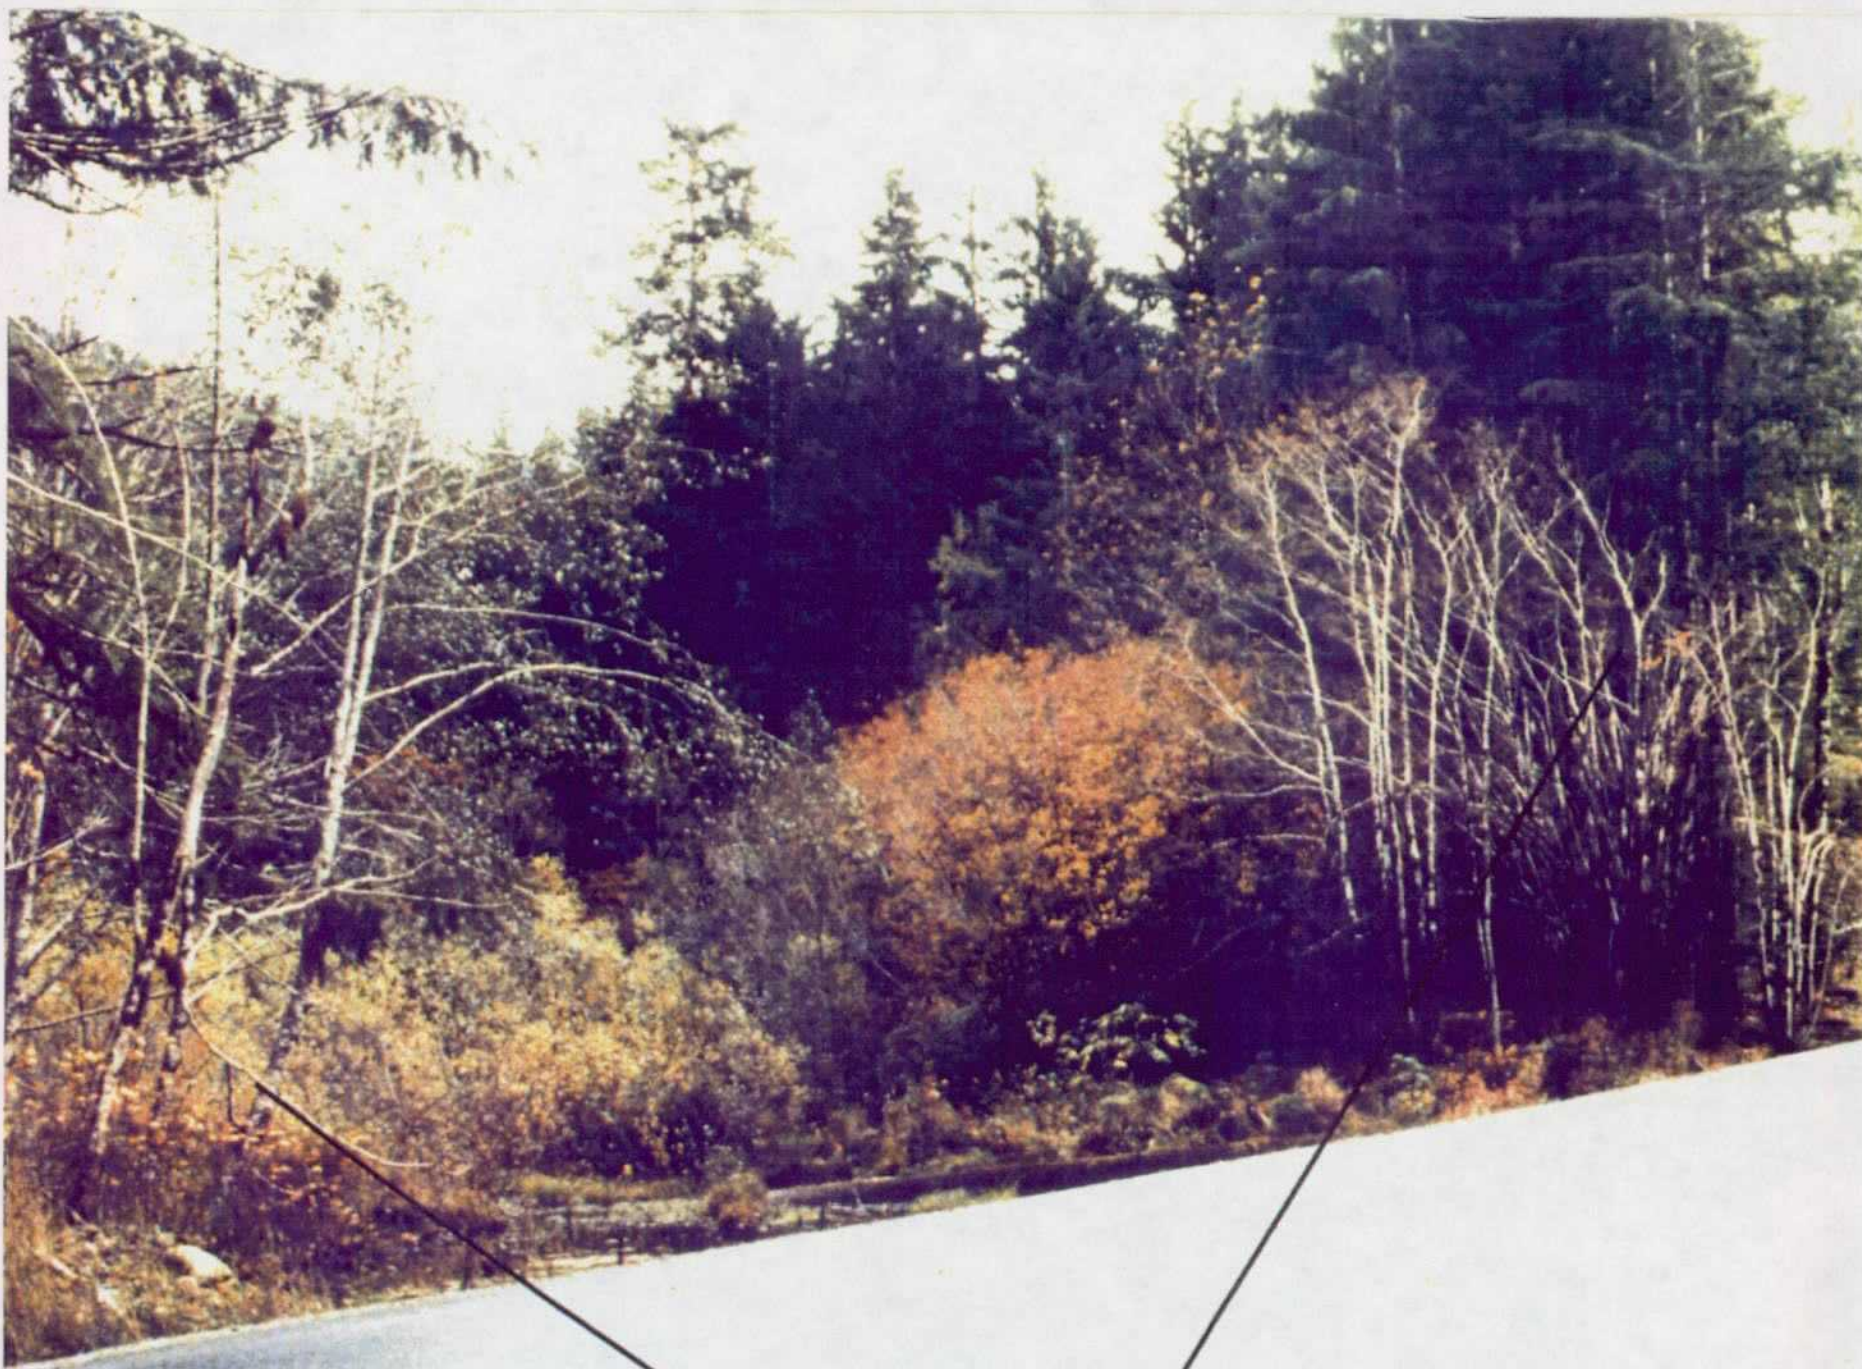
C:1 Pond vista, 180+00  
to 181+00, fall 1988.

Directions: Keep pond edge clear;  
selectively thin alder clumps.

PHOTOGRAPH: Photo C:1 depicts the pond vista in the fall of 1988. The general appearance of the vista should be maintained as it is in the photo. Notice that not all vine maple and alder saplings have been removed at the ends of the vistas.

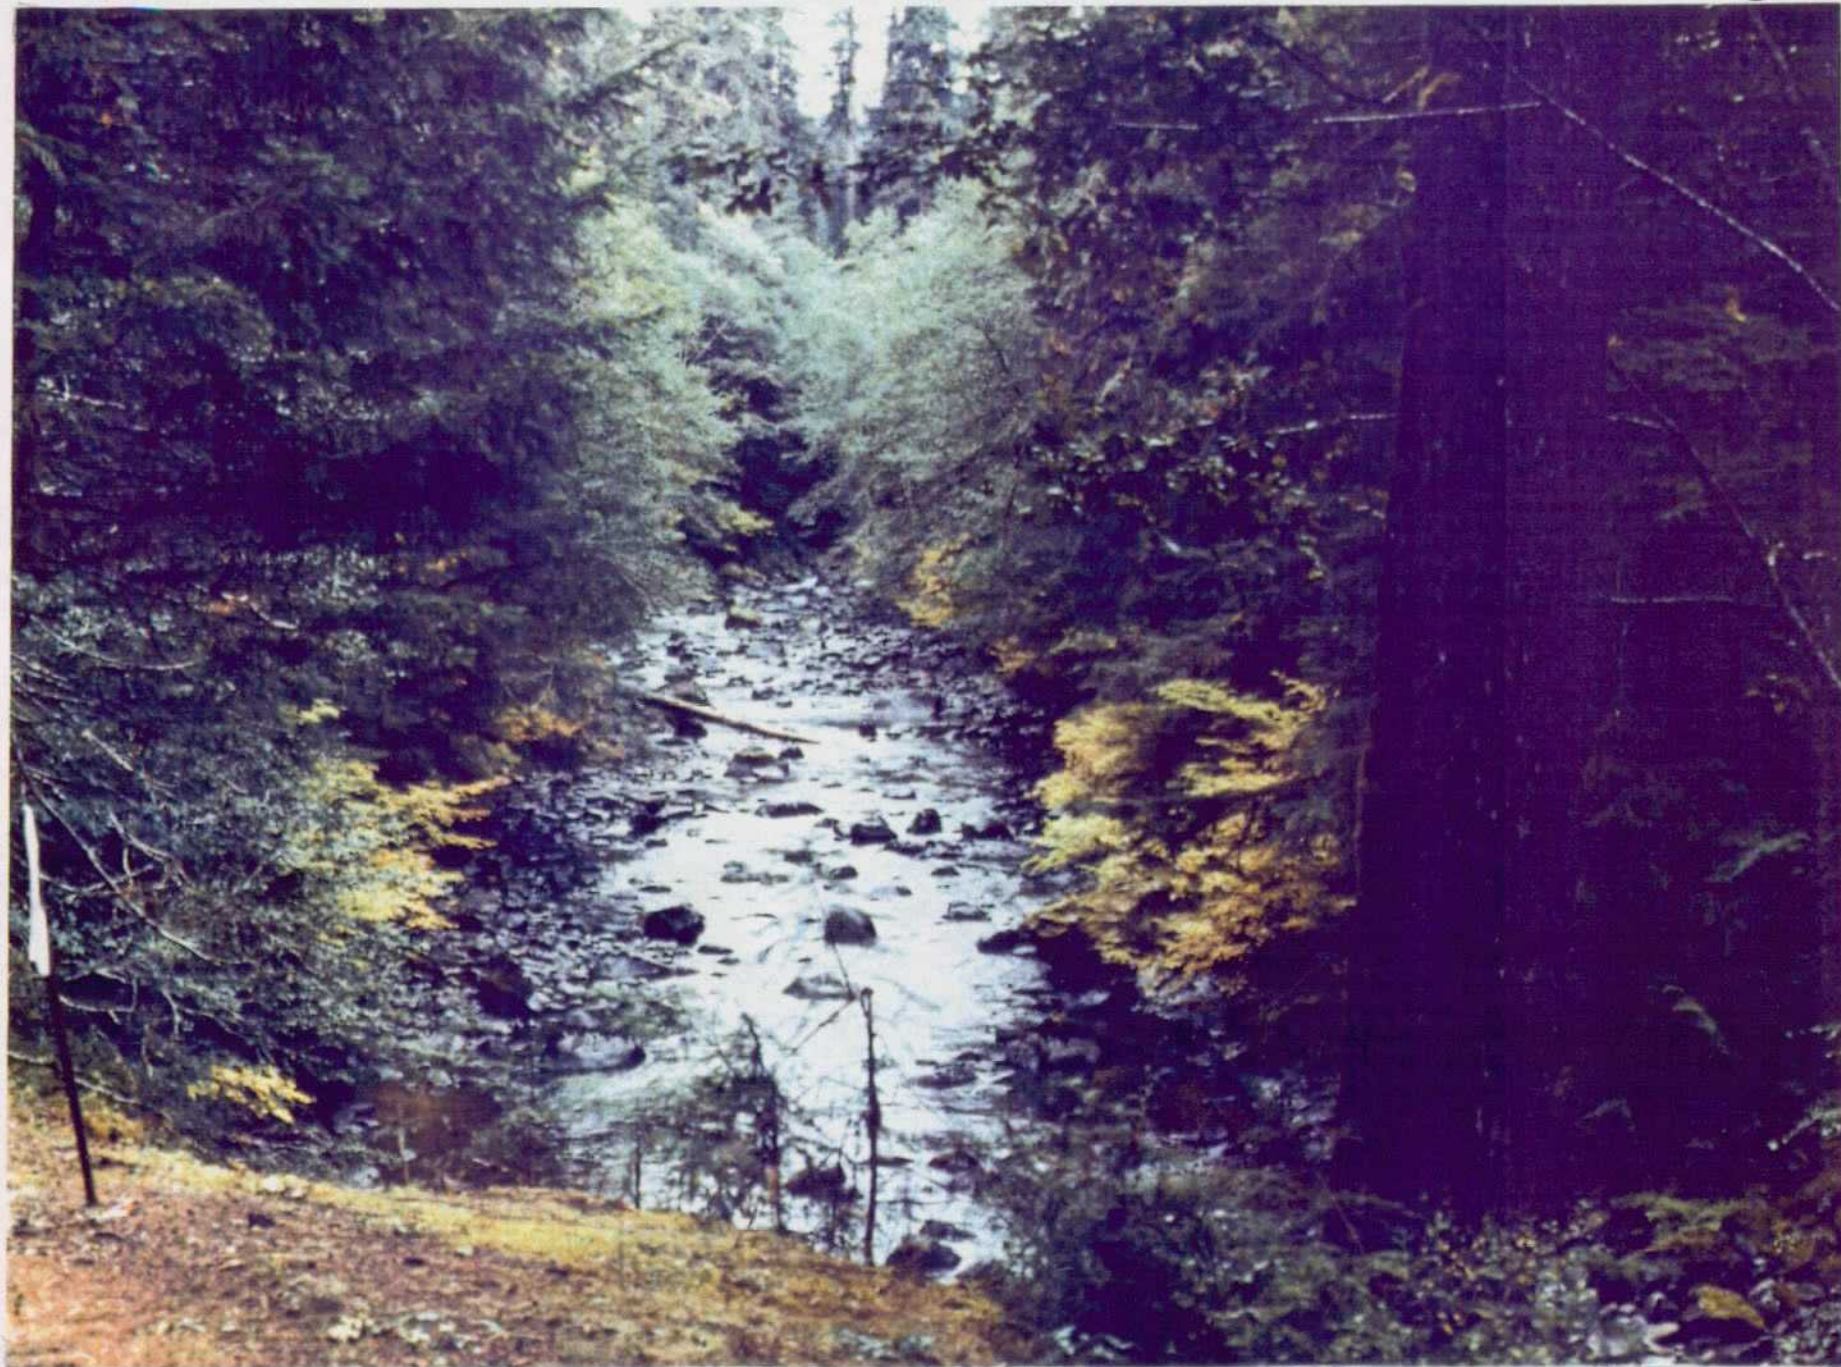
Photo C:2--View up river from  
just below 372+33 in first section,  
fall 1986.

INSTRUCTIONS: Remove brush 4 inches in diameter and less starting on a line roughly from pavement edge to big stump, to slope edge and down the slope as far as is needed to clear view to river (see Photos C:2 and C:3). Beyond the conifer clump that divides the vista into two sections, continue to remove brush 4 inches and less. Save western red cedar sapling, devil's club, and the serviceberry between them (see Photo C:4). Remove large alder blocking view in this section.

PHOTOGRAPHS: Photo C:2 is of the view up river from the lower section of the vista. Photo C:3 is the view down river. Photo C:4 is of the upper section of the vista. It shows the large alder to be removed and three small plants to be saved.

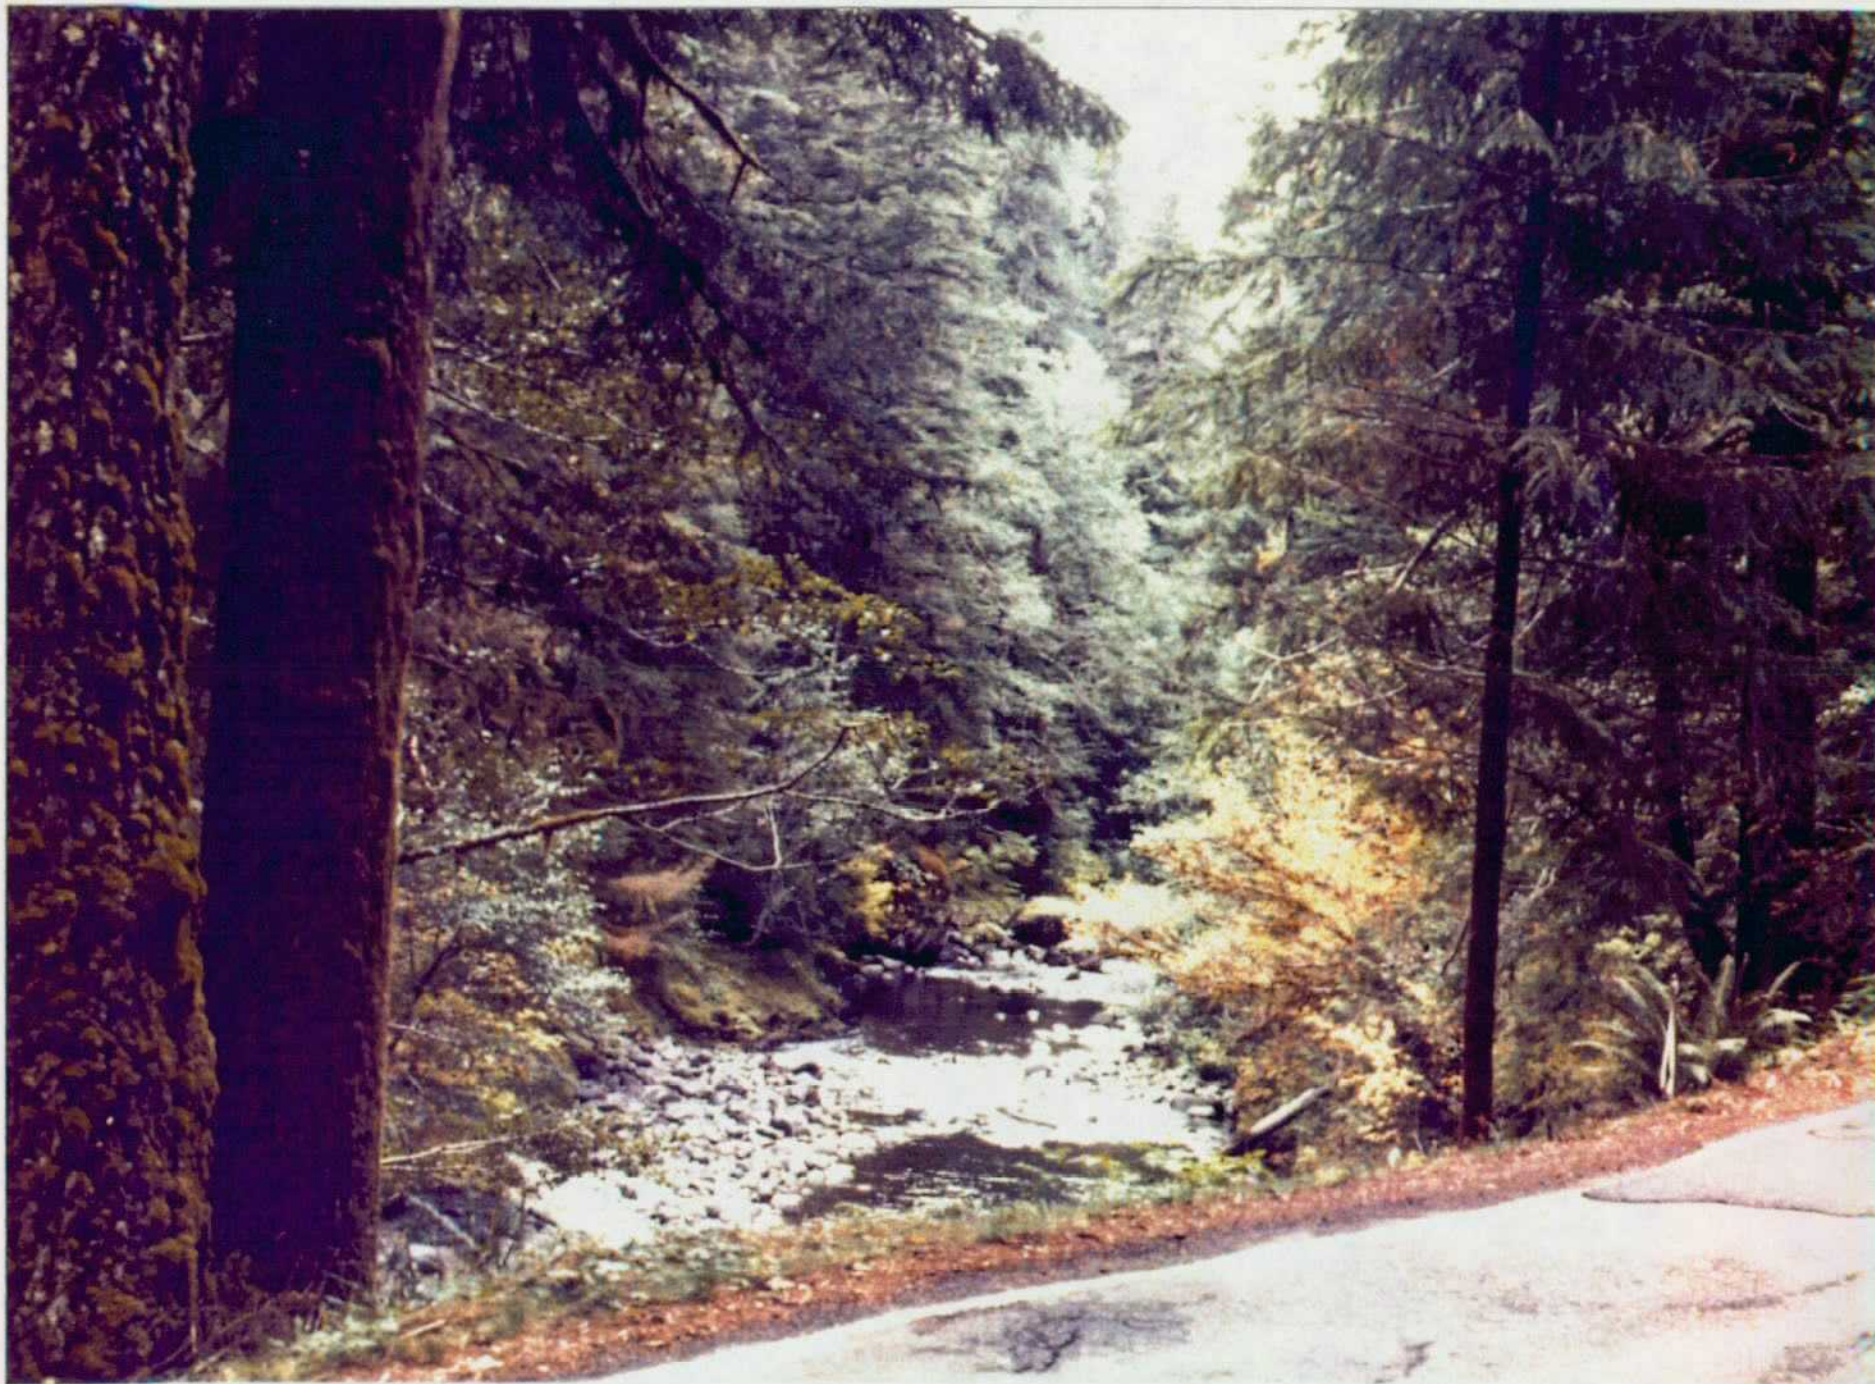
Photo C:3--View down river from  
about 324+44, fall 1986.

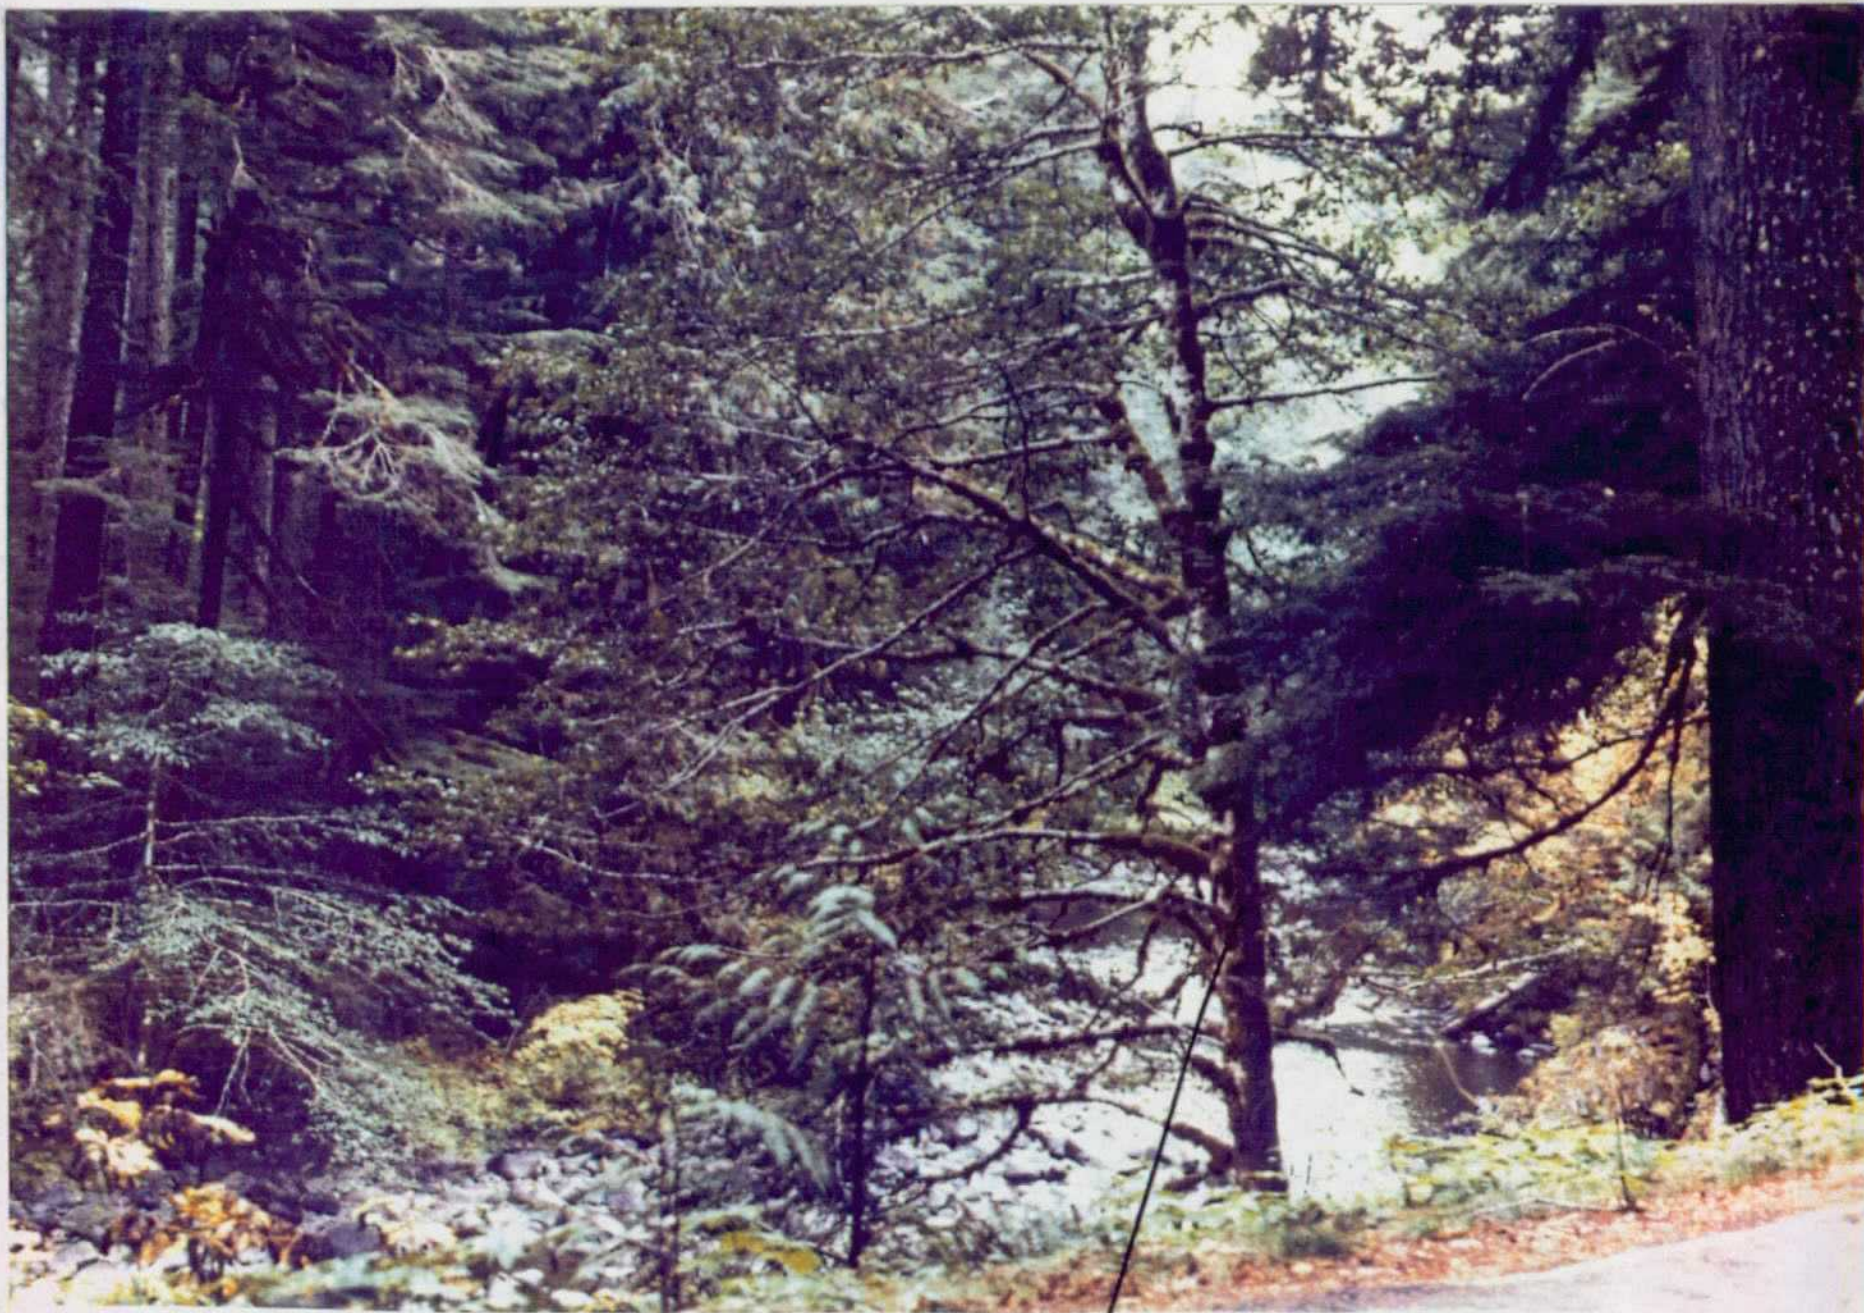
Photo C:4--View down river from  
about 324+95, fall 1986.

Directions: Remove alder,  
save cedar, Devil's club, serviceberry.

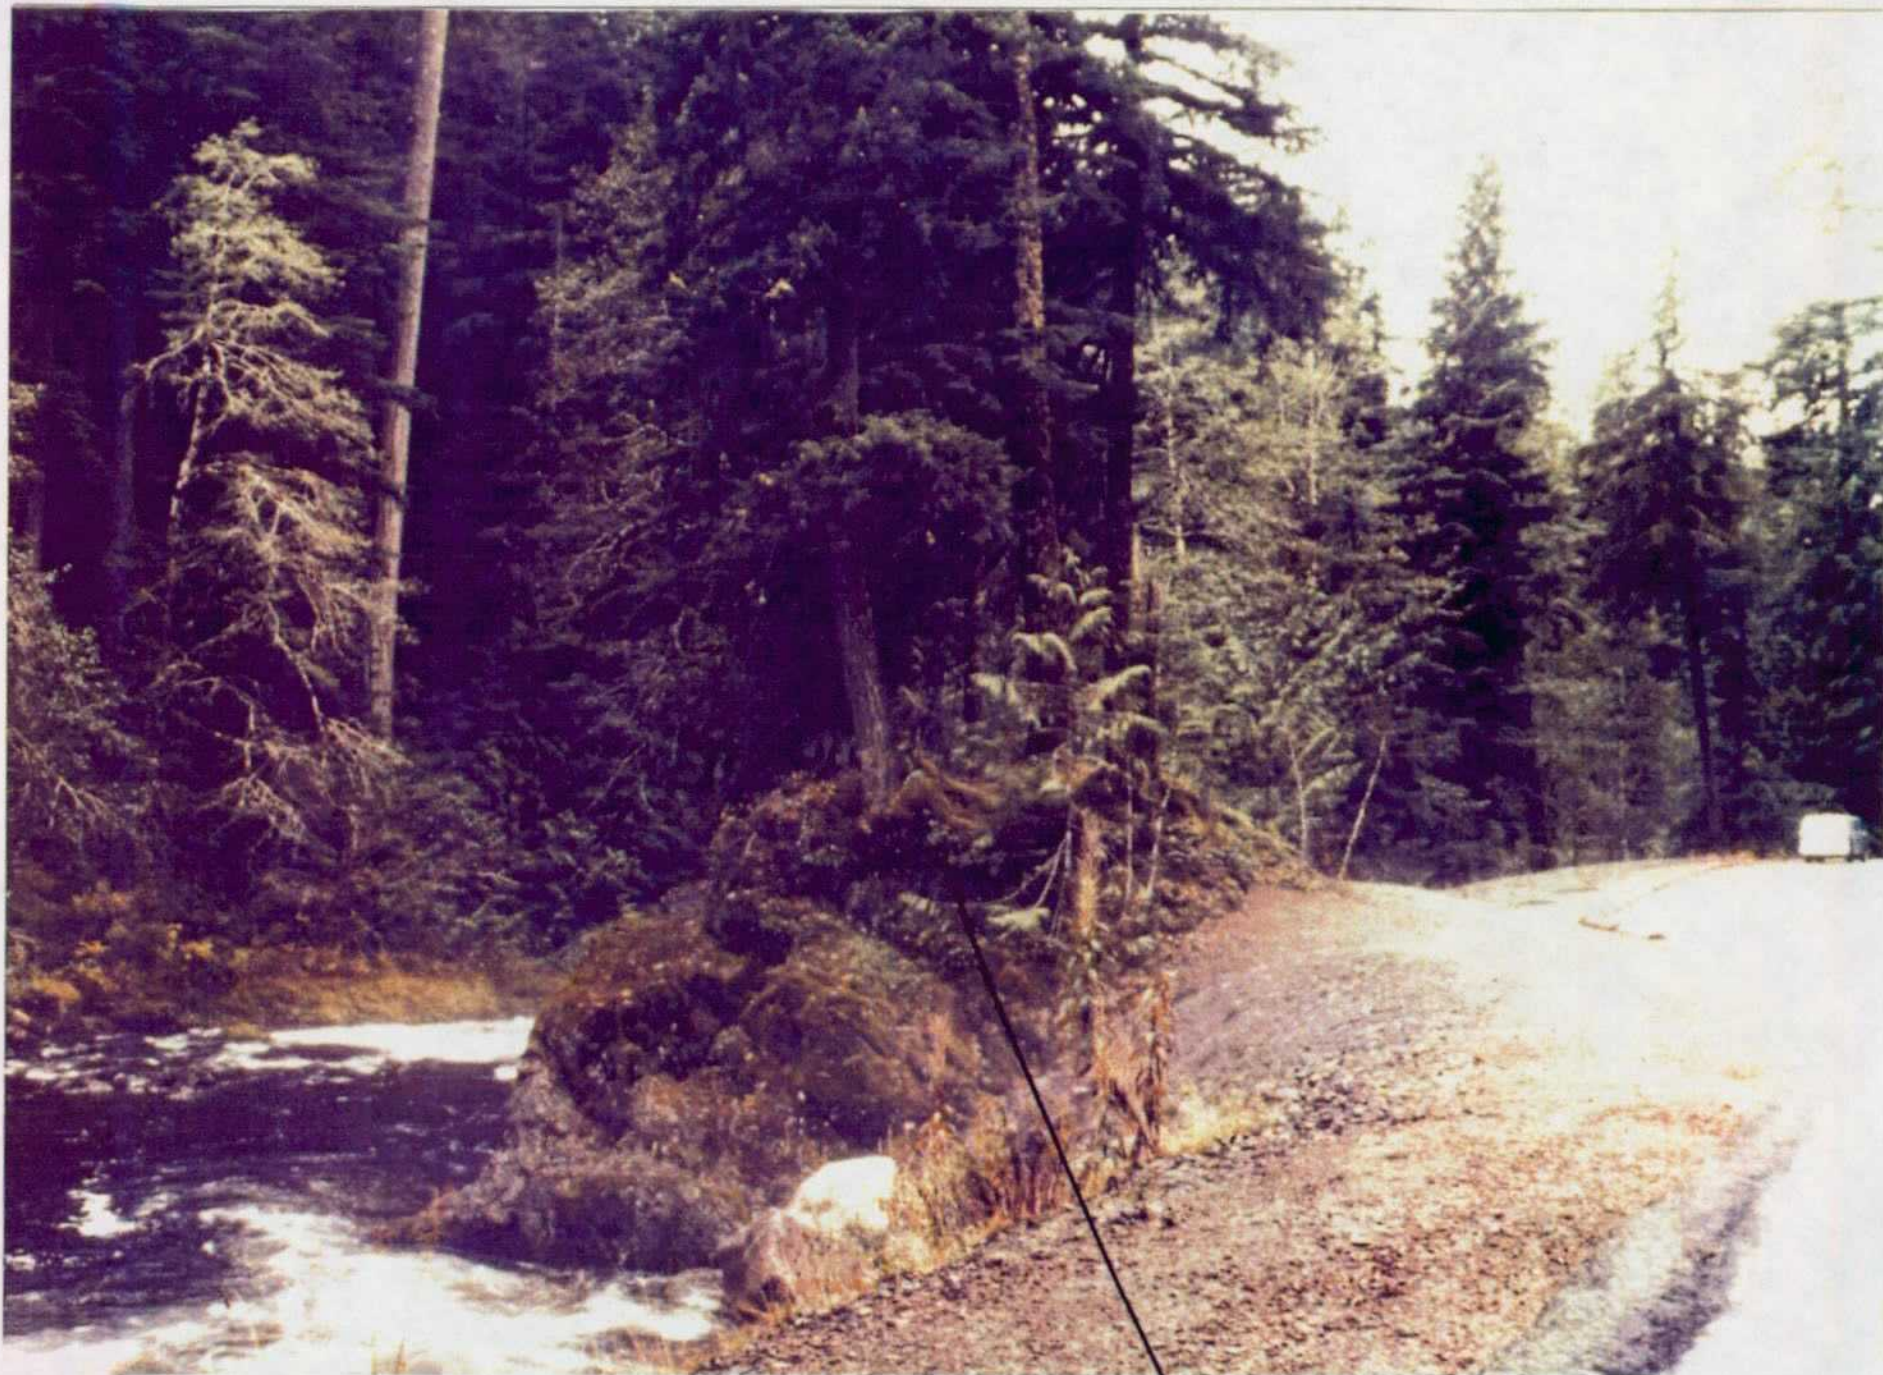
Photo C:5--View from knoll  
toward vista end, fall 1988.

Directions: Do not clear knoll.  
Prune and limb vegetation  
as needed.

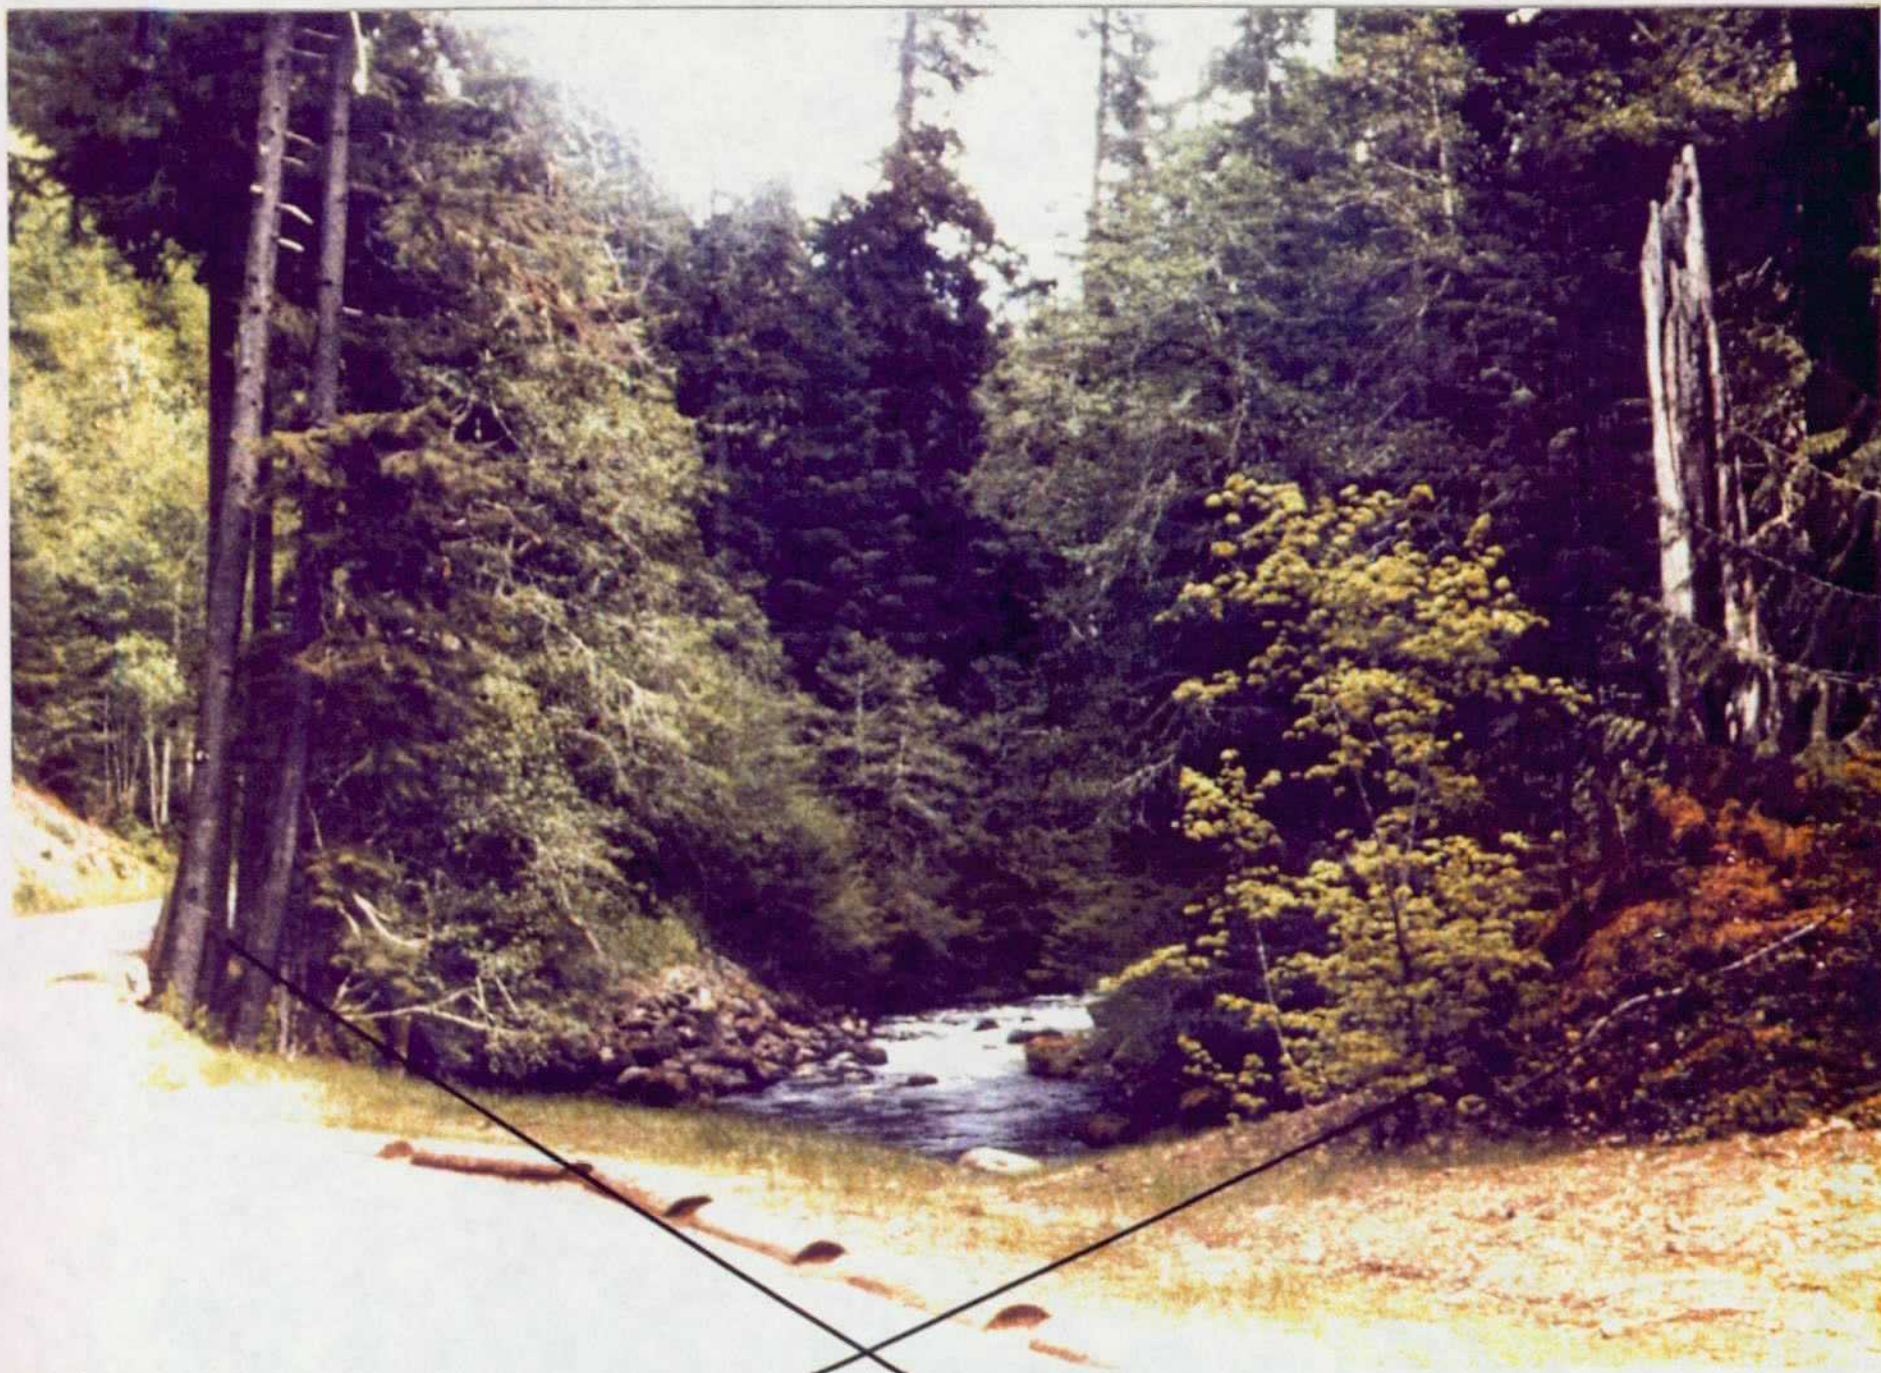
Photo C:6--View up river through  
second vista section, spring 1989.

Knoll, trees marking  
upper end of second section.

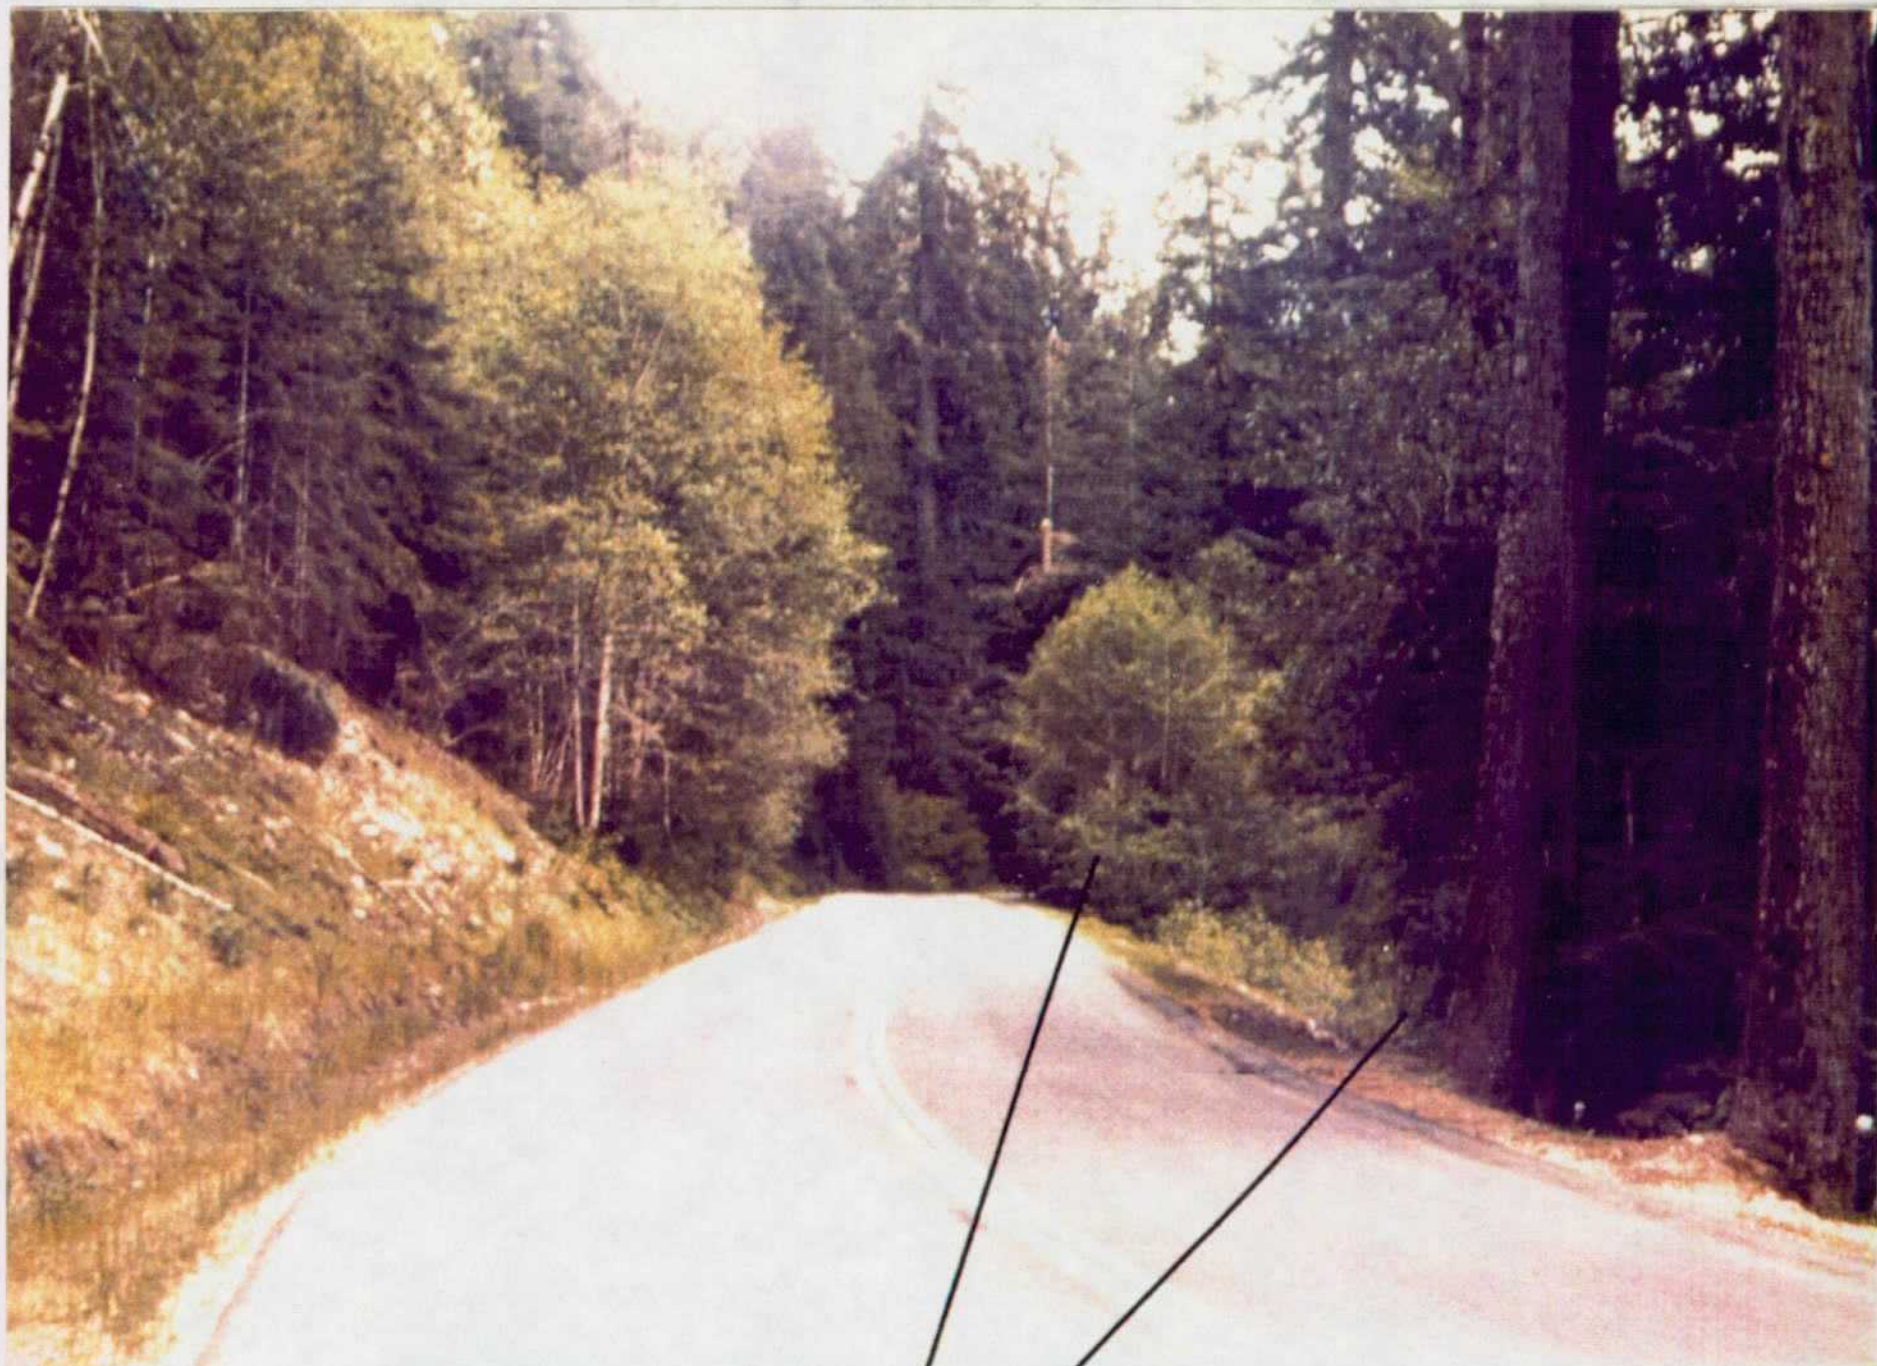
Photo C:7--View up road  
to third vista section, fall 1989

Third section.

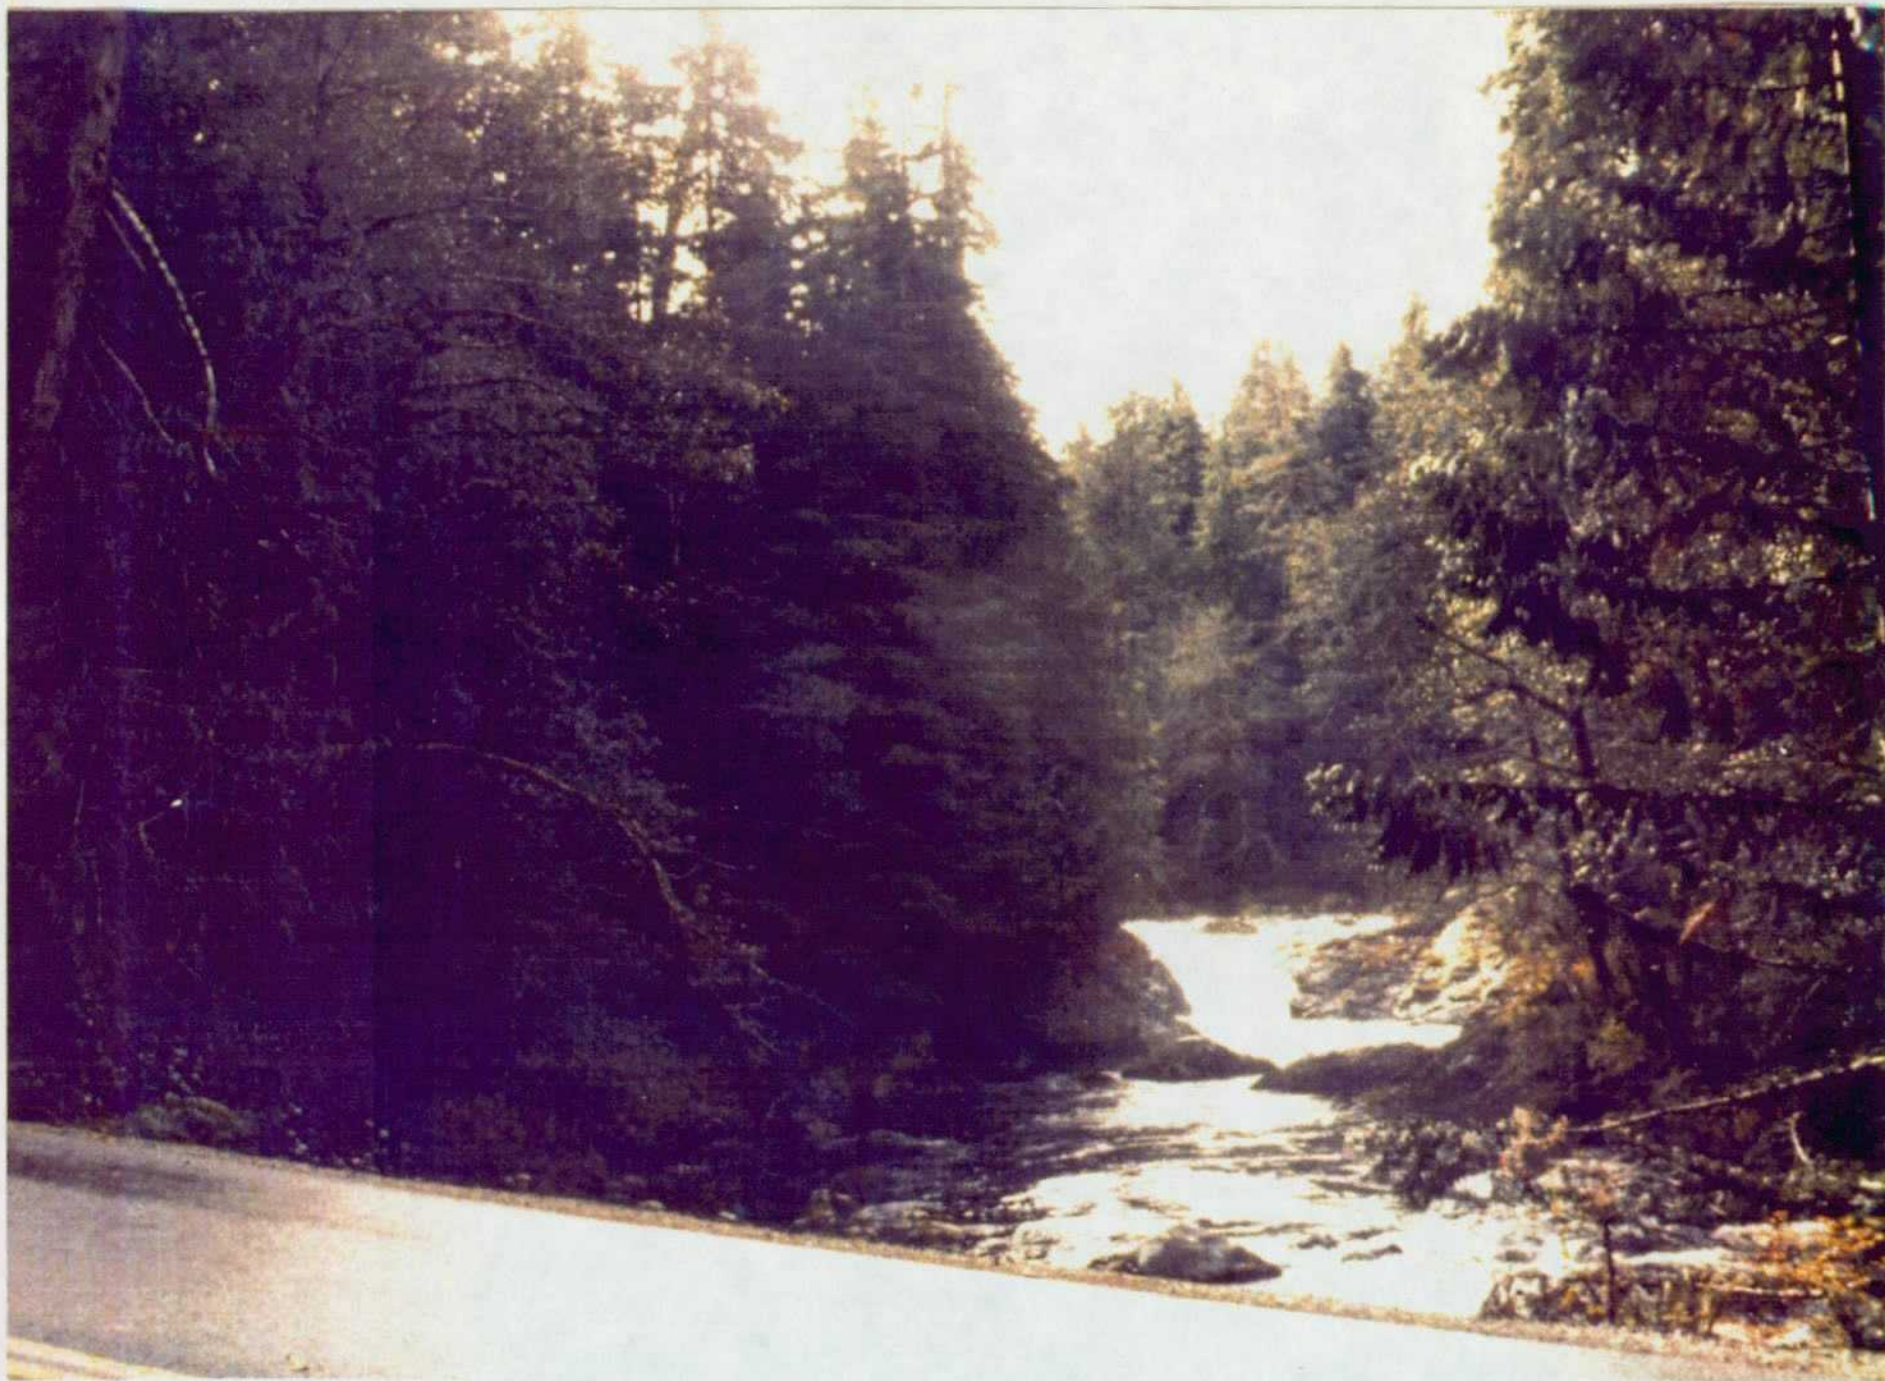
Photo C:9—View up river  
to Salmon Cascades, fall 1988.

PHOTOGRAPHS: Photo C:9 view of Salmon Cascades from upper section of vista just above Salmon Cascades Exhibit sign. Photo C:10 view down river from above Salmon Cascades Exhibit sign. Photo C:11 – view of river looking down the road.
