SOLEDUCK VALLEY ROAD

NATIONAL PARK • WASHINGTON

# vegetation management and maintenance guide

september 1990

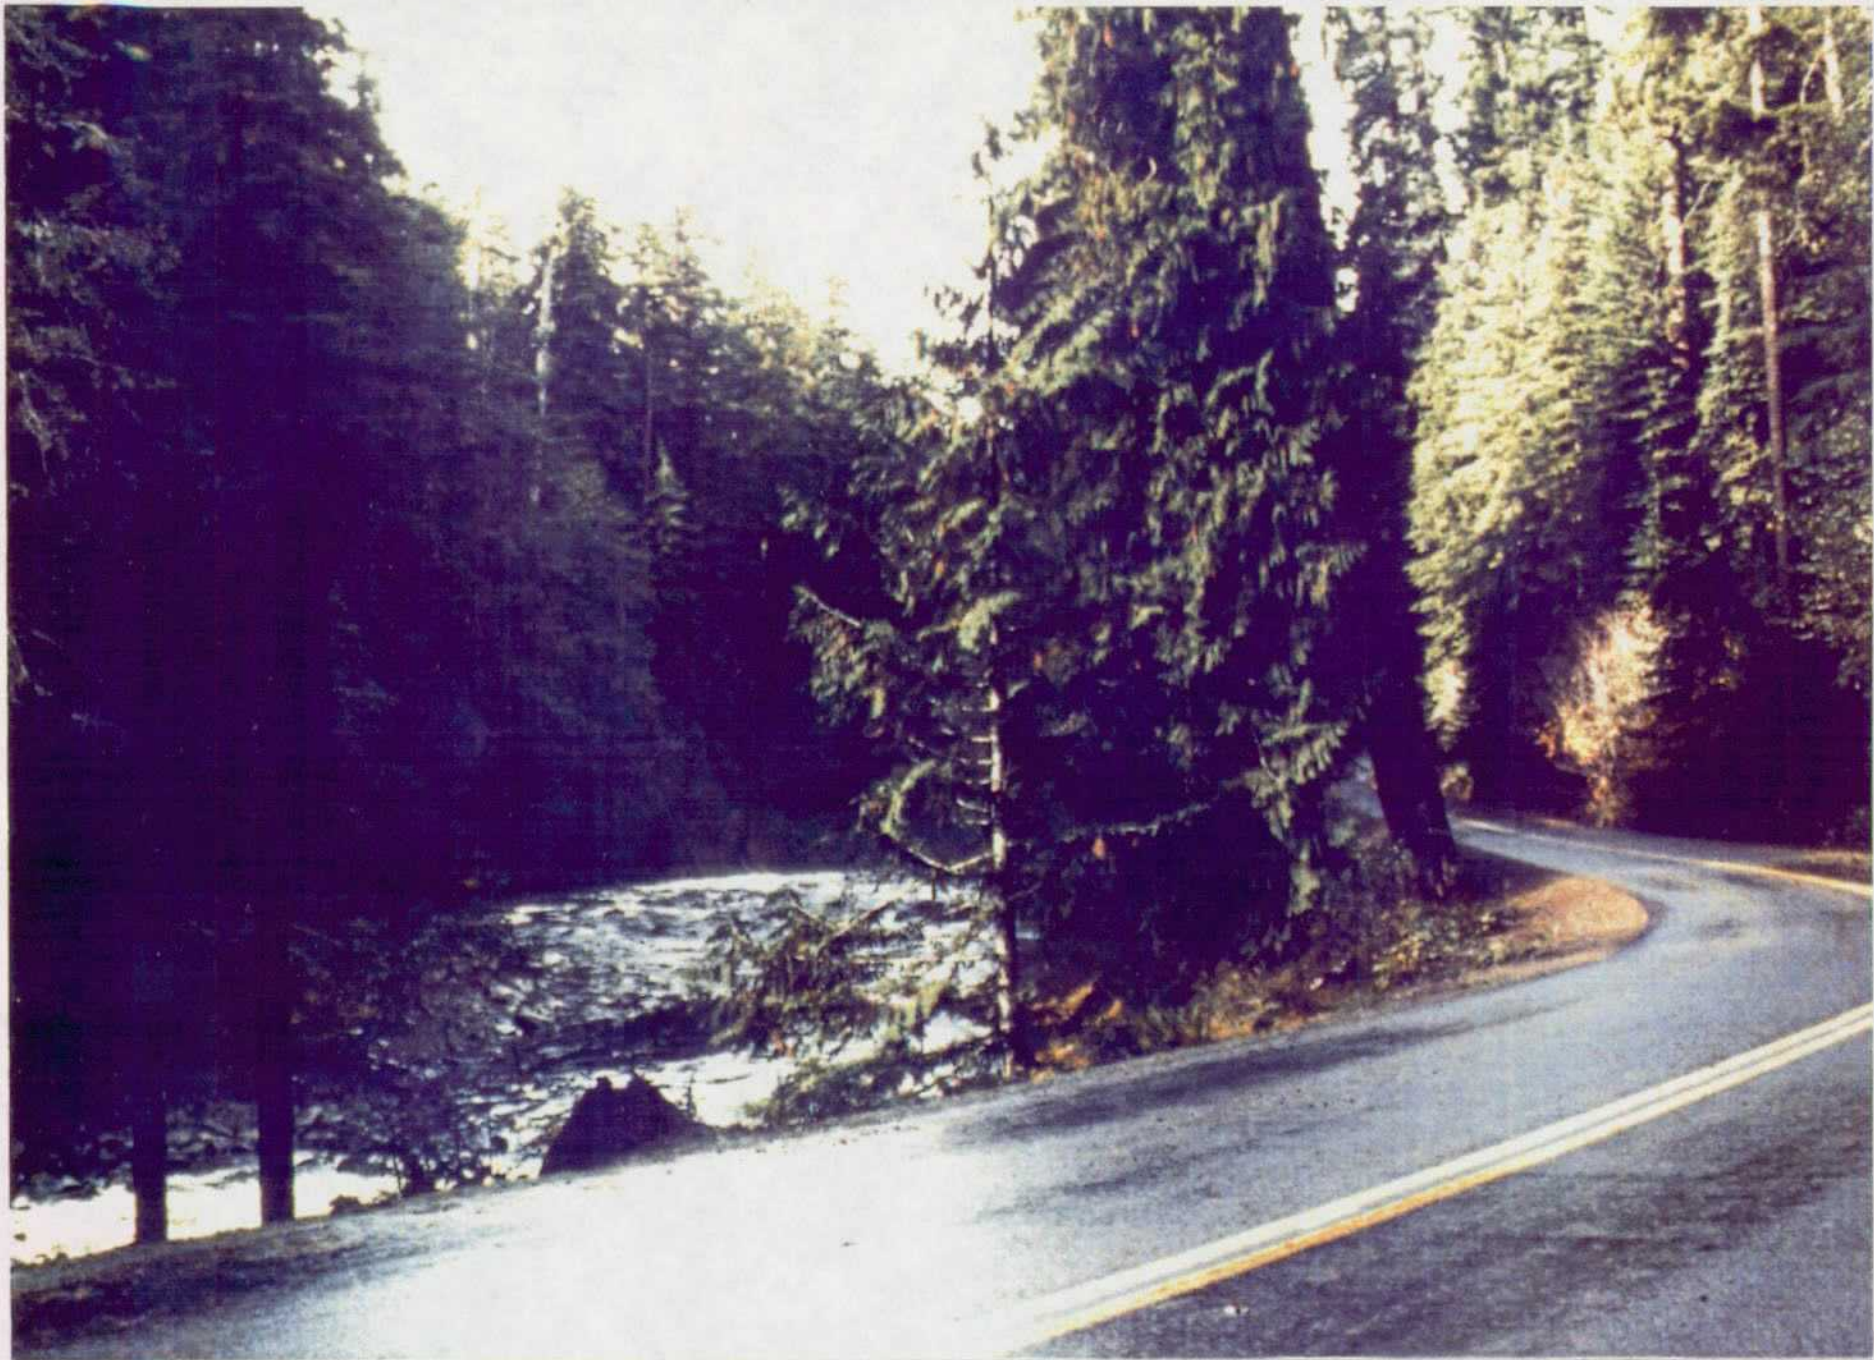
Photo C:10--View down river  
from above Salmon Cascades Exhibit  
sign, spring 1989.

PHOTOGRAPHS: Photo C:9 view of Salmon Cascades from upper section of vista just above Salmon Cascades Exhibit sign. Photo C:10 view down river from above Salmon Cascades Exhibit sign. Photo C:11 – view of river looking down the road.

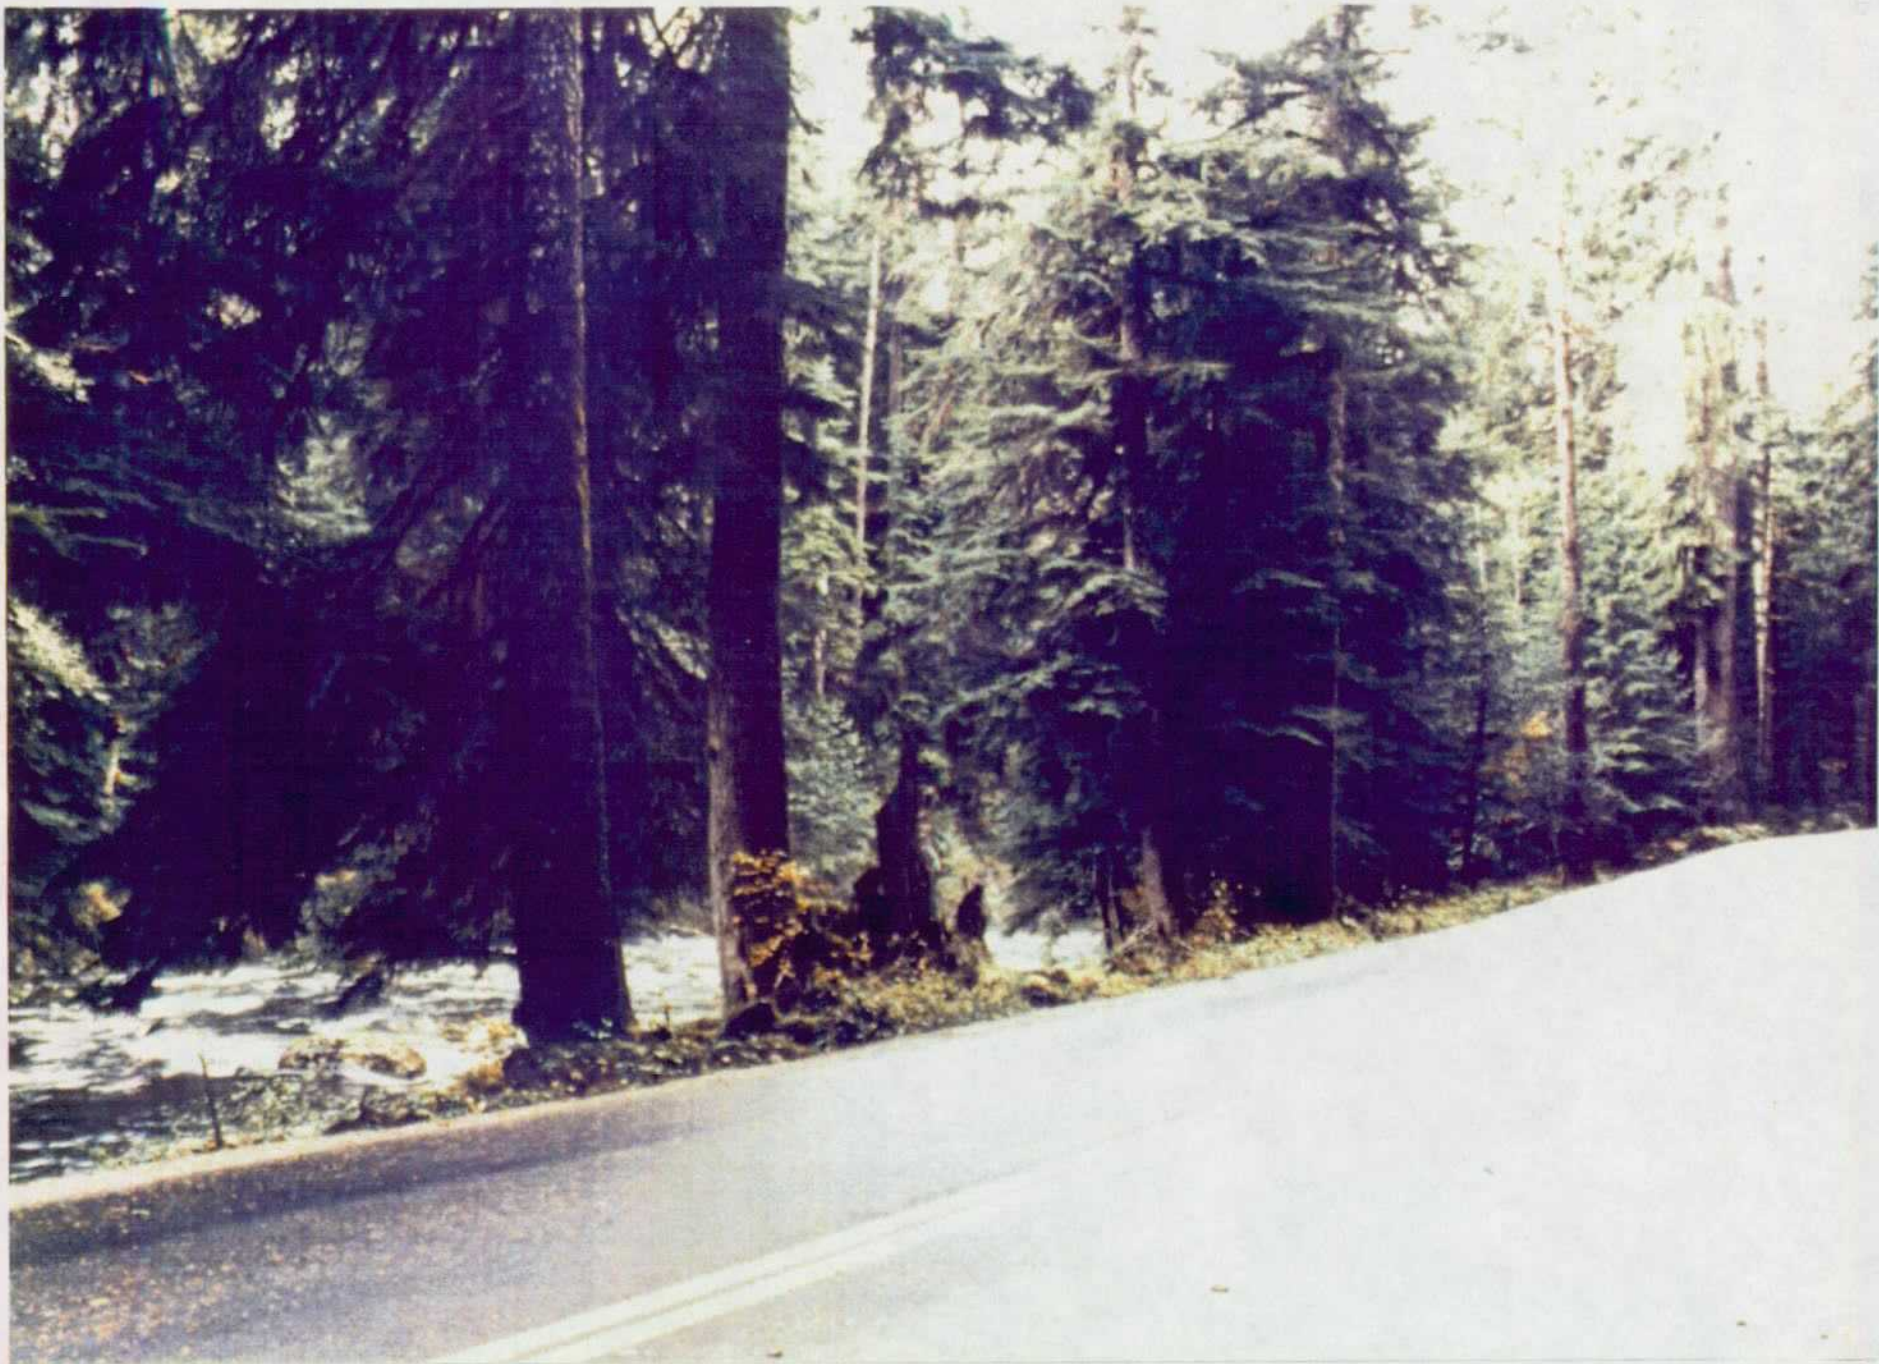
Photo C:11--View down road  
toward end of vista,  
spring 1988.

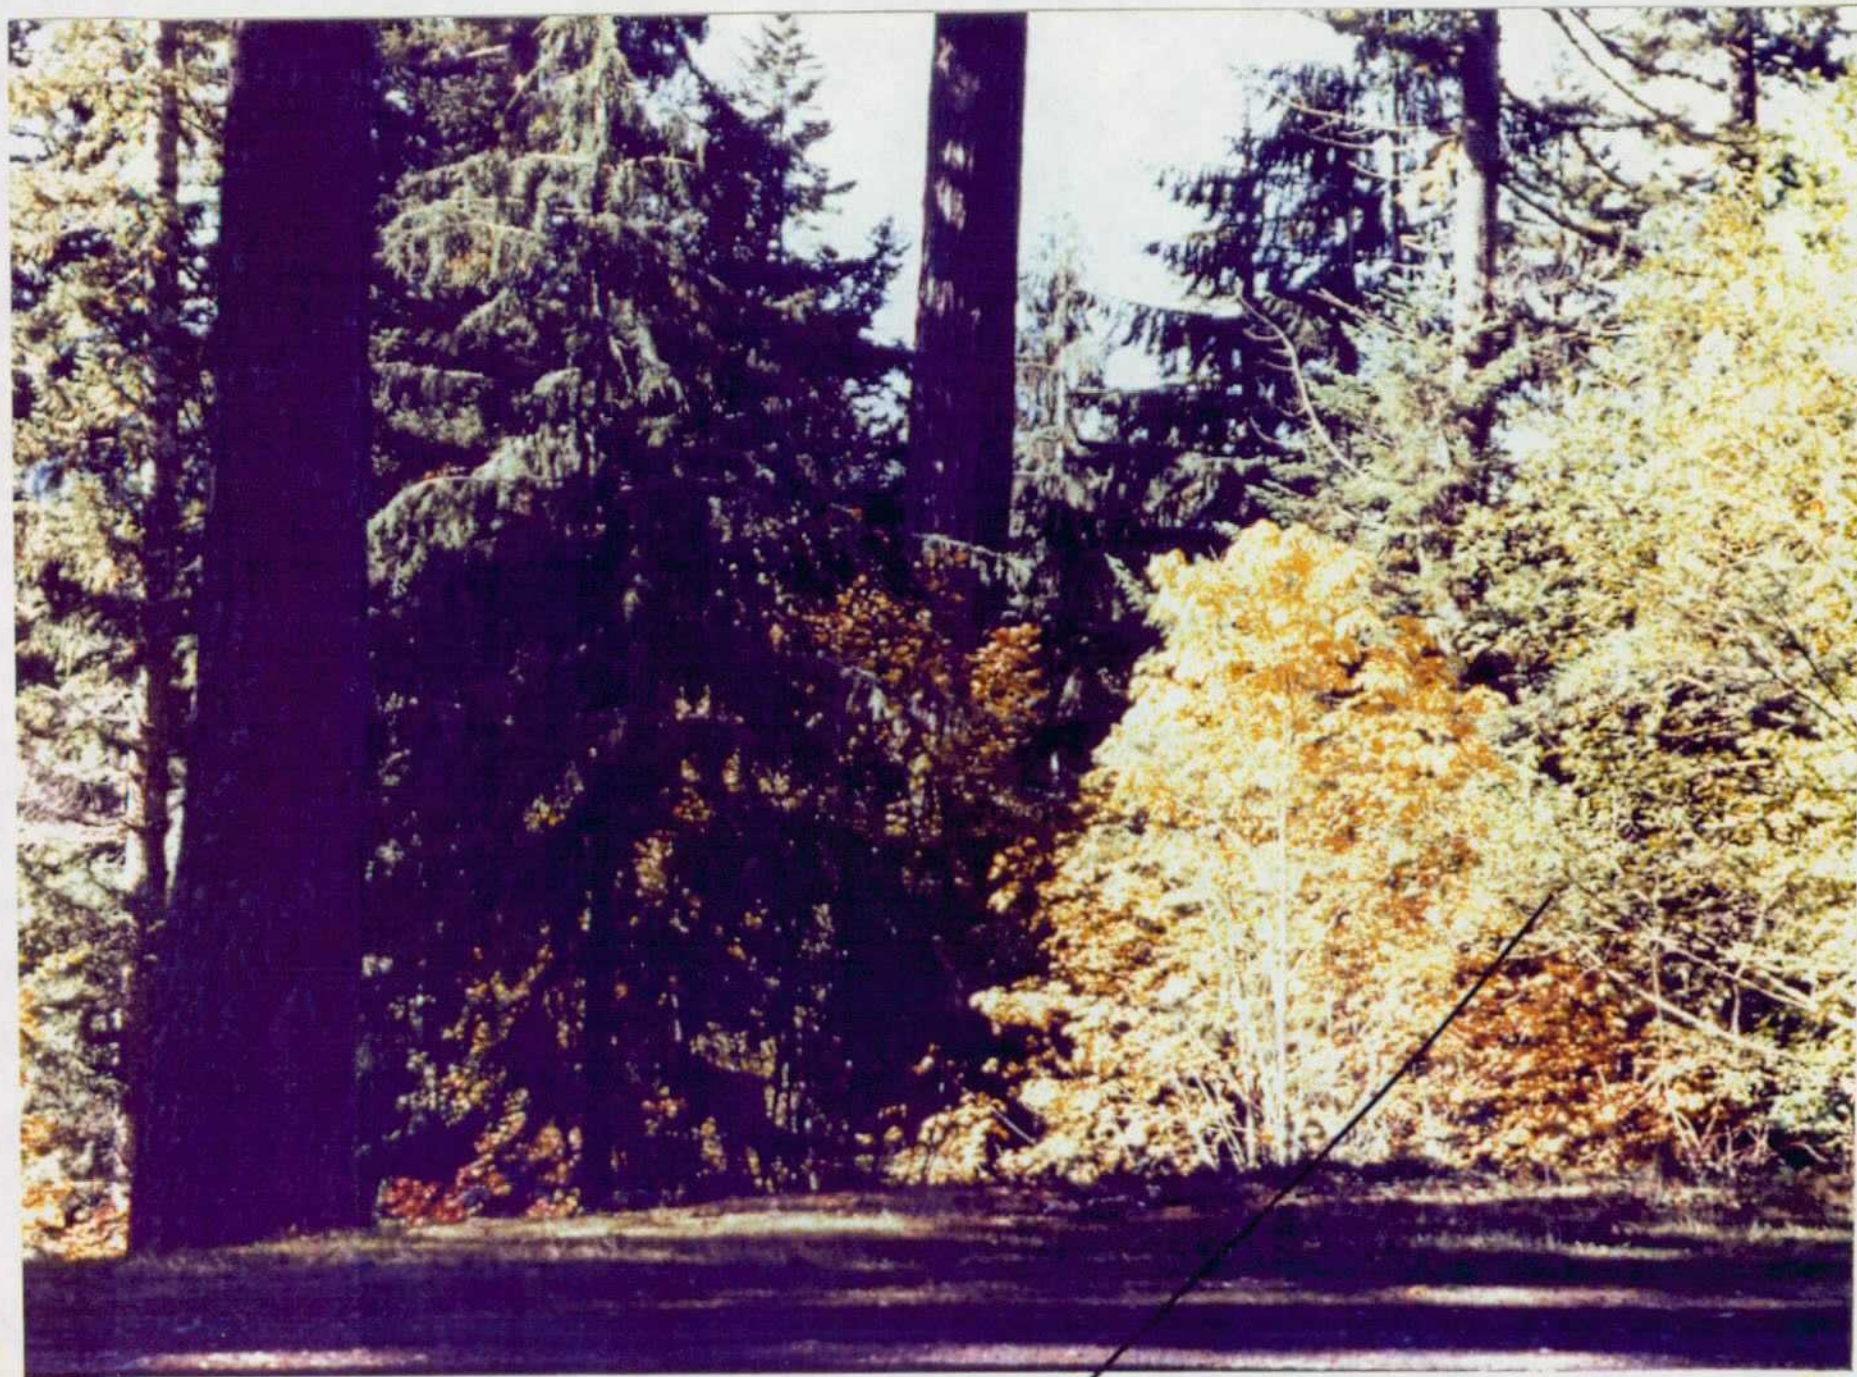
Photo C:12--Alder clump marking  
lower end of clearing, spring 1989.

Directions: Stop clearing  
at alder clump on right.

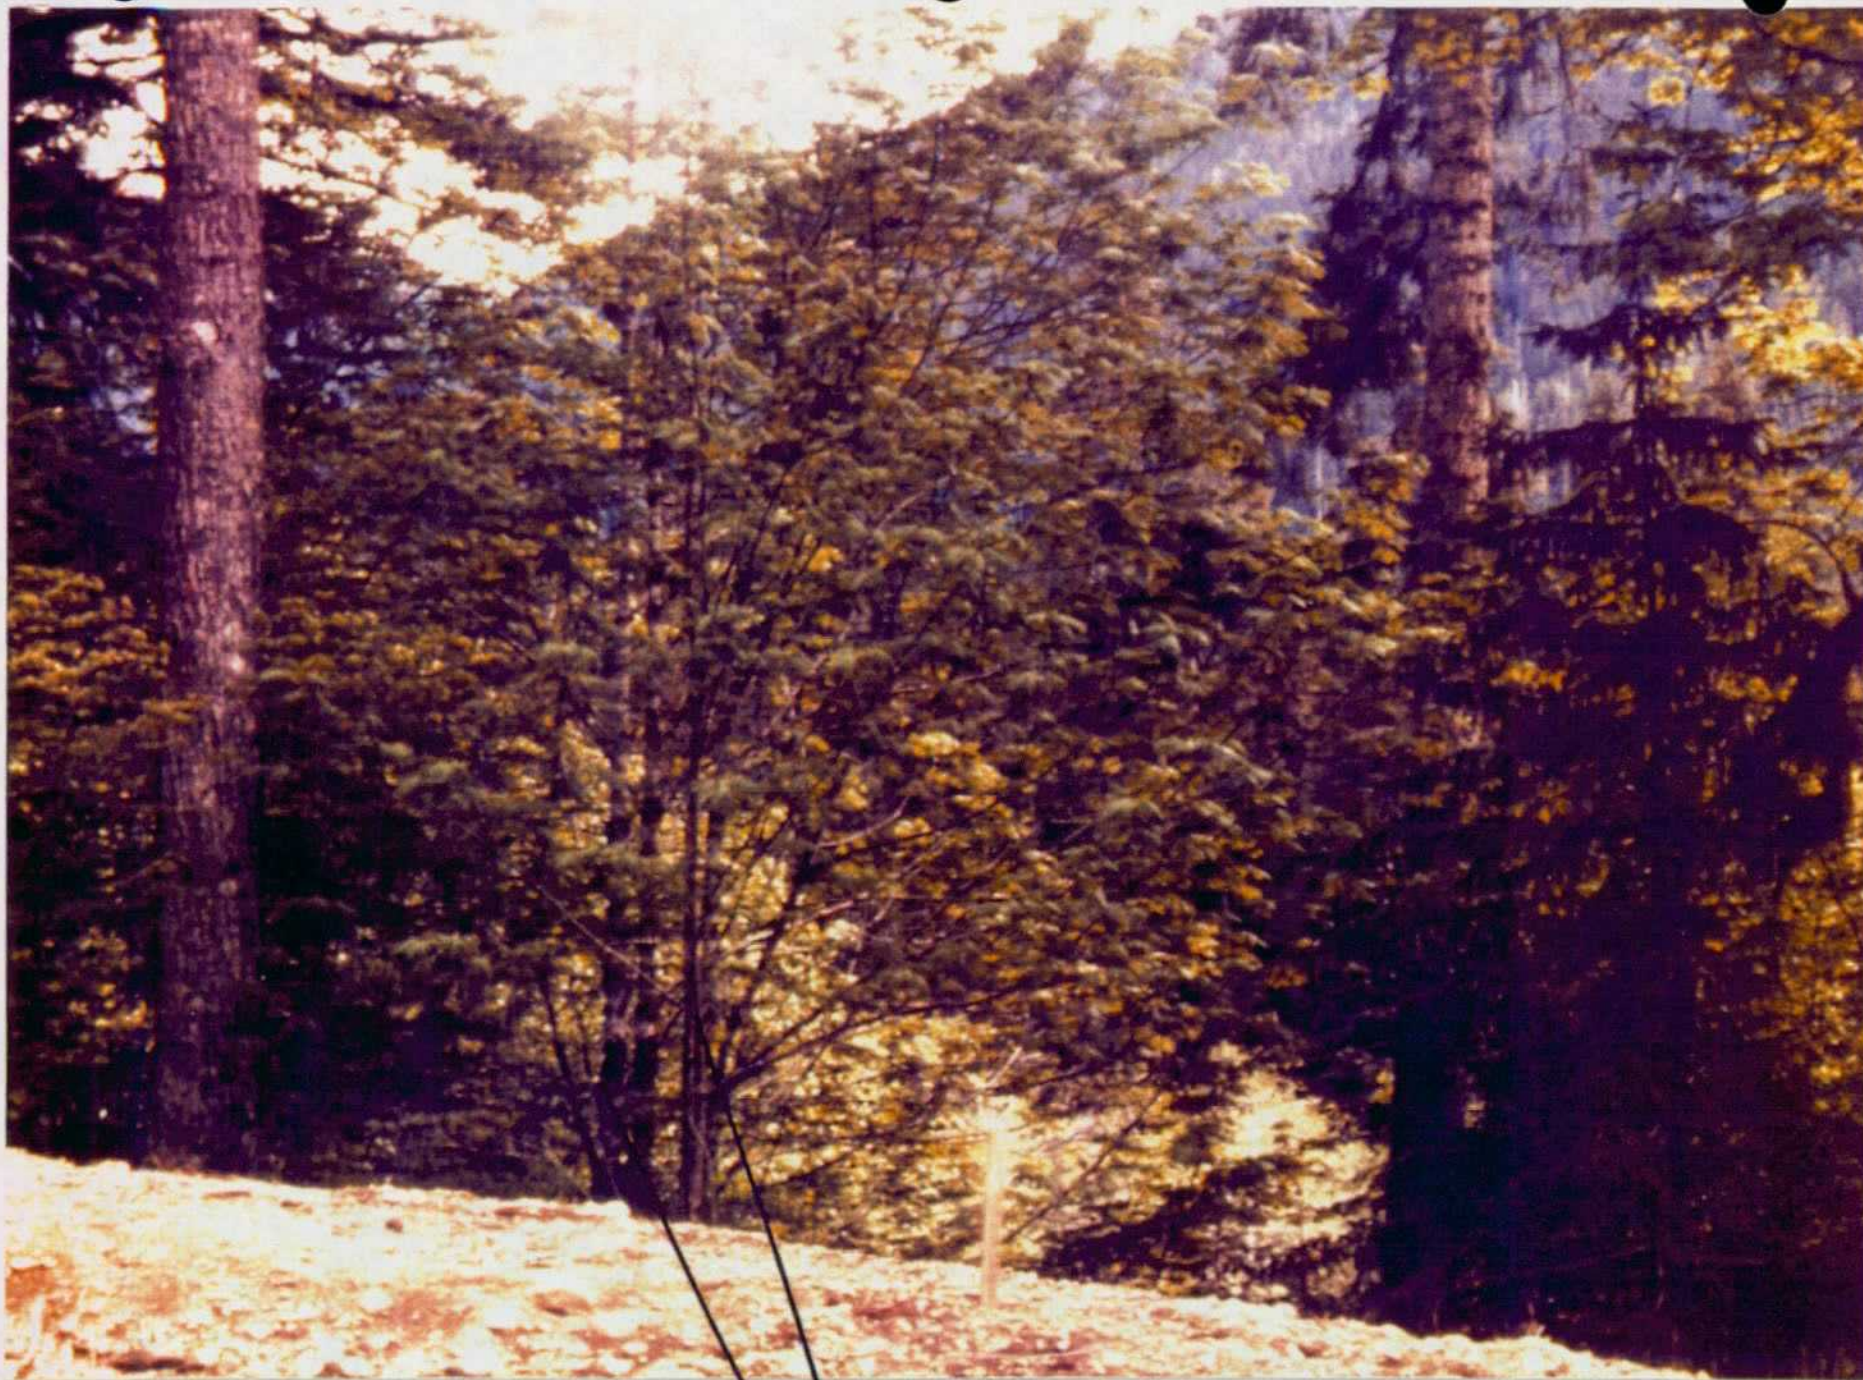
Photo C:13--Big leaf maple  
to be removed from upper end  
of vista, spring 1989.

Directions:  
Remove trees.

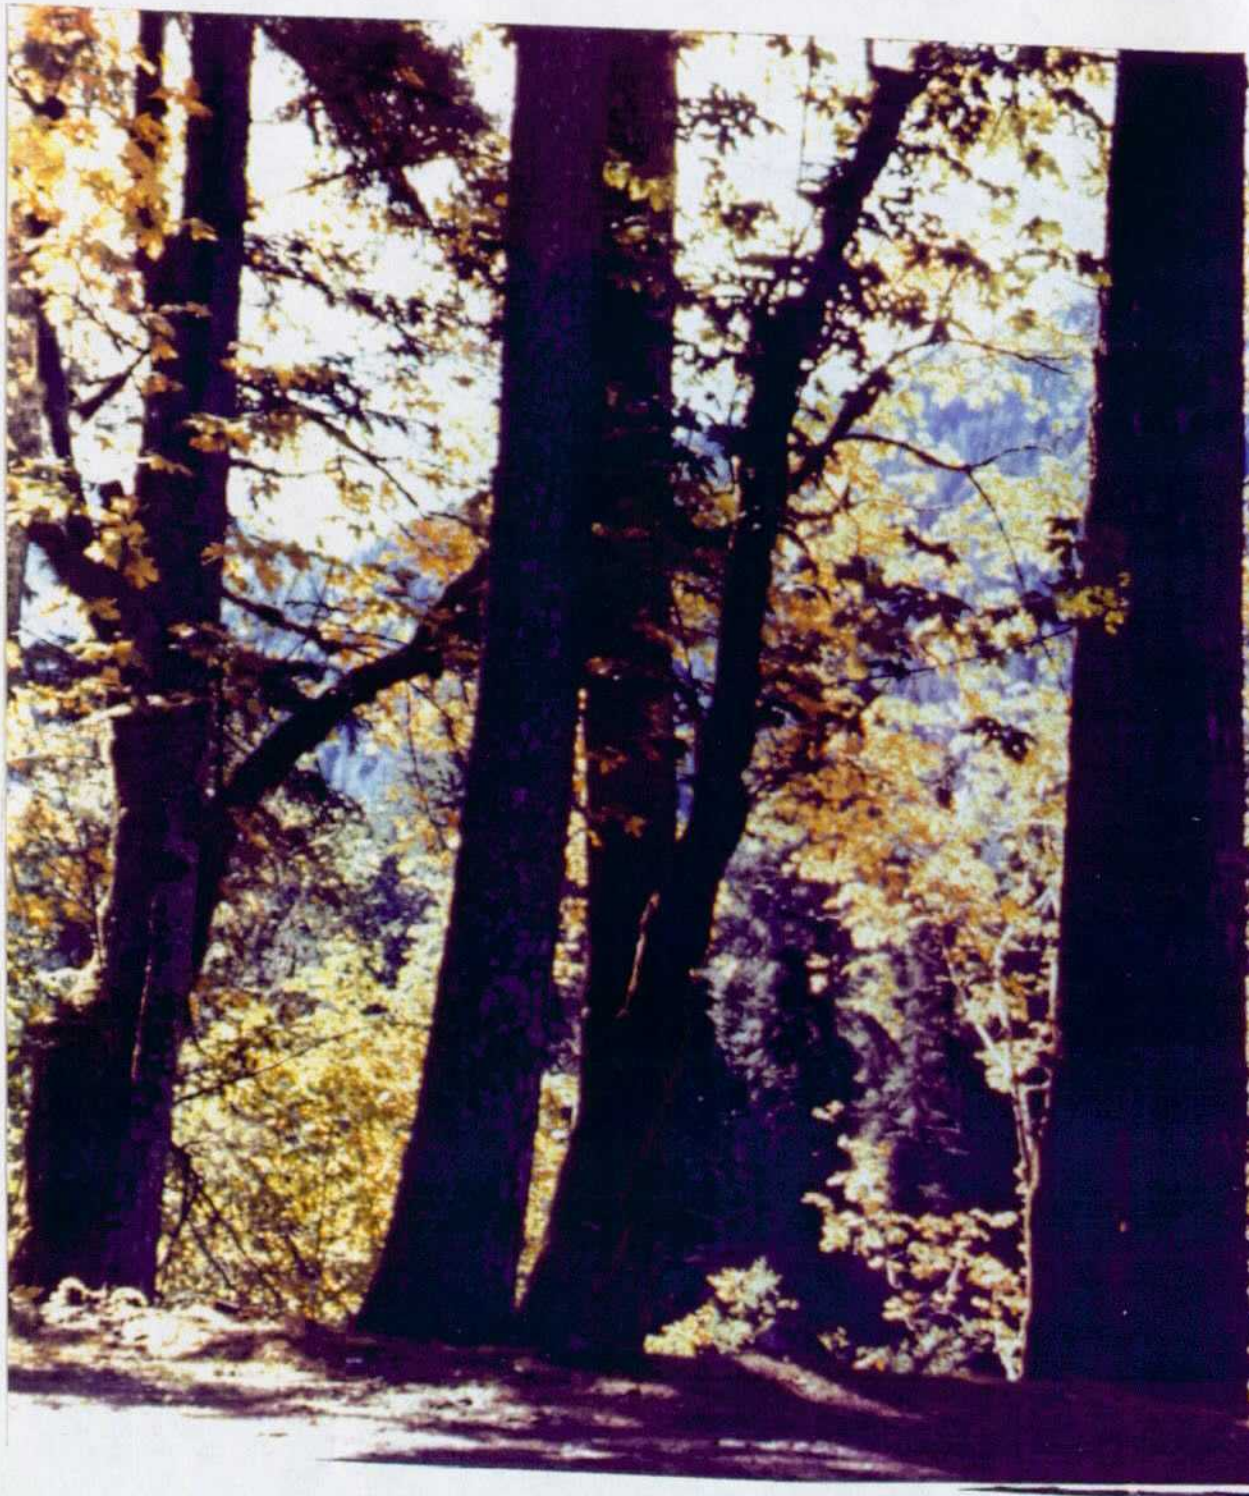
Photo C:14--Center section  
showing cleared vista, fall 1986.

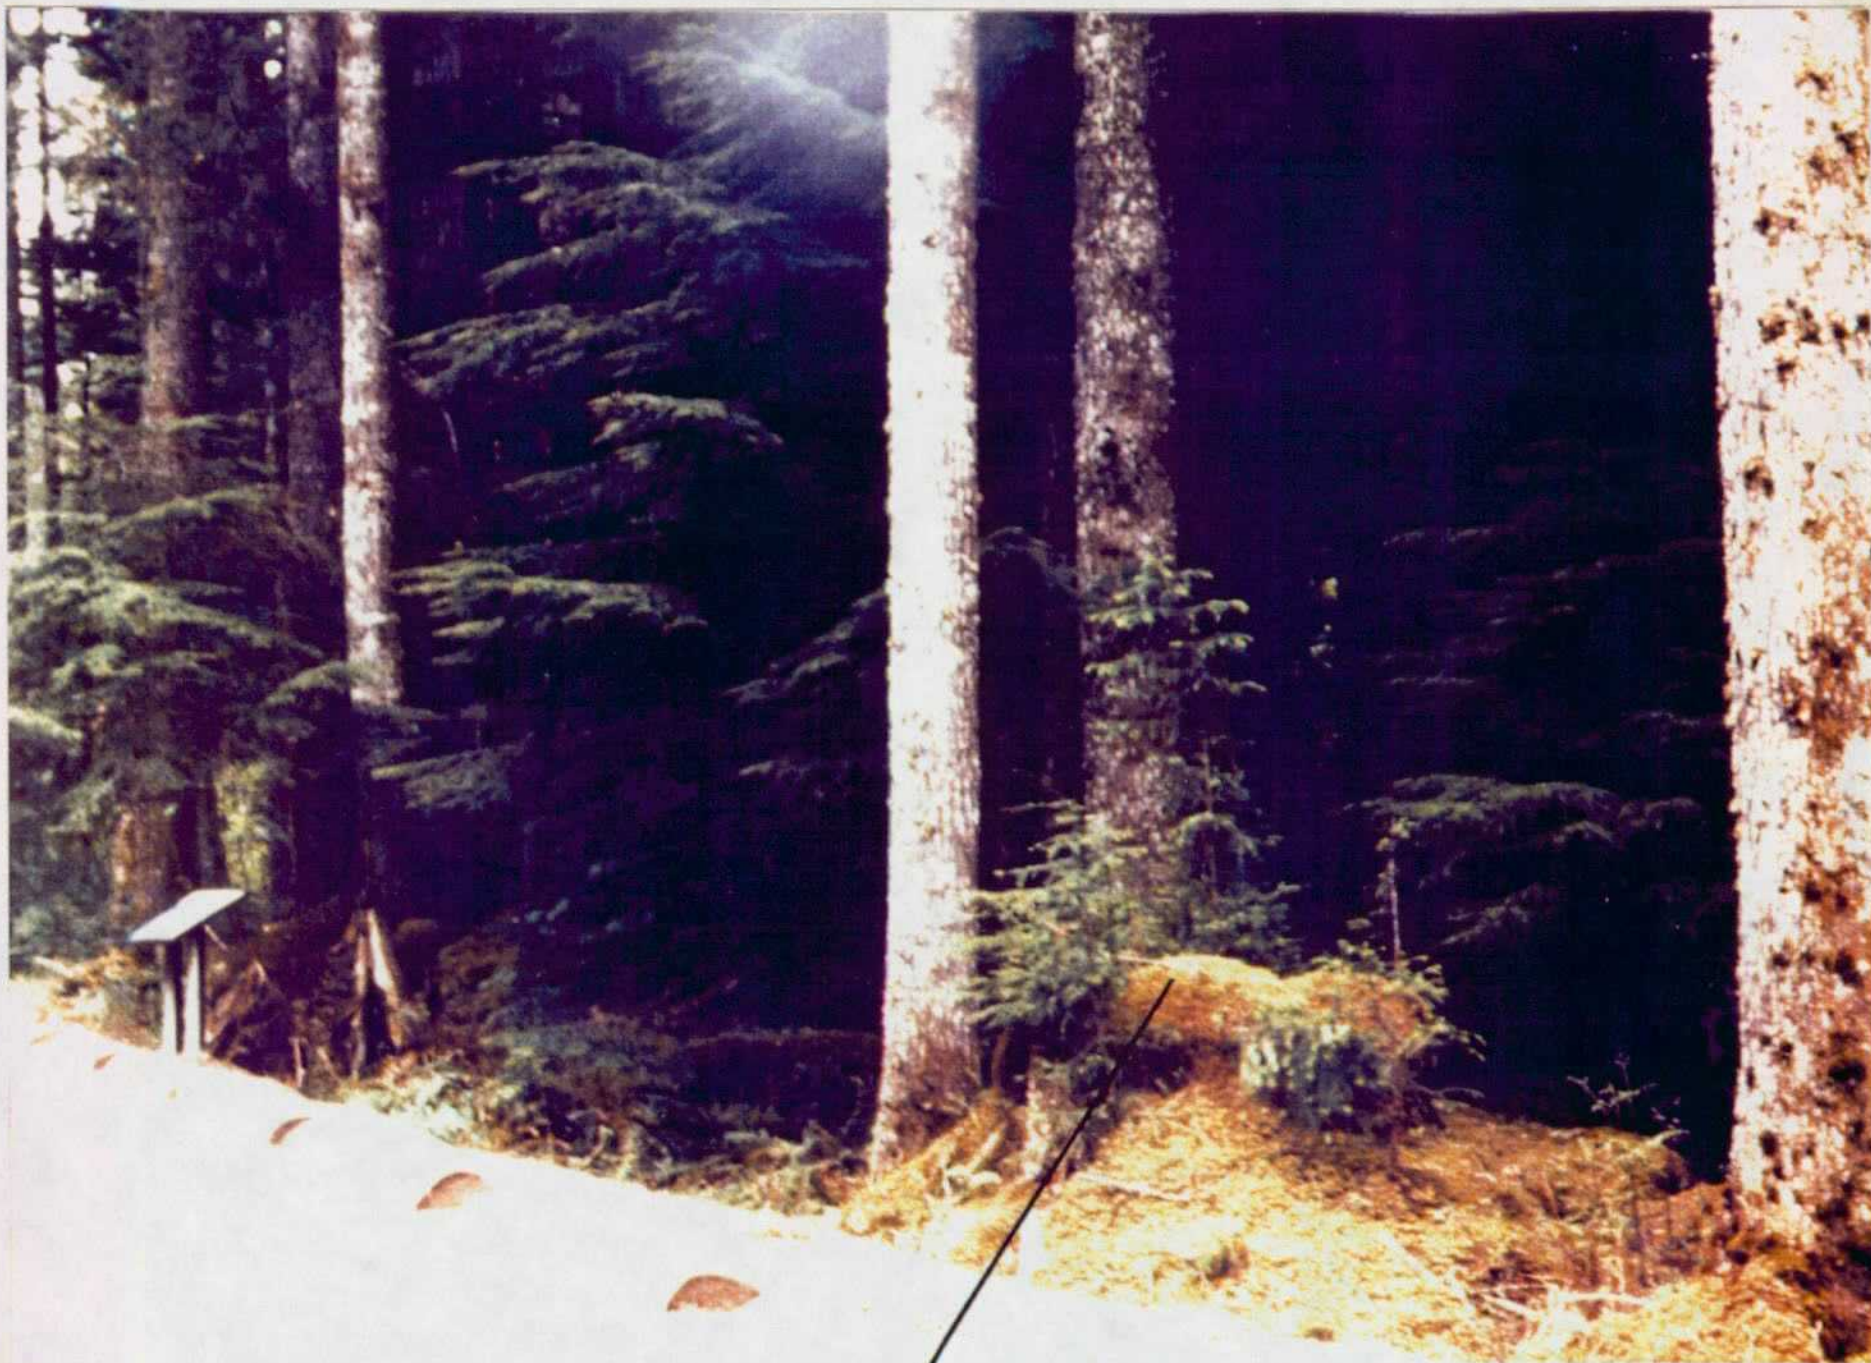
Photo C:15--Hemlocks on nurse log  
at about 462+00, spring 1989.

Directions:  
Do not clear nurse log.

INSTRUCTIONS: Selectively thin hemlock saplings and brush 4" in diameter and smaller. Paint hemlock stumps with borax to prevent fungus infection. Do not remove hemlocks from nurse logs (see Photo C:15). Limb as they grow larger.

PHOTOGRAPH: Photo C:15 – Hemlocks on nurselog.

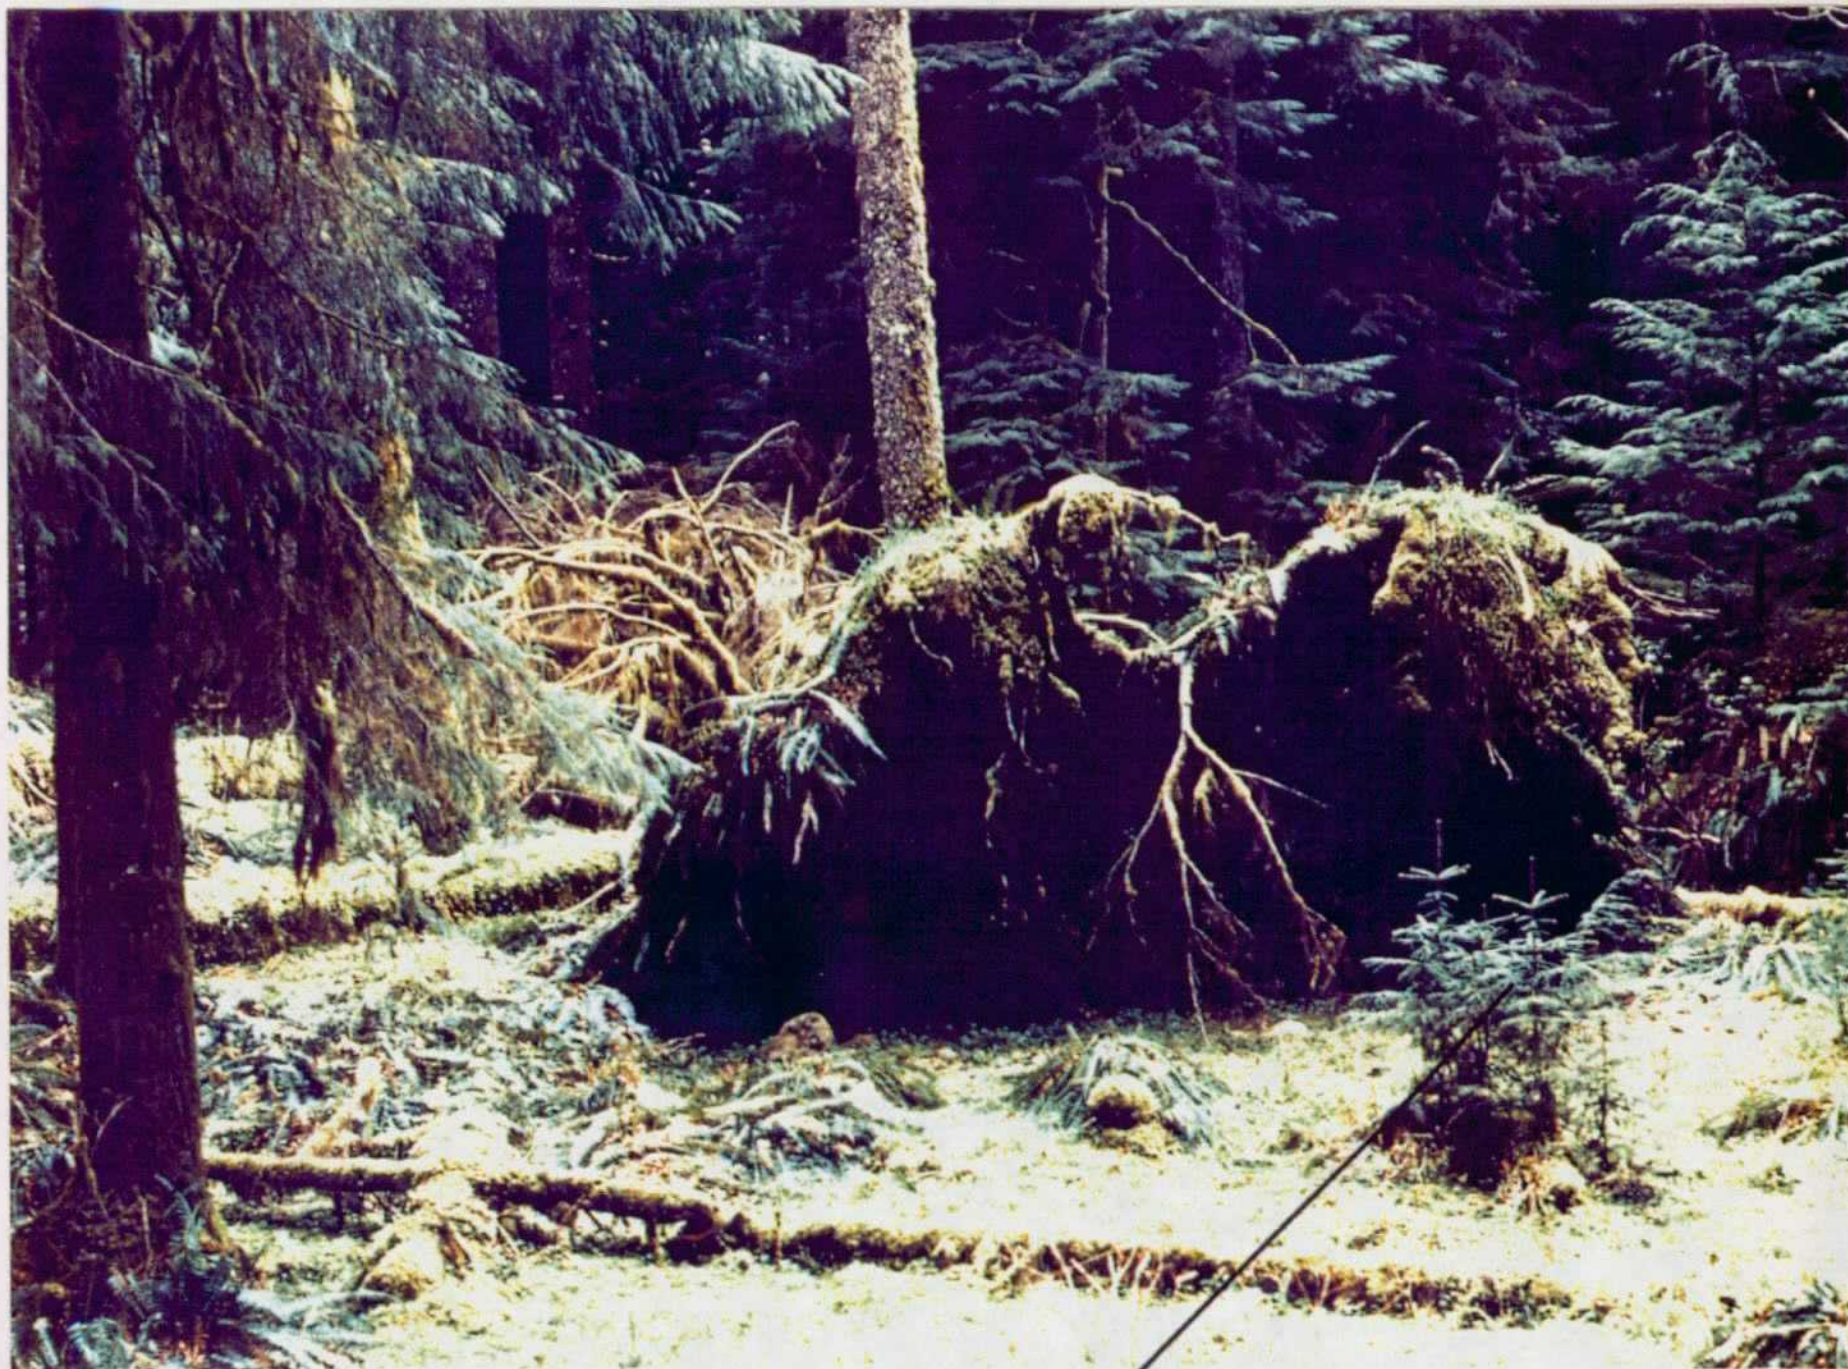
Photo C:16--Forest view  
at 475+00, fall 1986.

Directions: Save  
Sitka spruce seedlings.

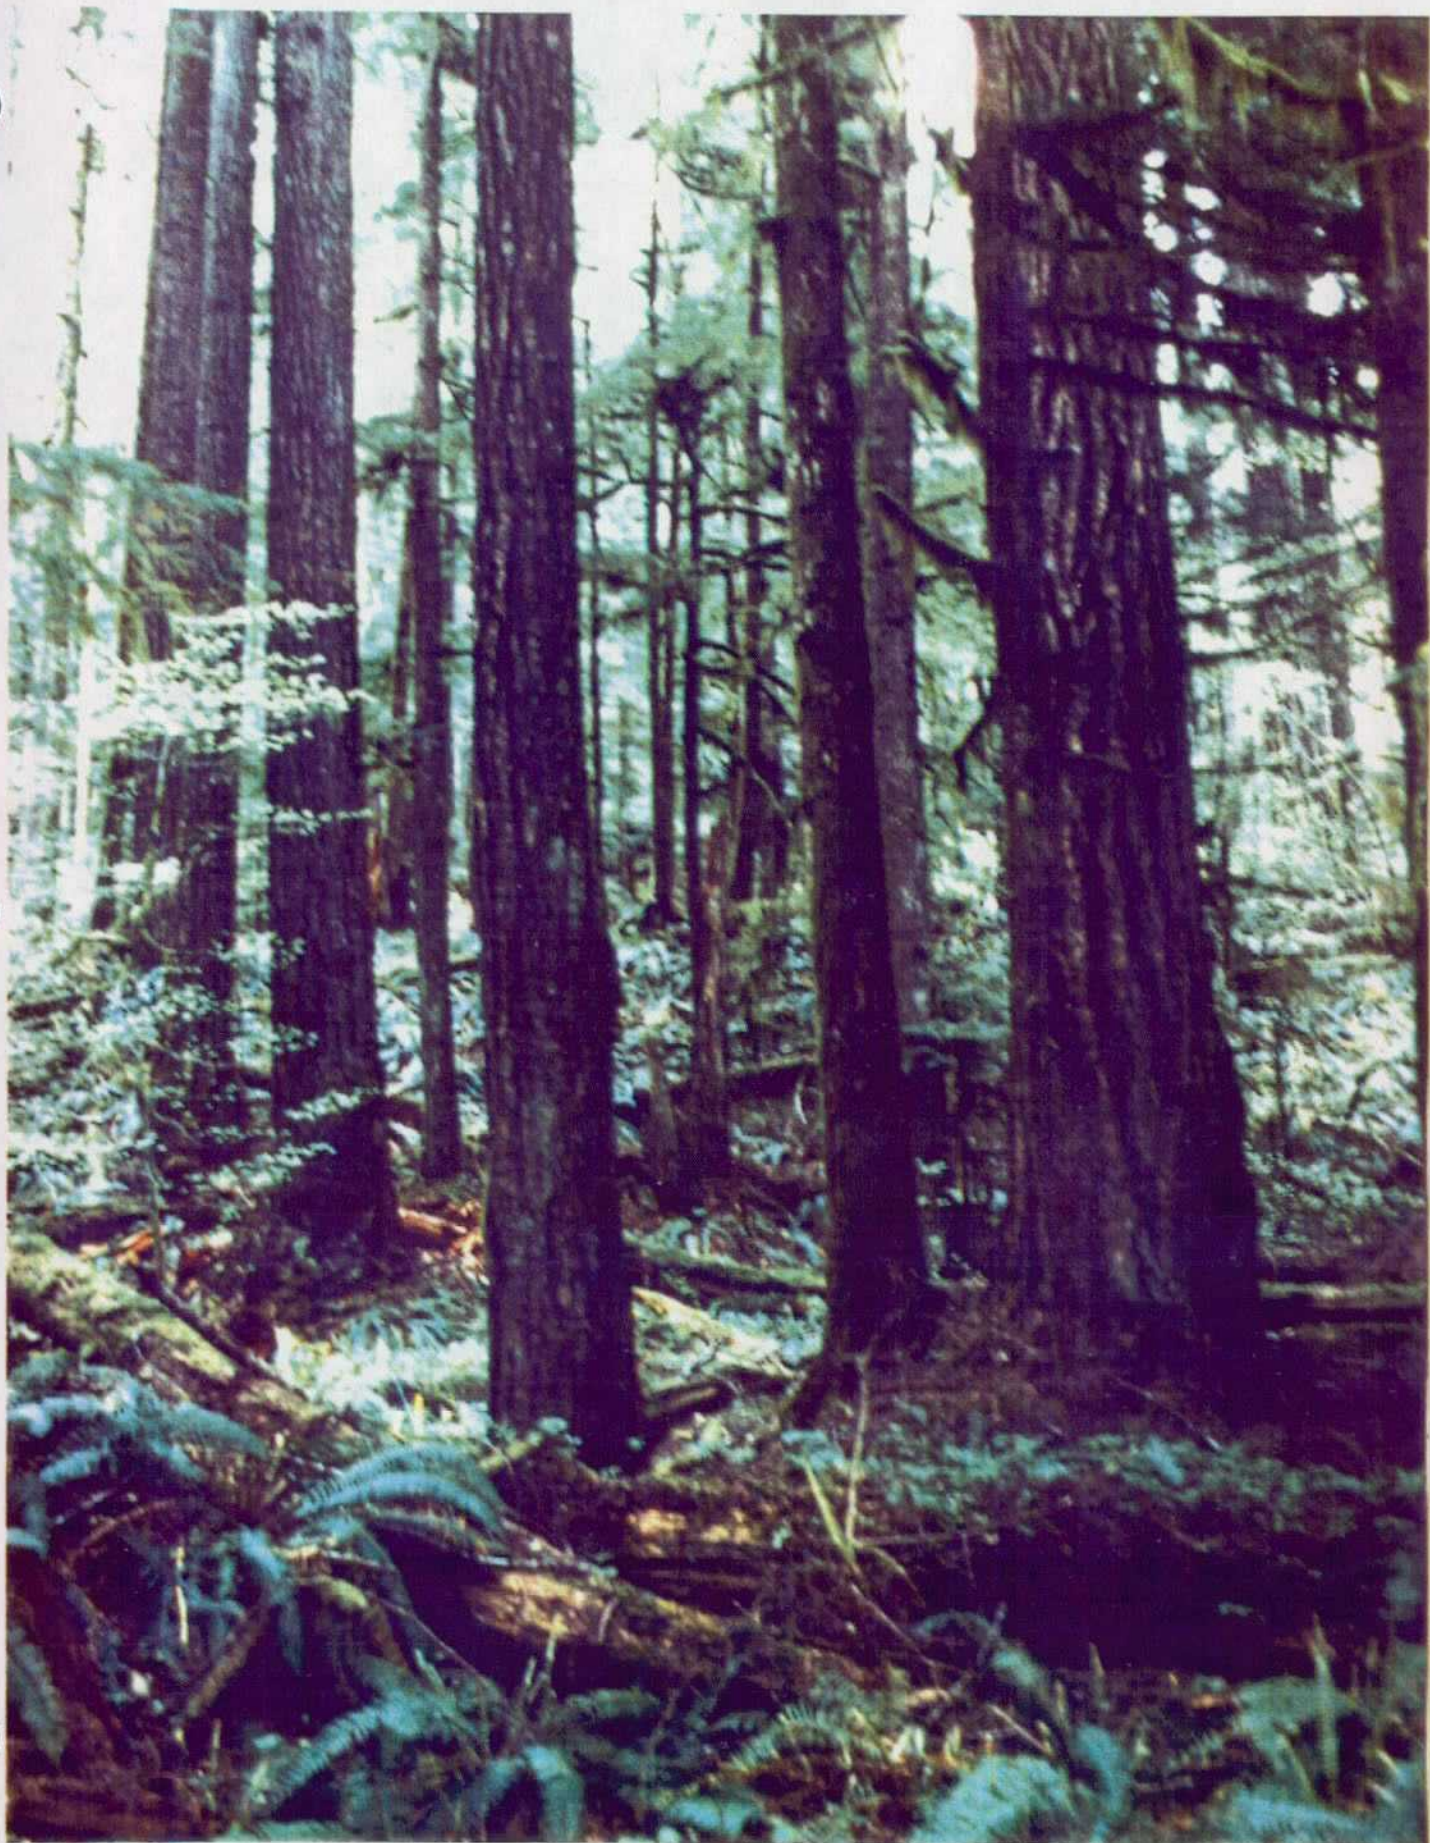
Photo C:17--Typical forest view.

INSTRUCTIONS: Except for berms and planted slopes, selectively thin hemlock saplings and brush 4" in diameter and smaller. Paint hemlock stumps with borax to prevent fungus infection. The idea is not to clear every hemlock from the road edge, but to do enough clearing to prevent a solid line of doghair from blocking views into the forest (see Photo C:17).

PHOTOGRAPHS: Photo C:17 – Example of forest view. Photo C:18 – View along vista.

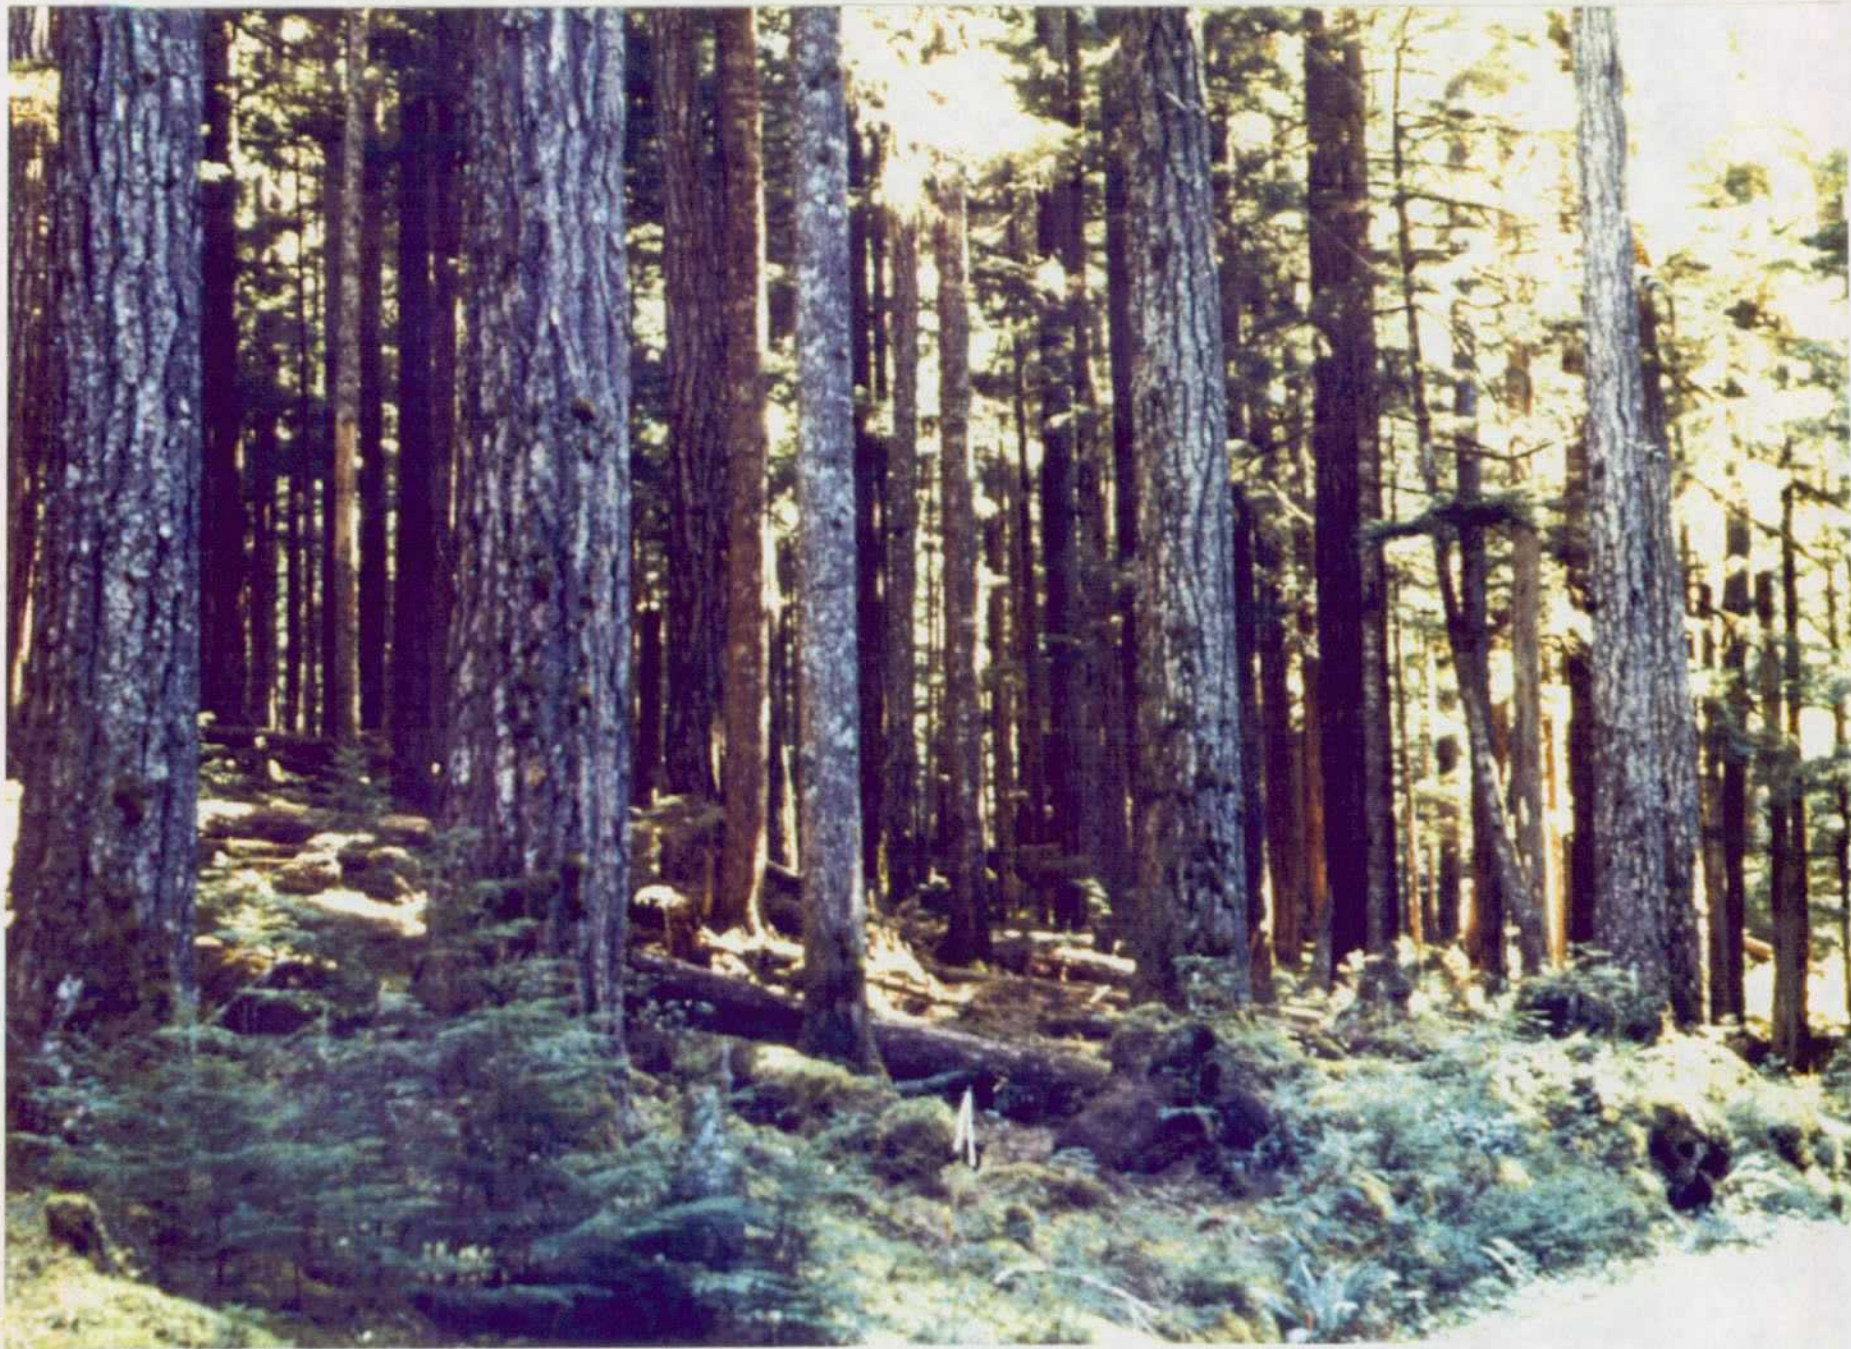
Photo C:18--Right 519+00 to  
537+00. Forest view along  
vista, fall 1988.
