# Inventory of Coastal Engineering Projects in Cape Hatteras National Seashore

Natural Resource Technical Report NPS/NRSS/GRD/NRTR—2013/713

Kate Dallas

March 2013

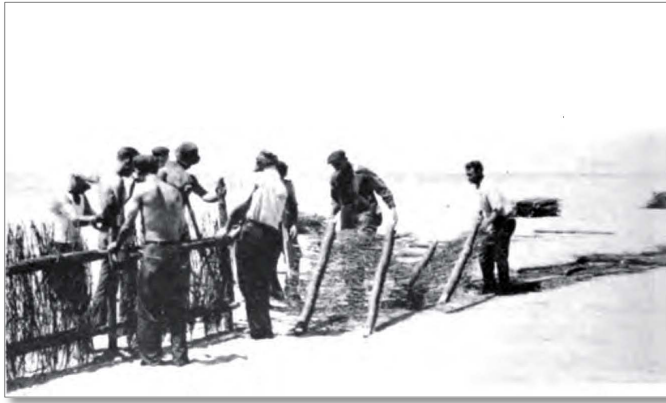
**Figure 4.** Installation of sand fencing in 1937 (NPS photo from Dolan 1985).

In response to rapid erosion, the NPS, in collaboration with the Civilian Conservation Corps and Works Project Administration, began a massive sand fixation program in 1937 (Figure 4) (Binkley 2007). Sand fences were erected along 174 km (108 mi) of the North Carolina coast from the Virginia State Line to southern Hatteras Island, trapping windblown sand and forming barrier dunes (Figure 5). The dunes were then further stabilized with vegetation. By 1941 the project had installed 1,250 km (780 mi) of sand fencing, planted 26 km<sup>2</sup> (6,510 ac) of grass and over 3 million trees and shrubs, and built 120 km (75 mi) of dikes and jetties at a cost over \$1.7

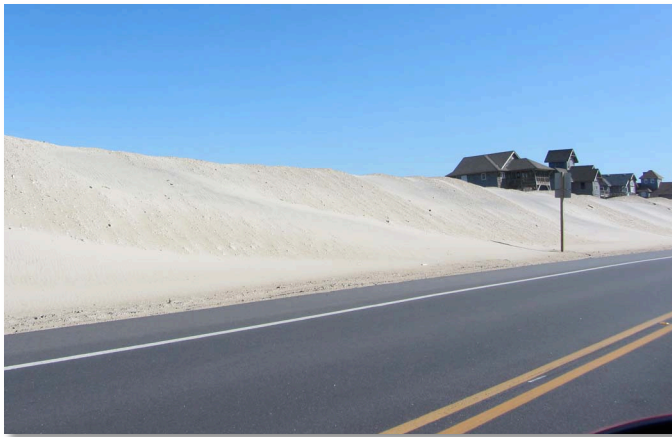
**Figure 5.** Constructed dunes (seen here north of Rodanthe in March 2012) parallel Highway 12 nearly the entire length of CAHA (image by Kate Dallas).

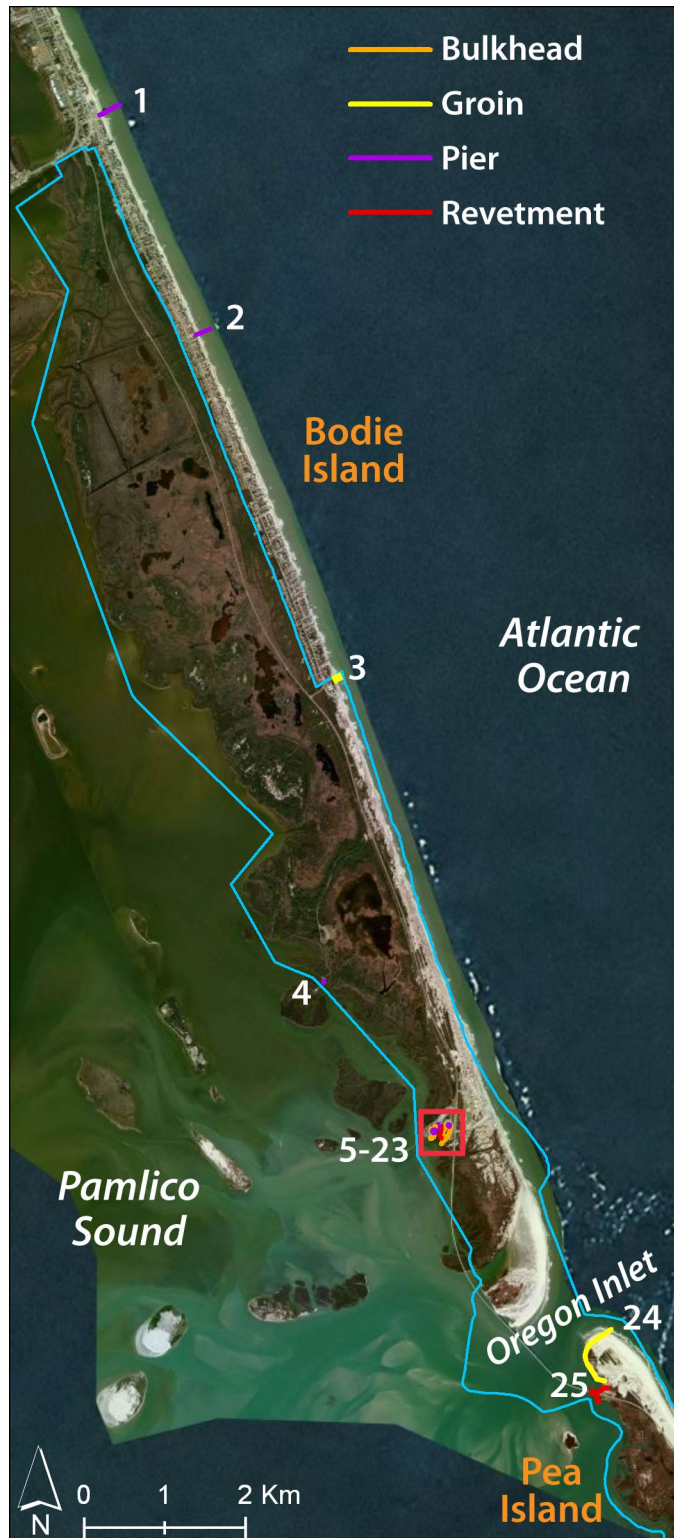
**Figure 6.** Bodie Island and northern Pea Island structure map. Blue line shows park boundary. Area in red box is enlarged in Figure 9 (image from ESRI Bing Maps basemap layer 2012).

The Town of Nags Head has two large recreational piers, Jennette's Pier (#1 Figure 6) and the Nags Head Fishing Pier (#2 Figure 6), both located outside of the park. Jennette's Pier was the first pier built in the Outer Banks in 1939. The pier was rebuilt in 1947 and 1963, remodeled in 1996, and demolished in 2008 to be replaced by the current pier, which was completed in 2011. Nags Head Fishing Pier, located in southern Nags Head, was constructed in 1947, rebuilt after the Ash Wednesday Storm in 1963, and has been repaired many times (Village Realty, Inc. 2012).

At the boundary between the Town of Nags Heads and CAHA is a NCDOT concrete stormwater outfall pipe that is protected by timber pilings (labeled as a groin, #3 Figure 6 & Figure 7). Plan drawings from the NCDOT show that the outfall and pilings were proposed in early 1960s and were likely built soon thereafter. The outfall and pilings have been repaired over time, including the most recent repair in 2003 (John Abel, NCDOT, phone conversation, 10-25-12). Throughout the developed areas of CAHA there are additional ocean outfalls that may function as groins (total number unknown). However, they are typically buried in the beach and since they were not visible in our aerial imagery, they were not included in this study.

On the soundside of Bodie Island near the Bodie Lighthouse is a wooden pier used by the Off Island Hunting Club (#4 Figure 6). The hunting club formed in the early 1960s and the pier was originally built around the same time and has been repaired over time by the club, most recently after Hurricane Irene in 2011 (Dan Barker, President Off Island Gun Club, email, 10-23-12). Further south along the sound side of the island is the Oregon Inlet Fishing Center Marina and U.S. Coast Guard Oregon Inlet Station (Figure 8), which has bulkheads, piers, and a revetment.

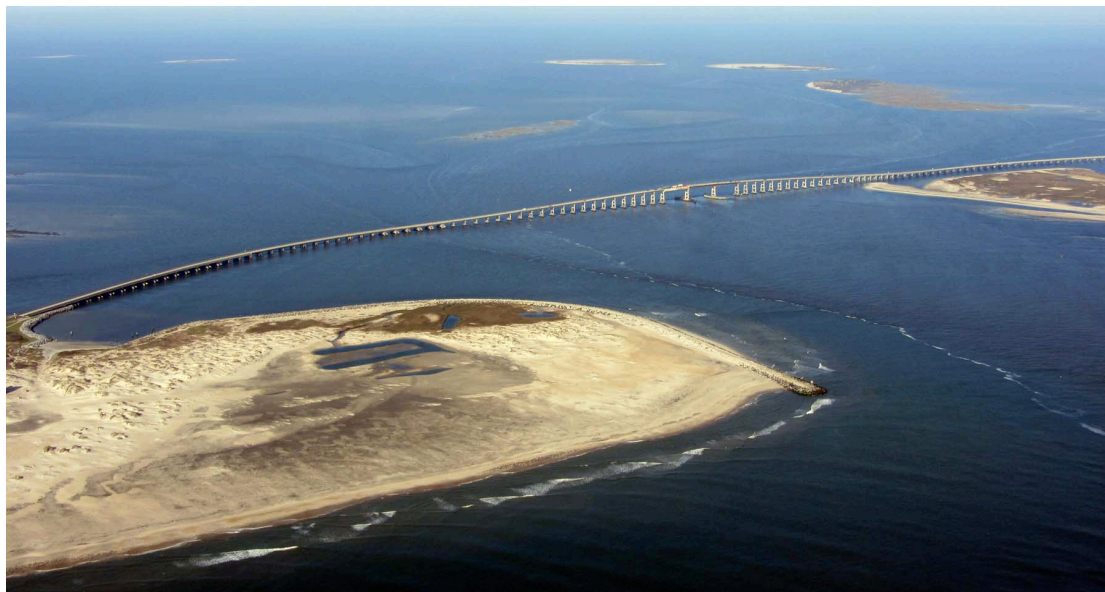
**Figure 10.** The Herbert Bonner Bridge across Oregon Inlet and the northern end of Pea Island. The terminal groin is visible in the middle of the image. View is to the northwest (image by Kate Dallas).

Oregon Inlet separates Bodie Island and the northern end of Pea Island (Figure 10) and is the only permanent tidal inlet between Rudee Inlet in Virginia Beach, Virginia, about 137 km (85 mi) to the north of Oregon Inlet, and Hatteras Inlet about 72 km (45 mi) to the south. The Herbert Bonner Bridge was built across the inlet in 1962–1963 (Riggs and Ames 2009) and is scheduled to be replaced soon. Oregon Inlet is a high-energy environment and is the primary route to the ocean for hundreds of commercial and recreational fishing vessels. From 1999 to 2001 an average of 311 commercial fishing boats used the inlet 3,900 times per year (USGAO 2012).

In order to stabilize the inlet and maintain the attachment between the north end of Pea Island and the bridge, a 905-meter (2,970 ft) long terminal groin (Figure 10) and 420-meter (1,350 ft) long rock revetment were built from October 1989 to October 1991 at a cost of \$13.4 million (Riggs and Ames 2009, NCCRC 2010a) (#24 & 25 Figure 6). While the terminal groin has largely stabilized the northern end of Pea Island, the southern end of Bodie Island continues to encroach into the inlet and sand has accumulated in the inlet along the northern side of the groin (Figure 10) (NCCRC 2010a).

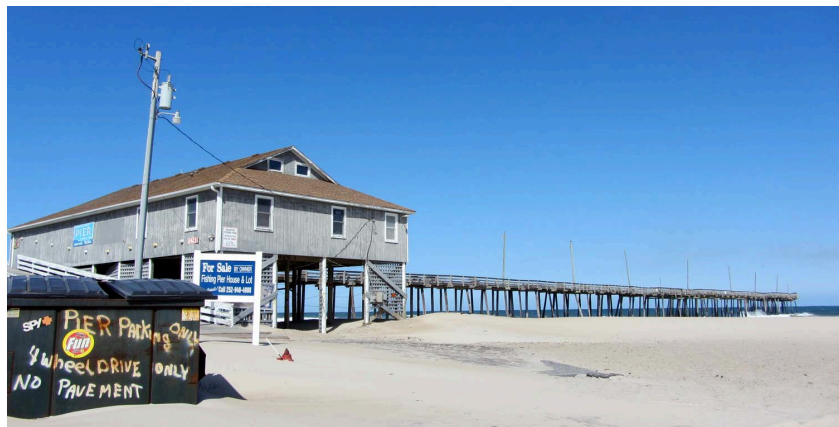
**Figure 13.** The Hatteras Island Fishing Pier in Rodanthe (#26 Figure 14, image by Kate Dallas).

The 260-meter (853 ft) long Hatteras Island Fishing Pier is located in the community of Rodanthe (Figure 13 and #26 Figure 14). The pier was built in 1960, demolished and rebuilt after Hurricane Floyd in 1999, and repaired after Hurricane Isabel in 2003 (Rodanthe Pier staff, phone conversation, 10-4-12). Roughly 1,800 m (5,900 ft) of beach to the north of the pier was nourished in 1965 with sand dredged from Pamlico Sound (NPS 1965).

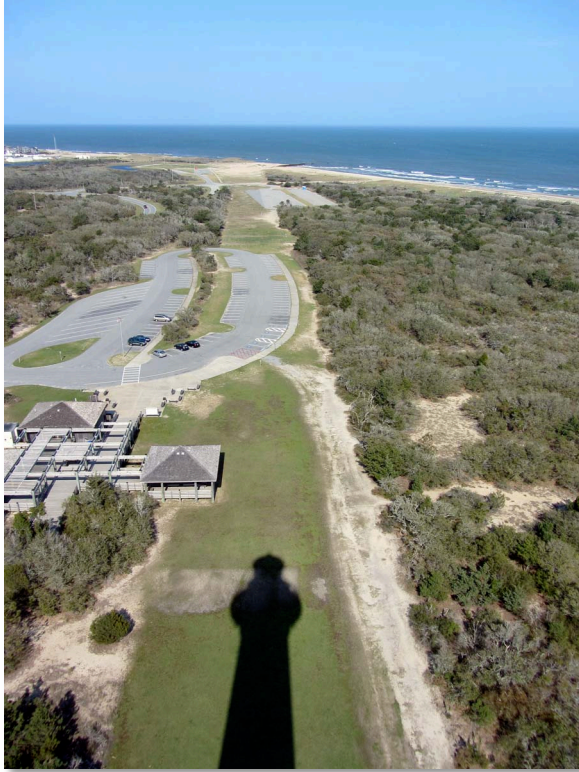
**Figure 15.** View from the top of the Cape Hatteras Lighthouse. The bare strip of land in the middle of the image is the path the lighthouse took during its move inland in 1999. View is to the northeast (image by Kate Dallas).

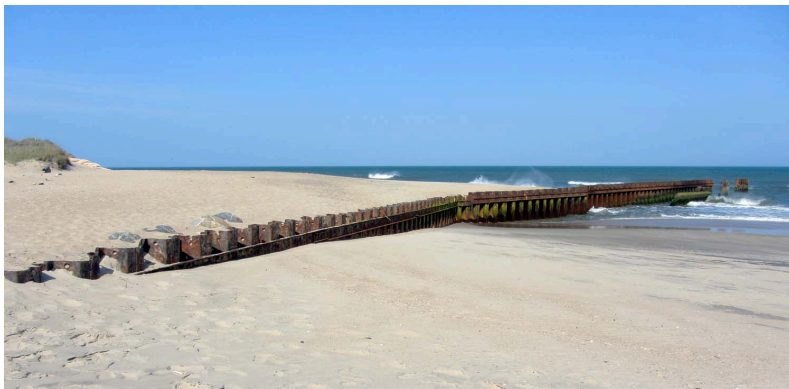
**Figure 16.** Steel sheet-pile groin (that was built in 1969 to protect a Navy facility) at the former location of the Cape Hatteras Lighthouse (#31 Figure 14). View is to the northeast (image by Kate Dallas).

The Cape Hatteras Lighthouse area was nourished 10 times from 1964 to 1973 with a total of 2,012,480 m<sup>3</sup> (2,632,225 yd<sup>3</sup>) placed at a cost of over \$5 million (WCU 2012). In 1969, the Navy built 3 groins to protect a Navy facility, which later became a Coast Guard station, north of the lighthouse. The groins have been successful at trapping sediment, but have accelerated erosion rates farther south (see Impacts section). Maintenance of the groins ended when the lighthouse was moved inland in 1999 and the groins have gradually deteriorated. Currently, the primary impact on the shoreline is from the remnant of the southern groin (Figure 16).

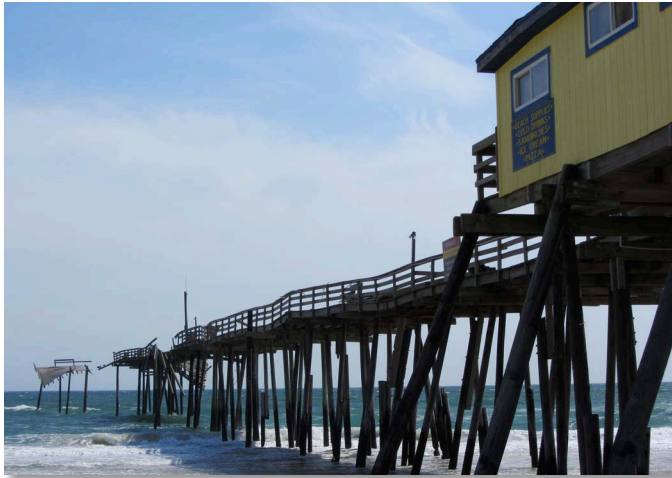
**Figure 17.** The Frisco Pier has been extensively damaged by storms and was closed in 2009 (#32 Figure 14) (image by Kate Dallas).

The wooden Cape Hatteras Pier, known locally as the Frisco Pier, was originally built in 1962 (#32 Figure 14) (Bowers 2012). Numerous hurricanes have caused extensive damages and the pier was closed in 2009 due to safety hazards. During our site visit to the park in April 2012 the pier was in very poor condition (Figure 17).

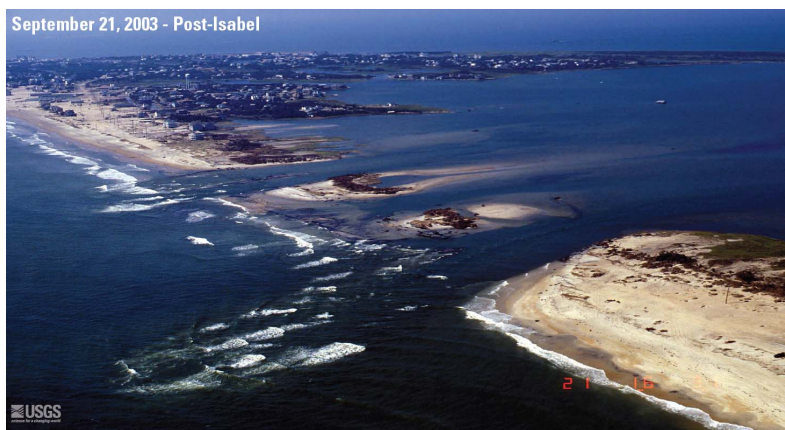
**Figure 18.** Hatteras Island breach near Hatteras Village after Hurricane Isabel in 2003. View is to the northwest (from USGS 2009).

Between Frisco and Hatteras Village (Figure 2) Hatteras Island is extremely narrow (roughly 150 m [490 ft]). NPS plan drawings (1972) show the dunes in this area were nourished in 1972. A 600-meter (1,604 ft) wide inlet with three distinct channels developed in this location during Hurricane Isabel in September 2003 (Figure 18). The USACE and NDCOT closed the inlet and rebuilt the highway in October–November 2003 using 650,000 to 764,560 m<sup>3</sup> (850,000 to 1,000,000 yd<sup>3</sup>) of sediment dredged from the navigation channel between Hatteras and Ocracoke Island (Pendleton et al. 2004) at an estimated cost of \$6.5 million, excluding road and utilities reconstruction (Smith et al. 2006). A second, smaller breach opened south of Hatteras Village and was filled in October 2003.

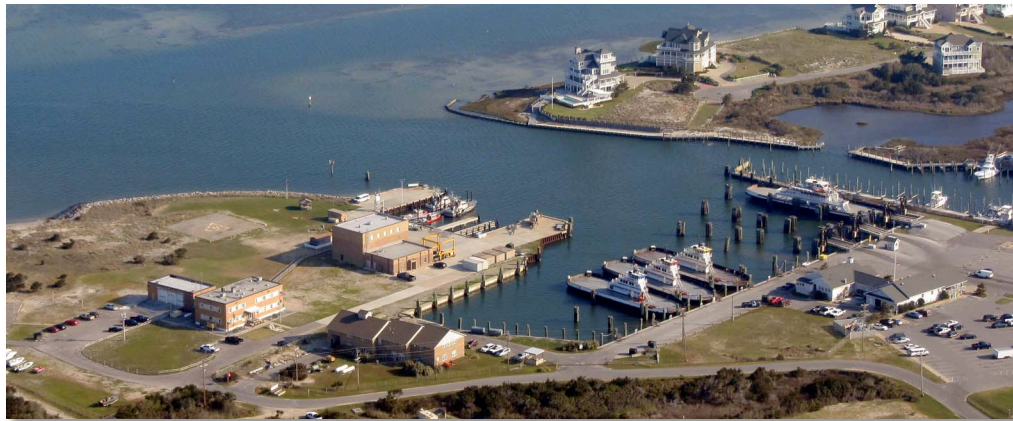
**Figure 19.** The Hatteras Ferry Landing Marina and Hatteras Island U.S. Coast Guard Station. View is to the north (image by Kate Dallas).

The NPS began providing ferry service from Hatteras Village to Ocracoke Island in 1957 (Binkley 2007). Today, ferry service provided by the State of North Carolina operates from the Hatteras Ferry Landing Marina (Figure 19). A concrete and timber bulkhead extends along the eastern and southern margins of the marina (#34 Figures 20 and 21). Historic images from Google Earth show that the marina and bulkhead along the eastern side of the basin were added in the mid-1990s. Three short concrete piers (#35–37 Figure 21) are used by the Hatteras ferry, but no information could be found on their history.

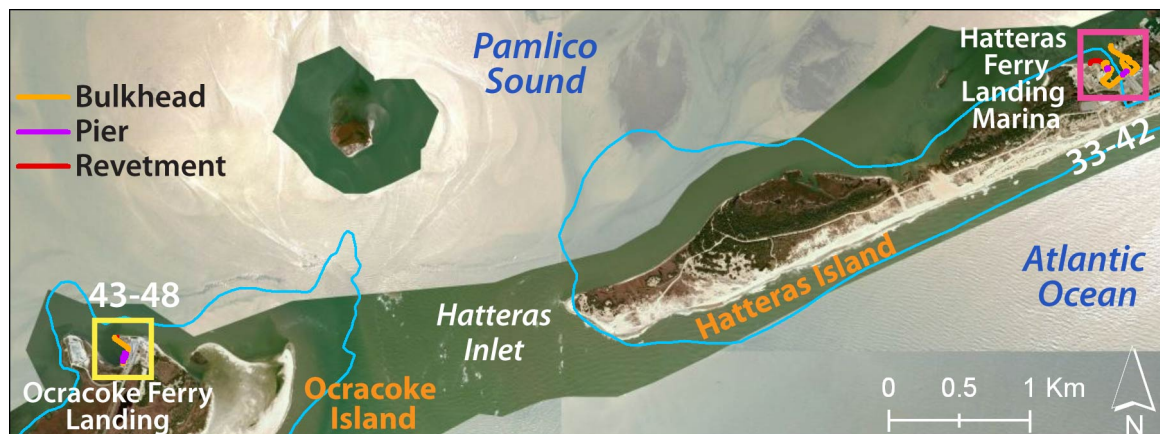
**Figure 20.** Southern end of Hatteras Island and northern end of Ocracoke Island structure map. Blue line shows park boundary. Areas in yellow and pink boxes are enlarged in Figure 21 (image from ESRI Bing Maps basemap layer 2012).

The Hatteras Inlet and the section of the Rollison Channel adjacent to the park (from the Hatteras Ferry Landing Marina to Hatteras Inlet) (Figure 20) are maintained by the USACE. The total volume of sediment dredged from these locations is unknown, but data from 2007–2012 shows that 243,228 m<sup>3</sup> (318,130 yd<sup>3</sup>) was dredged from Hatteras Inlet and 149,005 m<sup>3</sup> (194,891 yd<sup>3</sup>) was dredged from this section of the Rollison Channel over the 5-year period (Dee Dee Fauser, USACE, DVD, 1-28-13).

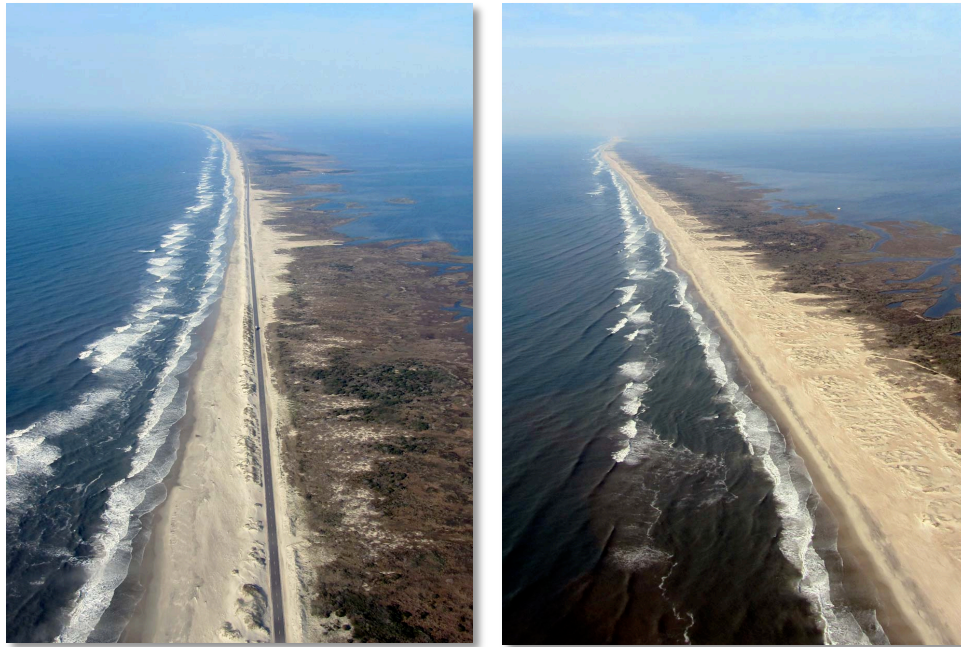
**Figure 26.** Comparison of Ocracoke Island (left) and Portsmouth Island (right). The artificial dunes that parallel the highway on Ocracoke Island (left) have fixed the shoreline location, while the beach has continued to narrow over time. In contrast, Portsmouth Island (right) has naturally migrated inland and maintained a relatively wide beach and well-developed dune system (images by Kate Dallas).

Beaches in CAHA have narrowed by as much as 85% and in Birkemeier et al. (1984) were reported to be routinely less than 30 m (98 ft) wide. The narrowed beaches concentrate wave energy dissipation in an increasingly restricted area, resulting in steeper beach profiles and increased erosion (Dolan et al. 1973). The steepening of the beach face is linked to the constructed dune ridges, a natural sand deficiency, and net shoreline erosion related to sea-level rise (Riggs et al. 2009a). Subsequently, this increasingly high-energy environment is thought to limit turtle and shorebird nesting sites (Riggs and Ames 2009). Comparison of natural Portsmouth Island (south of CAHA, Figure 2) with the manipulated Ocracoke Island illustrates a striking dissimilarity in beach and dune width between stabilized and natural barrier islands (Figure 26).

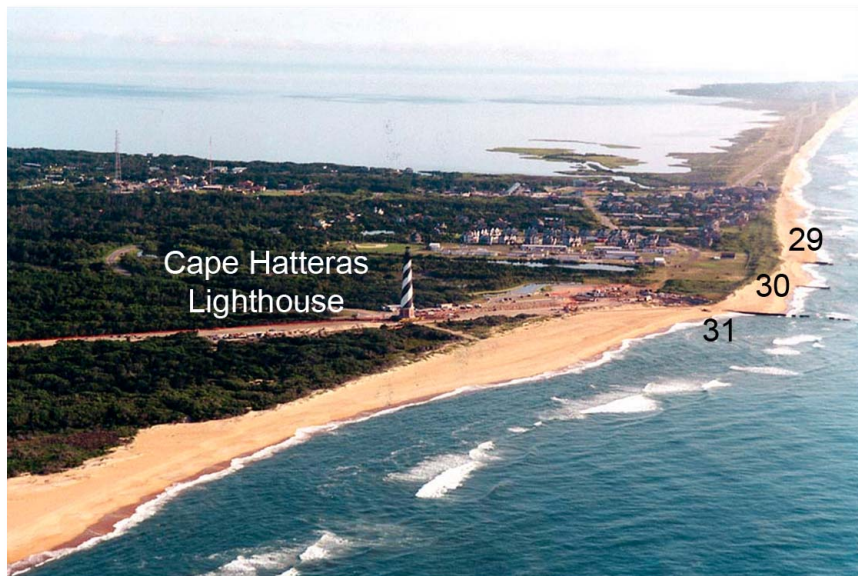
**Figure 30.** Cape Hatteras Lighthouse and groins. View is to the northwest (image by Scott Geib).

Groins (#29–31 Figure 30), sandbags, offshore plantings, and beach nourishment have all been employed to help stabilize the beach fronting the historic Cape Hatteras Lighthouse. As with much of the CAHA coastline, the shoreline in the vicinity of the lighthouse has historically eroded as the barrier island system naturally adjusts to sea-level rise (Dolan and Lins 1985). From 1872 to 1988 the Cape Hatteras Lighthouse shoreline retreated nearly 440 m (1,440 ft), averaging -3.8 m/yr (-12.5 ft/yr) (Figure 31) (NRC 1988). South of the groin field there was a local maximum in the erosion rate of -8 m/yr (-26.2 ft/yr) (Inman and Dolan 1989).

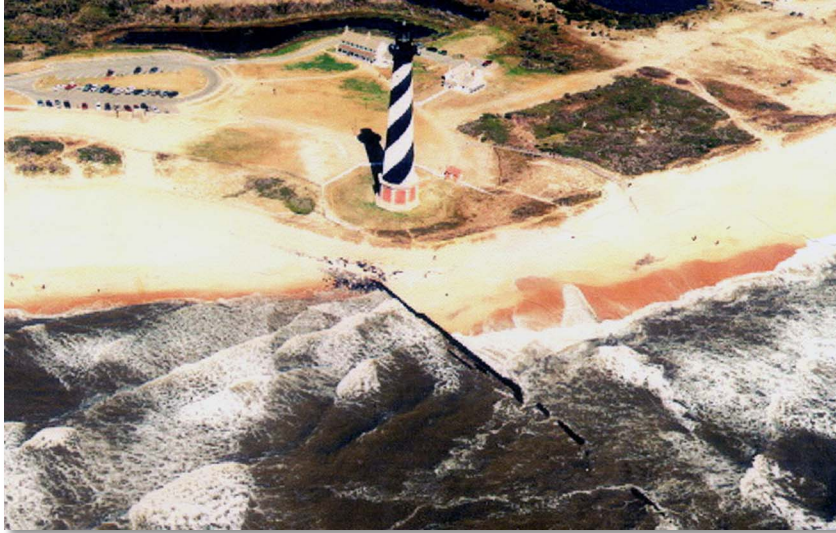
**Figure 32.** Photograph shows the proximity of the lighthouse to the ocean prior to relocation (circa 1990). Note the impoundment of sediment along the north (right) side of the groin. View is to the west (NPS photo).

Prior to the lighthouse's relocation inland, the structure was about 50 m (164 ft) from the water's edge (Figure 32) with periodic storm surge and swell reaching the structure (NRC 1988). The groins, built in 1969 by the U.S. Navy to protect a former Navy facility, have impounded sediment on their northern sides, resulting in erosion on their southern flanks (Figure 30) due to the net southerly alongshore sediment transport direction. Given the groin impoundment, consistent long-term erosion rates, and a shoreline inflection point, it is likely that some degree of shoreline stabilization has been gained from the installation of groins, sandbags, and beach nourishment projects in the area since the 1930s. Since the groins are no longer maintained, it is likely that the groins will eventually collapse and the inflection point will subside. Areas to the north of the groin field that have benefitted from a wide beach due to groin impoundment will likely experience erosion following groin collapse.
