This report provides a detailed description of the hydrology of the western portion of Big Cypress National Preserve - an area that includes the Barron River Canal corridor and the Turner River Watershed (Fig 1-1). Part 1 of the report provides a brief introduction to the study. Part 2 provides an in-depth review of the historical and present-day hydrology of the Barron River Canal Corridor. Part 3 provides an in-depth review of historical and present-day hydrology of the Turner River Watershed. Part 4 provides an overview of the major findings of the hydrologic monitoring and mapping work collected over the past two years in the Barron River Canal Corridor and the Turner River Watershed.

In Fall 1999, Big Cypress National Preserve entered into cooperative agreement C-10762 with the Big Cypress Basin branch of the South Florida Water Management District in order to establish a hydrologic monitoring program in the western portion of Big Cypress National Preserve. Division of labor for the cooperative agreement was as follows. The Big Cypress Basin agreed to provide "seed money" to fund start-up costs of the project, including funds to pay for installation of groundwater wells,

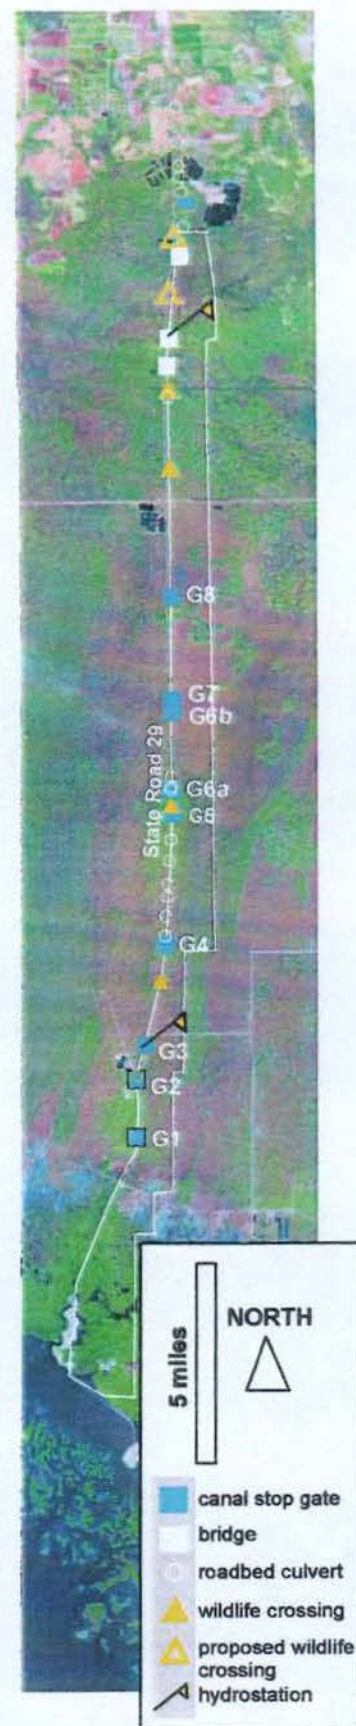
Fig 2-4. Satellite-image map showing major hydrologic control structures along State Road 29.

Wildlife undercrossings were added at 4 locations during road construction to decrease roadway mortality but the road does not contain continuous fencing as seen on I75, probably by merit of its lower traffic volumes. The southernmost undercrossing also includes a water conveyance channel under the road. Plans are underway to add two additional wildlife crossings in the Bear Island area (Fig 2-4).

A few hydrologic features were also added during construction. Several roadbed culverts were added at the tailwaters of Deep Lake Strand – all of which are circular concrete culverts measuring 2 foot in diameter. Two adjustable canal weirs were also added: Gate 6A at Deep Lake and Gate 6B just downstream of existing Gate 7 (Fig 2-4).

This contrasts to construction efforts along the Tamiami Trail where the roadbed lies perpendicular to the regional flow regime and it was recognized that periodic breaks in the road grade would be needed to prevent overtopping. Even today, there are only three bridge-sized water conveyances in the section of State Road 29 that lies adjacent to the preserve, all of which are north of I75 proximate to Bear Island. A series of smaller culverts and conveyances are located between Deep Lake and Copeland (Fig 2-4).

While the State Road 29 grade has a minimum number of water conveyances, its adjacent canal contains a water control feature that the Tamiami Trail is noticeably lacking: stop gates in its canal. The Barron River Canal contains 10 stop gates (Fig 2-4). Seven of the stop gates are metal stop gates that insert between concrete slots at each bank. A crane is used to remove the metal gates during the wet season and to re-insert them during the dry season. These gates were originally designed so that they could be removed one panel at a time, but have since been welded together to prevent leakage between the panels. Under current conditions, the gates can only be fully inserted or fully removed (Fig 2-4).

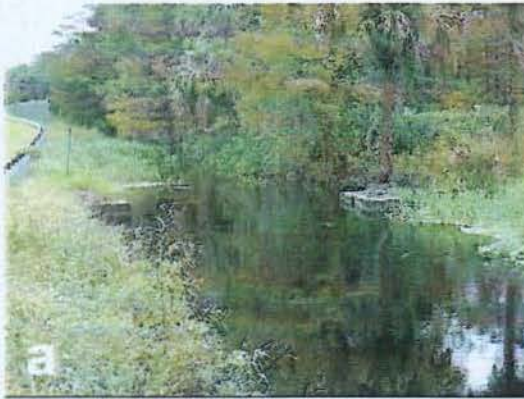
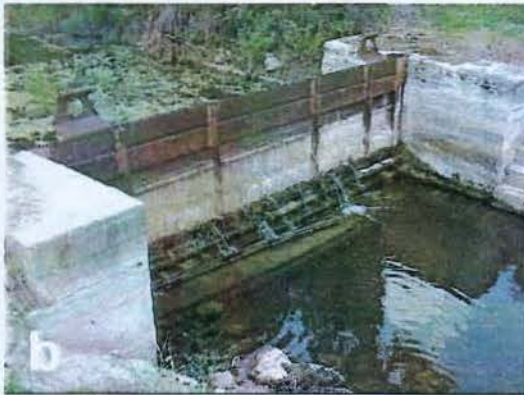
Photo 2-7. Photo of Gate 5 at Deep Lake under open (a) and close (b) conditions.

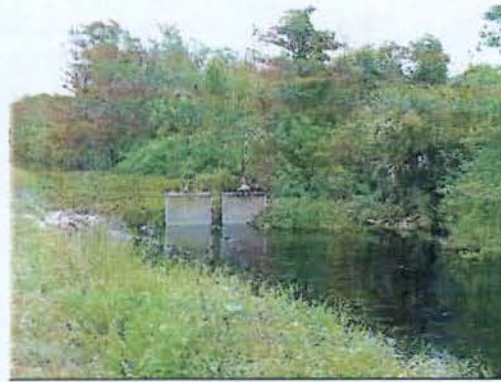
Photo 2-8. Photo of water flowing over the crest of Gate 6B.

Three weirs were recently added (in the 1990s) presumably to address these deficiencies at Deep Lake (Gate 6A), just downstream of Gate 7 (Gate 6B), and just north of the preserve at Sunniland. These weirs span the canal channel as a solid concrete structure with windows that are open and closed via "captain's wheels" accessible from the weir's crest. This design is superior to the original gates because they can be manually operated, they prevent leakage at the base, and prevent leakage through the weir.

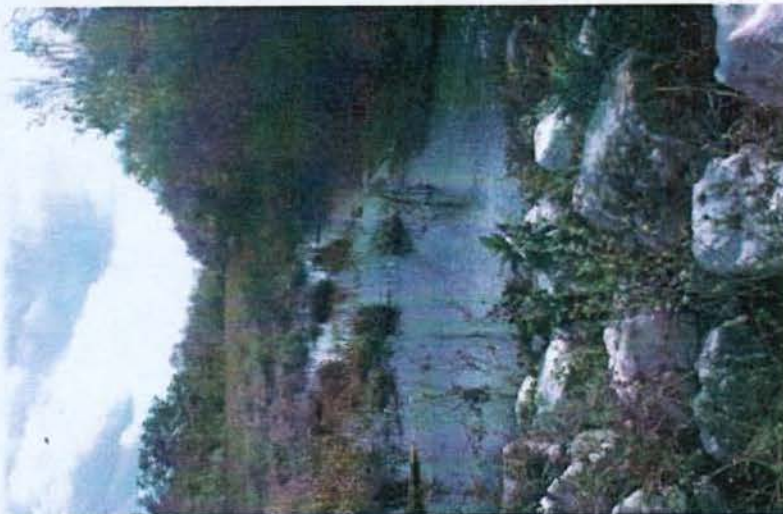
photo  
3-5

Filled in canal south  
of H.P. Williams Way-  
side, looking south

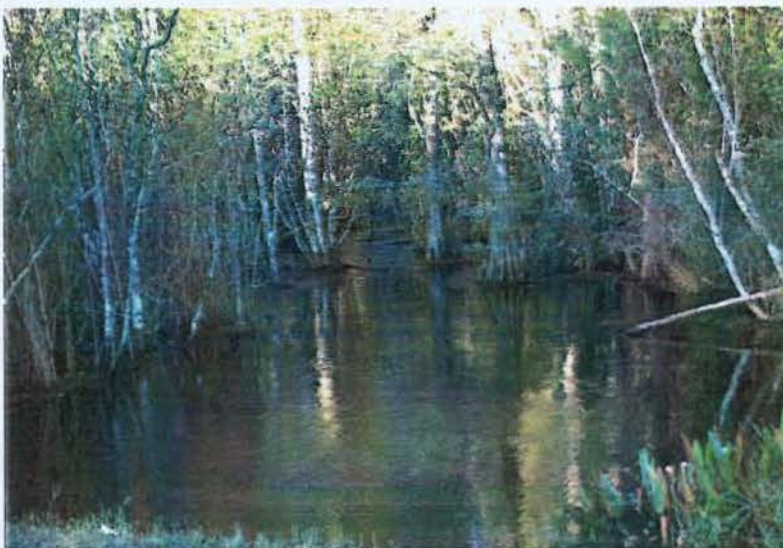
photo  
3-6

Turner River's head-  
water culverts on  
Turner River Road
