# Hydrologic Evaluation of the Canoa Ranch along the Upper Santa Cruz River

Frank Postillion,  
Chief Hydrologist  
David Scalero,  
Principal  
Hydrologist  
&  
Mark Krieski  
Engineering  
Manager

Pima County Regional  
**FLOOD CONTROL**  
DISTRICT

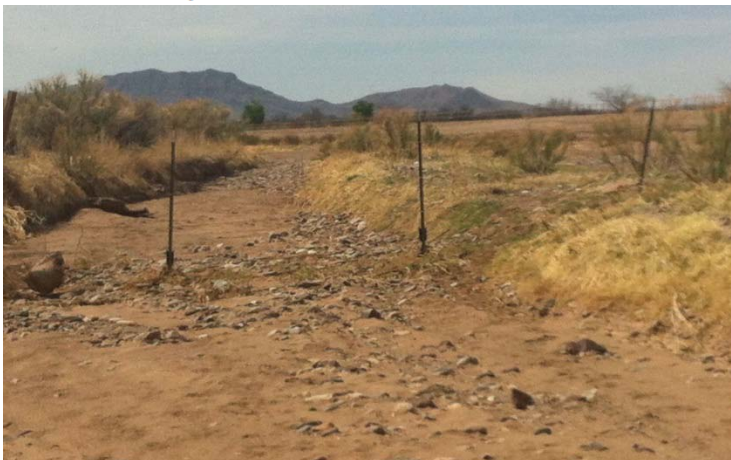
Downstream discharge from the NIWWTF to diminish 3-5 MGD (Alisos); and improved WQ enhances upstream GW recharge . Photo-Elephant Head Bridge 3/2013
