# ***Dynamics of Rare and Sensitive Waters in Saguaro National Park***

**A Final Report for the  
2014 George Wright Society, U.S. Geological Survey, and National  
Park Service Park Break Program**

**March 2014**

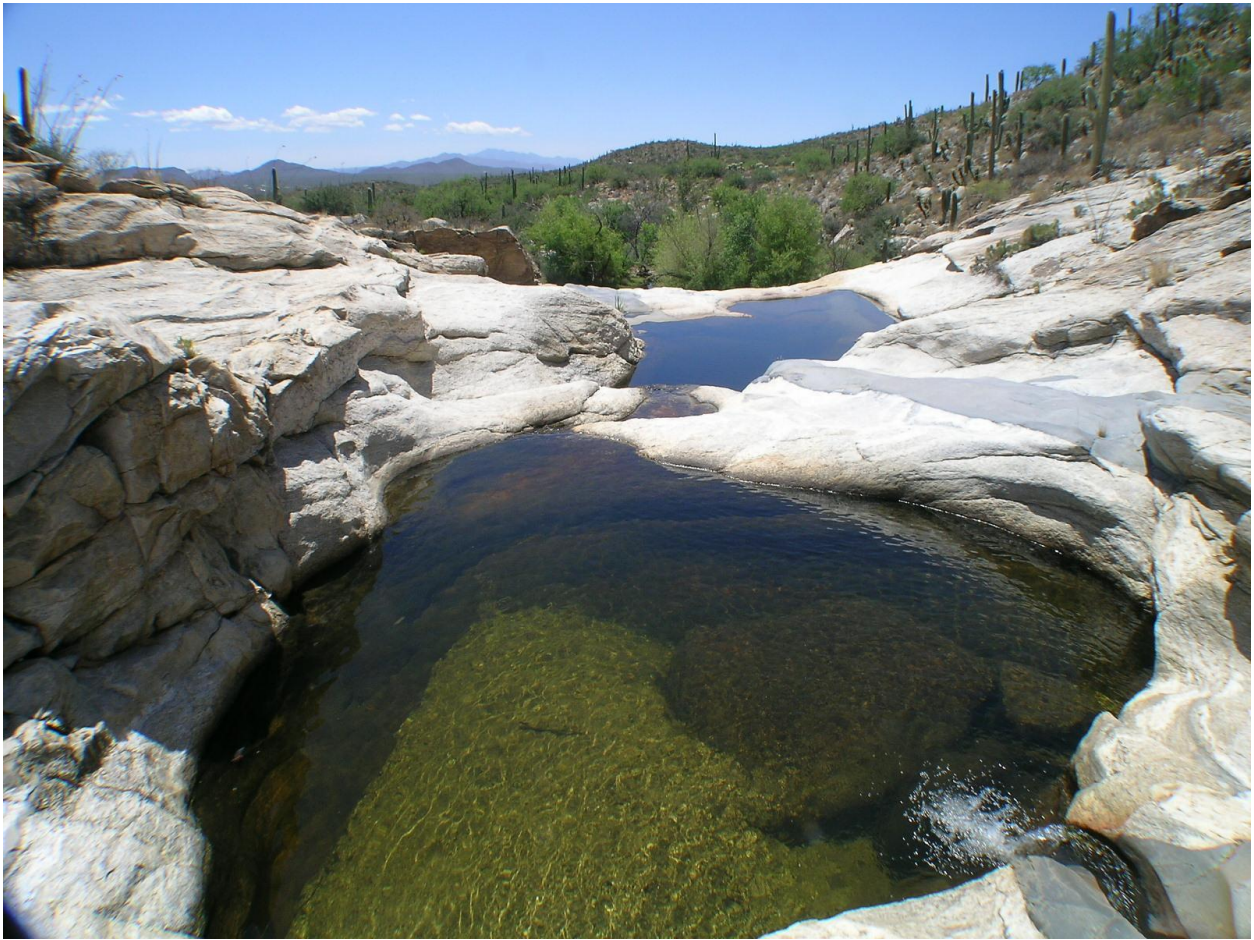
**Figure 1:** *Madrona Pools (tinajas) in Chimenea Creek at Madrona Ranger Station. Water levels in Pool 1D (in background) have been monitored since 2004. The pool has not been observed to go dry since regular observations began in 1996.*

Typical tinajas occur in streams throughout the Rincon Mountains, usually (but not always) in clusters associated with outcrops of hard metamorphic bedrock (as in Fig. 1). The park regularly monitors approximately 240 tinajas associated with leopard frog habitat, but there are many others (especially at high elevations) that are not regularly monitored. MacLeod et al. estimated capacity for more than 64 tinajas in RMD, and found that they ranged from close to 0 cubic meters to more than 44.1 cubic meters.

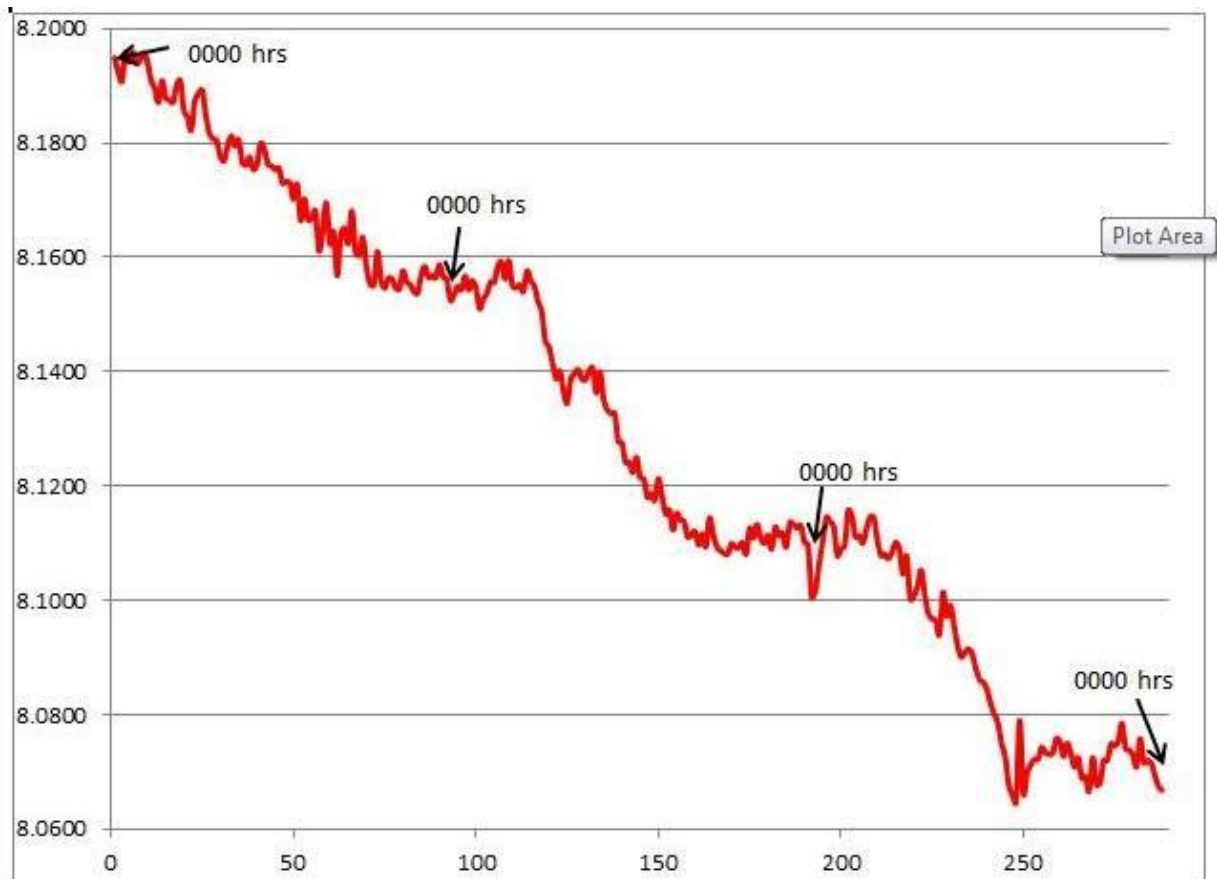
**Figure 2:** Detailed daily water levels of Pool 1D during a 3-day period in June. Y-axis is pool level; x-axis is number of 15-minute intervals. Pool levels rise slightly at night, then decline during the day, presumably due to evapotranspiration.

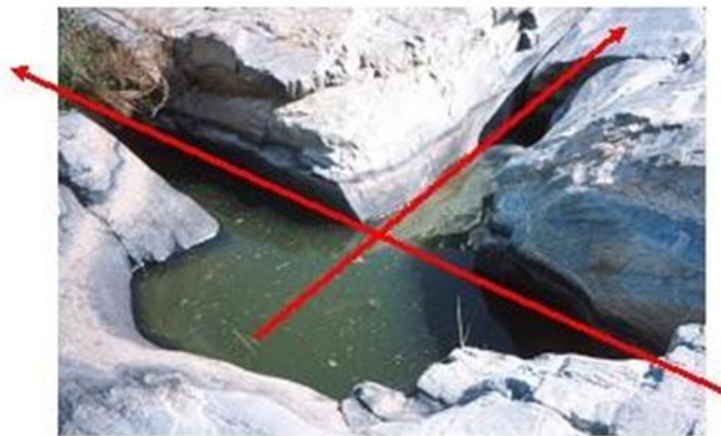
**Figure 3:** Photo of a “typical” tinaja located in Wildhorse Canyon. Red arrows indicate directions of prominent bedrock fracture.

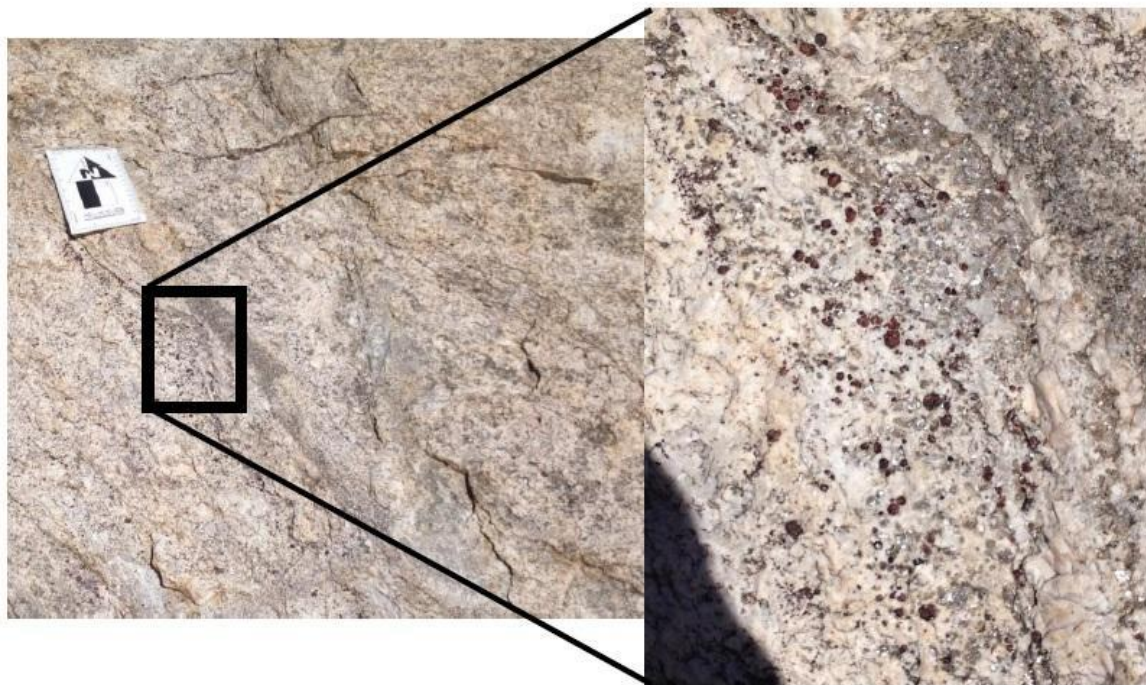
**Figure 28:** View of some banding in the granitic gneiss at the lower Madrona pools at Chimenea creek. Garnets, white mica, feldspar and quartz can all be seen in the banding

Field Observation: Overall rock lithology at Madrona Pools was granitic Gneiss. As we move higher in the drainage system we noticed the banding became more noticeable and the feldspars increased in size becoming pegmatic. Garnets were also present commonly forming in bands with white mica and quartz (Figure 28).

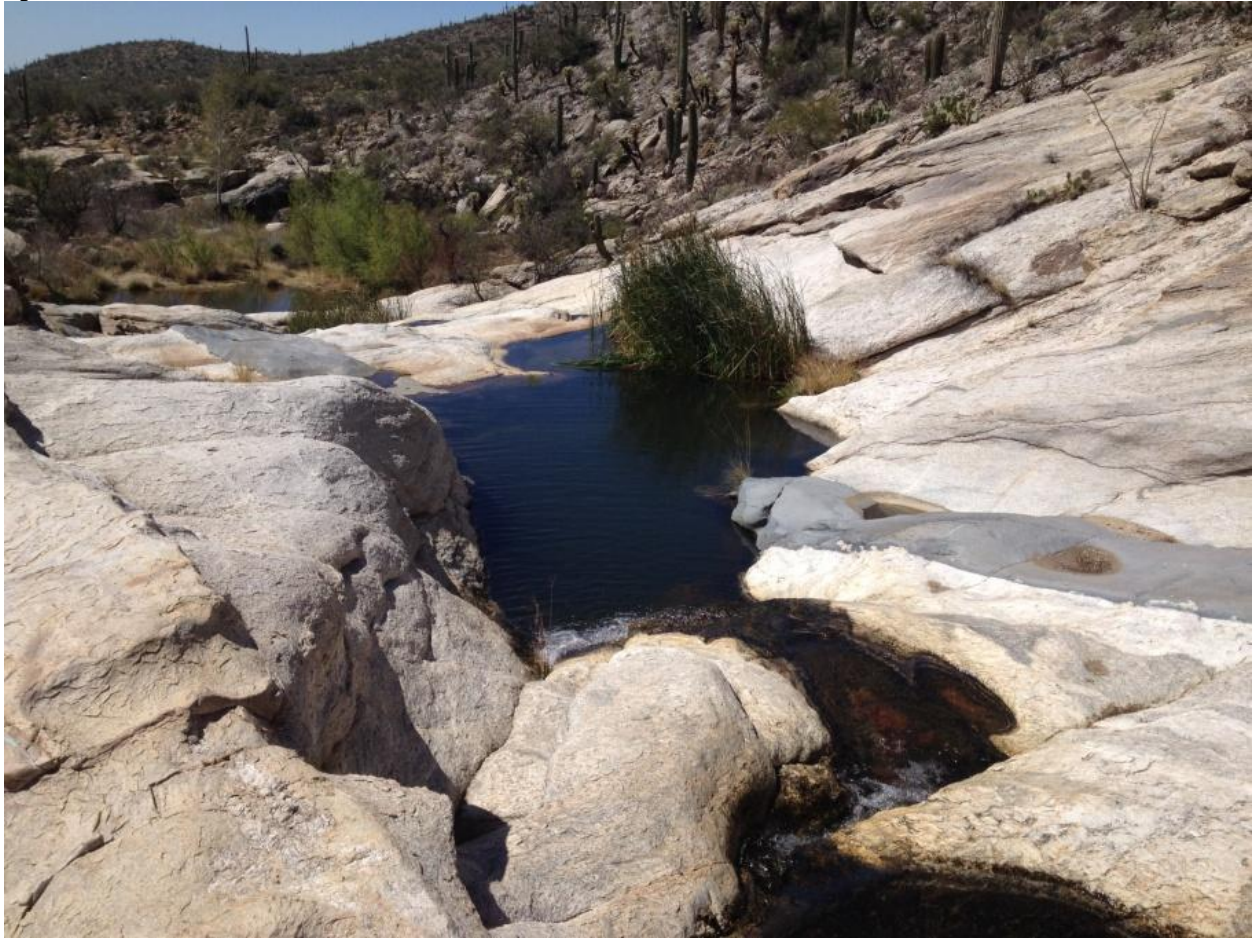
**Figure 29:** A portion of the lower Madrona pools displaying the dike that follows the  $200^{\circ}$  strike.

The major joint set trending south became less noticeable after pool 1F. We noticed an assumed dike in this drainage that trended around 200 degrees (Fig. 29). This coincides with the major joint set, and is not cut by other joints trending this direction. However, it is cross-cut by the eastern trending joint set, thus the intrusion had to have occurred before the large scale

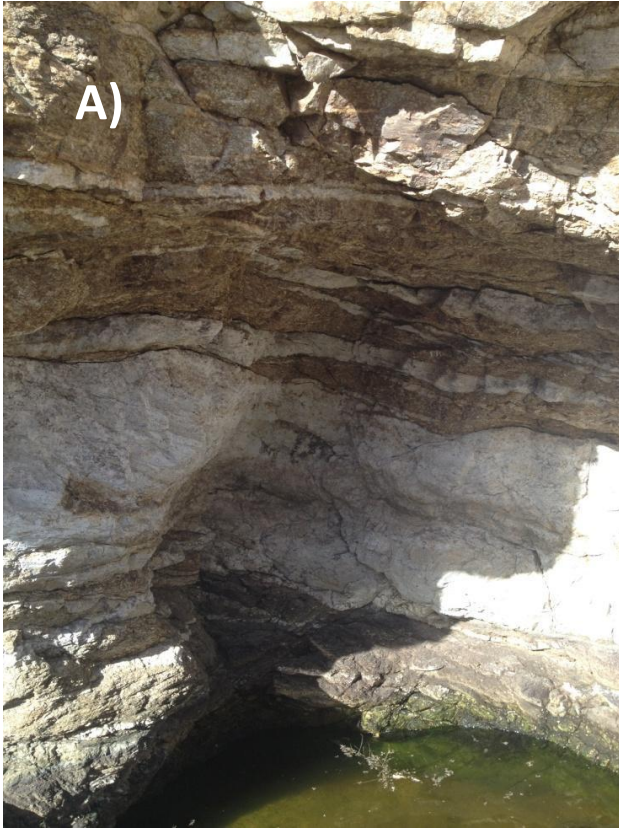
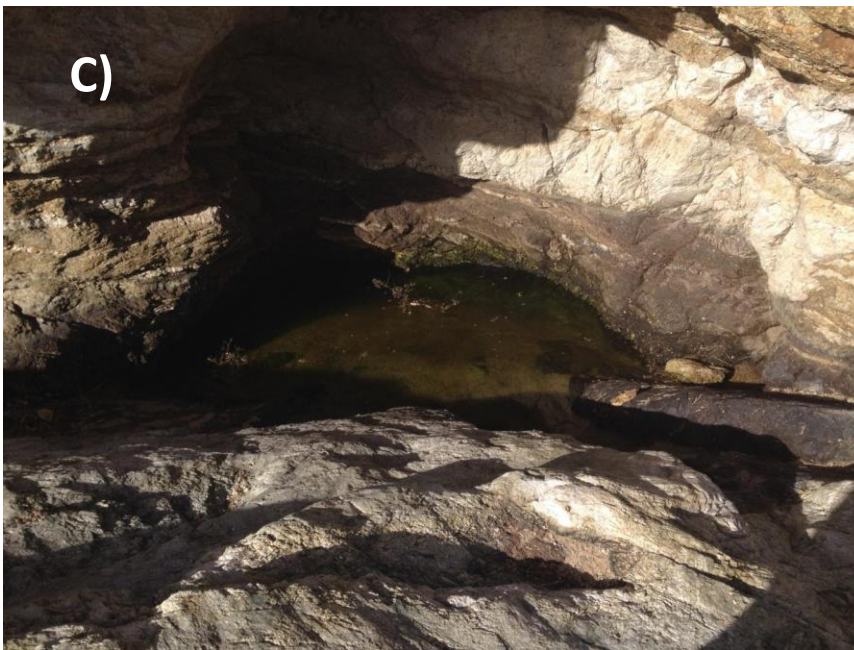
**Figure 30:** Images comparing the pools. A) Lower portion of Loma Verdes AV3 show discoloration of water and banding on rock wall. B) Portion of the lower Madrona pools showing clarity of the pools. C) Closer view of AV3.

In the Loma Verde drainage the channel contains more sediment than the channel in Chimenea. The pools located in or in close proximity to this sediment seem to be less defined than the pools located in solid bedrock. Another difference between pools is that the pools from Chimenea creek are clear while the pools from Loma Verde contain more algae and are dirtier. This also reflects the higher sediment value at Loma Verde (Fig. 30).

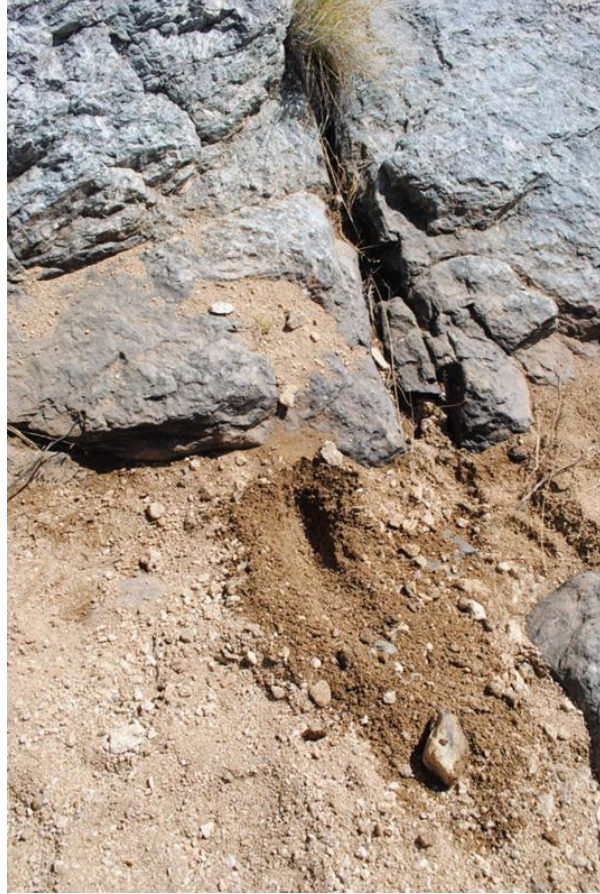
**Figure 37:** Photo of moist contact zone between exposed bedrock and sediment within the stream channel in Park Break Canyon. Sediment was dug out, revealing an increase in moisture with increasing depth.

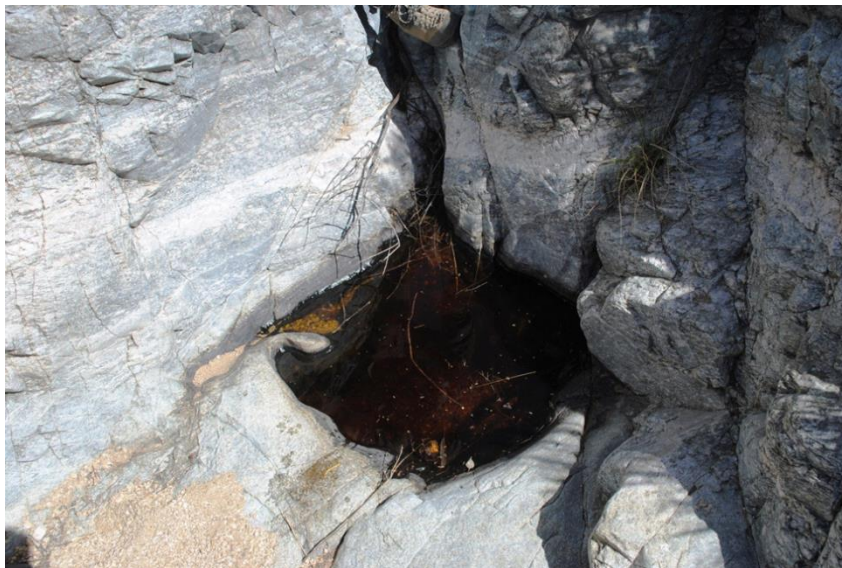
**Figure 38:** A shallow tinaja at the base of a steep dryfall in Park Break Canyon. The water was heavily discolored a red/orange color. Wasps were observed drinking from the tinaja.

After visiting Steel Tank and exploring the immediate vicinity near the tank, Park Break participants attempted to return to the trailhead via the Vista Trail while examining the associated drainage along the way. The Vista Trail is no longer operational and is in the process of being restored. The Park Break participants hiked down via the newly-named Park Break Canyon to examine the geologic structure of the canyon. Approximately 10 tinajas were found within Park Break Canyon. Additionally, several moist spots were found in soils near exposed bedrock (Fig. 37) and when soil was dug out, the moisture levels increased with depth. Several of the pools were associated or located at the base of dryfalls. One shallow (approximately .25m deep) pool located at the base of a steep, narrow dryfall was filled with red/orange discolored water (Fig. 38).
