National Park Service  
Inventory and Monitoring Program  
Northeast Temperate Network  
Lakes, Streams, and Ponds Monitoring  
Rapid Hydro-geomorphic Assessment

2012 Original datasheets organized by year, then site.

# PHYSICAL CHARACTERIZATION/WATER QUALITY FIELD DATA SHEET (FRONT)

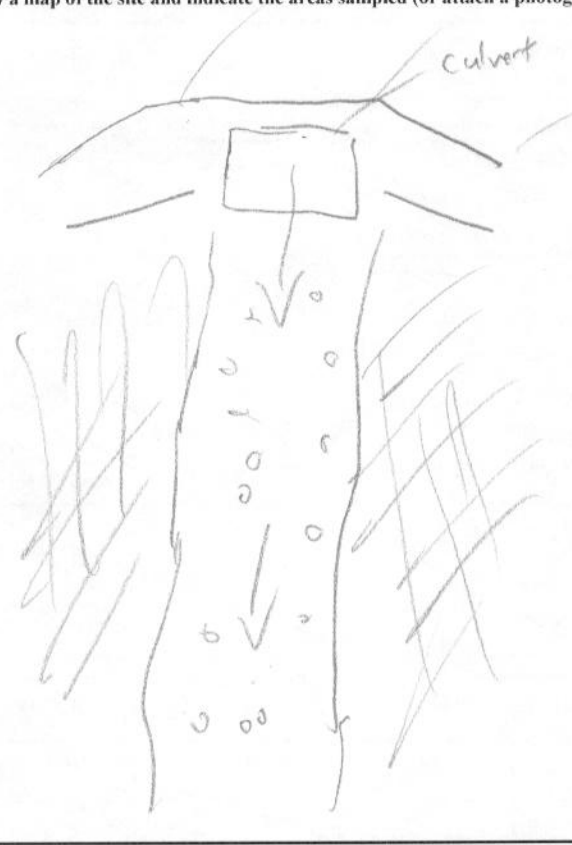
| SITE LOCATION/MAP | <p>Draw a map of the site and indicate the areas sampled (or attach a photograph)</p> | | |
