ARCHITECTURAL DATA SECTION  
of  
PART I - HISTORIC STRUCTURES REPORT

for  
THE DUNKARD CHURCH  
ANTIETAM NATIONAL BATTLEFIELD SITE

by  
Archie W. Franzen  
Architect  
October 1960

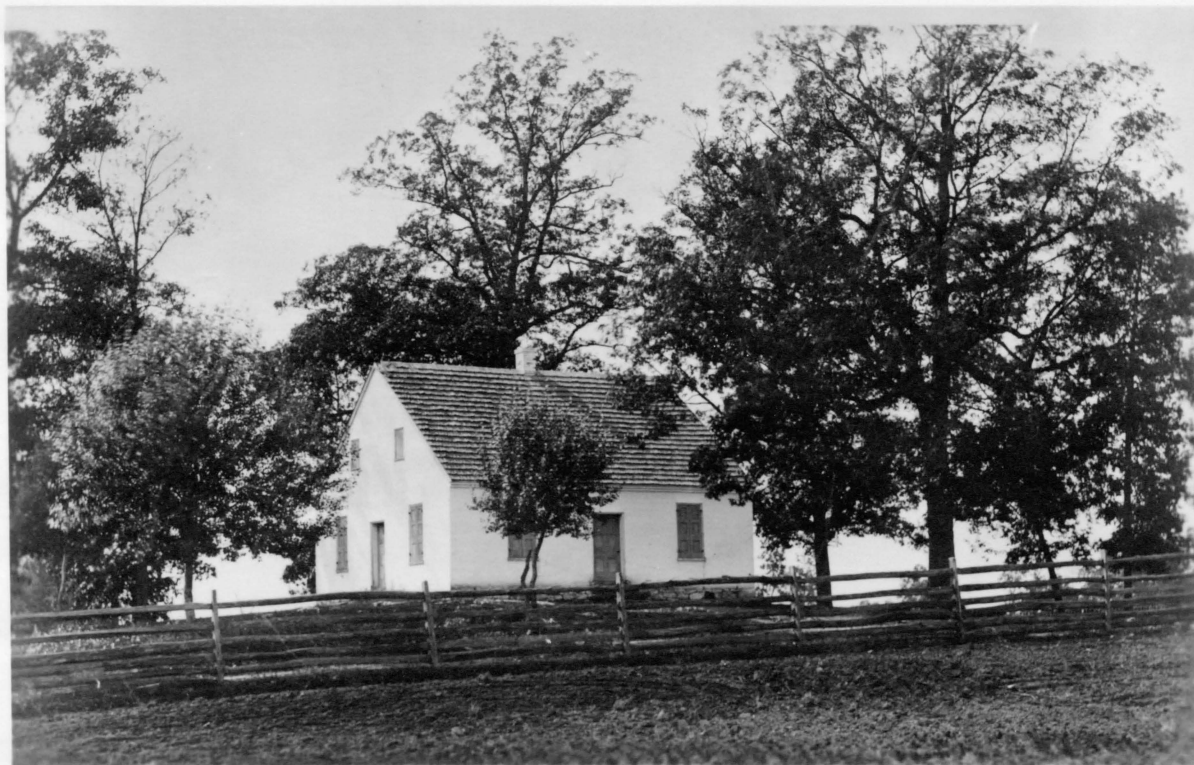
A view looking northwest in which the number of rows of shingles agree with that in a period Brady print. The shingle exposures are quite long and figure about 12". This appears to be an early view but no date can be ascribed to it with certainty. The entrance on the end of the church was used by the women (to the left) and that on the front by the men. The latter faced the Hagerstown Pike.

Copied from a photo loaned  
by Dr. W. H. Shealy of  
Sharpsburg, Maryland

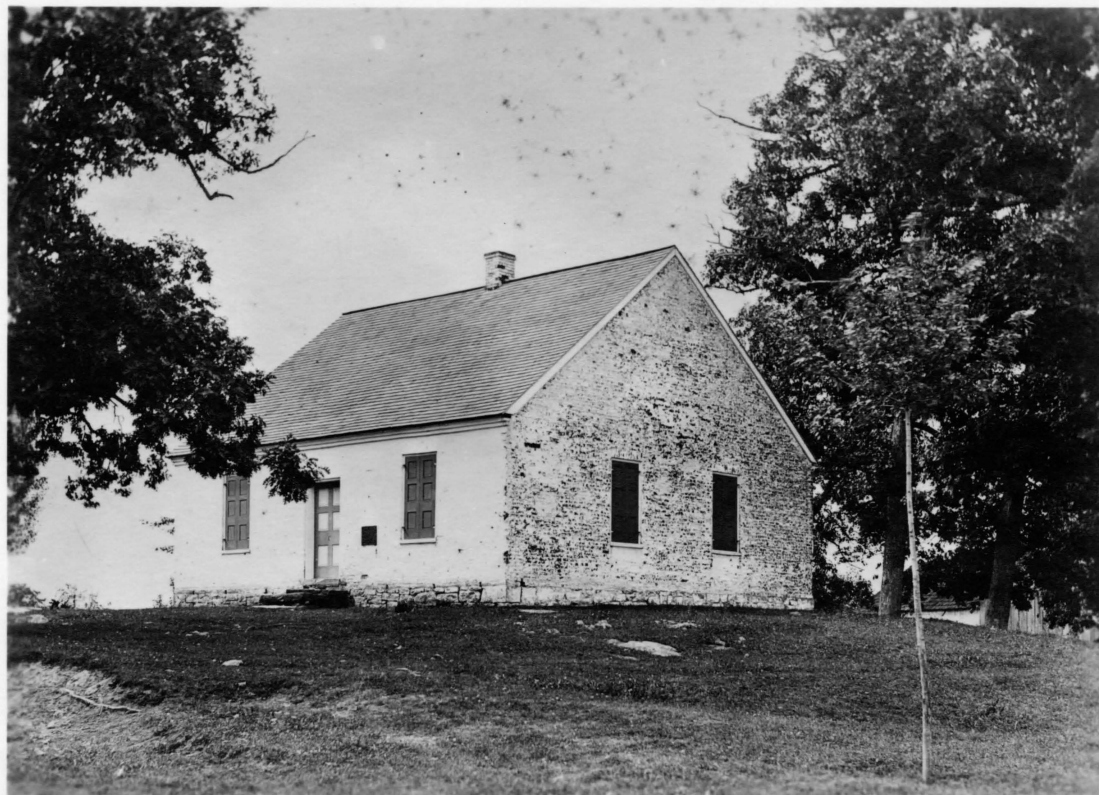
PHOTOGRAPH 2

Looking southwest the brick coursing in the north wall can be clearly seen. This view establishes the window heights and the height of the roof peak and was taken either during the 1890's or shortly thereafter. Counting the shingle courses and comparing with earlier views proves that the structure had been re-shingled. The minister's location was at the north end of the church between the two windows appearing on the right in this photo. The door on the left wall was the men's entrance.

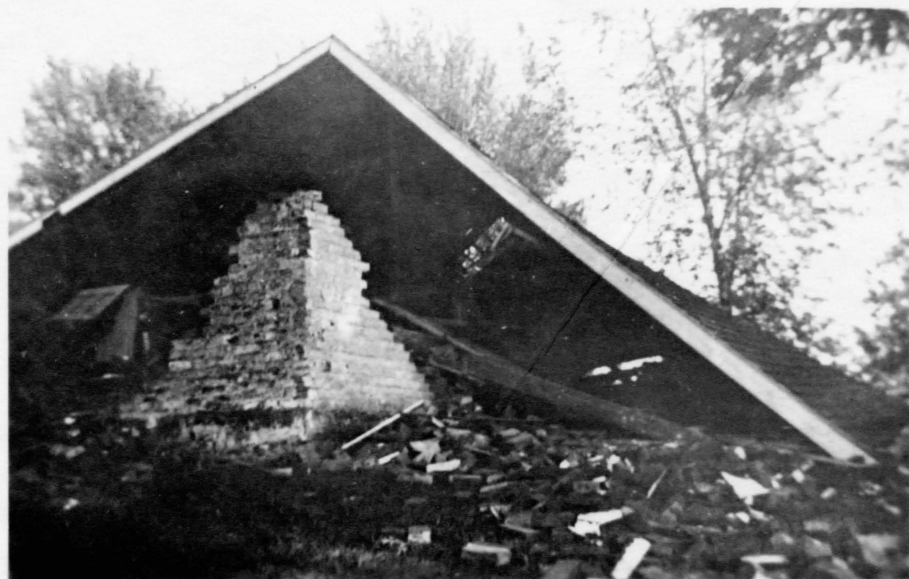
PHOTOGRAPH 4

This photo shows how complete the damage to the structure was after the storm of May 23, 1921. Indistinctly showing in this reproduction are the roofers indicating that solid roof sheathing was not employed.

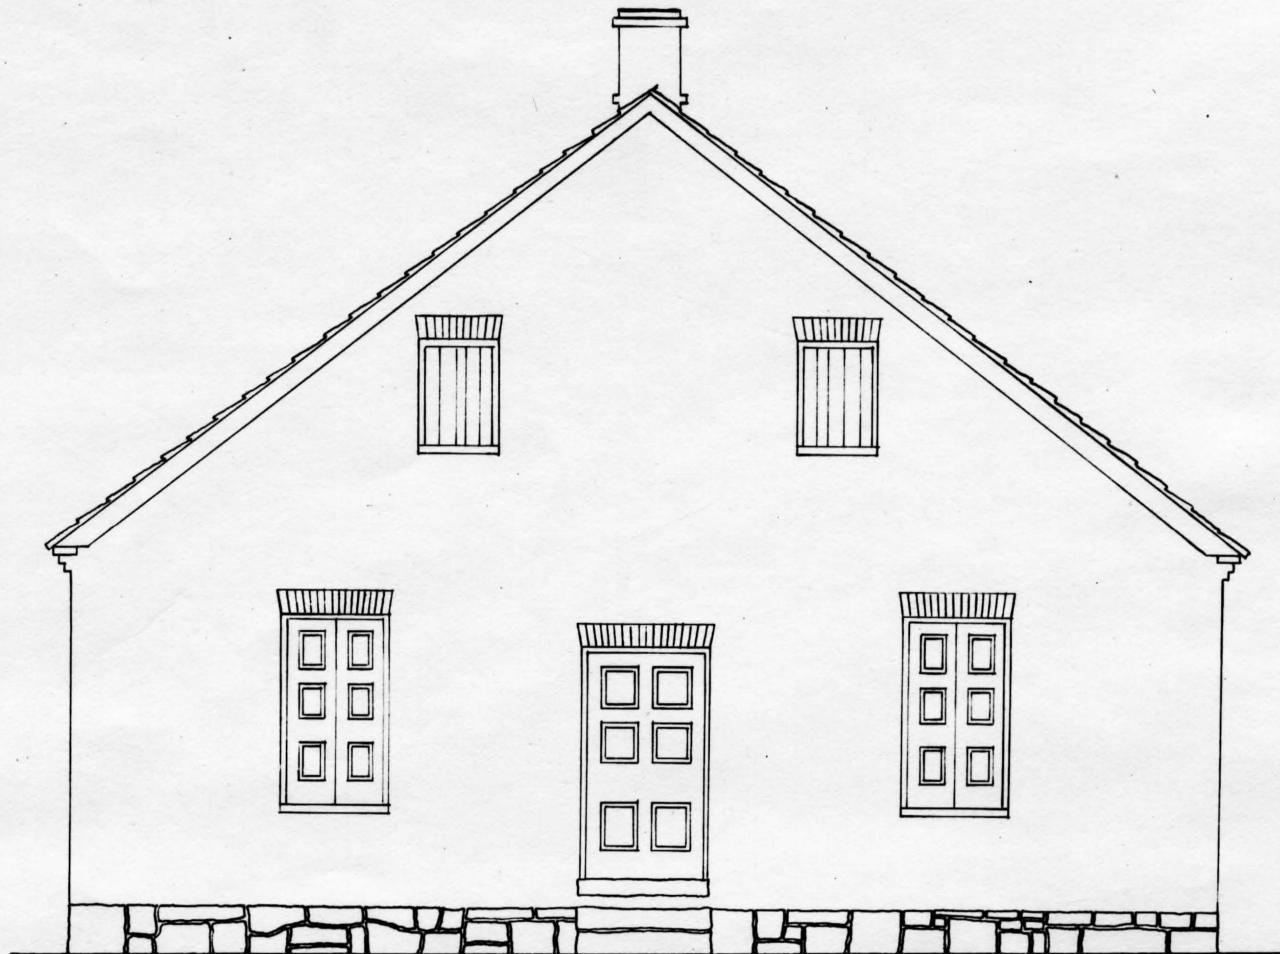
SKETCH "D"

At the south end within the gable were located two windows as shown. It is said that the attic was not used other than for storage and the servicing of the stove-pipes to the chimney. The windows provided light on the occasion of these uses. The shutters were a board and batten type in contrast to the panel type used on the first floor windows. The door here was used by the women of the congregation as their entrance. Note how the top brick at the eaves projected from this face of the building to provide a termination for the tapered verge board. The brick work of this elevation suffered damage from artillery fire during the Battle of Antietam.

SOUTH ELEVATION
