HISTORIC STRUCTURES REPORT  
PART II

ARCHITECTURAL DATA SECTION  
on the  
McLEAN ICE HOUSE

APPOMATTOX COURT HOUSE NATIONAL HISTORICAL PARK

Prepared by  
Orville W. Carroll  
Architect  
February 1964

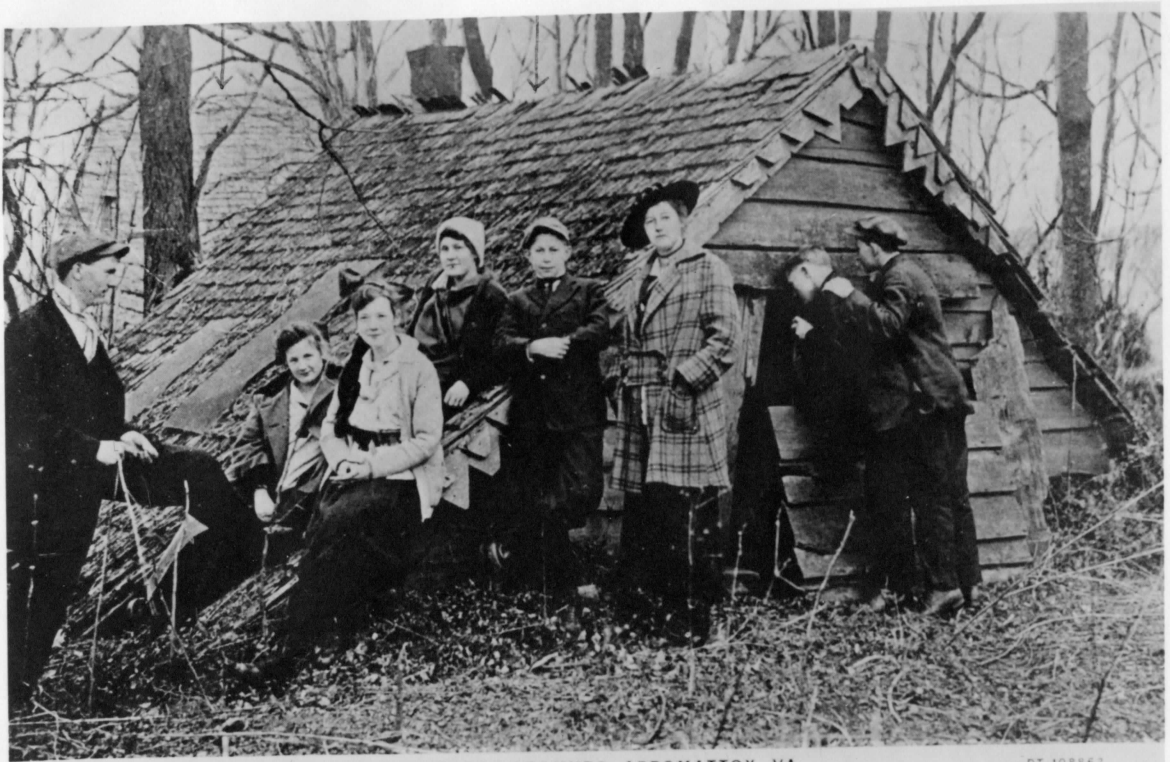
The Ice House stood approximately 14 feet east of the McLean House on the property line of Lot No. 21. This view is looking at the northeast corner of the Ice House with the detached kitchen showing in the background.

Photo: W. E. Burgess, ca. 1915  
Copy Neg. No. EODC 4477

It is recommended that a wood shingle roof be used to conform with the McLean House. The proposed shingles would be No. 1 grade, 18" long with square butts, kept between 3-1/2" - 6" in width and laid six inches to the weather. The top shingle row on the west slope would form a four inch weather projection as seen in Illustration No. 1.

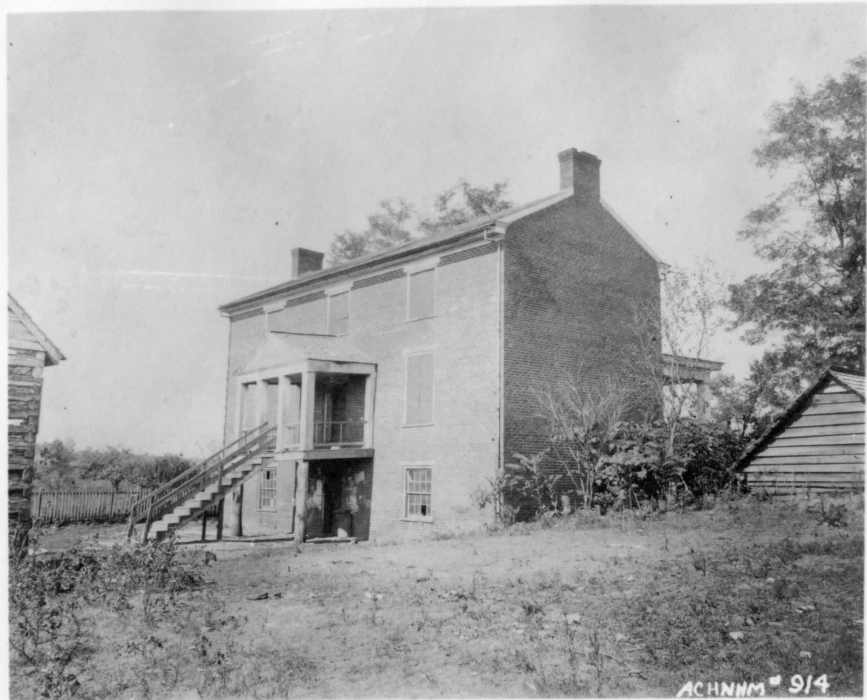
ILLUSTRATION NO. 2

A rear view of the Ice House can be seen to the extreme right of this photograph. Evidently the south or rear side did not have the decorative barge board seen in Illustration No. 1.

Photo: A. H. Plecker, ca. 1892  
Neg. on file ACENHP

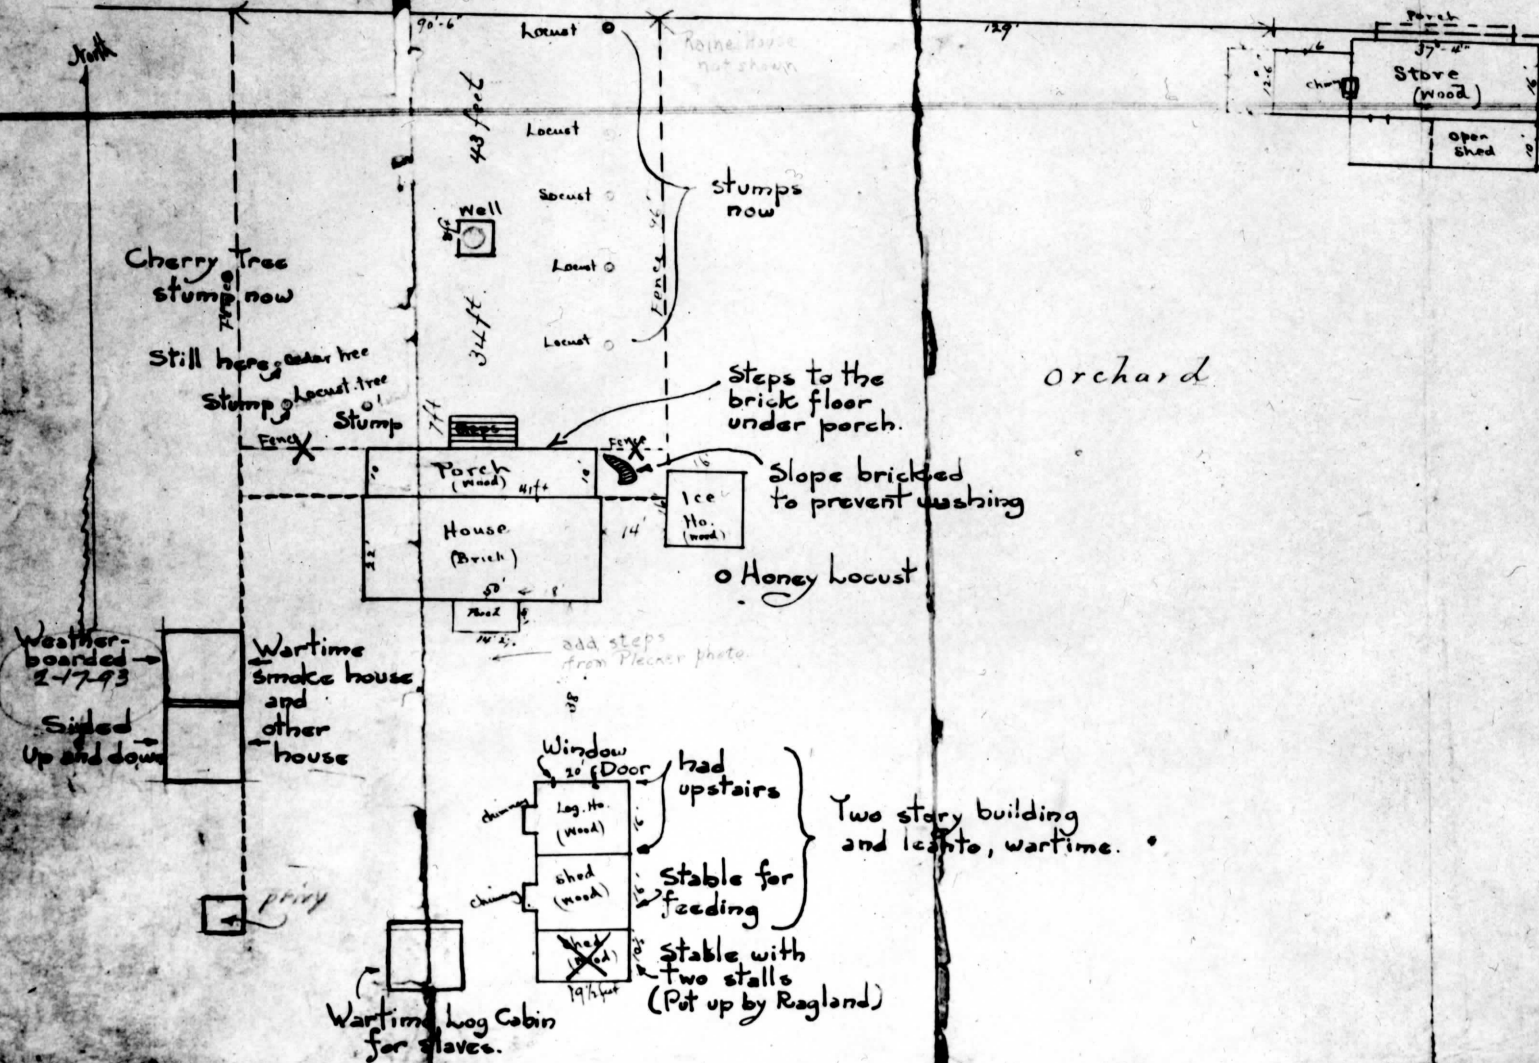
ILLUSTRATION NO. 3

Second copy of the P. C. Hubard drawing executed in 1893 and annotated by Ragland Featherston in 1940. The Ice House was still standing in 1893 during the dismantling of the McLean House. The dimensions are shown as well as the distance from the McLean House. These dimensions compare with the archeological findings in 1962.

Original Hubard drawings on file ACHNHP
