HISTORIC STRUCTURES REPORT  
PART II, PORTION, RAINWATER CONDUCTORS  
INDEPENDENCE HALL

Independence National Historical Park  
Philadelphia, Pennsylvania

July 1964

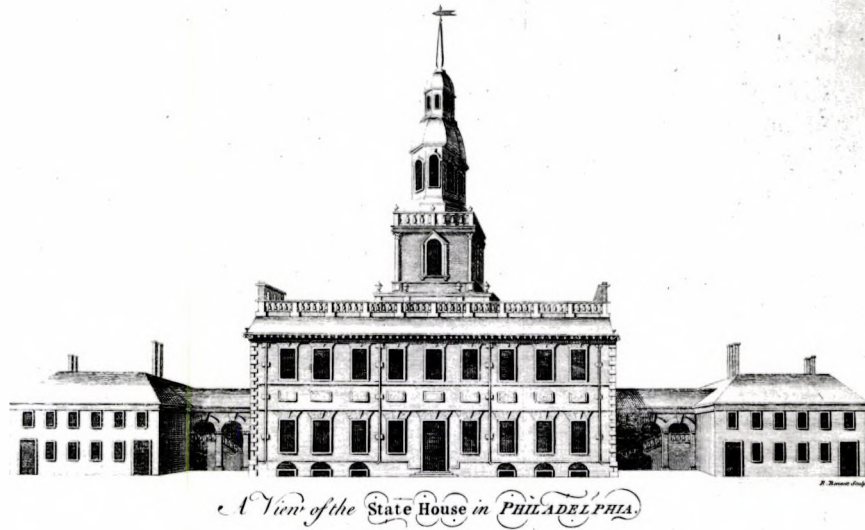
Adaption of Scull and Heap map dated 1769;  
engraver R. Bennett. Circular pipes clearly  
indicated by the spout ends.

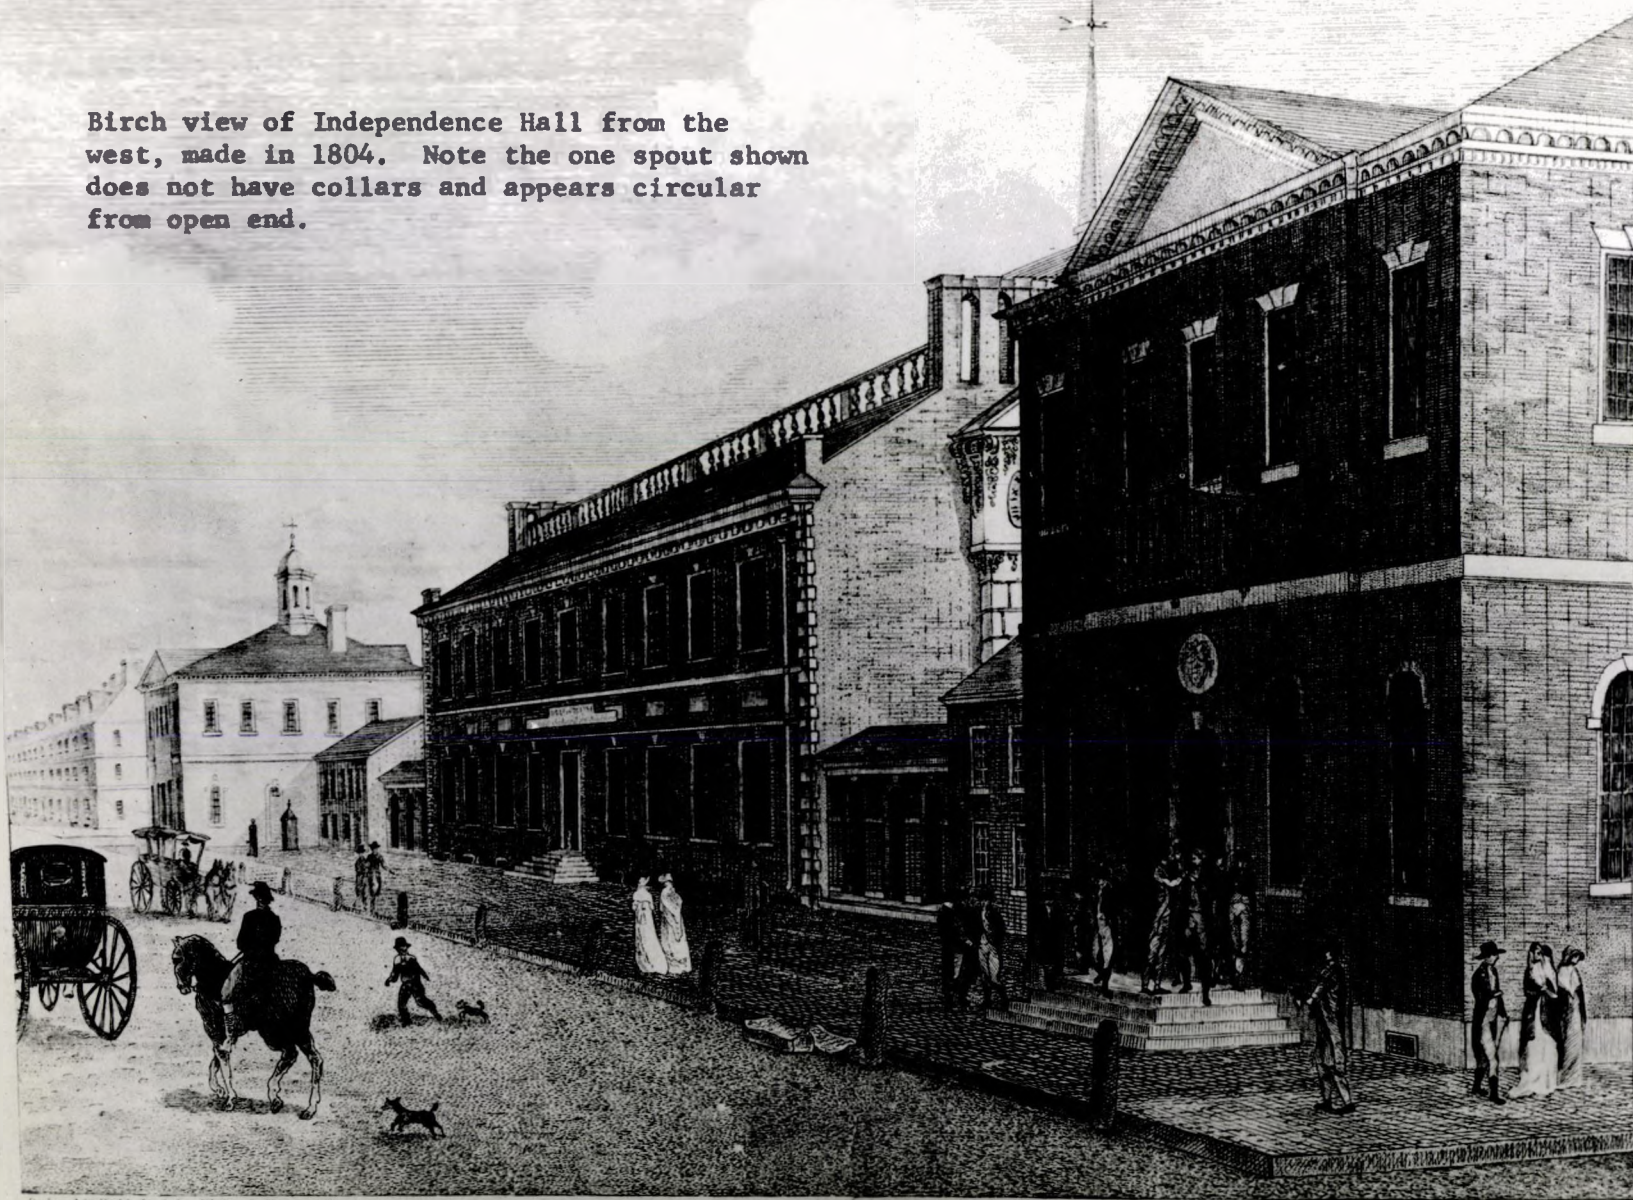
Birch view of Independence Hall from the west, made in 1804. Note the one spout shown does not have collars and appears circular from open end.

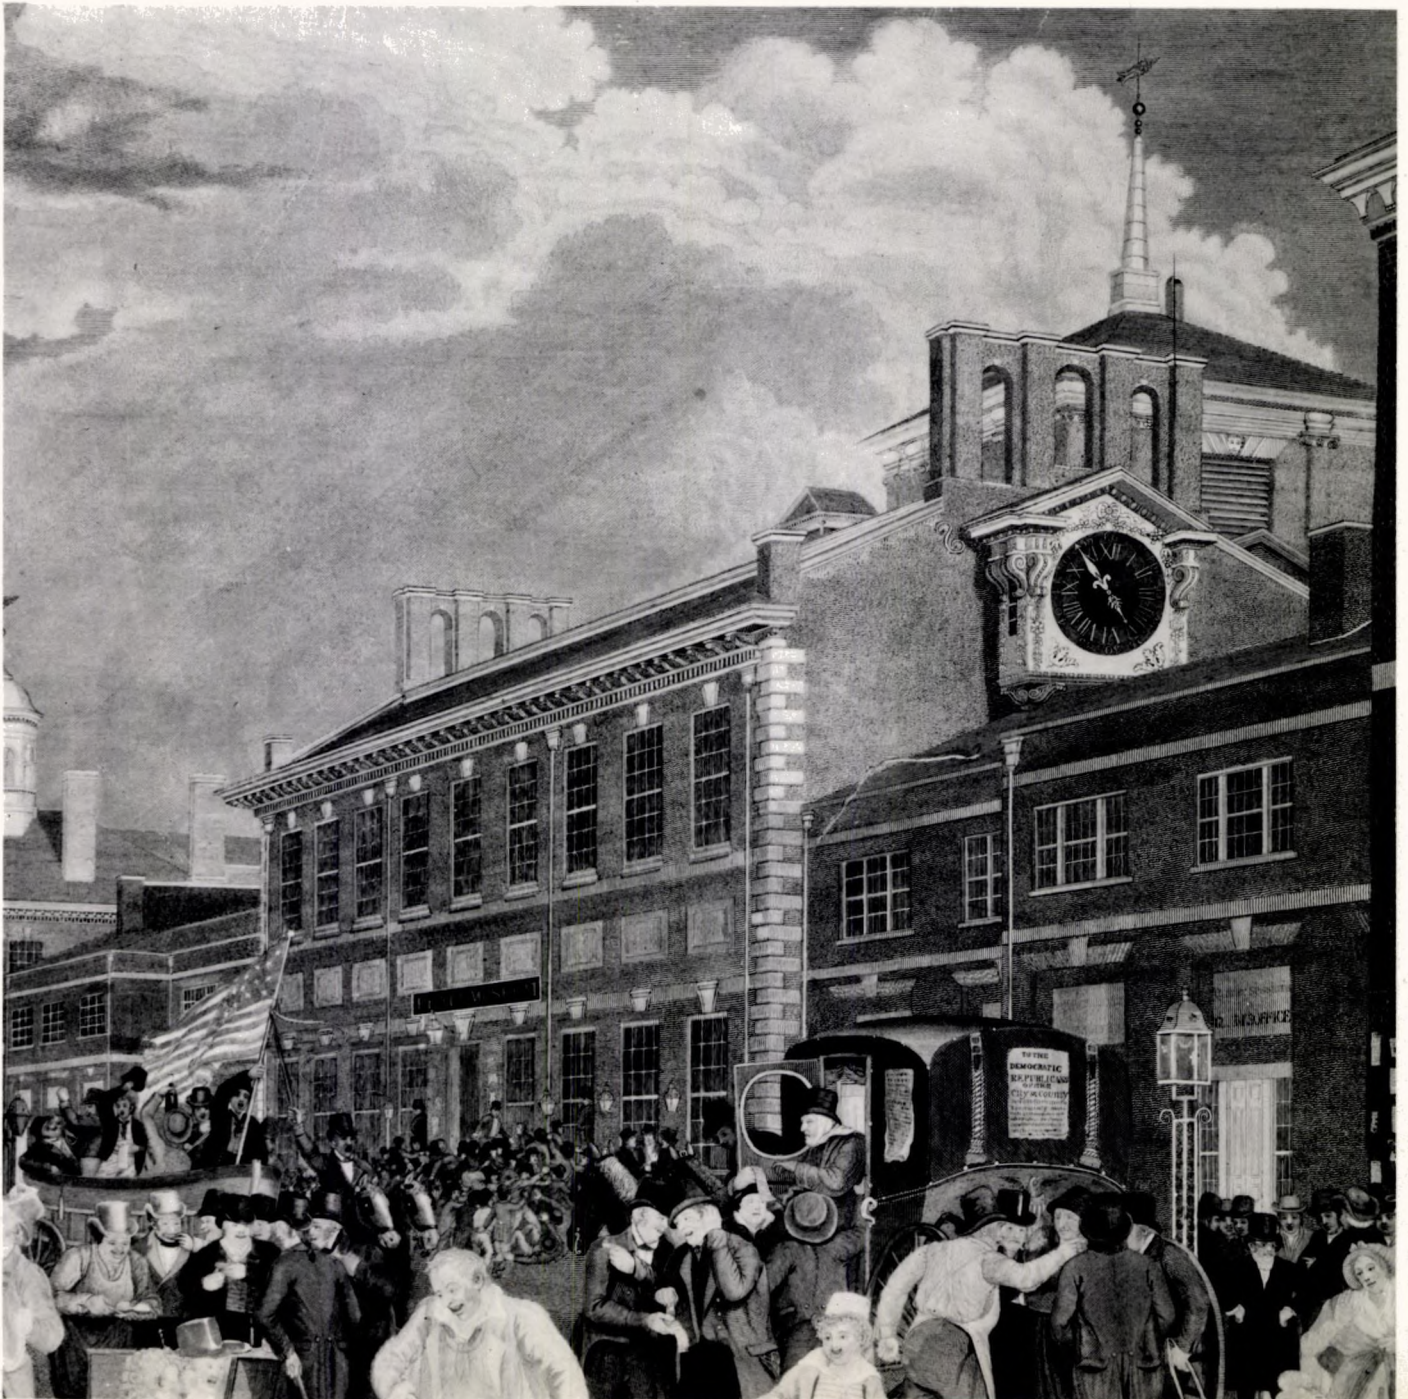
"Election Day, 1815" by John Lewis Krimmel, a detailed and accurate view of Independence Hall. The circular spouts and spout heads shown here are those which replaced the originals in 1785.

John Lewis Krimmel print, "Election Day, 1815 [at Independence Hall]," (see Illustration No. 5) is the most detailed and accurate view of the building before the development of photography. A notable feature is the absence of collars on the circular downspouts. The Birch print also omits the collars. It is thought that in 1785 they were not replaced during the installation of the copper spouts. In addition, available information on rainwater conductors indicates that in the late eighteenth and in the early nineteenth centuries collars for the spouts were not a common feature.

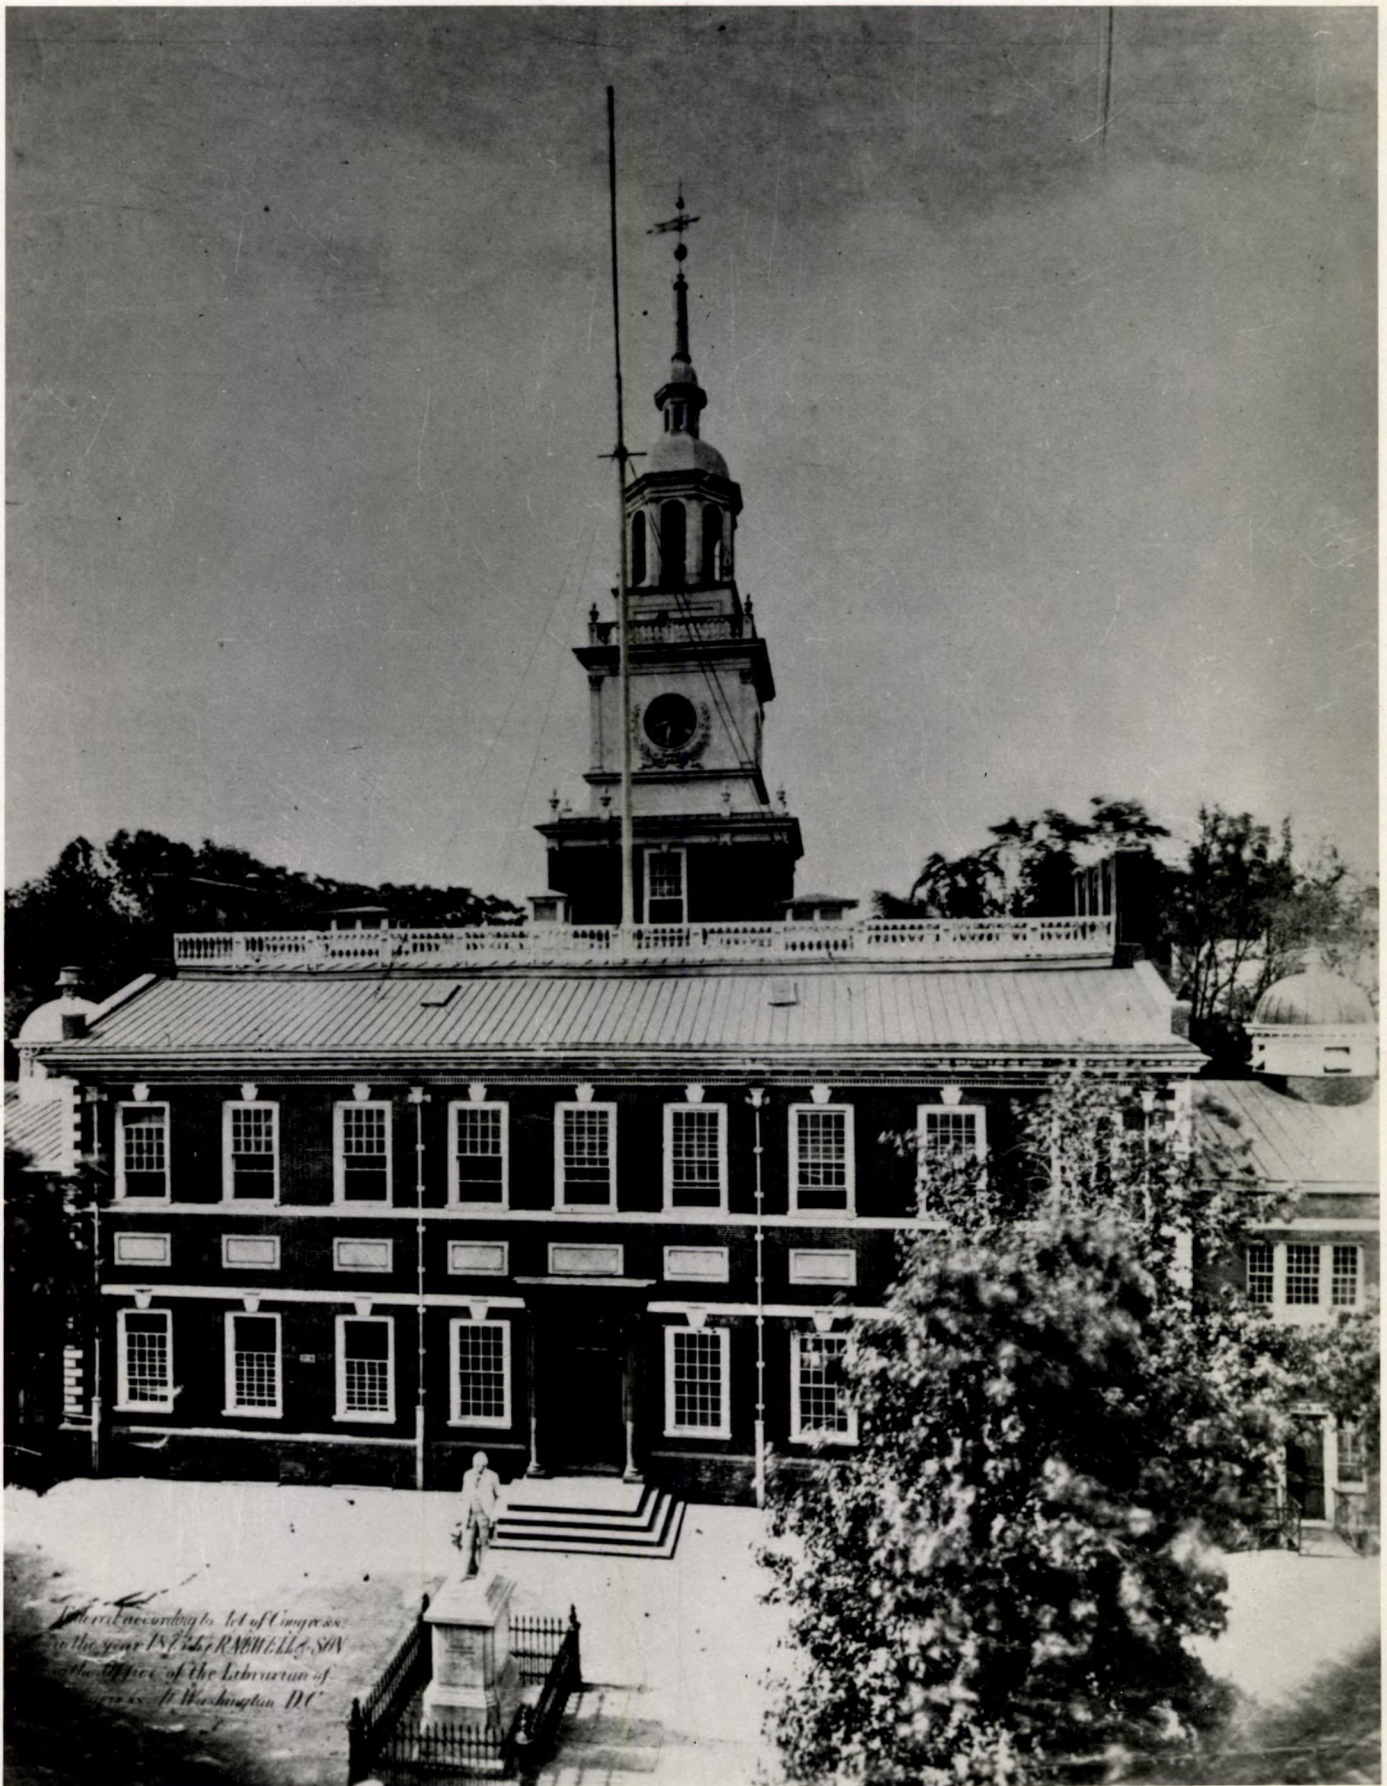
Independence Hall in 1873. Photograph taken prior to the Etting restoration provides detailed view of earlier alterations.  
Courtesy of Historical Society of Pennsylvania.

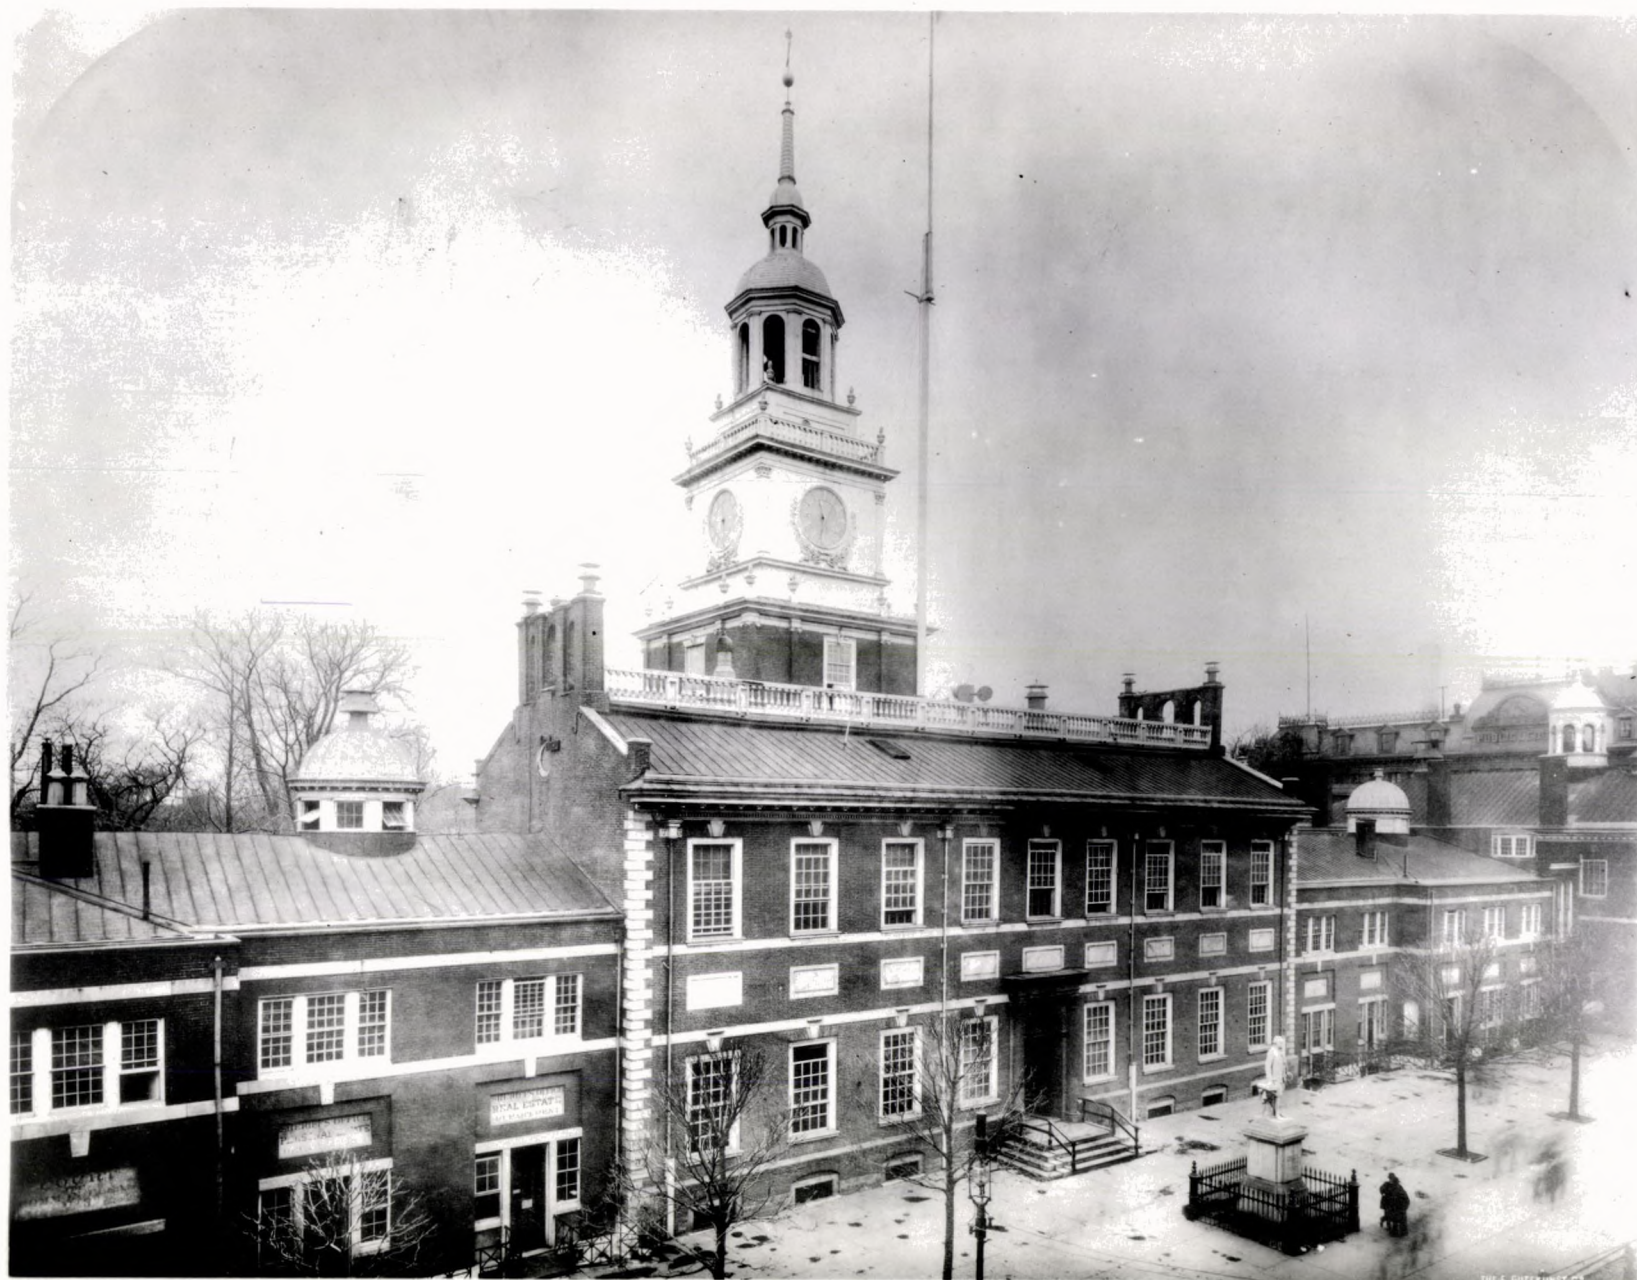
Chapter II  
Illustration No. 9

View of Independence Hall after the Etting restoration (about 1878).  
Note absence of collars from east and west end downspouts.

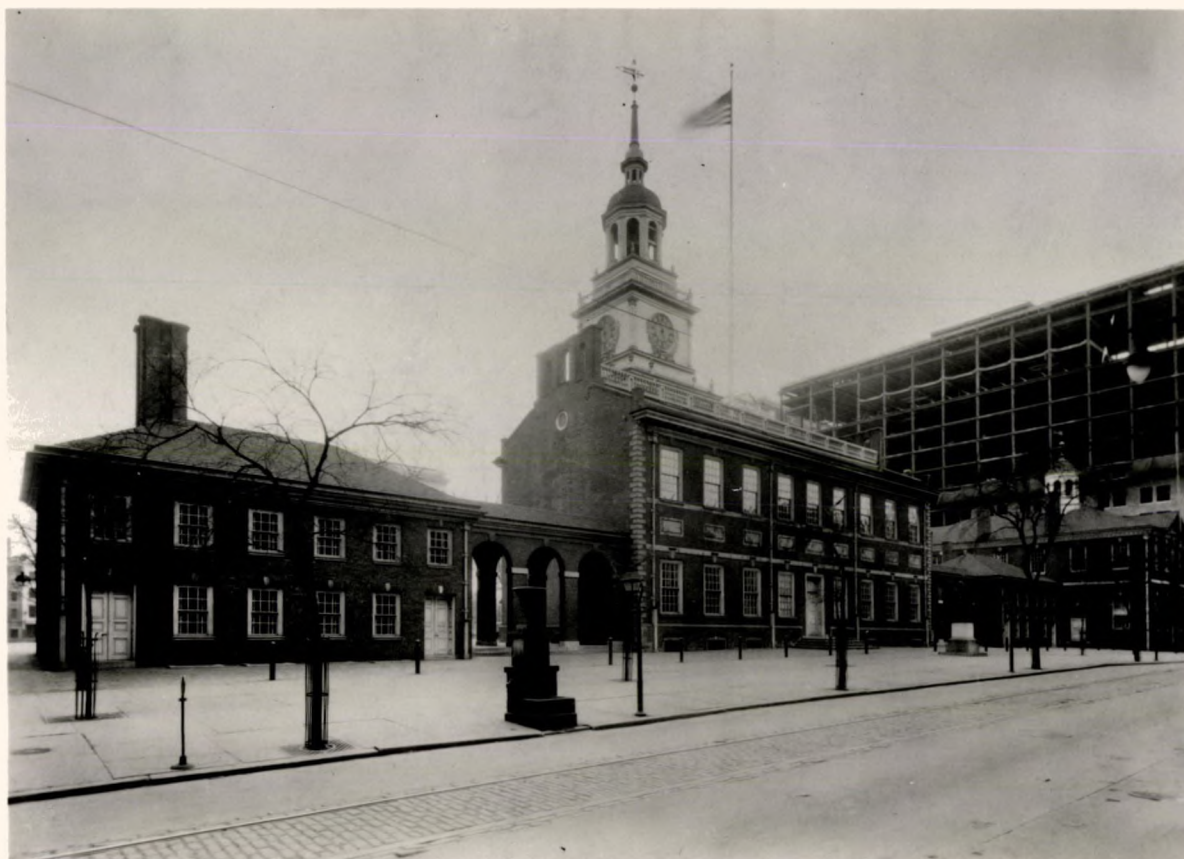
Independence Hall, 1925. The rectangular copper downspouts as they appear today. Courtesy of City of Philadelphia.
