# Status of Climate and Water Resources at Organ Pipe Cactus National Monument

*Water Year 2018*

Natural Resource Report NPS/SODN/NRR—2019/2029

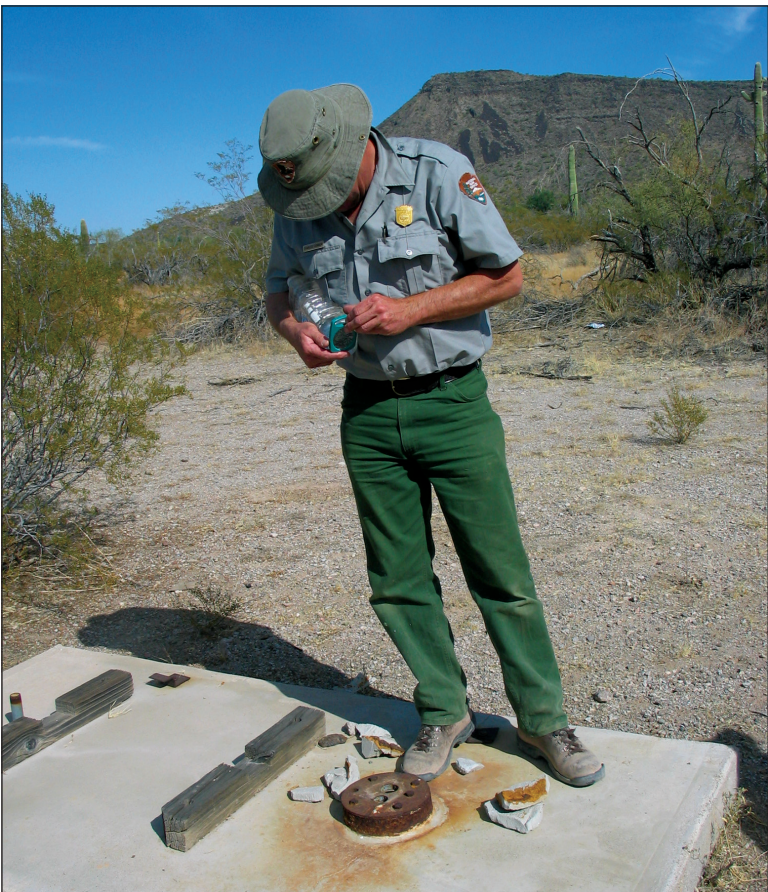
Figure 3-2. Park employee conducting monitoring at the Bates #2 well.

Eight of the monument’s nine monitored wells are visited quarterly by park staff as part of the Organ Pipe Cactus NM Ecological Monitoring Program (Figure 3-2). Headquarters #5 is monitored annually by the Arizona Department of Water Resources (ADWR). ADWR data for Headquarters #5 are available at the ADWR [website](#). The park has several additional wells. Monitoring occurred at most of these in previous years but was discontinued due to decline of water levels below the bottom of the well, obstruction, or other damage. More detailed information on monitoring methods may be found in the SODN groundwater monitoring protocol (Filippone et al. 2014).

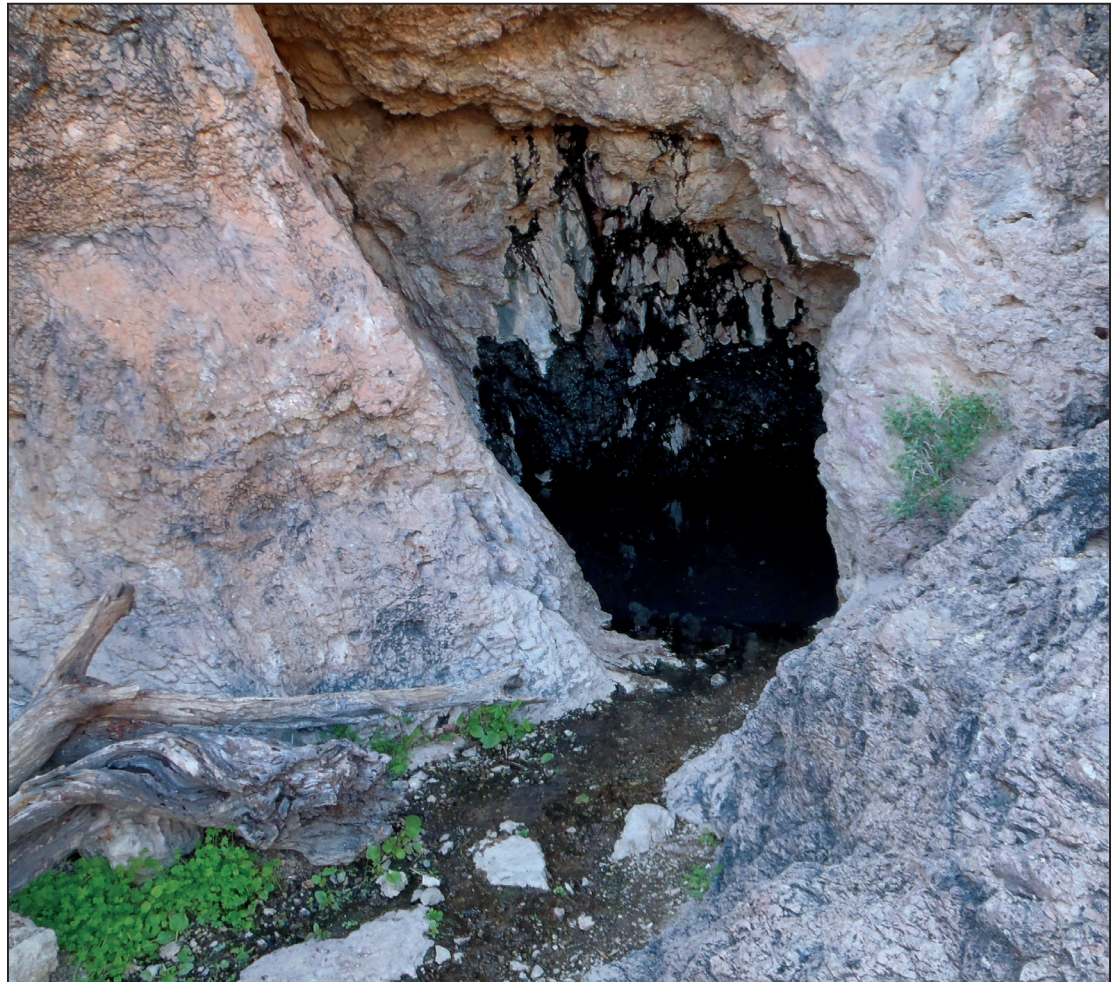
Figure 4-1. Dripping Springs Orifice A and adjacent, non-channelized, wet area resulting from overflow from pool. Organ Pipe Cactus National Monument, March 2018.

Dripping Springs (Figure 4-1) emerges as numerous seeps that flow down a wall recessed in a bedrock cliff to form a bathtub-sized tank. It is fed by numerous seeps

along the back wall of the tank. The spring was wetted during the WY2018 sample. The main orifice (Orifice A) is the largest pool, approximately 2 × 2 × 3 meters (6.6 × 6.6 × 9.8 ft). At time of sampling, it was filled with warm, non-flowing water. A short, damp, non-channelized section of wetted substrate extended from the mouth of the pool toward the hiking trail (Figure 4-1). A small seep (Orifice B) adjacent to the pool generated an amount of water too small to effectively sample.

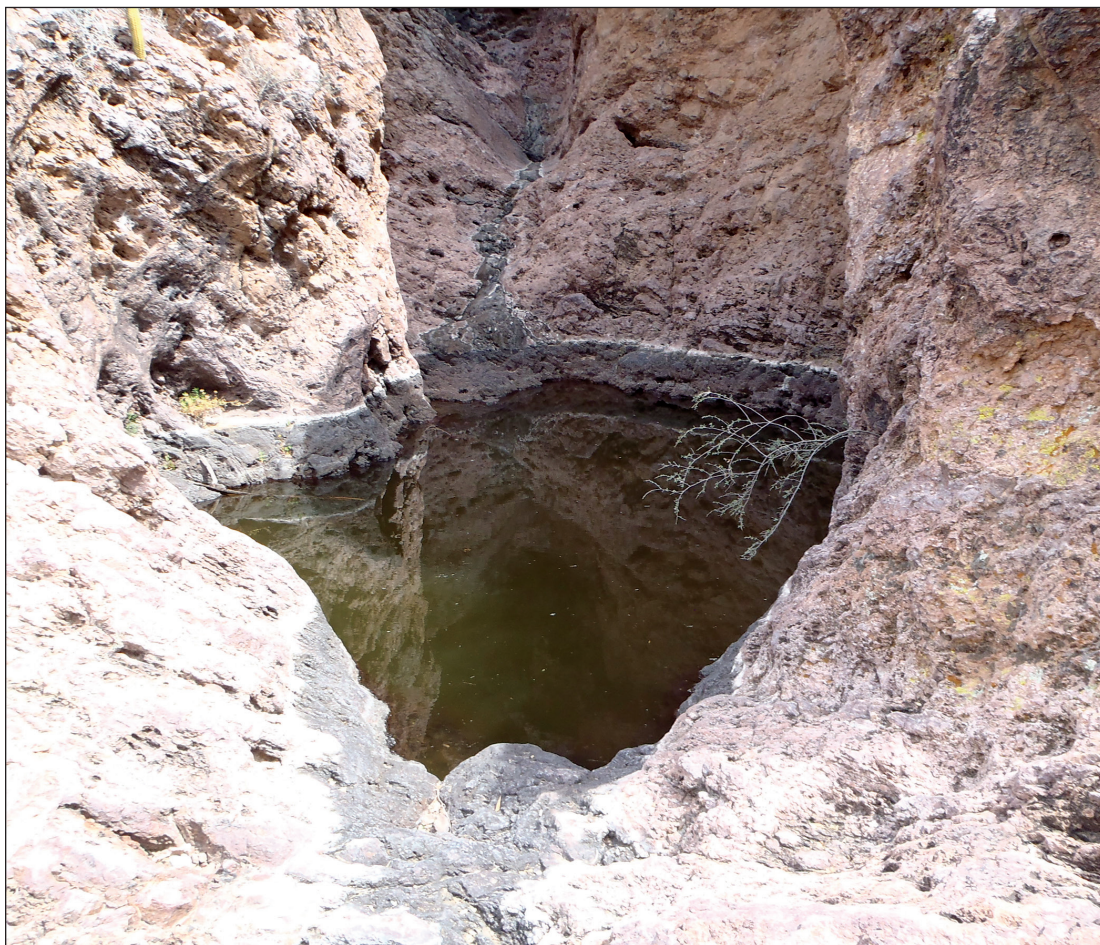
Figure 4-3. East Arroyo Tinaja orifice, Organ Pipe Cactus National Monument, March 2018.

East Arroyo Tinaja (Figure 4-3) is a large, persistent tinaja. The spring was wetted during the WY2018 sample. The primary orifice pool (Orifice A) is a round, 10 × 10-meter (32.8 × 32.8-ft), bedrock tank that lies below a bedrock pouroff. The water is cool and murky, with no apparent movement. Two “bathtub rings” were visible above the pool during sampling, indicating historically higher water levels. The pool was approximately 70–100 centimeters (2.3–3.3 ft) deep, as estimated from the measurement location at the side of the pool. The pool is located in a large, distinct drainage that continues both up- and downstream. A distinct bathtub ring and staining indicate that a persistent channel can form on the two meters (6.6 ft) of bedrock immediately downstream of the pool, though it appears to be shallow, im-

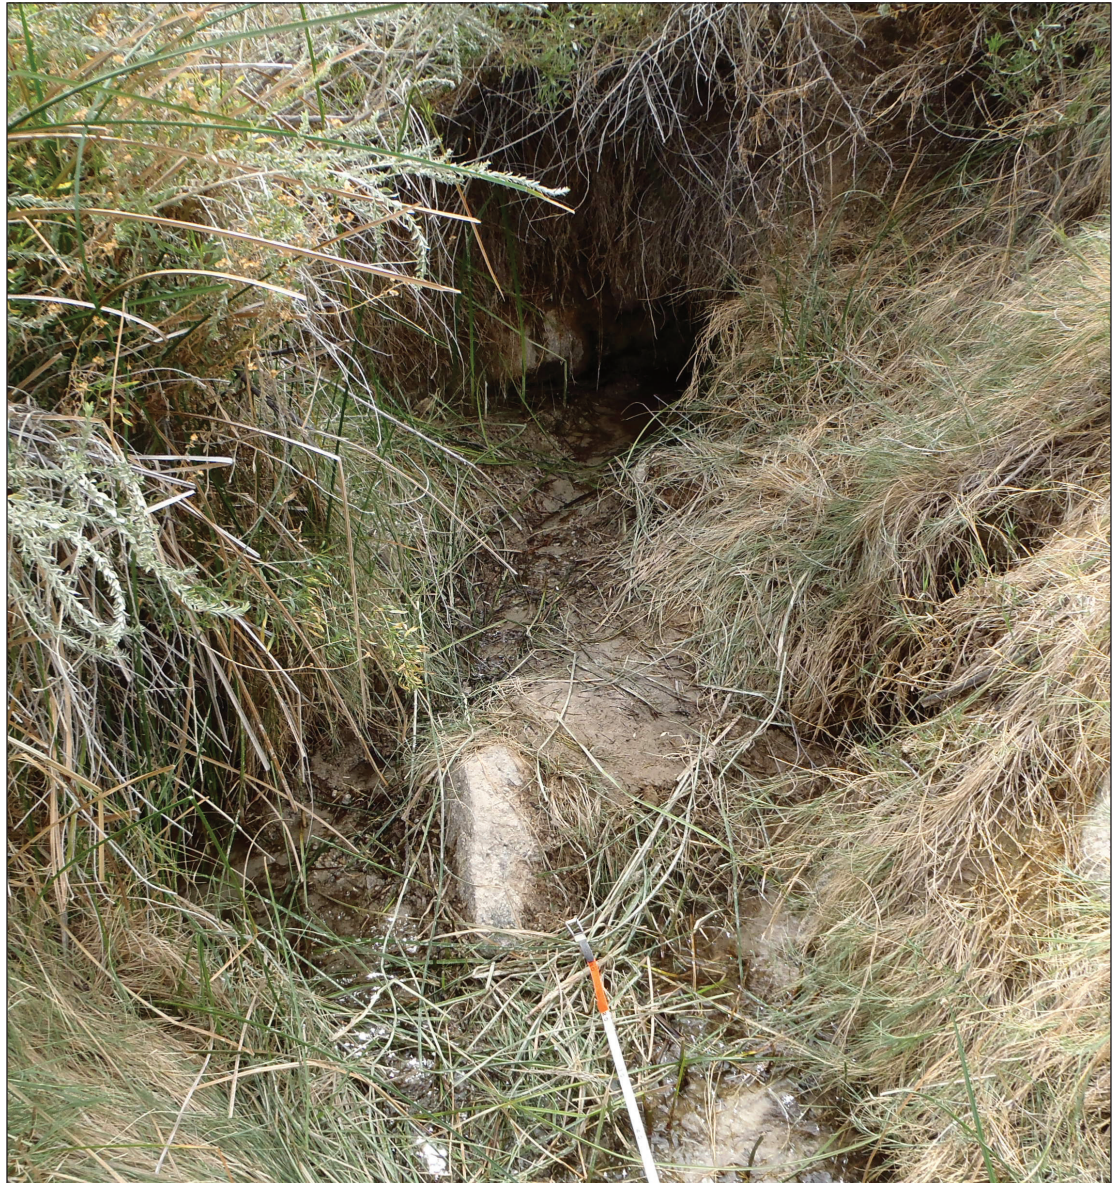
Figure 4-5. Quitobaquito Spring orifice, Organ Pipe Cactus National Monument, March 2018.

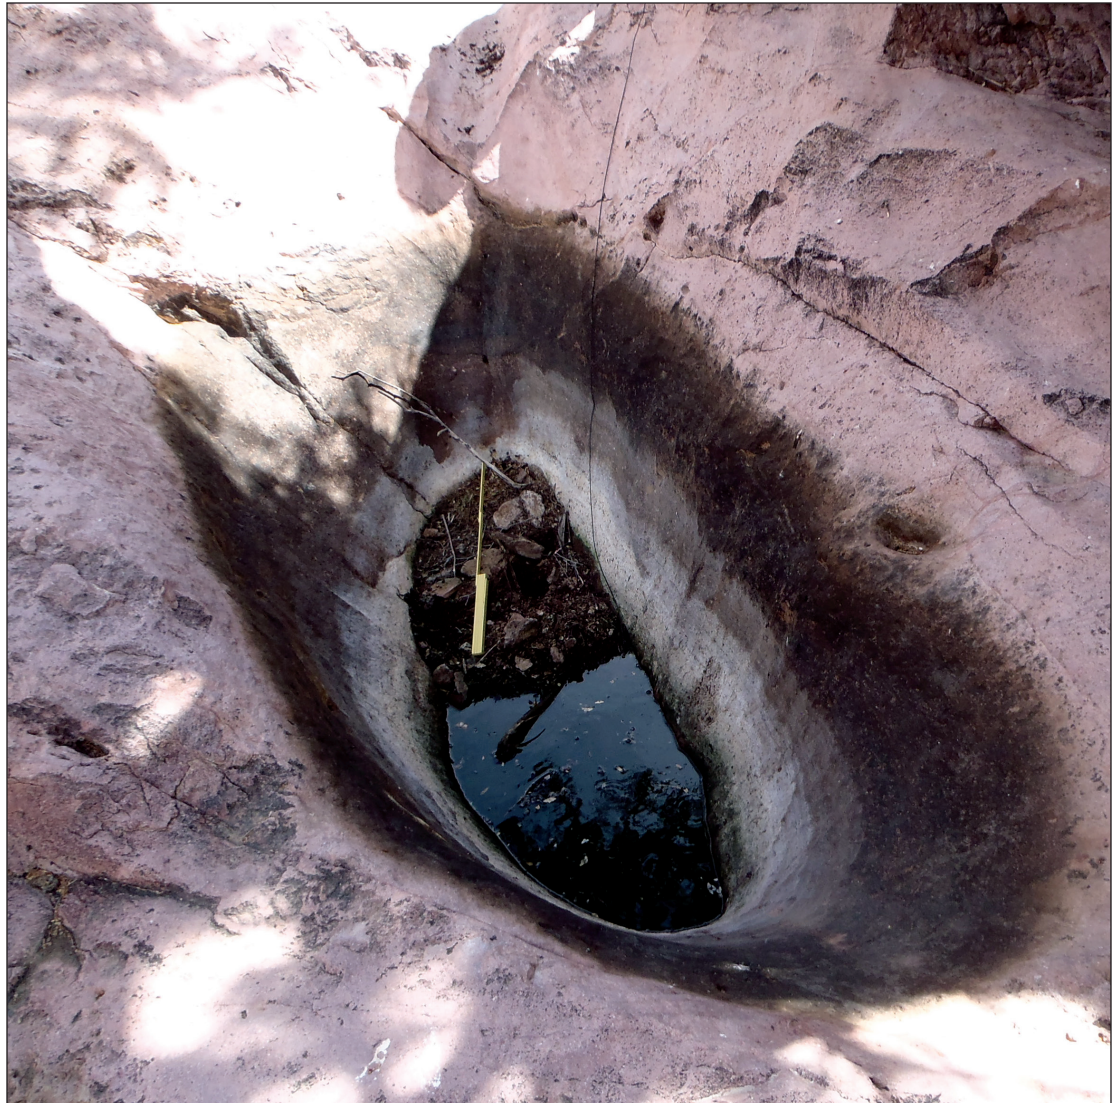
Figure 4-7. Snake Pit Tinaja orifice, Organ Pipe Cactus National Monument, March 2018.

Snake Pit Tinaja (Figure 4-7) is a small, isolated tinaja in the middle of a large channel dominated by gravel and boulders. It contained water at the WY2018 visit. The cool water (15.2°C, 59.4°F) had no visible in- or outflow. While other tanks were noted on the hike in, no others were found in the immediate vicinity.
