# Climate and Water Monitoring at Gila Cliff Dwellings National Monument

Gila Cliff Dwellings National Monument

***Climate and surface water are closely related. At Gila Cliff Dwellings National Monument, the Sonoran Desert Network monitors both to track broad-scale change and provide early warning of potential problems.***

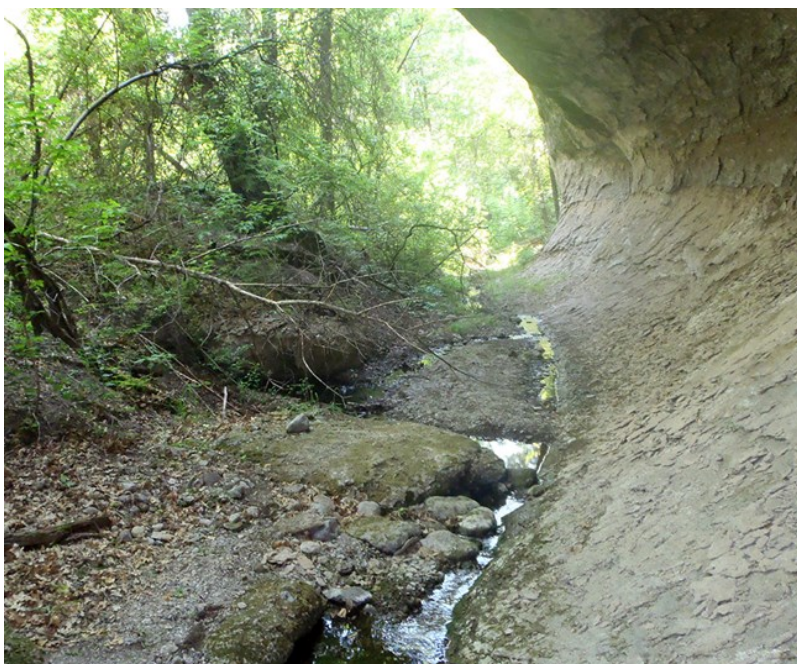
Cliff Dweller Canyon Spring downstream of orifice, May 2019.

Cliff Dweller Canyon Spring is a rheocrene spring (*a flowing spring that emerges into one or more stream channels*). When last characterized (in water year 2017), the spring emerged near a large bedrock wall as a pool below a boulder. The springflow immediately became a shallow, narrow brook, ending as it entered the ground downstream. The brook was interrupted by scattered pools and small, braided sections. The substrate was sand, gravel, and small cobble, with patches of bedrock. The water was uniformly cold and clear, even in pools where flow lost velocity. There did not appear to be surface flow upstream of where the spring emerged from the bed of the ephemeral stream.
