# Preservation/Restoration of Moton Field

Tuskegee Airmen  
National Historic Site  
Tuskegee, Alabama

*Historic Structure Report*  
Hangar Number Two

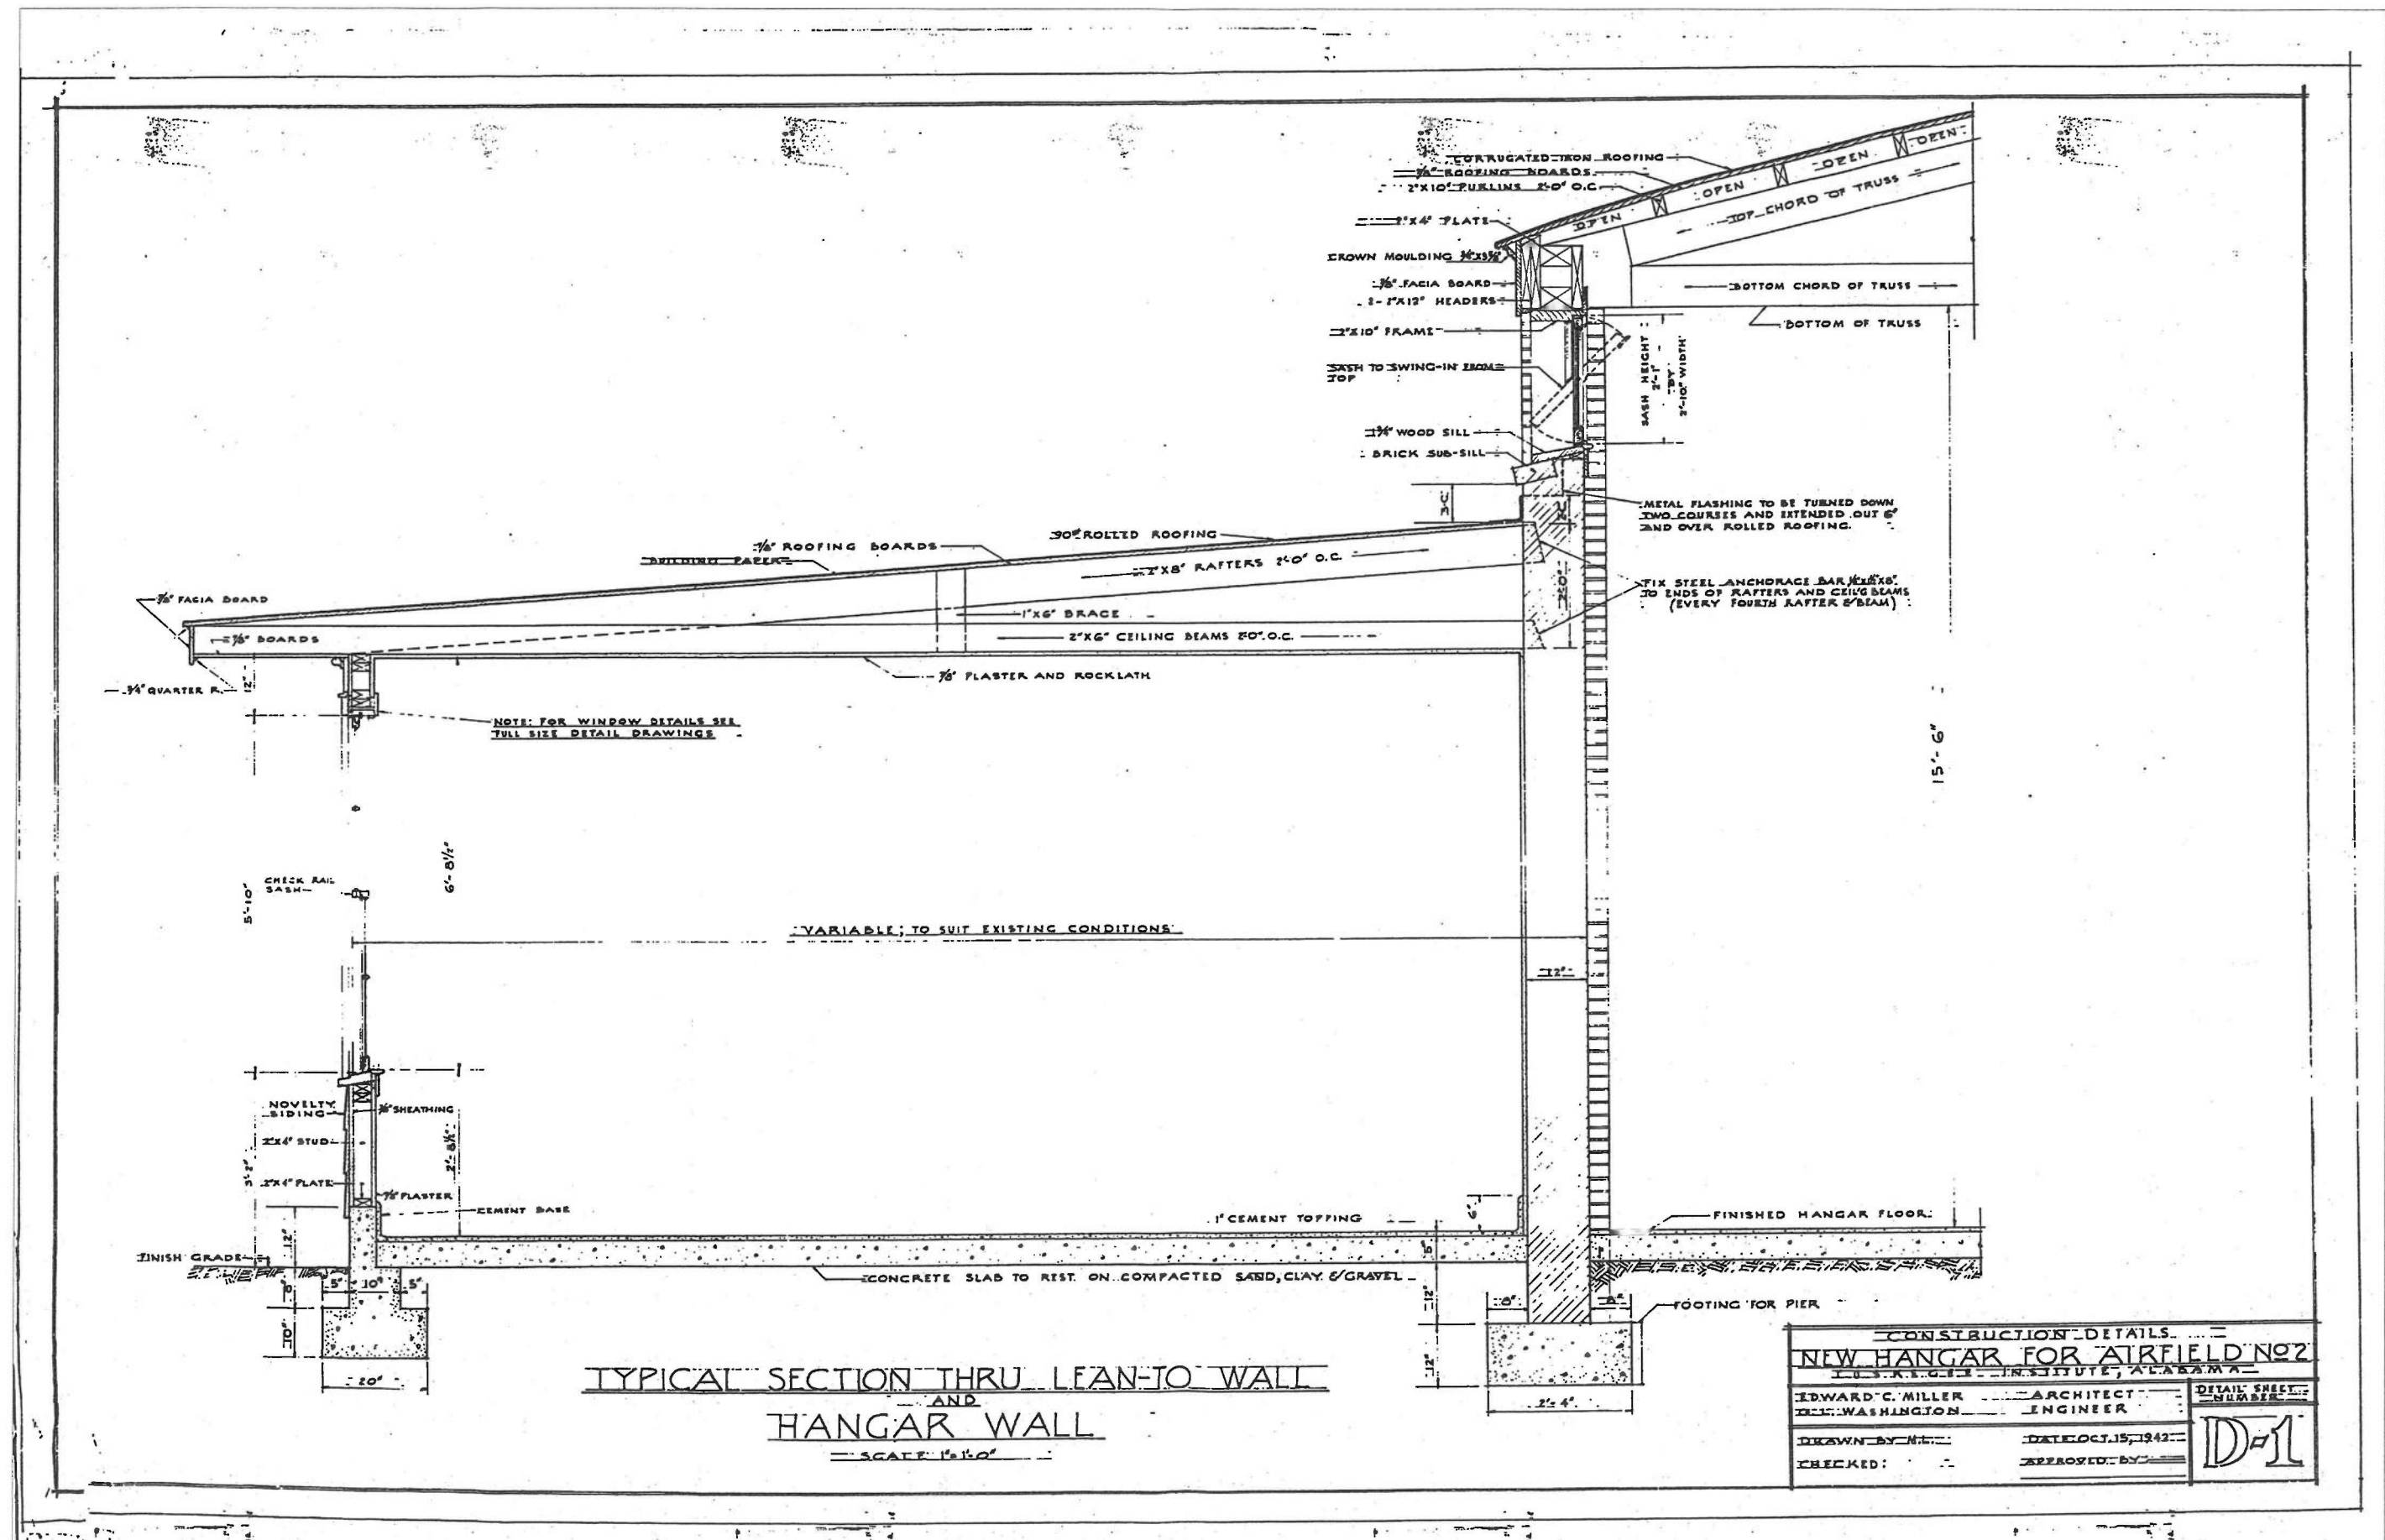
**Figure 2:** Construction details drawing of Hangar Number Two, dated October 15, 1942.  
 Physical Plant, Tuskegee University.

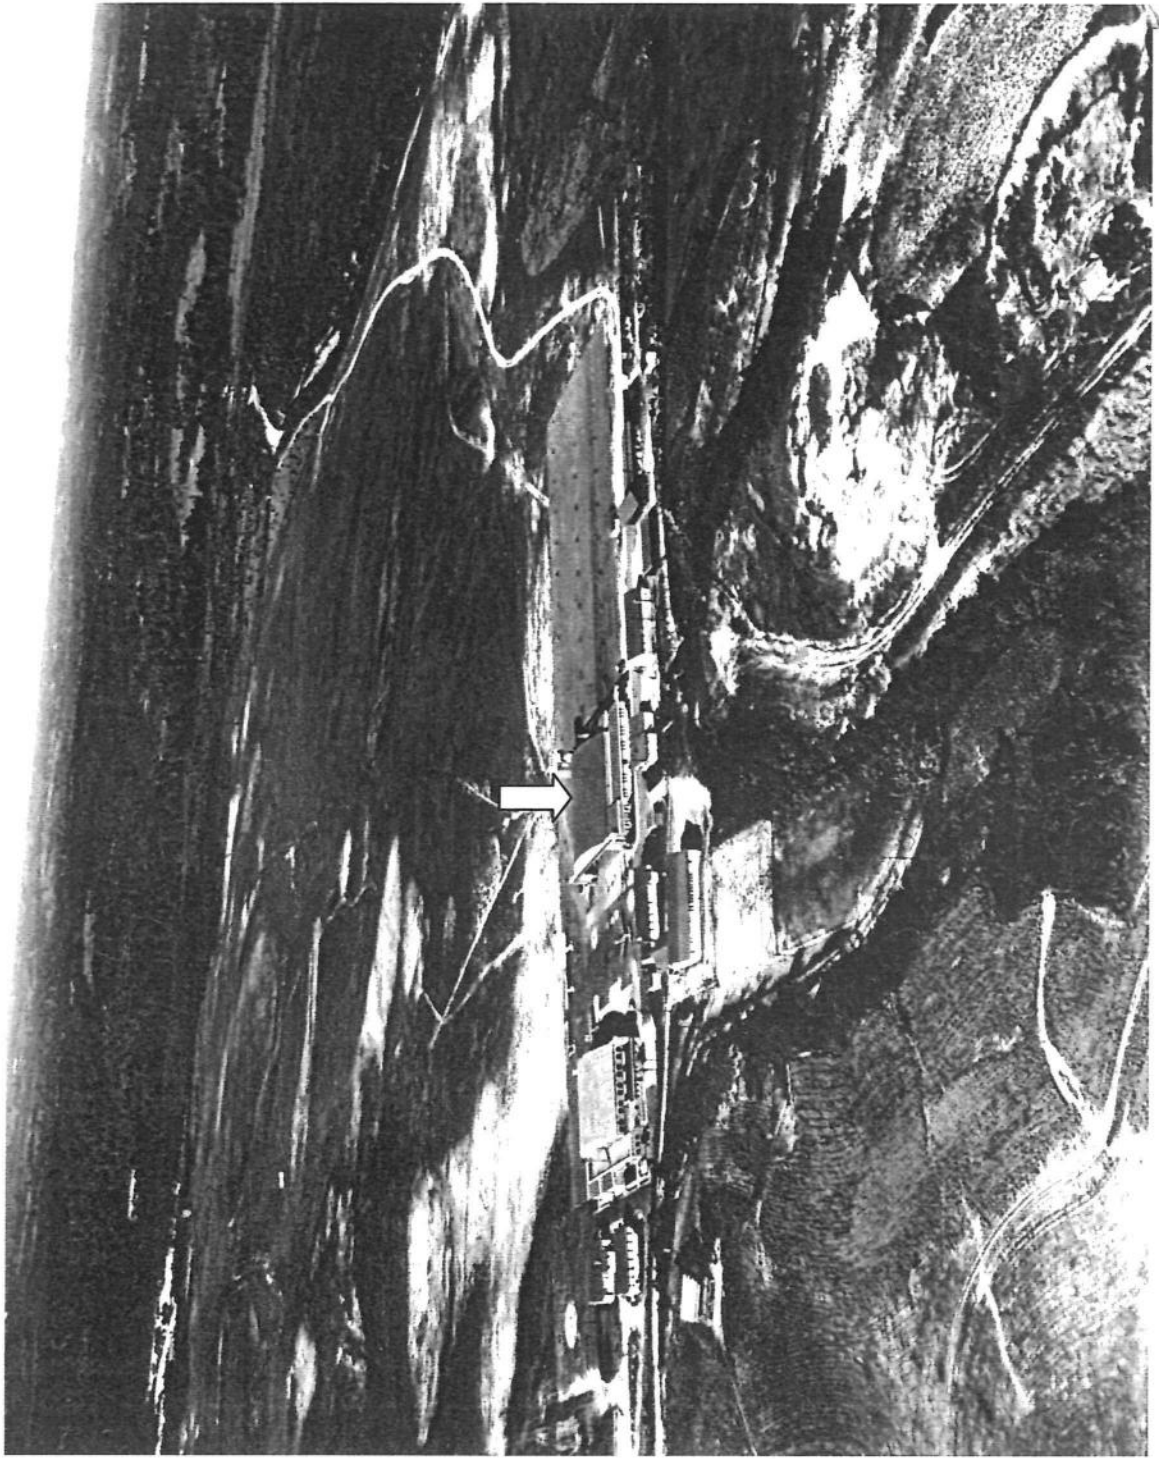
Figure 4: Circa 1945 aerial photograph of Moton Field showing Hangar Number Two. Historic Photograph Collection, National Park Service Curatorial Storage Facility, Tuskegee Institute NHS.

Numerous historic photographs of Moton Field document Hangar Number Two as it was constructed.<sup>32</sup> Two aerial photographs from c.1944 and post-March 1945 provide good views of the hangar.<sup>33</sup> (See *Figure 4*.) According to these photos and the original architectural drawings, the large hangar area was constructed of brick masonry. The dope room on the building's southwest corner, the boiler room on the rear east facade, and the control tower were also of brick construction for fire safety purposes. The remainder of the perimeter rooms around Hangar Number Two were of frame construction finished with novelty wood siding. (See *Figures 5, 6*.) The hangar's segmentally arched roof was covered with roll roofing rather than the corrugated metal used on the first hangar. (See *Figure 7*.) A number of historic interior photos of Hangar Number Two also exist, documenting some interior finishes and furnishings. (See *Figure 8* and *Appendix A*.)

The c.1945 aerial photograph provides a view of the south and west sides of the hangar. (See *Figure 4*.) The entire south side of the hangar space and the perimeter rooms is visible. Also, the west side of the large hangar space with sliding hangar doors can be seen. This photograph confirms that the window and door openings, frame and masonry walls, shed roofs, and other details that can be seen of the south perimeter room facade match those of the 1942 architectural drawings.

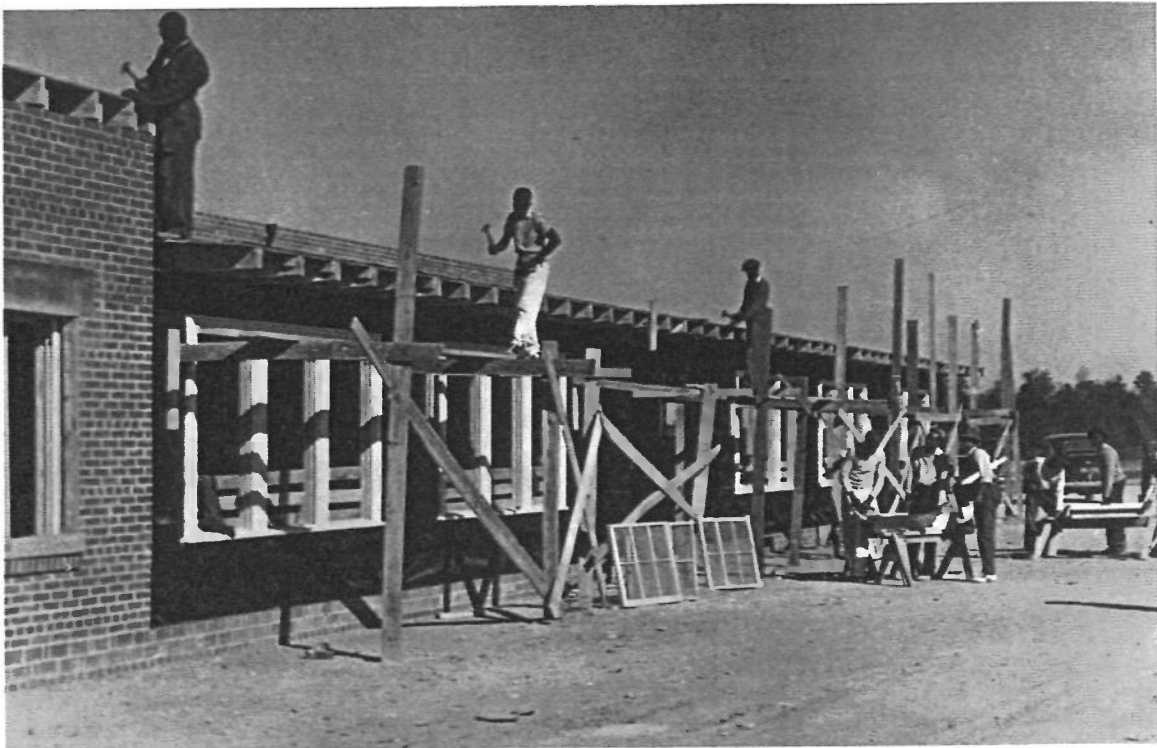
**Figure 5:** Historic photograph of Hangar Number Two perimeter rooms under construction. Historic Photograph Collection, Howard University.

A photograph of the south side perimeter rooms under construction clearly shows the masonry wall of the dope room, the frame wall of the link trainer room and class room, the shed roof structure, and window and door openings. (See *Figure 5*.) Another historic photograph from April 1945 shows cadets and visitors sitting on benches outside the north wall of the north side perimeter rooms. (See *Figure 6*.) This photo shows details of the six-over-six double-hung windows, window screens, window moldings, novelty wood siding, a door with a frame canopy above it, and boxed eave overhangs with vents there were part of the frame portion of the north side perimeter rooms. The window and door arrangement and other details shown in the photo match the window and door arrangement and details for the north side perimeter rooms indicated on the original 1942 architectural drawings. A third photograph also shows the north side perimeter rooms with cadets sitting in front of it. (See *Appendix A*.) As in the previous photo, the window and door arrangement and details match those of the original architectural drawings. A fourth photograph shows a portion of the north side perimeter rooms from an angle looking toward the Control Tower. (See *Appendix A*.) This photo documents the evidence of frame canopies above the door openings along the north side of the perimeter rooms. Also, two light fixtures on the hangar's northwest corner are visible. A fifth historic photograph documents the roof of Hangar Number Two. (See *Figure 7*.) The roll roofing on both the hangar space and the perimeter rooms, the horizontal siding, window openings, and vent of the east roof end, and the brick chimney on the north side of the boiler room are all visible. A sixth photograph

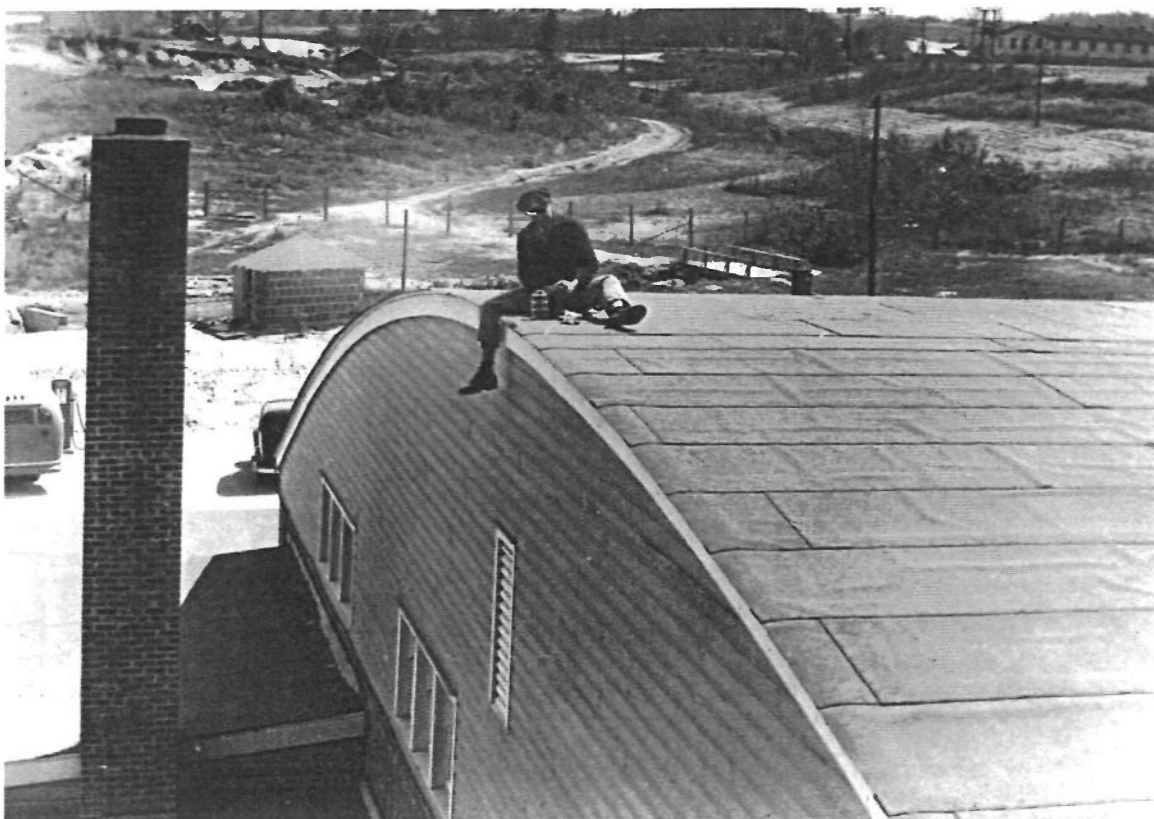
**Figure 7:** Historic photograph documenting the roof of Hangar Number Two. Historic Photograph Collection, Howard University.

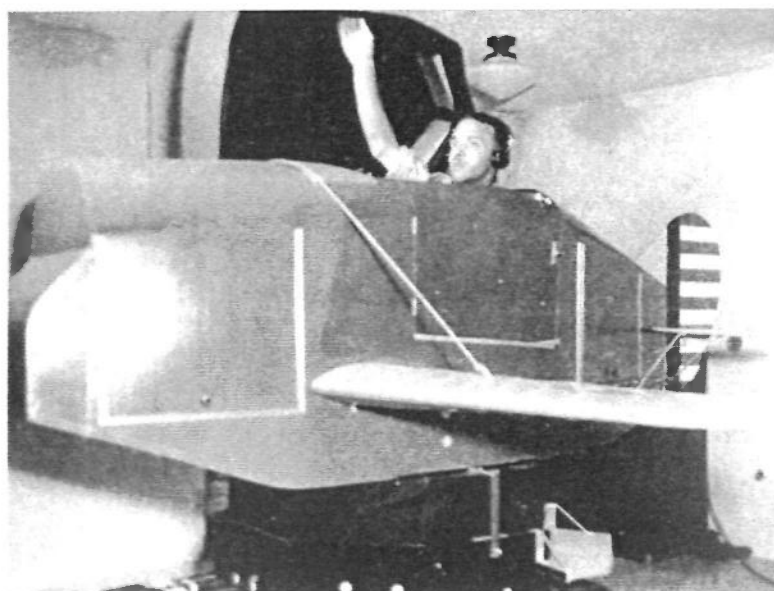
**Figure 8:** Historic photograph of a cadet in the Link Trainer Room in Hangar Number Two. Historic Photograph Collection, AFHRA, Maxwell AFB.

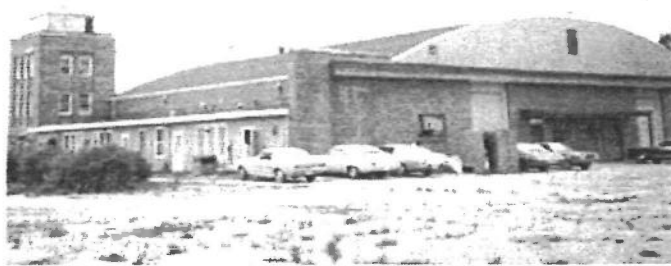
**Figure 9:** 1977 photograph of Hangar Number Two showing alterations made by the Tuskegee University Veterinary School. Booker Conley's Files, Physical Plant, Tuskegee University.

drawings were prepared by the architectural and engineering firm Lockwood Greene for more alterations to the hangar for the Veterinary School.<sup>35</sup> The hangar was used for environmental labs for the school's large animal practice, which included cattle and swine. A very large door was reportedly put into the hangar to accommodate giraffes, but it is not known if any giraffes were actually brought there.<sup>36</sup> A large number of animal corrals and pens used by the school were located at the rear of Hangar Number Two. Photographs from the 1970s illustrate these alterations.<sup>37</sup> (See *Figure 9*.)
