Department of Naval Architecture and Ocean Engineering  
Ocean Engineering Capstone Design

## Flooding and Erosion in Fort Castillo de San Marcos

by  
Team Monuments Pals

April 28, 2020

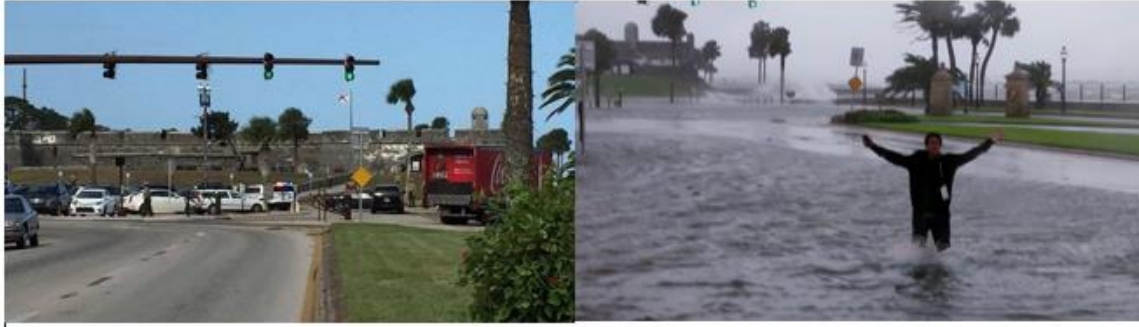
Extreme storm events threaten the functionality of the National Park Headquarters to the north and the parking lot to the south. Figure 2 shows the southern road leading to the entrance of the parking lot. The right portion of Figure 2 shows the result of 3 feet of flooding due to the storm surge associated with Hurricane Irma in 2017.

**Figure 2: Avenida Menendez road stoplight located at the entrance to the parking lot. The right image shows the results of 3 feet of flooding during Hurricane Irma in 2017 (Kaijuzilla)**

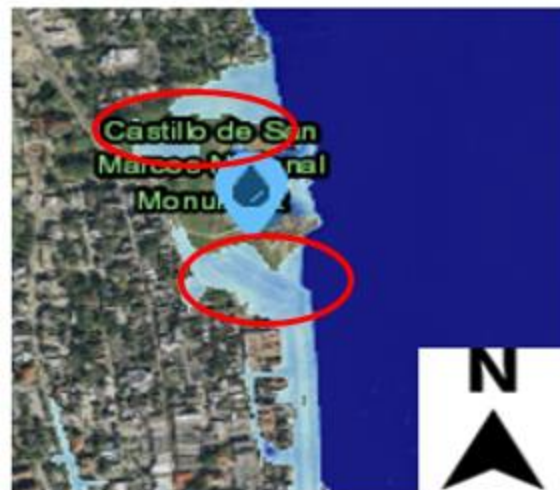
**Figure 5: Aerial view of the potential flooding areas due to a storm surge of 3 feet above MHHW (NOAA Sea Rise Viewer tool).**

Figure 5 shows significant flooding impact on the southern parking as well as the city streets along the seawall with a storm surge of 3 feet above MHHW. Flooding also reached the northern headquarters location and neighboring area.

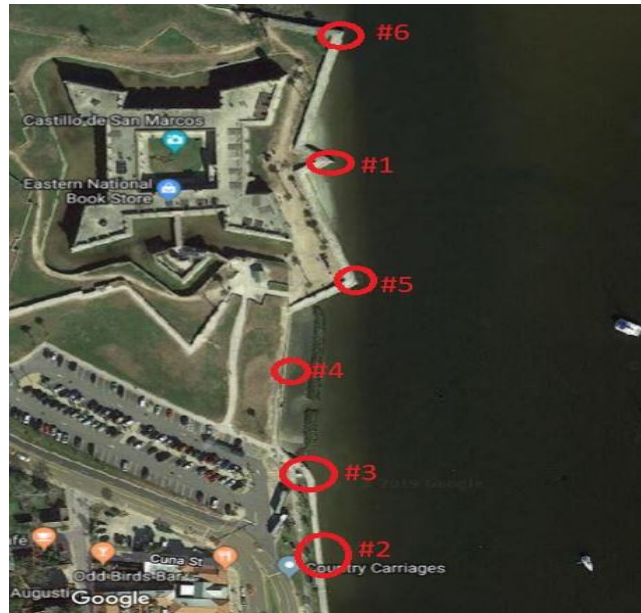
While walking from the north wall to the south wall, six different measurements were taken to find water temperature, salinity, conductivity, dissolved oxygen and pH as shown in Table 1. The locations of these measurements are shown in Figure 10. These values were able to guide the group on understanding mangrove growth and where their growth will be the most successful.

**Figure 10: Location of Measurements (Google Maps, 2019)**

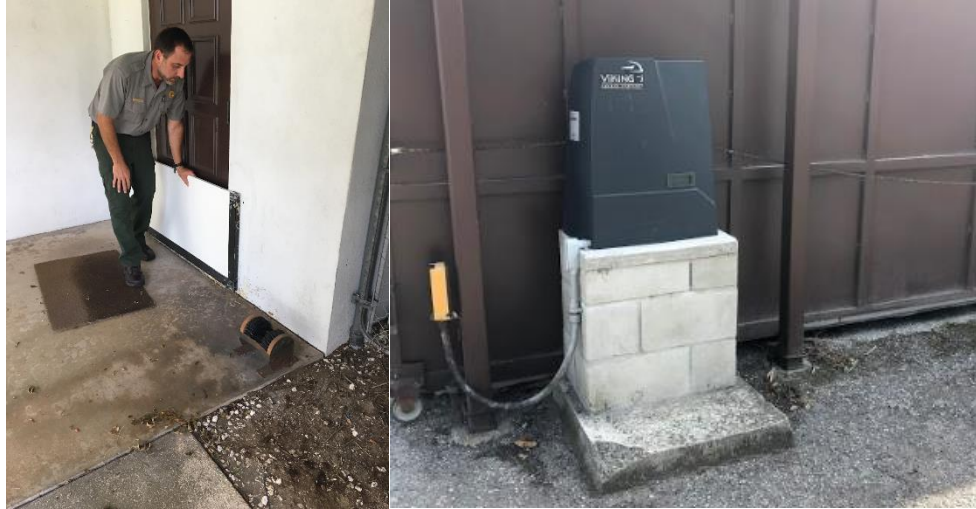
**Figure 11: Headquarters Raised Structures and Flood Walls**

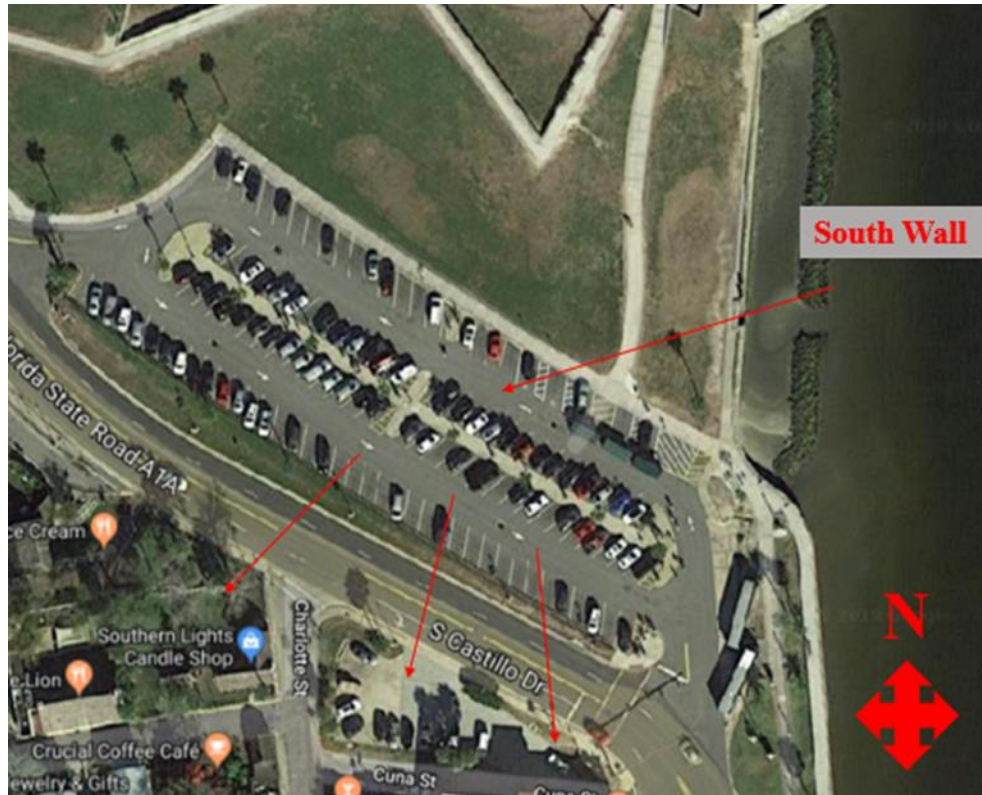
The south wall flooding was different from the north. The rangers explained that the south wall would flood, leading to flooding to the parking lot, and finally to downtown St Augustine, shown in Figure 12. They also stated that the parking lot was a vital part of their income, and its downfall would cause major economic effects. Additionally, unlike the north wall, the south wall did not have any mangroves but did have oyster growth and a breakwater as shown in Figure 13. Though the breakwater did lower the wave energy, it only did so at low tide. During high tide, the breakwater was almost completely submerged, lowering wave energy slightly and not limiting flooding at all, as shown in Figure 13. The breakwater also did nothing for sediment transport. With only two small inlets, there was no sediment being built up over time.

**Figure 12: Map of South Wall and Parking Lot. Arrows signify direction of flood flow. (Google Maps, 2019)**

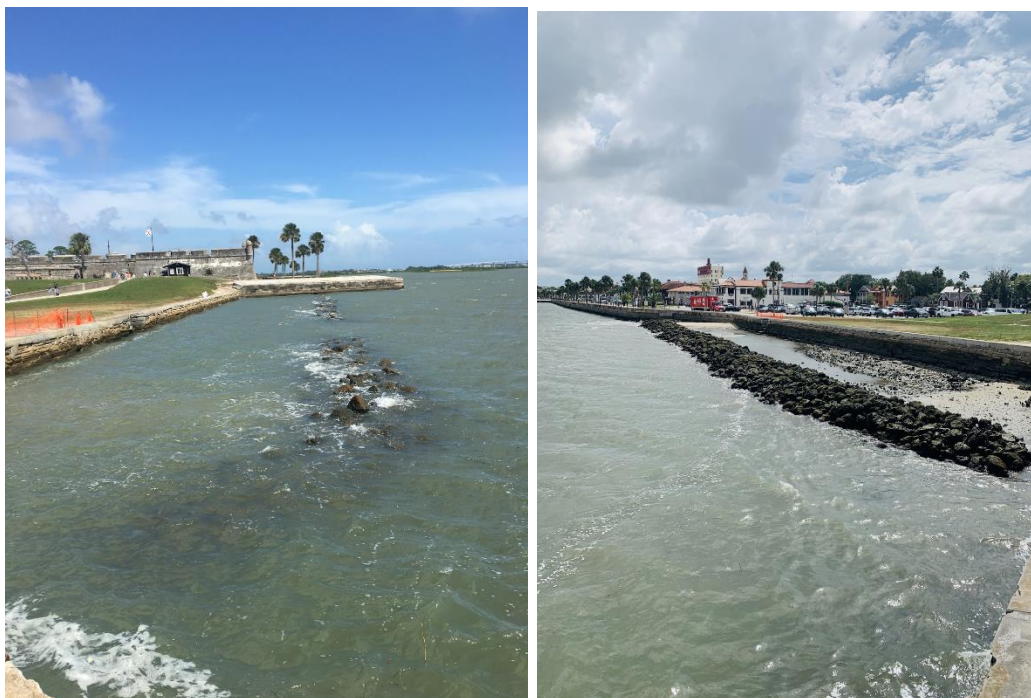
**Figure 13: South Wall at High and Low Tide**

From the earlier discussion of site conditions and orientation that the south seawall has an ineffective breakwater due to its low elevation at high tide as shown in Figure 33. Therefore, a possible alternative would be to build a revetment in place of this breakwater. A revetment would involve a design toe, slope, and splash in accordance to the wave energy hitting the southern wall along the lines of the design taken from the Coastal Engineering Manual, shown in Figure 33.

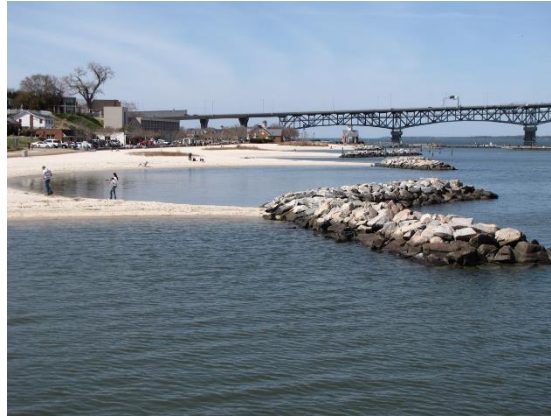
One of the design alternatives to prevent erosion on the north side of the fort is a breakwater. Figure 19 is a real life example that is trying to be matched. It is a breakwater on the York River in Virginia and works to break down wave energy and create a tombolo. A tombolo, shown in Figure 20, is an example of sand accretion which extends the beach and limits erosion. Limiting erosion, sand accretion and the dissipation of wave

**Figure 19: Breakwater example (National Park Service Breakwater, 2012)**

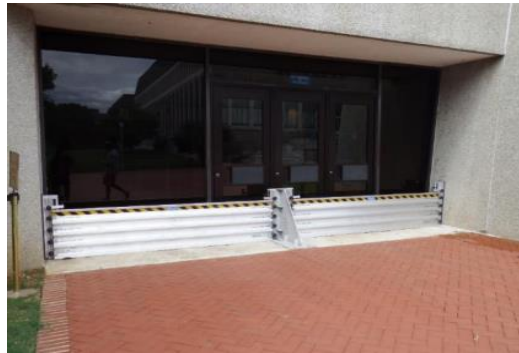
One of the main focuses of the project was flood-proofing the headquarters on the north side of the project area. Traditional flood proofing tactics are extremely effective in limiting flooding of the building. Tactics such as placing vertical bulkheads with removable flood barriers as shown in Figure 23, and elevating the building as shown in Figure 24 produce efficacious results that will prevent further flooding to the building. While these tactics may be effective, they require manual labor for installation before heavy tides/storms/hurricanes. Building elevation may also be cost-prohibitive. Another tactic for protecting the headquarters deals with wet flood proofing. Wet flood proofing allows the water to enter the building, but it creates holes throughout the building to allow water to flow out. Figure 25 shows an example of wet flood proofing for the headquarters. Wet flood proofing can be advantageous because it is fixed, immovable, and does not require any manual labor before rising water levels. This tactic does allow

**Figure 23: Flood barriers outside Rickover Hall at USNA**
